Upper Bulkley floodplain habitat:  
modifications, physical barriers, and sites of  
potential importance to salmonids

Final Report

April 21, 2014

Prepared by Michael H.H. Price, on behalf of SkeenaWild Conservation Trust

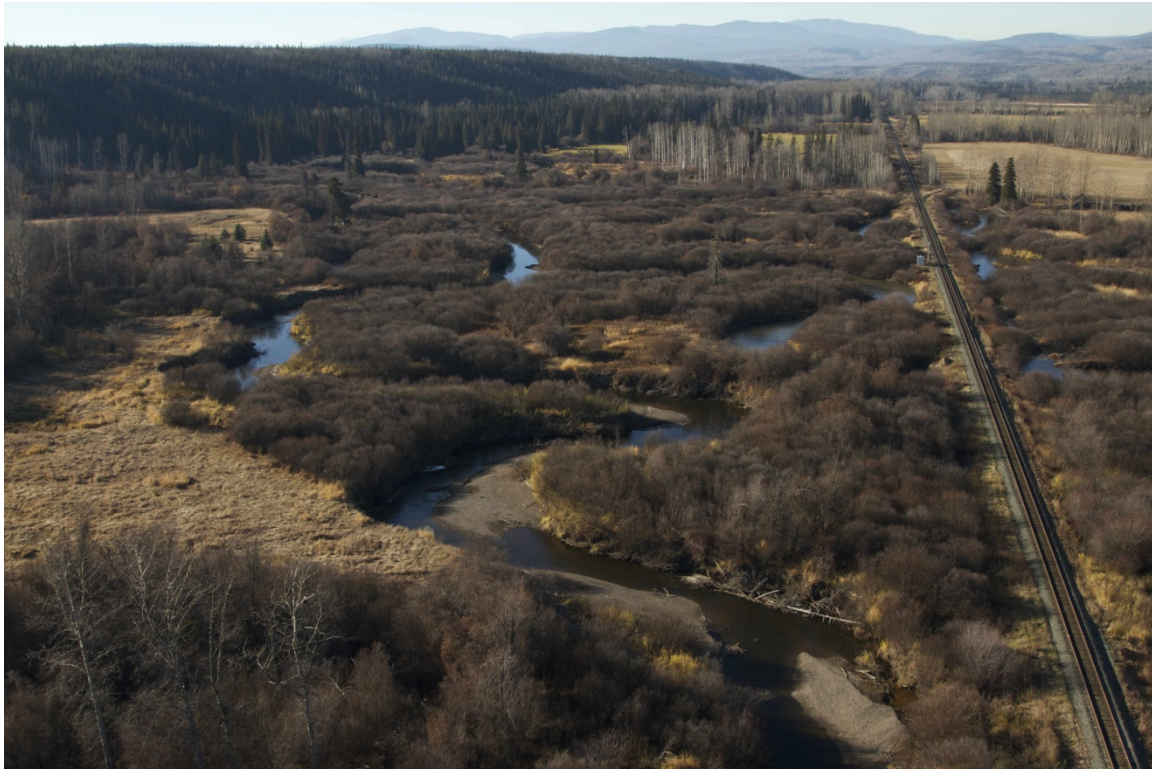
**Figures 1 and 2.** Confinement of the Upper Bulkley River due to railway infrastructure (top), and use of rip-rap to stabilize “Forestdale” road on the Upper Bulkley River 2km downstream of Bulkley Lake (bottom), October 2013. Photos: Brian Huntington.

increased sediment delivery, loss of floodplain connectivity, and increased peak flows. The ongoing periodic removal of large logjams by CNR removes key elements of water and sediment storage and energy dissipation, decreases channel complexity, and directly contributes to the loss of fish habitat as the channel becomes more incised and disconnected from the floodplain. Highway 16 also traverses the length of the Upper Bulkley River, with similar associated impacts to riparian habitat and floodplain functioning. All habitat modifications observed involve the use of rip-rap (Figure 2).

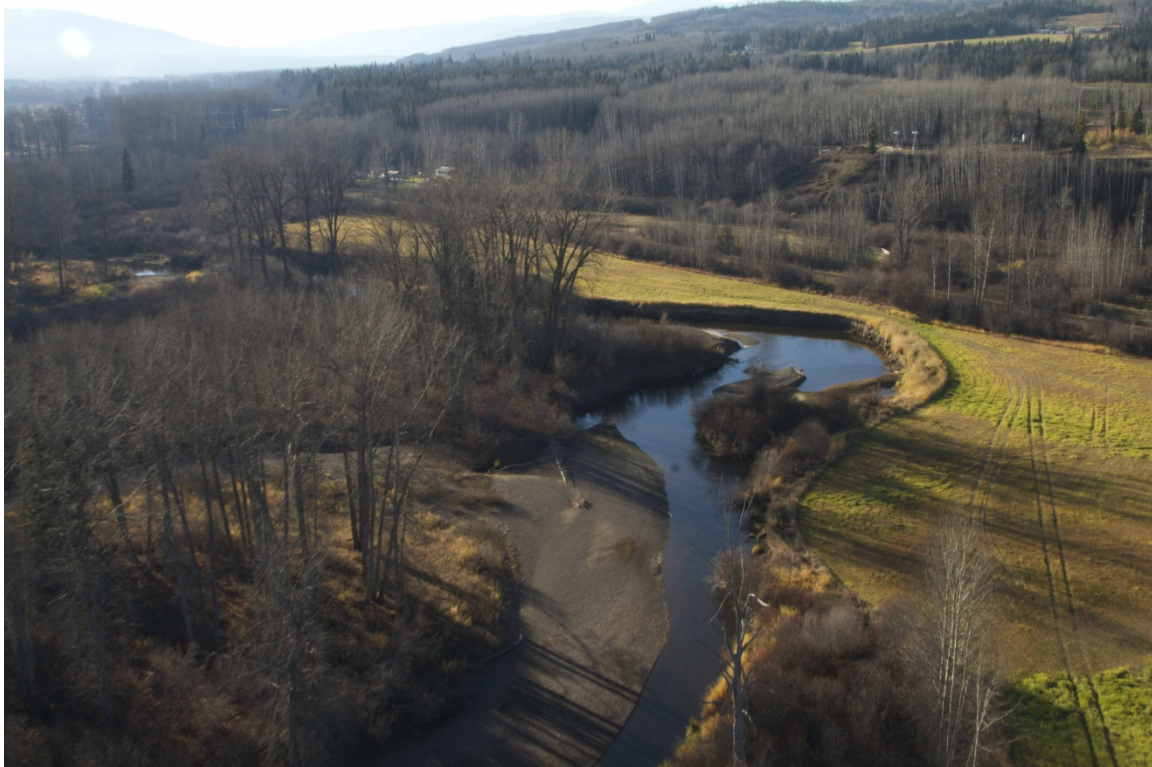
**Figures 3 and 4.** Hayfield extending to the bank of the Upper Bulkley River (top), and cattle on the river bar (bottom), October 2013. Photos: Brian Huntington.

Regarding agriculture, five ranches and 20 hobby farms running approximately 500 breeding cows were operating in the Upper Bulkley as of 1996 (Remington and Donas 2001); however, this number currently needs to be substantiated. Hayfields commonly extend to the bank of the Bulkley River (Figure 3), and much of the non-native grains and grasses have replaced native low-lying riparian vegetation occurred. Finally, two separate herds of cattle were recorded on the bank of the Bulkley River during the observation flight (Figure 4).

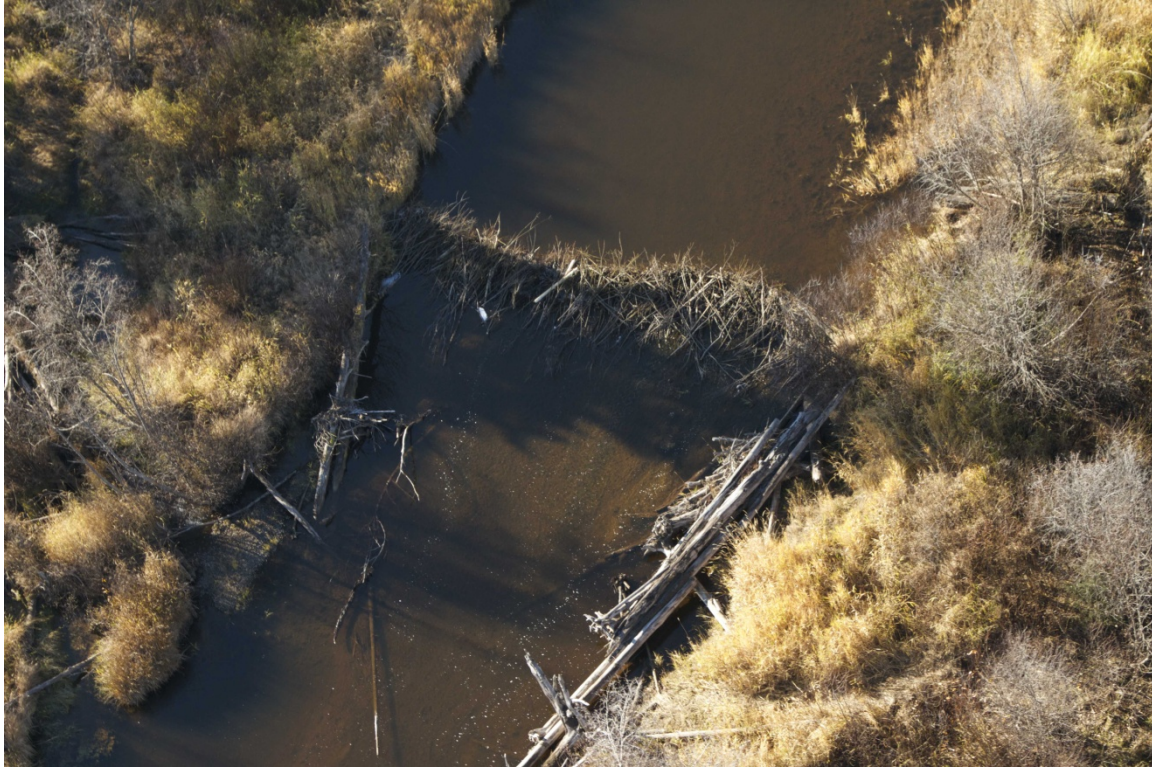
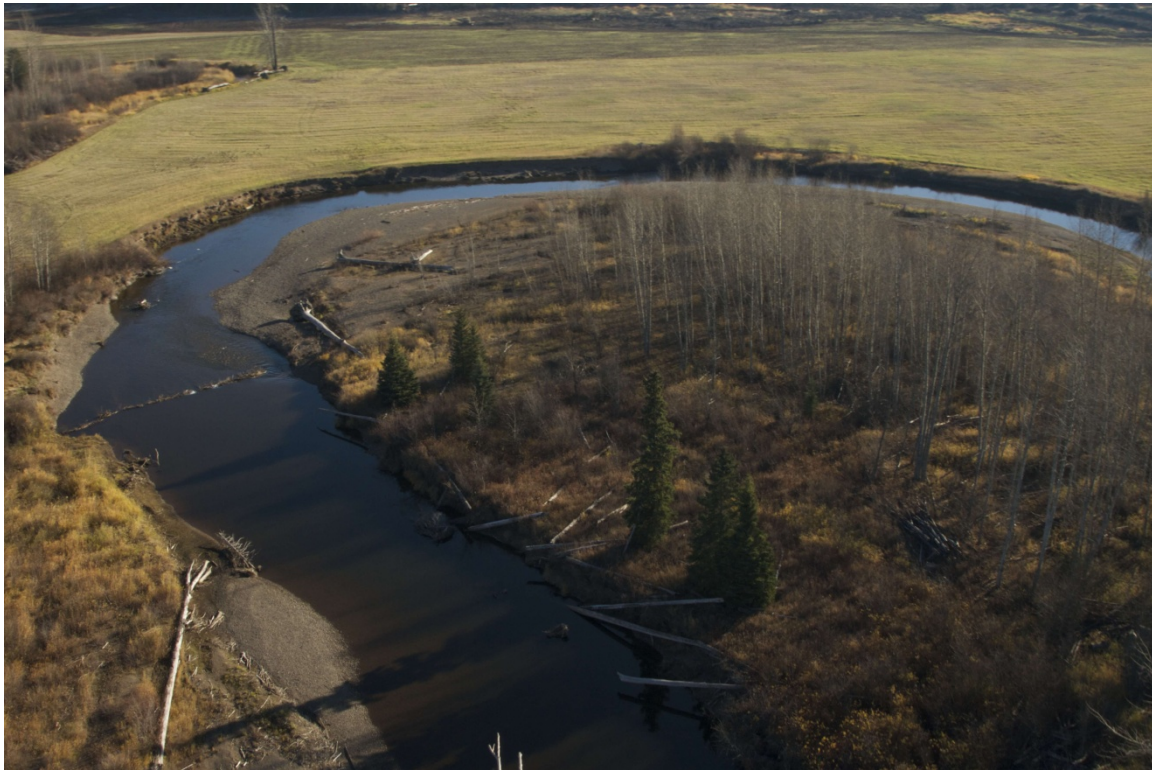
Beaver dams have long been cited as a potential barrier to adult salmon migration along the Upper Bulkley River. Of the 27 beaver dams observed (Table 3), 5 were located between Maxan Lake and Bulkley Lake (Figure 5), and 21 beaver dams were observed between Bulkley Lake and Houston (with 9 dams situated between Houston and Bulkley Falls). Eight of the beaver dams appear to have been breached, and may not constitute a physical barrier to salmon (Figure 6); though the release of an aging beaver impoundment may send a debris torrent downstream.

**Figures 5 and 6.** Beaver activity - intact dam (top), and breached dam (bottom) - recorded on the Bulkley River upstream of Morice River to the headwaters at Maxan Lake, October 2013. Photos: Brian Huntington.

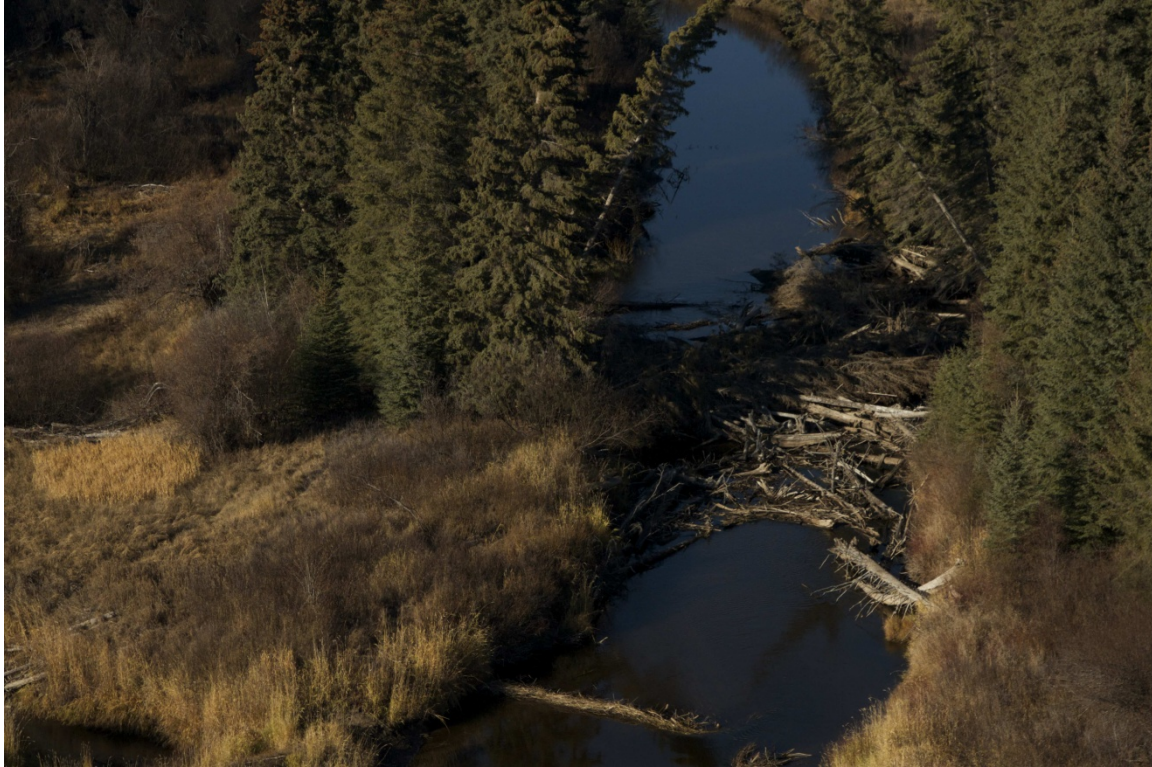
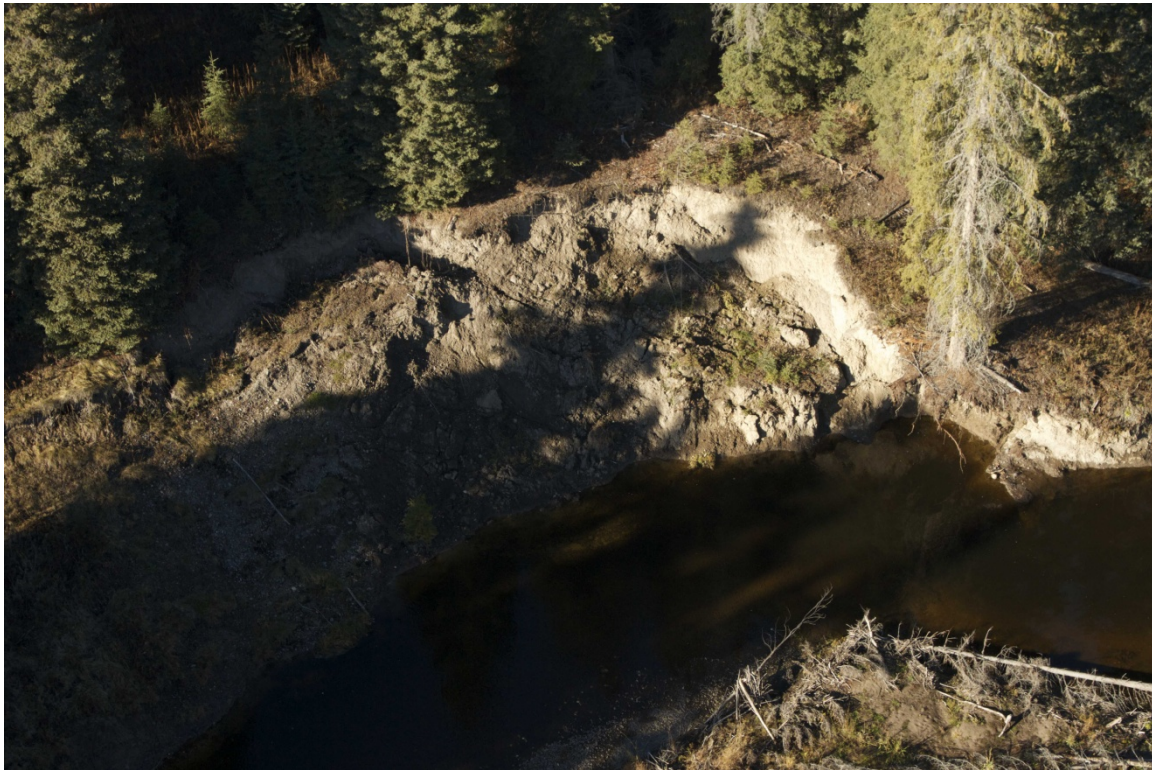
While large woody debris (such as in log-jams) is an important component of riverine systems for sediment storage, energy dissipation, channel complexity, and deep pools for salmon, they can also serve as a potential barrier to migrating adults when disproportionately large and/or numerous. A total of 9 locations were identified for the presence of large log-jams during our assessment (Table 4; Figure 7). All but one of the log-jams were located downstream of Bulkley Lake, and any one of them may serve as a potential barrier to salmon. Additionally, a single landslide was observed along Maxan Creek (Figure 8).

**Figures 7 and 8.** Log-jam (top) and landslide (bottom) recorded on the Bulkley River upstream of Morice River to the headwaters at Maxan Lake, October 2013. Photos: Brian Huntington.

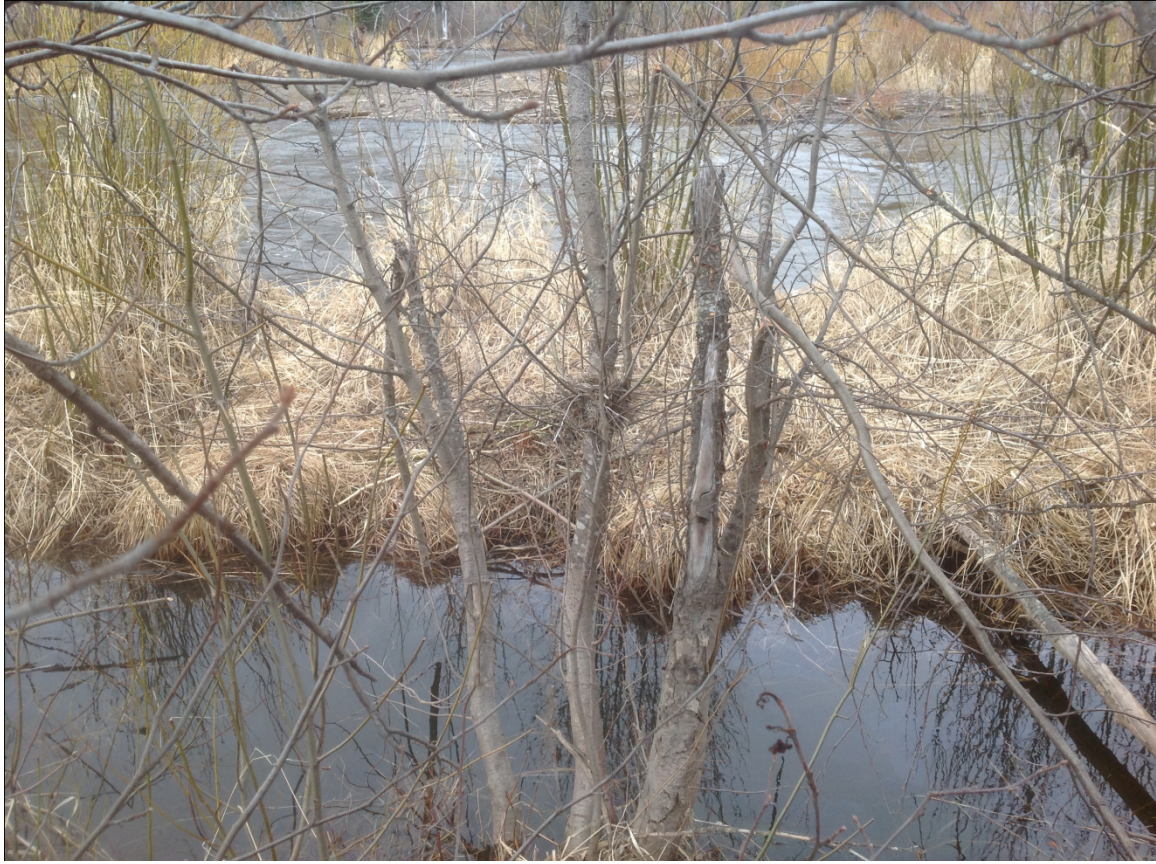
The dominant human activity occurring today along the Upper Bulkley River is agriculture, particularly in the form of hayfields grown for livestock. Much riparian forest habitat has been removed, with hayfields commonly extending to the river bank. Beyond the direct issue of riparian forest removal is the establishment and persistence of non-native grasses where once native low-lying riparian vegetation occurred (Figure 11). In some areas, such as the riparian habitat immediately downstream of Bulkley Lake, these non-native grasses form dense aggregations that effectively exclude all other flora. To what degree such a shift in terrestrial plant species may affect the overall riparian community assemblage is unknown, but it is likely that some forms of fauna (particularly terrestrial insects) have been reduced in abundance and/or displaced along the river banks where such exotic species are aggregated. In terms of habitat recovery, removal of non-native grasses in favour of a return to native species may be a very difficult task.

**Figure 11.** Introduced grasses displace native riparian vegetation along most sections of the Upper Bulkley River where hayfields are located adjacent to the river bank, April 2013. Photo: Michael Price.

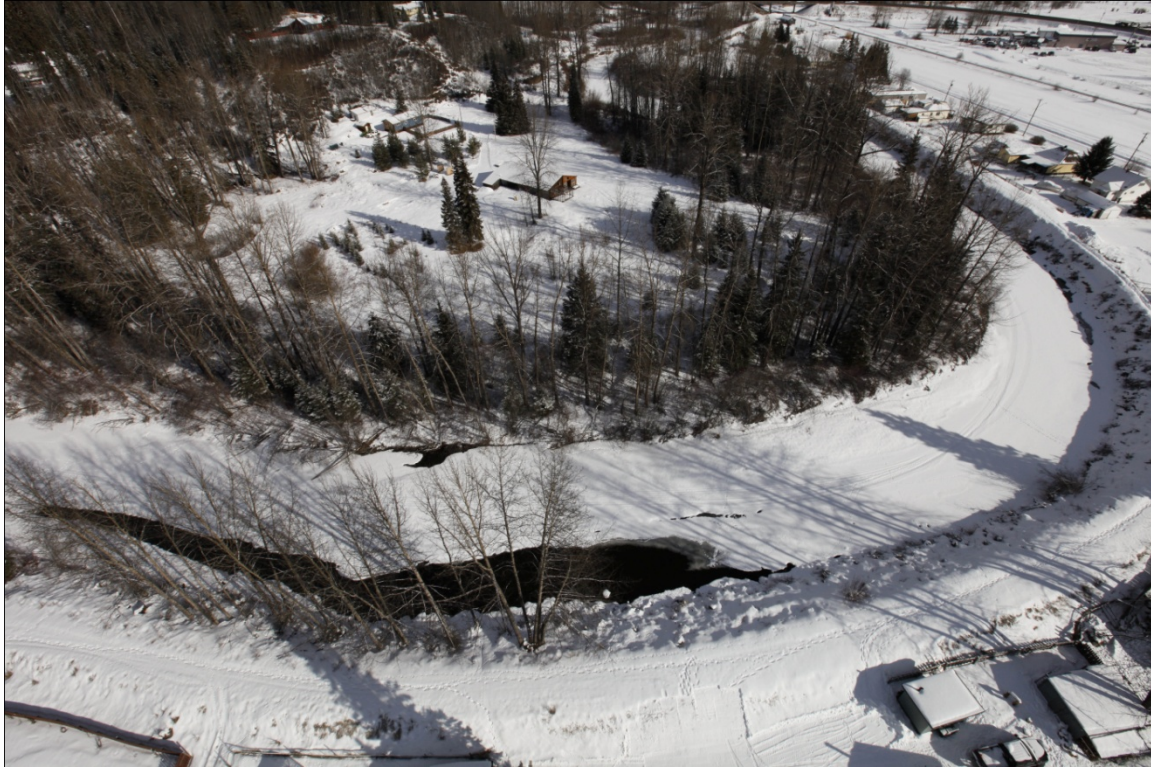
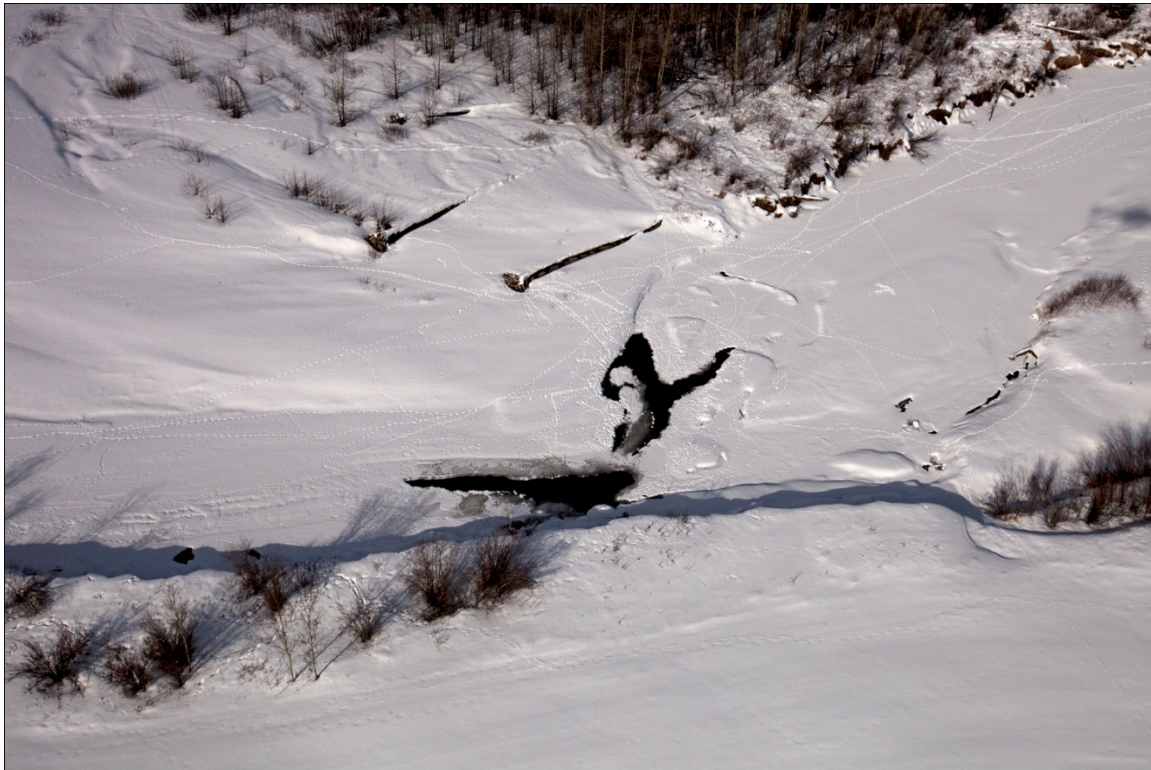
**Figures 12 and 13.** Locations of open water (potential areas of groundwater intrusion) recorded on the Bulkley River upstream of Morice River to the headwaters at Maxan Lake, February 2014. Photos: Brian Huntington.
