Fish Use Monitoring and Evaluation of  
Three Constructed Ponds  
within the  
Kalum Forest District:

*Copper River 3km, Killutsal Creek and Clear Creek*

December, 2003

Prepared by:  
Acer Resource Consulting Ltd.  
4810 Halliwell Avenue,  
Terrace, BC V8G 2J4  
Ph: 250-638-0110

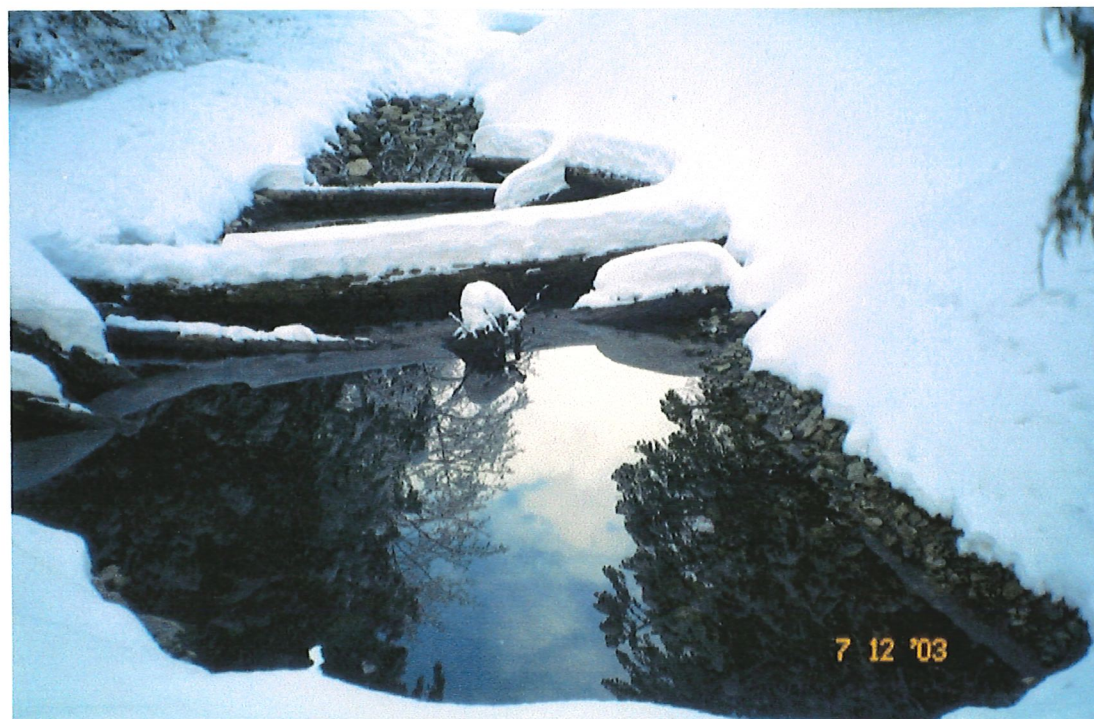
The current assessment of the headwater pond (Pond 1) concurred with previous REE results, noting moderate to poor overall project performance for the same reasons. The headwater pond remains isolated from the other ponds and the site remains isolated from the mainstem due to winter dewatering. Biological performance objectives are therefore not being met due to limited fish access and use of the pond, and stranding of fish. In addition, several redds observed near the outlet of the project were dry or in very shallow water, indicating poor incubation conditions due to limited flow. In terms of overall physical condition and quality of rearing habitat, however, the pond maintains deep pools with stable LWD cover; with no evidence of significant shifting, infilling or overall instability. Dissolved oxygen and temperature were measured at 6 mg/L and  $5^{\circ}\text{C}$  and primary production was considered adequate to support salmonids.

Copper River 3 Km Headwater Pond, showing dewatering at outlet, December 7<sup>th</sup>, 2003.

coho consistent with biological objectives, however fish use is below expectations due to access restrictions and dewatering.

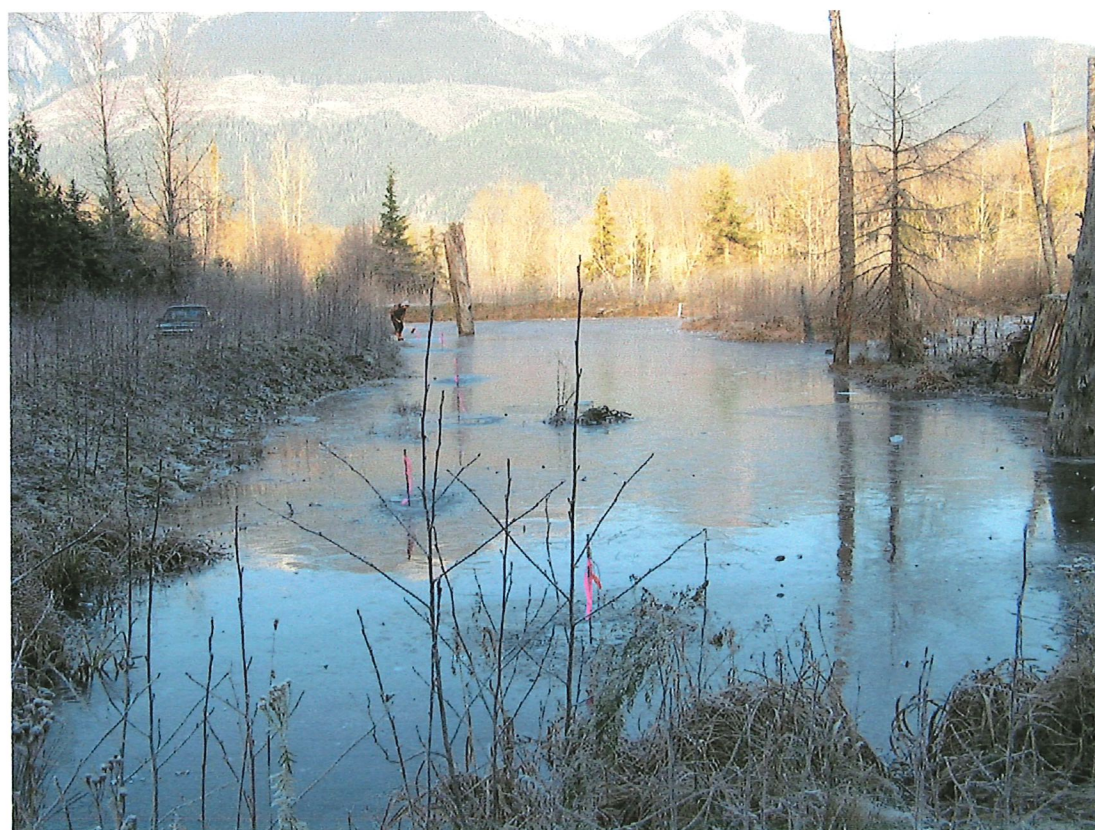
The current assessment by Acer on the 1810 m<sup>2</sup> lower pond concurred with the previous REE, finding good to excellent overall project performance. The project is still meeting initial biological objectives of increasing coho rearing and overwintering habitat, and eliminating flooding on the White FSR and associated fish-road conflicts. In terms of physical condition, Acer noted good to excellent results for berm stability, intake and outlet integrity and function, pool depth maintenance and flow. Although minor beaver activity was noted at the intake and outlet, dam building does not appear to threaten the project or reduce the overall condition or biological performance of the pond. In terms of rearing quality, the pond provides excellent overwintering habitat with adequate primary production, stable complex LWD cover and deep pools. No evidence of significant infilling, collapse, shifting or damage to the site was noted following a recent extreme high water event. The pond also produced good results for water quality with DO and temperature measured at 10 mg/L and 1°C at the furthest point from the intake beneath ice. Although ice covered a substantial portion of the pond, open water areas were present at the intake and outlet due to flowing water in Killutsal Creek.

Killutsal Creek Lower Rearing Pond, November 6<sup>th</sup>, 2003.

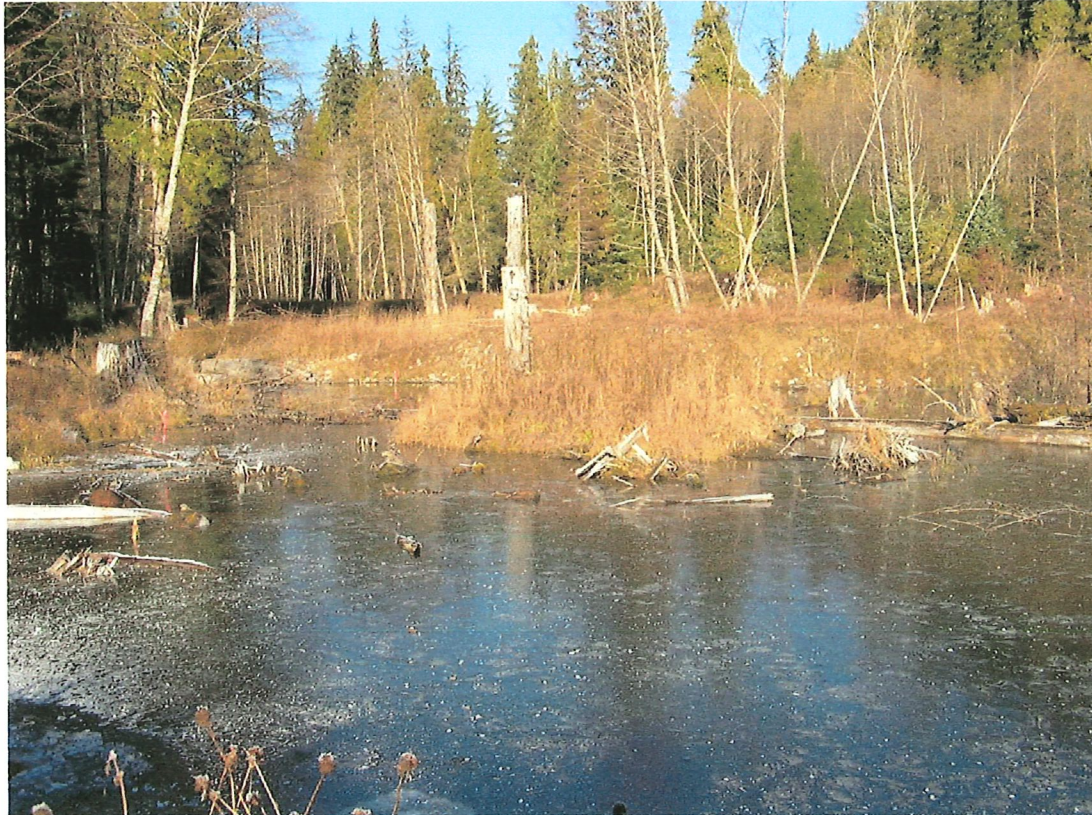
The current assessment of the 1190 m<sup>2</sup> lower pond (Site 4) found improved results for overall project performance, with both physical condition and biological performance at the site rated as excellent. Good to excellent results were noted for berm stability, cover elements, intake and outlet integrity and function, pool depth maintenance and flow. The site has maintained stable complex LWD cover and deep pool habitat with no evidence of significant infilling, collapse, shifting or damage from a recent extreme high water event. The pond also produced good results for water quality with DO and temperature measured at 9.5-10.5 mg/L and 2°C under ice at the furthest point from the inlet. Although ice covered a substantial portion of the pond at the time of survey, open water areas were present at the intake and outlet, and near groundwater seepage areas.

Clear Creek Eastern Side Channel, Lower Pond covered with ice, November 7<sup>th</sup>, 2003.

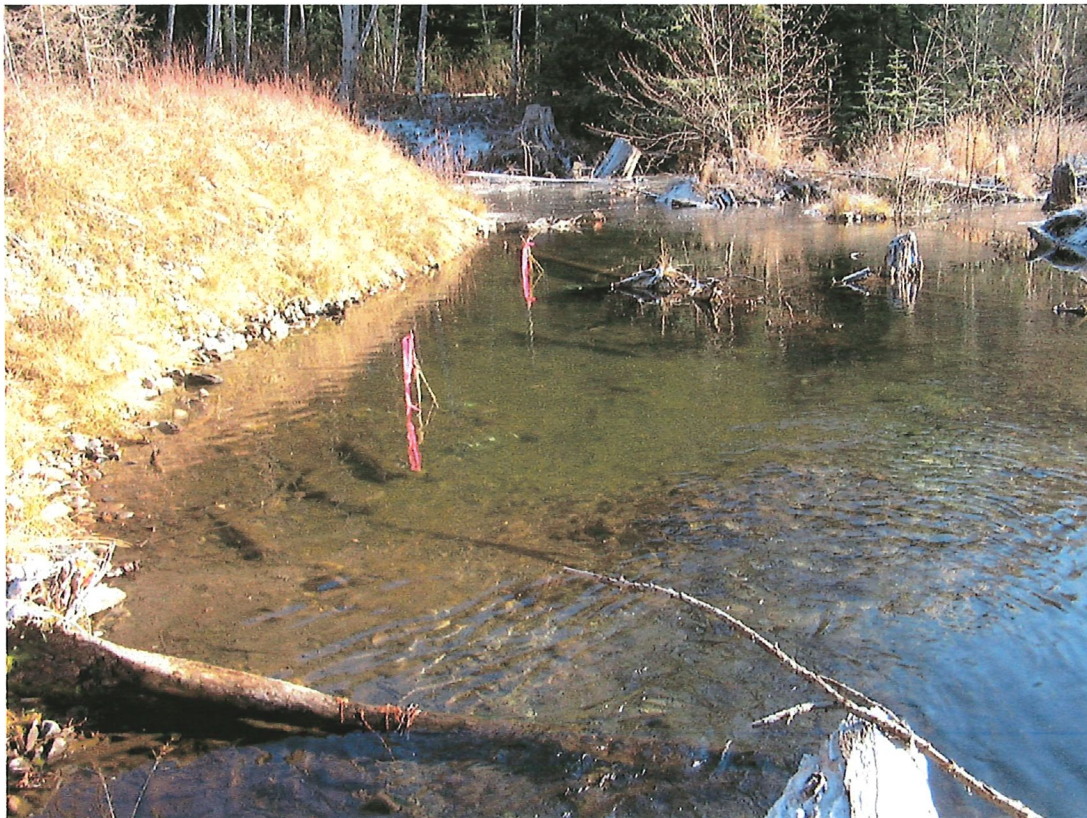
Clear Creek Eastern Side Channel, Lower Pond, ice-free area near intake, November 7<sup>th</sup>, 2003.
