# WATERSHED RESTORATION PROGRAM BABINE WEST DRAINAGES OVERVIEW ASSESSMENT OVERVIEW FISH AND FISH HABITAT ASSESSMENT FRBC CONTRACT #CSK3079 JANUARY 31,1998

Written by: Stephanie Bellehumeur, Biologist CLIFF MANNING FORESTRY SERVICES LT.D.

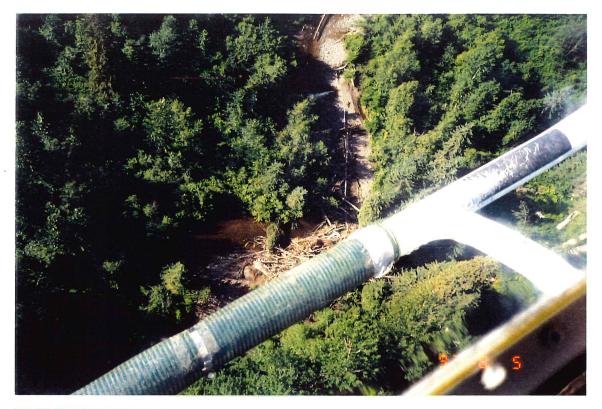
ABOVE: Twain Creek, Reach 1

This reach extends from Babine Lake to 1.1 km upstream. It is irregular meandering and occasionally confined with gradients ranging around 0.5%.

Twain Creek is reportedly one of the largest natural spawning areas on the lake (Leanne Olinyk, pers. com.), and this reach represents most of the available spawning habitat for this creek. It has a channel width of 17.0 m and thus is classified as an S2 under the Forest Practices Code. Spawning sockeye and kokanee use this reach extensively and numerous rainbow trout parr can also be found. It is also used by coho on a smaller scale, and in some years, by pink salmon (Jantz et.al., 1989). Floodwaters from the spring of 1997 have caused a lot of changes within this reach. Excess debris, bank erosion, and course changes have resulted (Leanne Olinyk, pers.comm.) According to David Bustard and Associates (1988), this reach provides good fry habitat at the top but does not contain good cover. Table 2 below summarizes information for Reach T1.

Due to the importance of Reach T1 to the fisheries resource, it is recommended for a Level 1 Fish Habitat Assessment.

Though reach T1 has not been directly affected by forestry activity, a Level I Fish and Fish Habitat Assessment is recommended due to its high fisheries value.

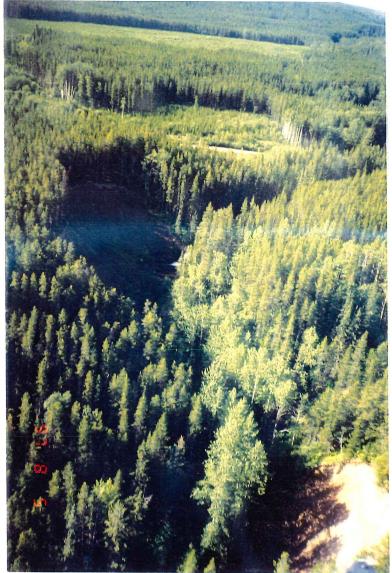
LEFT: Twain Creek, Reach 2 Slough bank

This reach is 3.0 km long. It is sinuous and frequently confined with gradients around 4%. There are two sets of falls (~10m) within this reach, both being impassable to fish. Biophysical data for reaches 2,6,and Tt1 are outlined in Table 3 (page 8). This area is characterized by extensive bank erosion. This section is expected to be a FPC classification of S2. The area above the falls was shocked in August of 1988 and was found to be barren. In order to confirm this, this area should be inventoried.

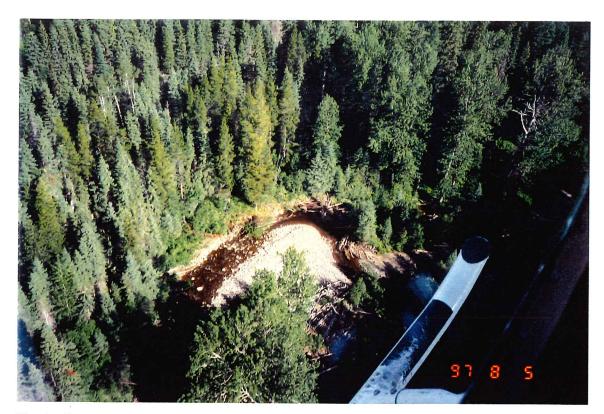
Twain Creek: Reach 3

This reach is 1.2 km long. Though this reach is not thought to contain any fish, it has excellent rainbow trout habitat and was suggested as an outplanting site by David Bustard and Associates (1988). There is an average wetted width of 8.7 m suggesting an S5 classification though this needs to be confirmed (Bustard, 1988). Mean depth is 25 cm and maximum depth is 35 cm. Pool area is low at only 10%, riffles accounting for the next 90%. The reach runs through an area of potentially unstable soils, and as such is characterized by numerous eroding banks. Surrounding forest is a pine/spruce type. It is an unconfined meandering stream with several gravel bars and log jams. It is crossed with a bridge on Augier road and flows adjacent to blocks 113-03 and 195-02.

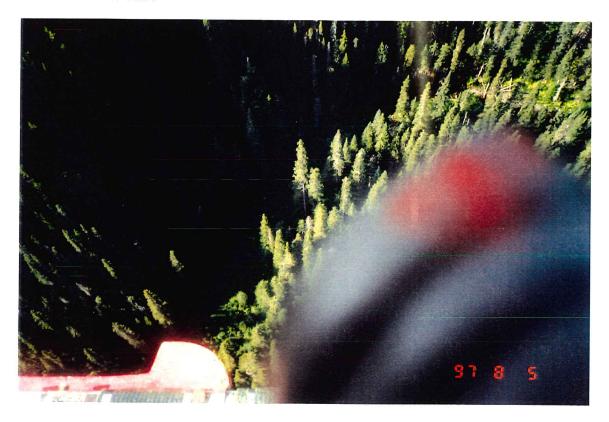
Twain Creek: Reach 4

This reach is irregular wandering and confined with gradients around 2%. It has a length of 1.5 km and extends to the junction with Tt1 (Twain tributary #1) where the input from this tributary significantly increases flow through the stream. The surrounding forest is mostly pine dominated. There is no forest development adjacent to this reach. This reach is expected to have a FPC classification of S5.

Because the lower reaches of Twain Creek have a high fisheries value and because of the already high naturally occurring sedimentation within this creek, it is recommended that the bridges on reaches T4 and T7 have erosion control prescriptions developed.

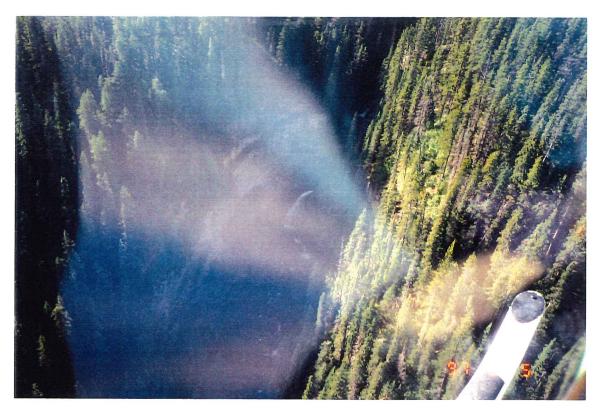
This reach is 1.7 km long extending from the junction with Tt1 to a set of  $\pm 10$  m falls. It is characterized by extensive steep, rocky banks. Flows are heavier here than in reach T6 because of a large tributary running in at the reach break. It runs adjacent to block 114-03, which is cut above the bank. It is surrounded by a spruce and pine forest.

Twain Creek: Reach 5, Falls

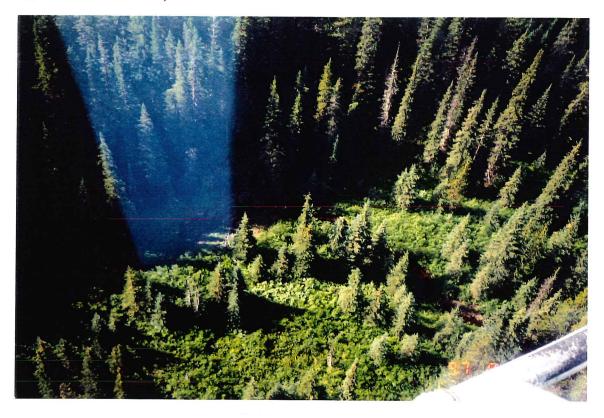
Twain Creek: Reach 7

This is an unconfined and irregular wandering reach with gradients around 2%. The total length is 6.6 km. According to C.C. Graham et.al. (1974), this reach has discontinuous flows, disappearing in sections. It is crossed with a bridge on a branch road off of the Twain and flows adjacent to blocks 106-02 and 106-01. There were no impacts noted during the aerial survey.

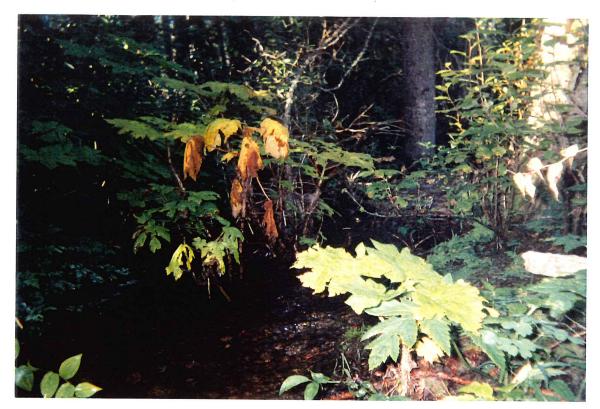
Cross Creek: Reach 1

This reach extends from Babine Lake to 400 m upstream. Gradients are around 2.5%. This is an unconfined sinuous reach. The area around it is flat and vegetation surrounding the stream is dominated by deciduous species (willows, alders). Beaver dams have been a problem in this reach, sometimes completely inhibiting fish passage up the stream (i.e. 1995, Table 1, p. 4). Coho, sockeye, rainbow trout and kokanee are present in this reach (David Bustard and Associates, 1988).

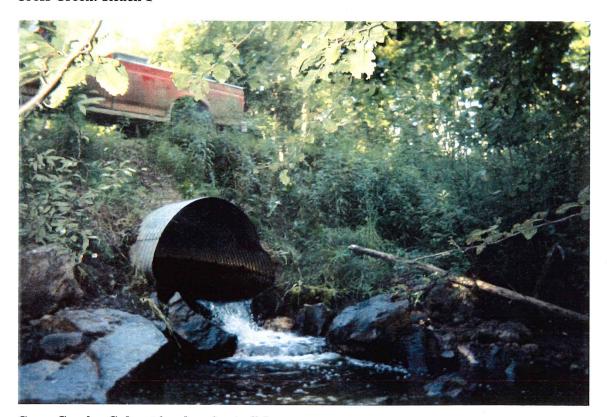
At present, the culvert crossing on Pendleton Bay Road is a complete barrier to all fish species. According to the Ned'u'ten Fisheries Commission (Leanne Olinyk, pers. com.) approximately 15% of sockeye and kokanee in this stream normally spawn above this culvert. It was also noted that they normally use approximately 600 m of this stream. In order to ensure maximum reproductive success, this reach should undergo a Level I assessment in the summer of 1998 and the culvert should be repaired before the spawning season.

Cross Creek: Culvert is a barrier to fish passage

The most important impact found during the Overview Assessment was a culvert representing a complete barrier to fish passage in Cross Creek. Though this is a Ministry of Transportation and Highways road, this reach is recommended for rehabilitation, as it does not conform to the Stream Crossing Guidebook for Fish Streams (1997). This states that there must be safe passage for fish on all fish streams. A level I assessment should be conducted in reaches C1 and C2. An engineered crossing should also be developed to determine the most acceptable type of crossing for this stream.

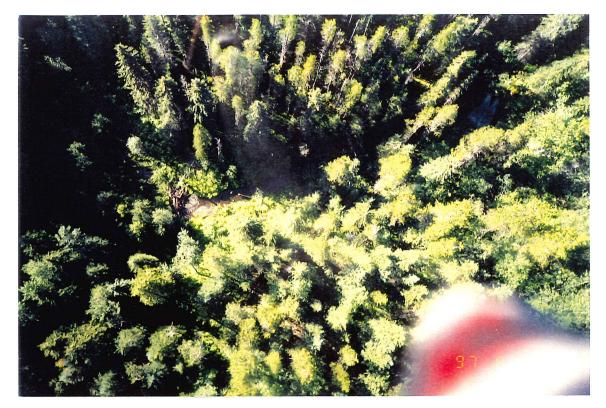
This reach is 6.0 km extending to a 10 m falls. It is characterized by an irregular wandering and confined channel with gradients around 4%. The surrounding topography consists of rolling hills. Morphology is riffle (20%) - pool (80%) with a fine gravel dominated substrate (David Bustard and Associates, 1988). This reach was shocked in 1988 with a catch of 2,728 juvenile rainbow trout. Use of this reach may be sporadic due to frequent years of low water (Hancock et. al., 1983).

ABOVE: Cross Creek, Reach 2 falls

Development in this area consists of one road crossing and some cottages. There is no forestry development in this reach. Because of the importance of this reach to this fisheries resource it is recommended for a Level I Fish Habitat Assessment.

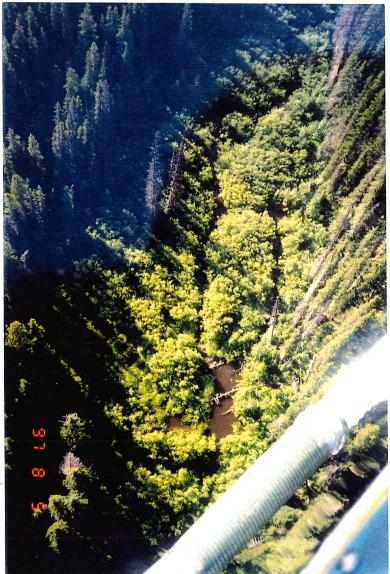
LEFT: Cross Creek, Reach 3

This reach is 1.6 km long and flows through a section of wetland. It is unconfined and irregular wandering with gradients of 1% resulting in a slow meandering stream. Beaver dams are common in this reach. Dominating vegetation consists of alders and willows. This section was surveyed by R.J.A. Forestry Ltd. in 1996 and was found to be a run/riffle stream with several pools. Average channel width was 3.1 m. Cover was found to be abundant at 40-70% resulting in excellent rearing habitat. In addition, bed material is dominated by gravels resulting in excellent spawning habitat and several deep pools result in good winter habitat. The only species found in this reach was Lake Chub. There isn't any forestry development adjacent to this reach.

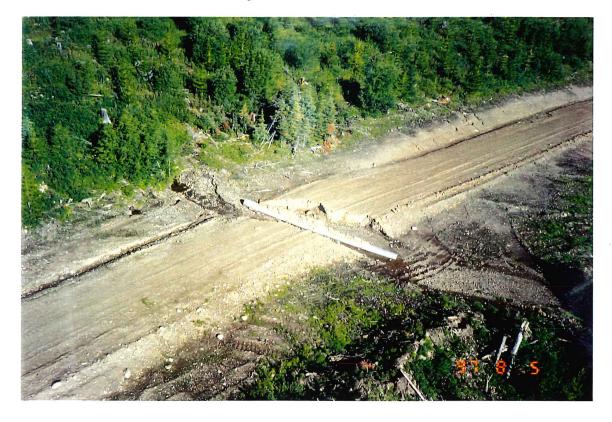
Pacman Lake tributary culvert failure

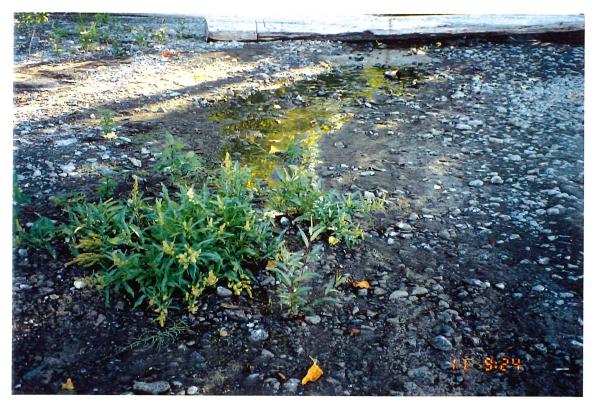
Deep Creek: Dewatering at the mouth- barrier to fish passage

It has been noted that Deep Creek is only used in years of high water by salmon for spawning. Low lake levels and lower levels of flow within the creek result in mouth dewatering. Though this is a natural occurrence, it may be possible to significantly increase fish production by establishing a permanent channel. This would also be an opportunity to develop a method of rehabilitating several other tributaries to Babine Lake which have this same problem. Reach I and II up to the first falls should therefore undergo a Level I and Level II assessment in the summer of 1998. Before rehabilitation work is begun, it needs to be determined if this dewatering is caused by excessive sedimentation from the creek and if logging impacts upstream have caused greater fluctuations in flow. This will determine the type of work that needs to be done.

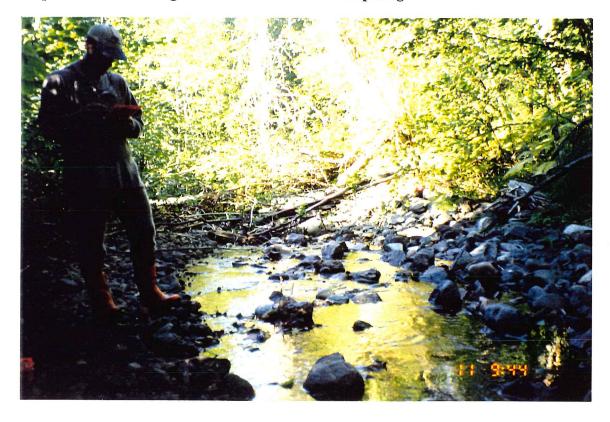
Deep Creek: Reach 1

This reach is 200 m long, beginning at the mouth. The channel is unconfined and has a width of 3.4 m. As such this reach has an FPC classification of S3. Residual pool depth is 35 cm, deep pools accounting for 20% of cover within this reach. Bed material is gravel/cobble. Surrounding vegetation consists of mature deciduous forests. Rearing, spawning, overwintering, and cover habitat have all been classified as good by Redden (pers.comm., 1997). Species found within this reach in the fall of 1997 included rainbow trout (adult and juvenile), coho salmon (juvenile), longnose sucker (juvenile), and prickly sculpin. Sockeye spawn here occasionally when access is possible since the mouth of the creek is often dewatered. Cutblocks upstream have potentially worsened this condition as very little if any riparian area was left behind. In 1996 pink salmon were also seen spawning here by the Ned'u'ten Fisheries Commission.

This reach is recommended for a Level I and II assessment.

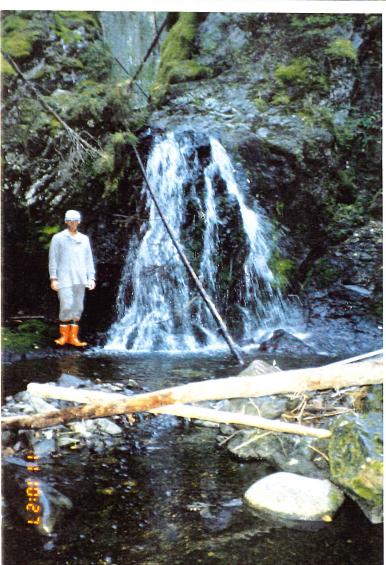
LEFT: Deep Creek, 4m falls in Reach 2

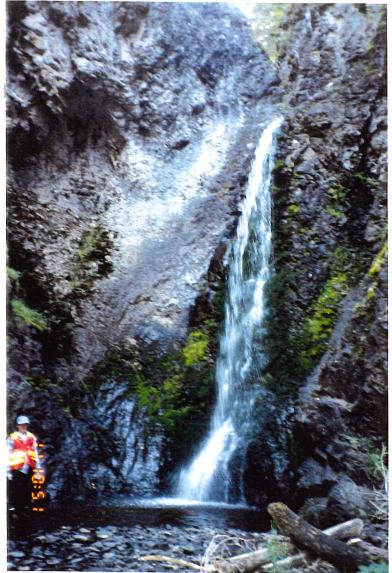
LEFT: Deep Creek, 12m falls, Reach

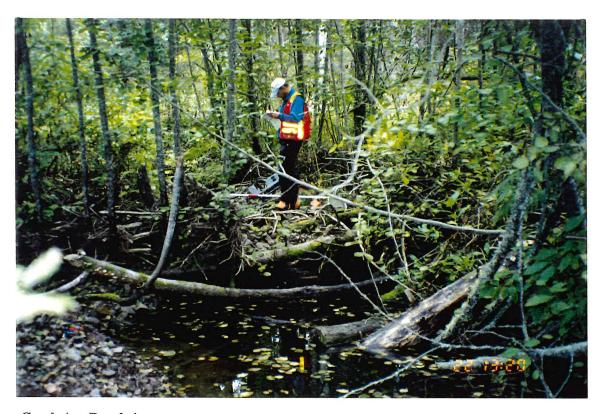
Creek A: Reach 1

Several disturbance indications were noted during the survey in the fall of 1997. These included eroded banks, small woody debris, and excessive bars. Excessive logging within this drainage is thought to have resulted in large flow fluctuations throughout the year sometimes resulting in dewatering. Sockeye and kokanee were once known to use the creek for spawning, but have not been seen coming into the creek for the past five years. These populations are thought to be extinct. Rainbow, coho, and lake chub are present in this creek. Rearing, spawning, overwintering and cover habitat for these species was rated as good.

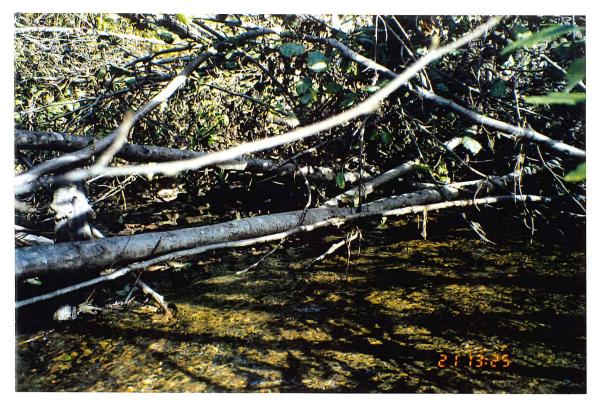
Creek B: Reach 1

This 400 m reach has been classified as S3 as it has a channel width of 3.9 m. Pools average 0.5 m and bed substrate is composed of gravels and fines. This reach is irregular meandering and unconfined. Morphology is riffle-pool with a gradient of 2%. Cover is about 50%, deep pools accounting for 40% of this. Surrounding vegetation consists of shrubs. Habitat is good for cover, overwintering, and rearing, and fair for spawning. Sockeye, rainbow, and lake chub are found within this reach.

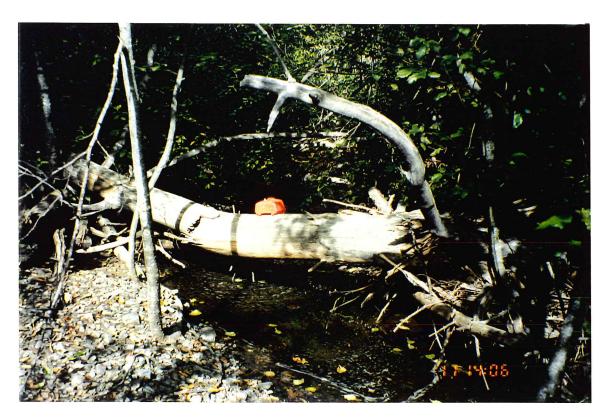
Creek B: Reach 4

Reach B4 is 600 m in length. This reach is also classified as S3 and has a channel width of 3.5 m. Cover comes mostly from deep pools, which average 0.45 m. Gradients within this reach are around 2.5% and morphology is riffle-pool. It is an irregular and occasionally confined reach with a gravel-cobble substrate. Surrounding vegetation is mature coniferous with a crown closure of 50%. Rearing, spawning, cover, and overwintering habitat are all good. This reach was noted as being very productive during the 1997 survey.

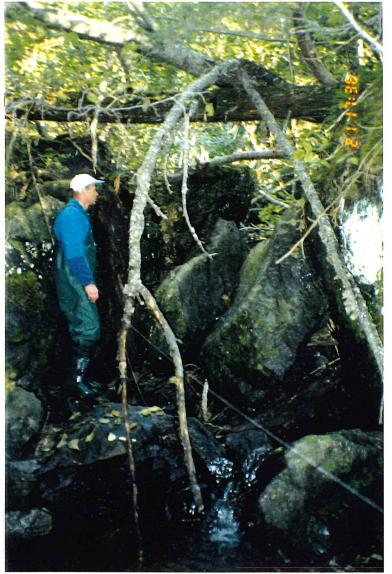
LEFT: Creek E: Rock slump in Reach 3

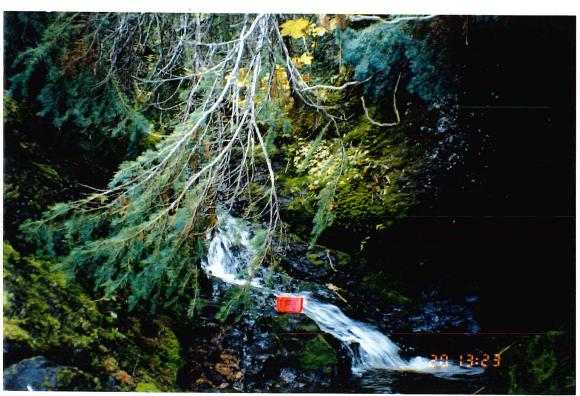
BELOW: Creek E: Cascades in Reach 4
