2001/2002 Forest Renewal BC Funded

**ENHANCING ENVIRONMENTAL
VALUES PROGRAM
COMPLETION REPORT
Book 1**

Ed Withers, AScT, Watershed Restoration Supervisor
Silvicon Services Inc.
March 2001

ENHANCING ENVIRONMENTAL VALUES PROGRAM COMPLETION REPORT 2001/2002

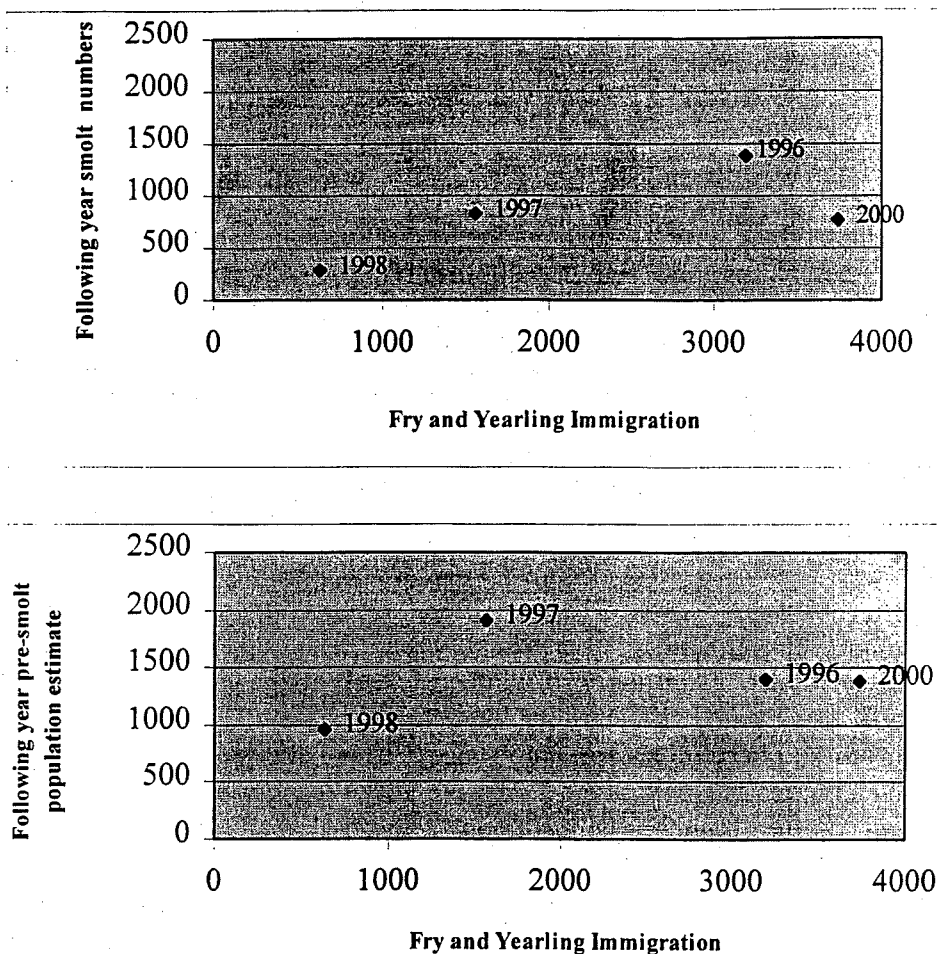
Figure 9. Combined Total of Coho Fry and Yearling Immigrants at Km 1011 Versus the Following Year's Smolt Numbers at Traps and Pre-Smolt Population Estimates¹⁴.

Several factors should be considered when assessing this year's estimates. Firstly, beaver dams located in the connecting creek channel between the two ponds were present during the summer, fall and winter of 2000 and may have limited coho distribution throughout the ponds in 2000, therefore restricting total productive area. An additional beaver dam was also present on the connecting channel to the large PNG channel during the summer and fall of 2000. However, the trapping CPUE during May 2001 indicated that coho were well-distributed except in the PNG extension channels (Table 2) suggesting this may not have been a factor¹⁵.

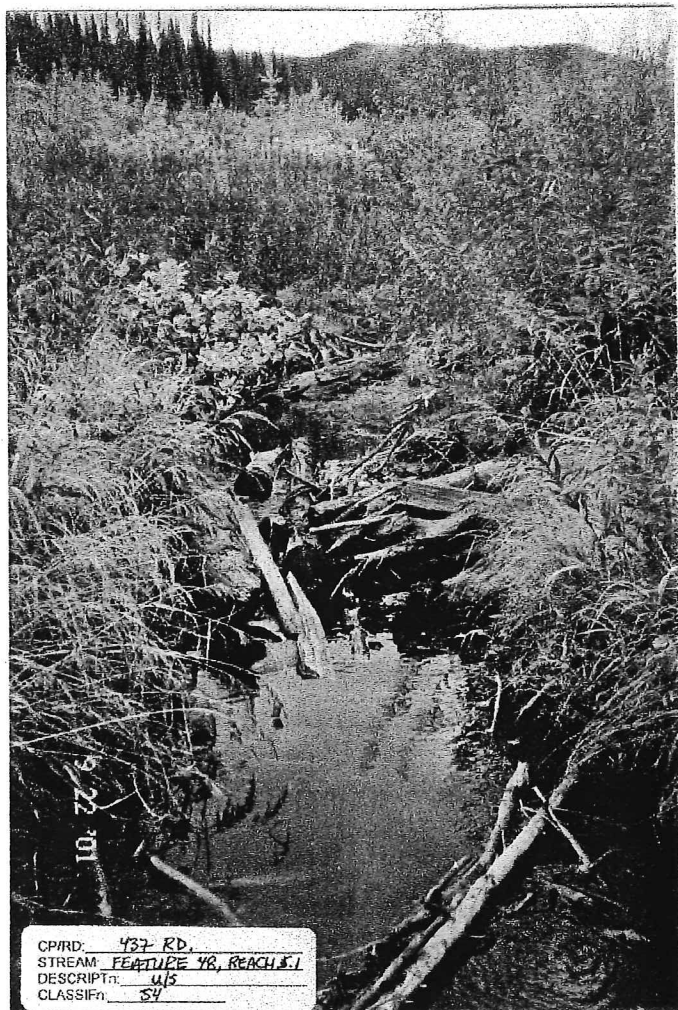
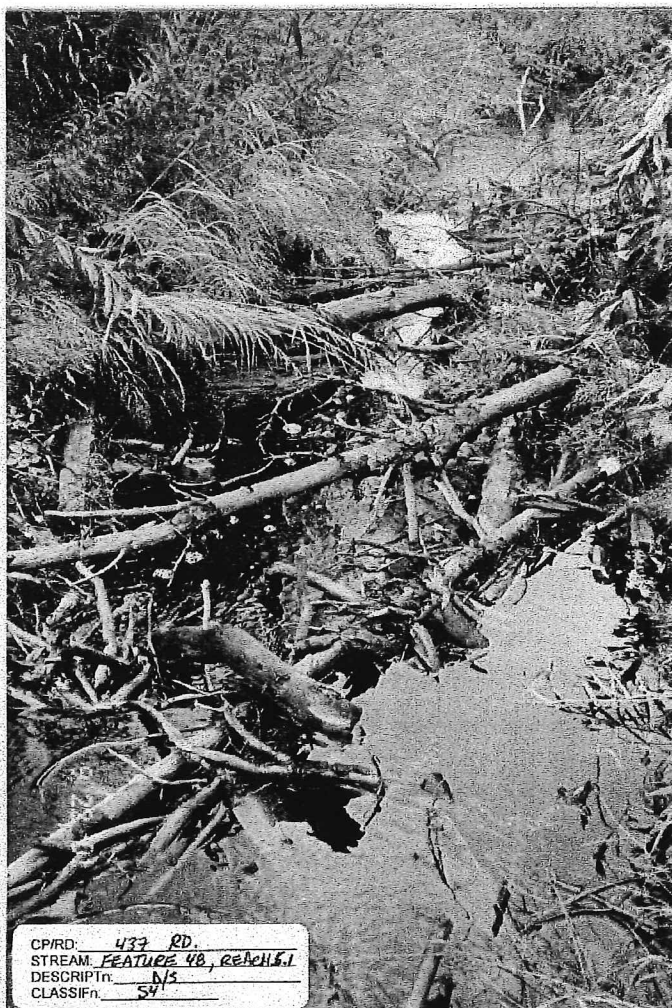
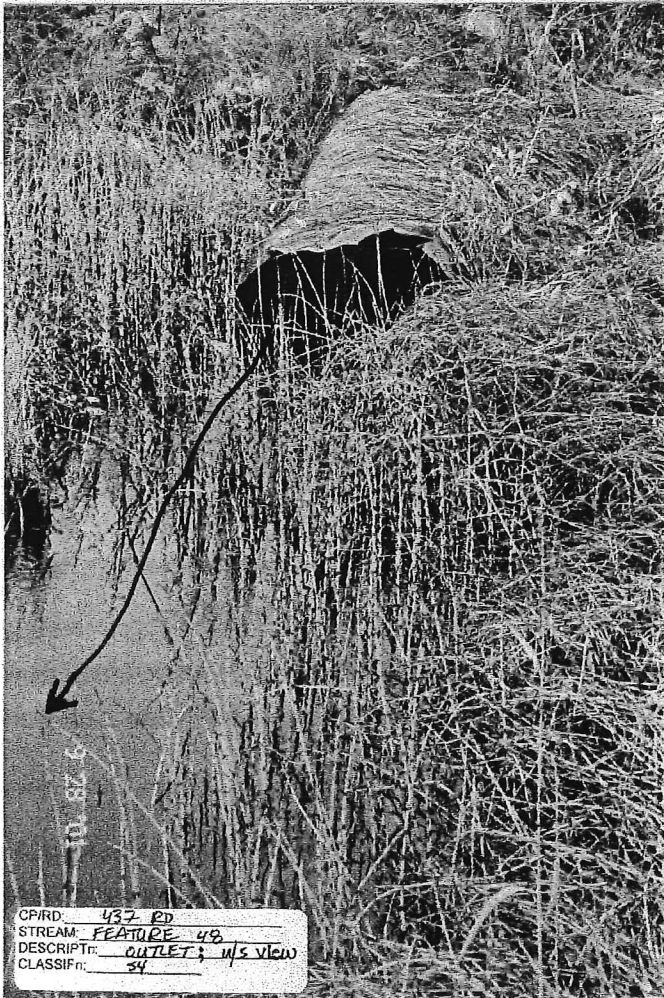
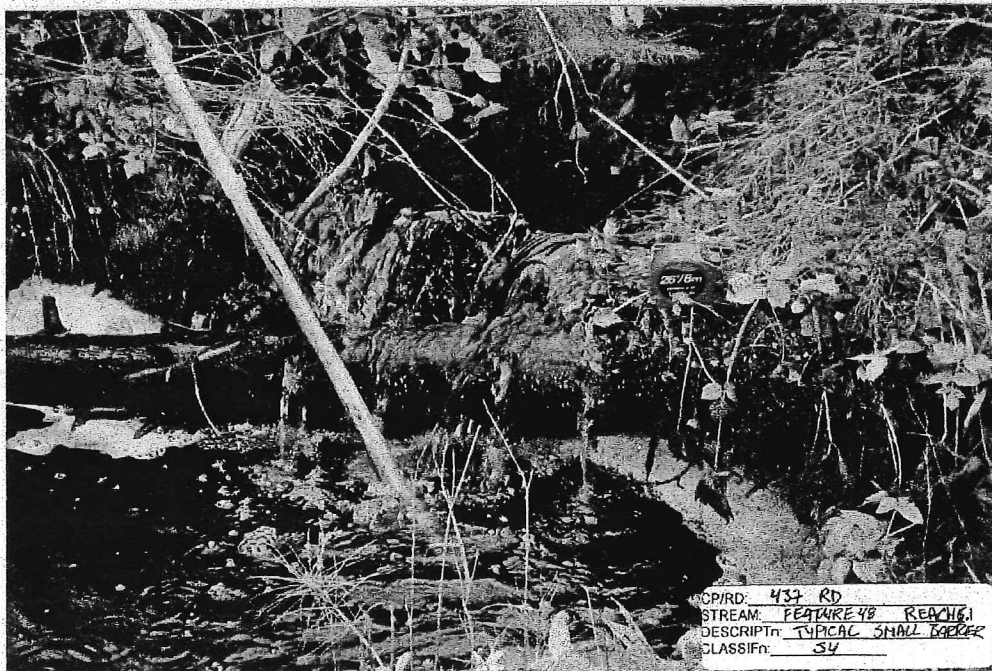
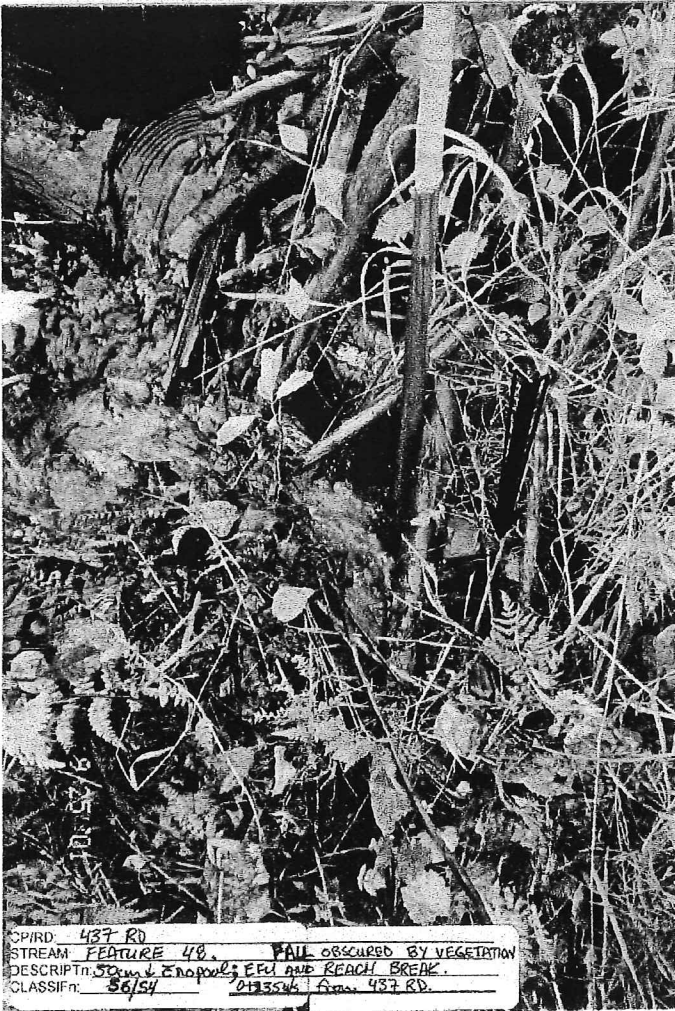
- SITE PHOTOGRAPHS-

Fish access to reach 1 has not been affected by the harvesting activities in CP 522-3. Although there was equipment moving through the stream channel throughout the length of sub-reach 5.1 and logging slash has ended up in the stream, the present habitat conditions in the stream are not detrimental to fish and provide good spring, summer and fall rearing habitat. The logging traffic through the stream reach has not resulted in the channel changing direction, it is still following its original course.

With careful consideration of the site characteristics and logistics it is recommended that the site be left as is. Significant improvements in habitat quality through implementation of restoration activities are not expected; therefore I would rate this site as a low priority for restoration works. There are 420m upstream of the confluence with the known fish-bearing tributary before the EFU occurs at a small natural barrier that prevents fish migration further upstream. The entire reach is accessible to fish upstream from the confluence with the known fish stream. Historically, the stream reach very likely provided only spring, summer and fall rearing habitat, which it continues to do.

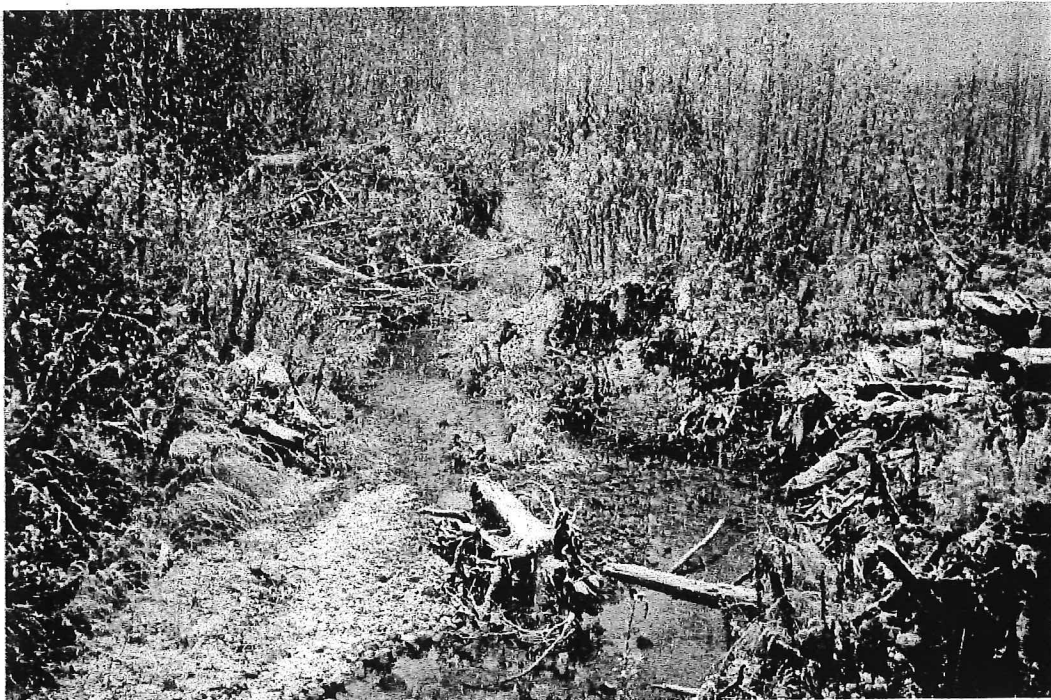
Photo 1. Downstream view from fire guard of initial channel washout and erosion site where stream enters cutblock.

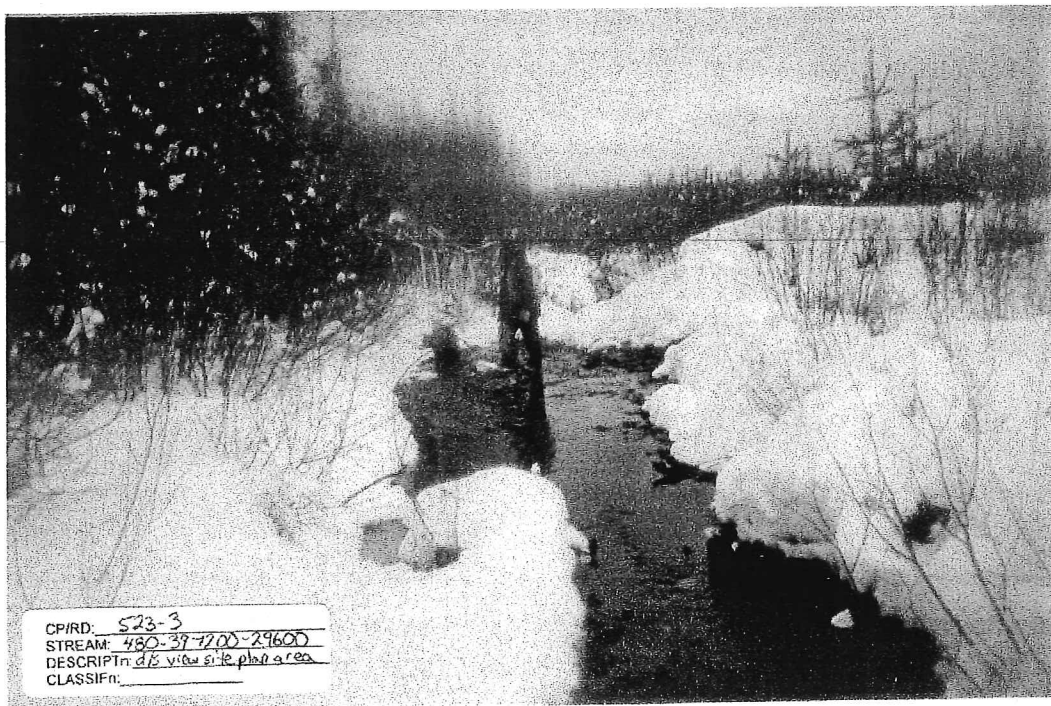
Photo 2. Downstream view of possible redirection route (to the left of crew person). Channel narrows just downstream of crew person.

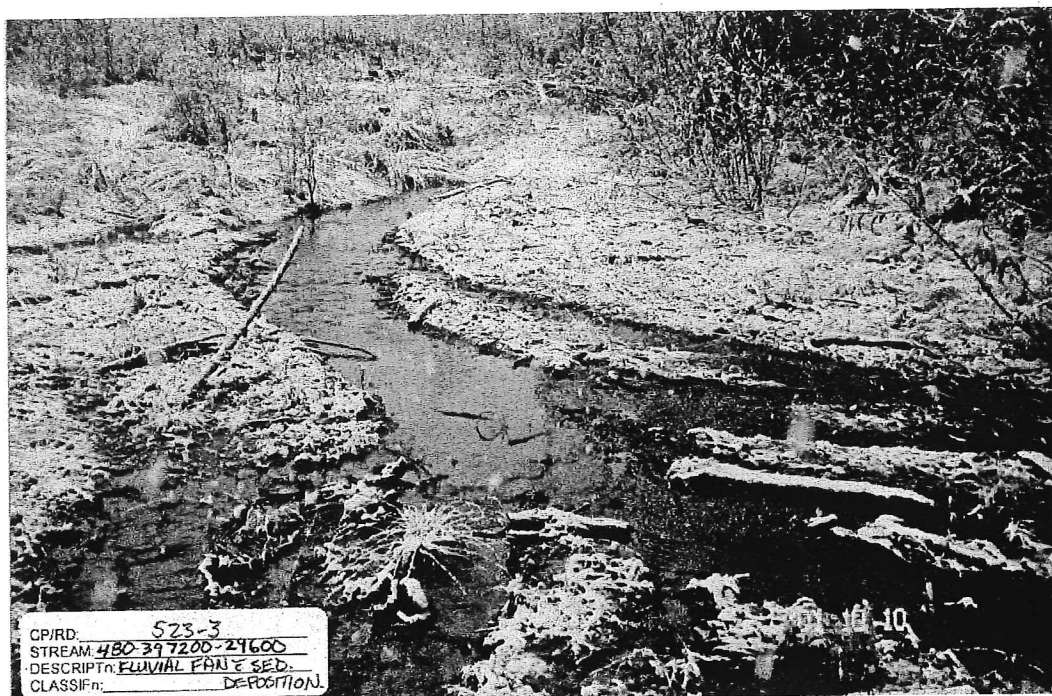
Photo 3. Upstream view of outwash fan.

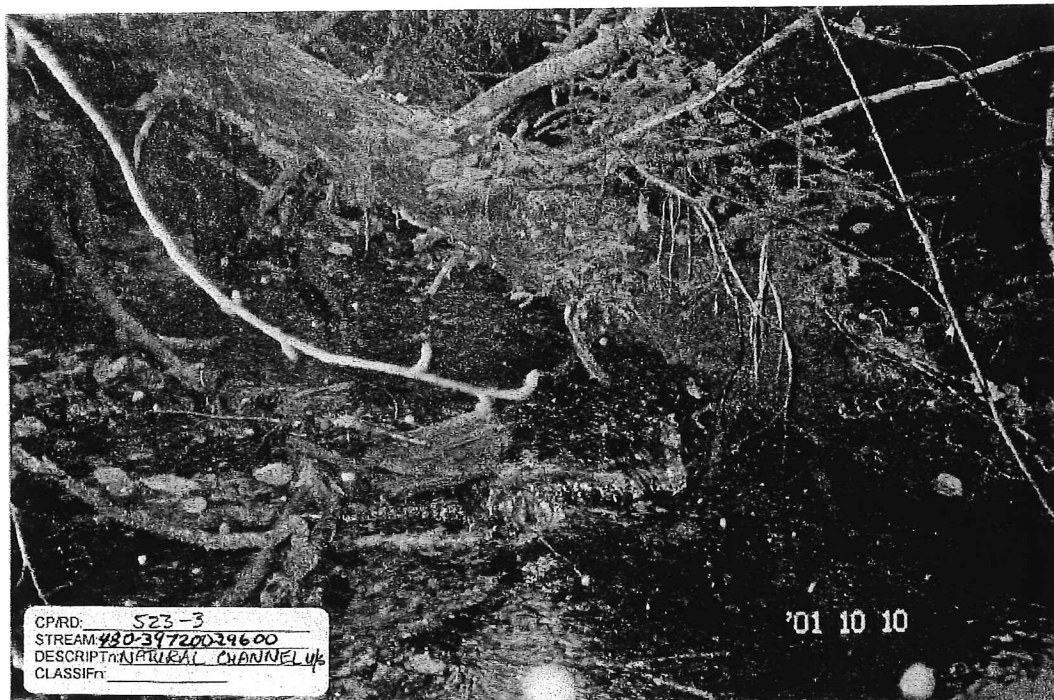
Photo 5. Upstream view of undisturbed stable channel located upstream of site.

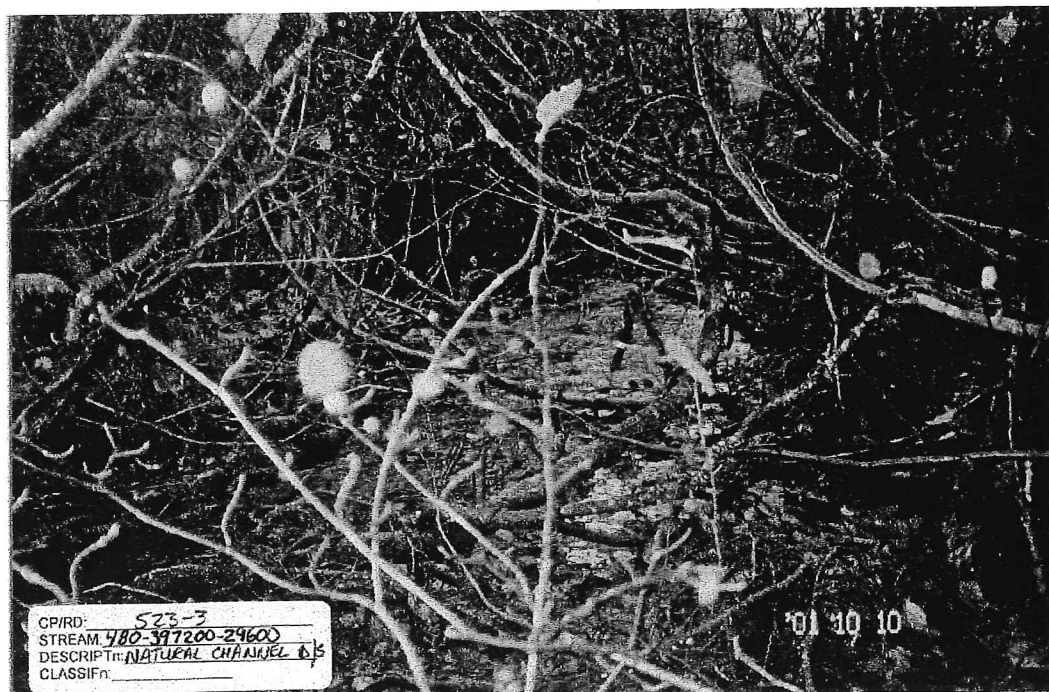
Photo 6. Downstream view of undisturbed stable channel located upstream of site.

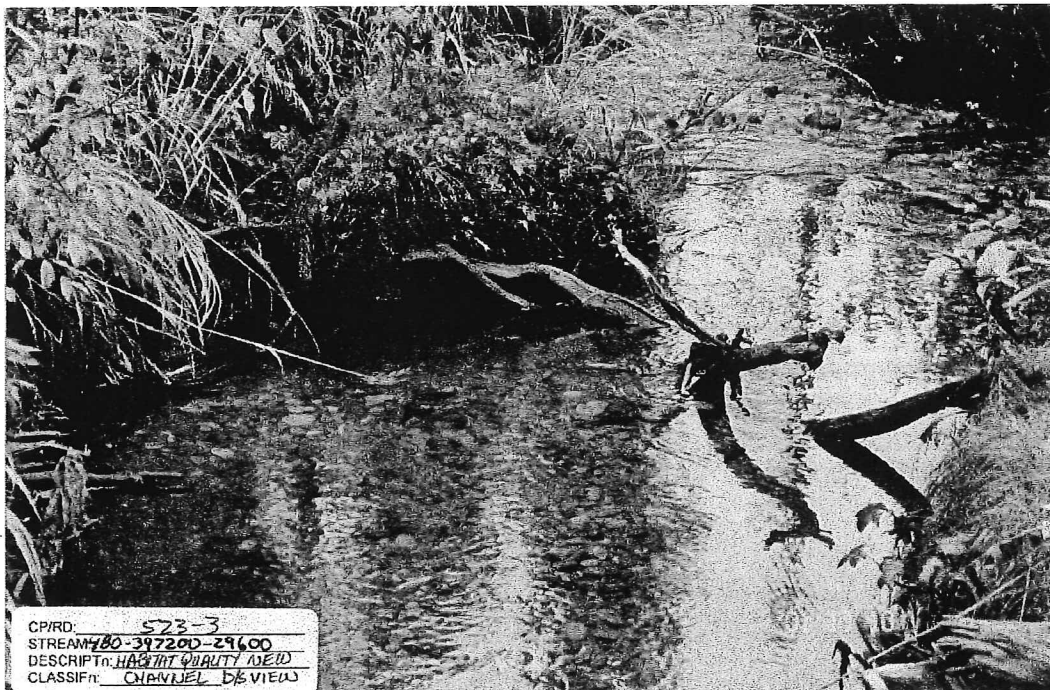
Photo 7. Downstream view of habitat in new channel.

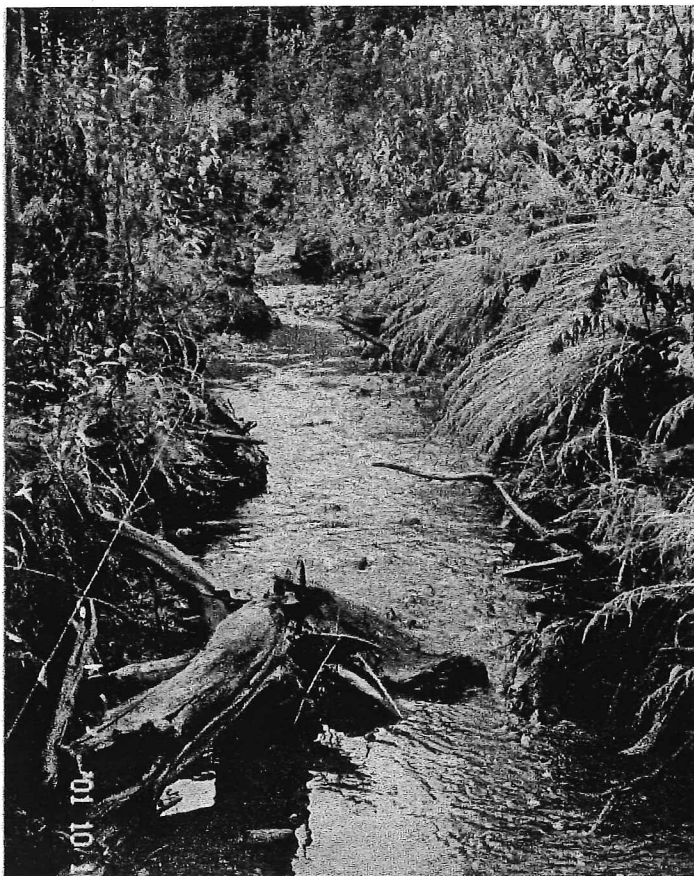
Photo 8. Upstream view of habitat in new channel.

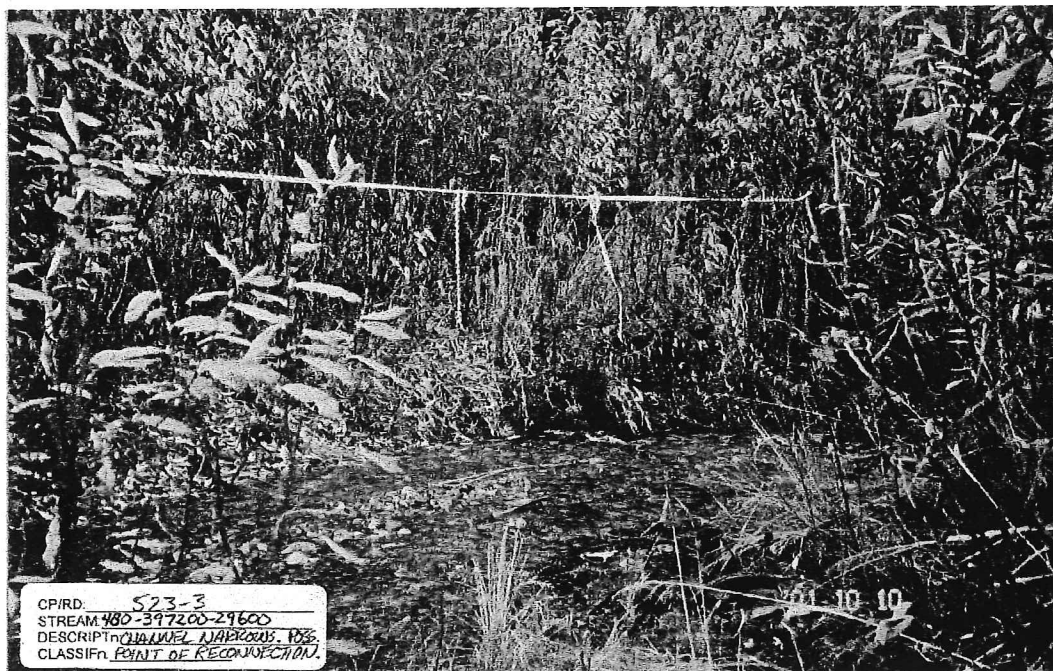
Photo 9. View across current channel to possible redirection route.
