Lakelse Sockeye Recovery Program
Williams Creek Upper Spawning Channel Completion
and Lower Channel Feasibility

February 2013

NF-2011-H-1

This report describes the work done in the design, construction and completion of the Upper Williams Creek Spawning Channel, Phase 2b.

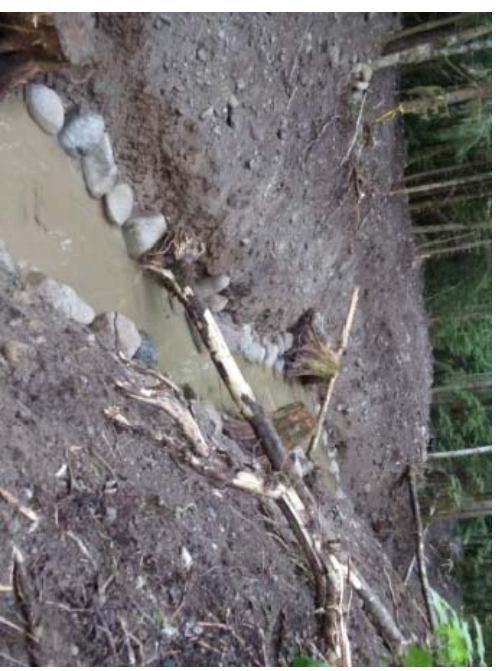
Typical Excavated Channel

Photo showing typical excavation from Williams Creek 2011 including boulder placement and large woody debris (stumps)

The design package for the remaining 200m of sidechannel was essentially the same as was used for the construction of the first 470m built in 2011. However, the elevation of the downstream end of the channel was now known, and an approximate elevation was selected for the water intake at Williams Creek. A new drawing was prepared for the tender and it can be found in Appendix 2.

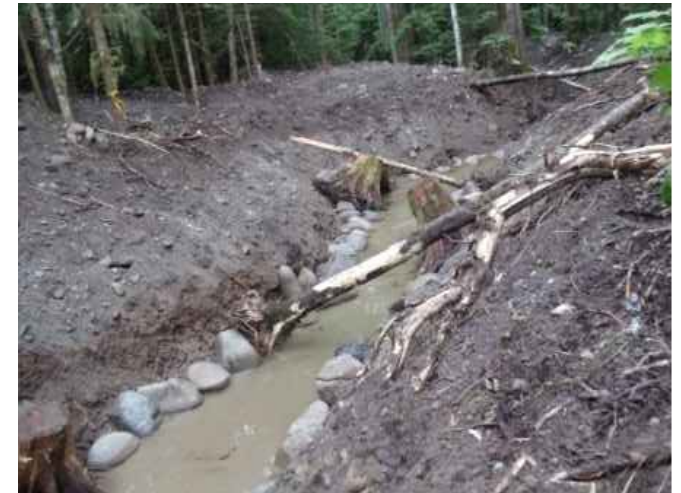
Photo showing Typical excavation from Williams Creek 2011 including boulder placement and large woody debris (stumps)

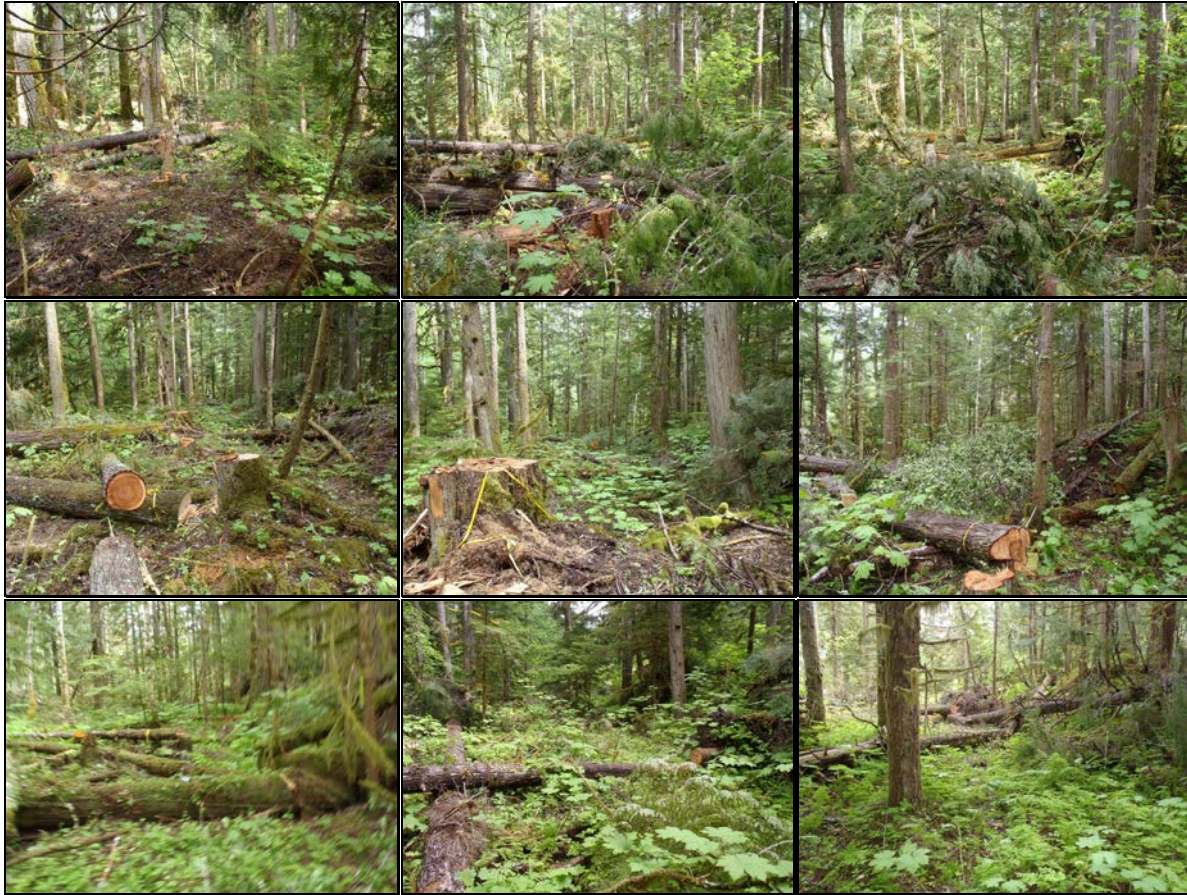
Photos 1-9, General Conditions of Channel Route After Tree Falling and Bucking

The photos below were taken facing east, walking along the route of the tree removal from the upstream end of the 2011 excavation to the parking area at the Williams Creek Bridge on Old Lakelse Lake Road. These Photos show the general condition of the channel route after the trees were fallen and bucked.

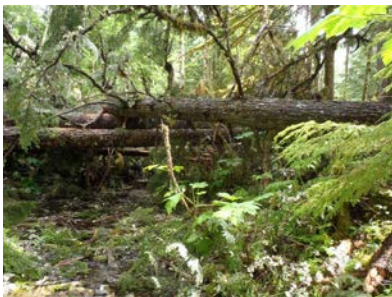
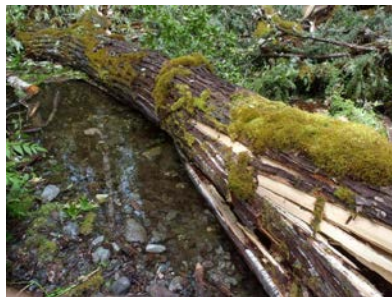
Photos 10, 11- Showing Trees Fallen Across Natural Channel

Some of the felled trees landed across the natural channel that runs parallel to the excavation route on the north side. All but one of these trees cross well above the channel. The one cottonwood in the channel does not appear to be impeding natural flow.

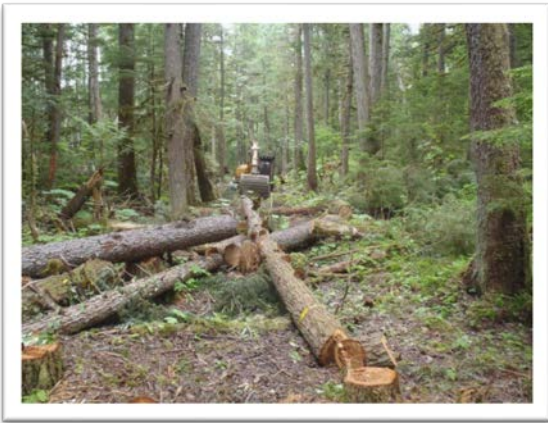
Photo 1: Clearing the channel route

- Safety meeting held
- Path cleared along channel route
- 50m of channel excavated
- Elevations taken @ 10m intervals
- 28 logs, 7 stumps and 10 boulders placed in channel

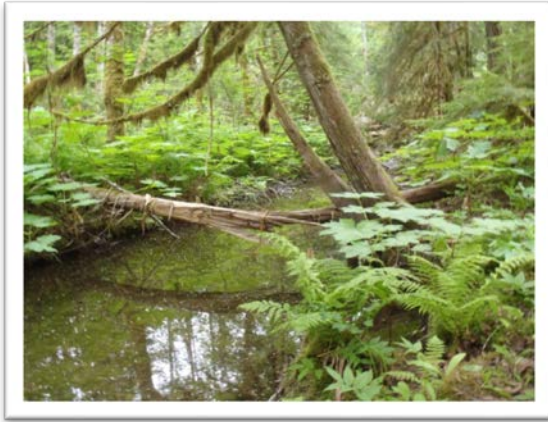
Photo 3: Adjacent natural channel

- Excavation of 35m of channel
- Placement of 22 logs, 9 stumps and 25 boulders
- Removal of logs that had fallen across adjacent natural channel when trees were felled to clear path for channel excavation
- Hand clean up of debris in natural side channel
- Monitoring of water level in natural side channel
- Channel bottom elevations @ 10m intervals

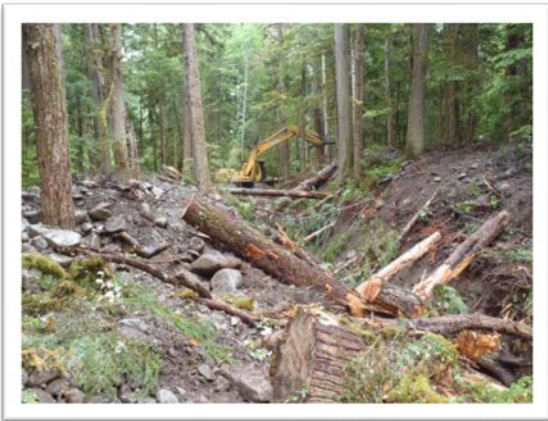
Photo 5: Continued channel excavation

- Excavation of 40m of channel
- Placement of 24 logs, 2 stumps and 100+ boulders
- Continued monitoring of water levels in adjacent natural channel
- Channel bottom elevations @10m intervals

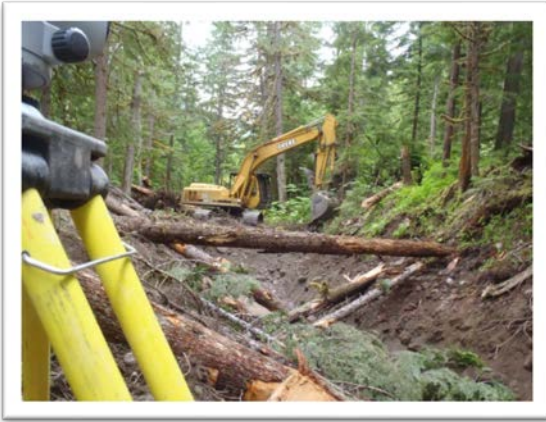
Photo 6: Continued channel excavation

- Excavation of 50m of channel
- Placement of 23 logs, 4 stumps and 60+.5m boulders
- Continued monitoring of water levels in adjacent natural channel
- Channel bottom elevations @10m intervals

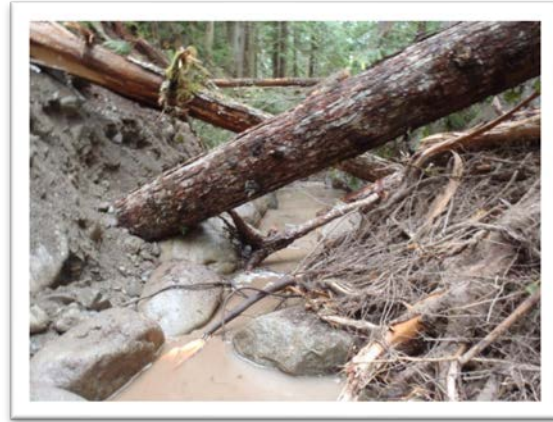
Photo 7: Typical excavated channel

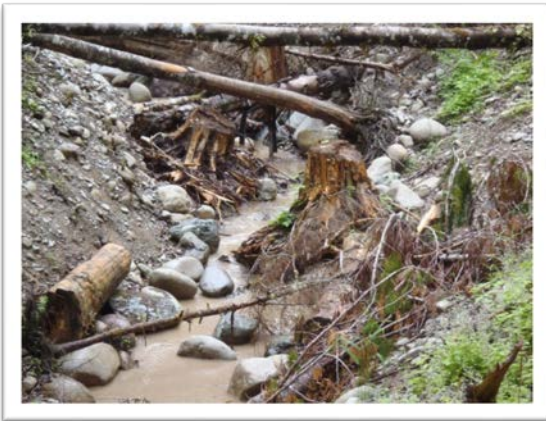
- Excavation of final 25m of channel
- Placement of 12 logs and 50 boulders
- Continued monitoring of water levels in adjacent natural channel
- Relocation of excavator to downstream weir location
- Levelling and widening of downstream plug for supporting excavator
- Begin excavation for placement of lock block weir
- Seeding of excavated material along 50m of channel at upstream end

Photo 8: Typical excavated channel

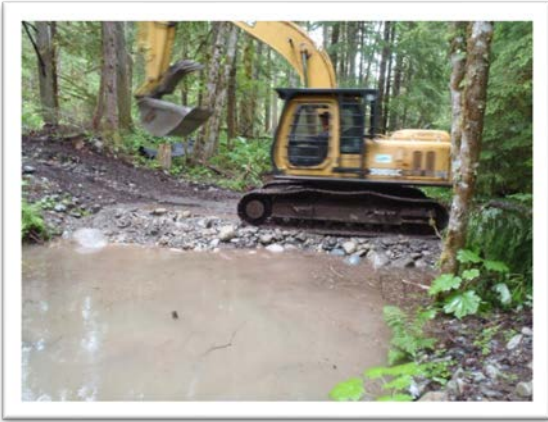
Photo 10: Lock block weir excavation continued

- Completion of lock block weir excavation to 0.75m below elevation of downstream channel bottom
- Continuous pumping of lock block weir excavation to maintain isolation between the excavation and the downstream natural channel
- Placement of lock blocks to form downstream weir

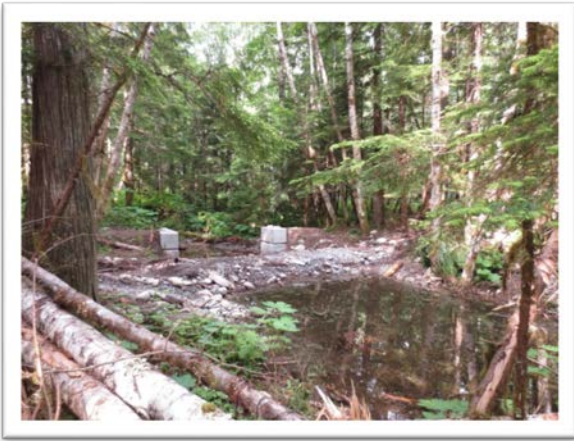
Photo 12: Looking downstream from 2011 channel towards lock block weir

- Backfill lock block weir to blend with natural topography
- Adjust natural channel to blend with weir sill elevation
- Elevations to tie in weir sill elevation with 2011 channel as built survey pin

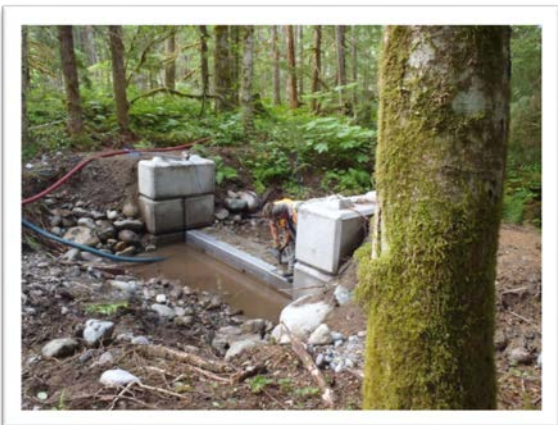
Photo 13: Installing lock block weir sill

- Seine and isolate lock block weir area
- Install sill and channel on lock block weir
