**NISGA'A LANDS  
FRESHWATER FISH AND FISH HABITAT  
TECHNICAL DATA REPORT  
FOR THE  
WESTCOAST CONNECTOR GAS TRANSMISSION PROJECT**

**August 2014**

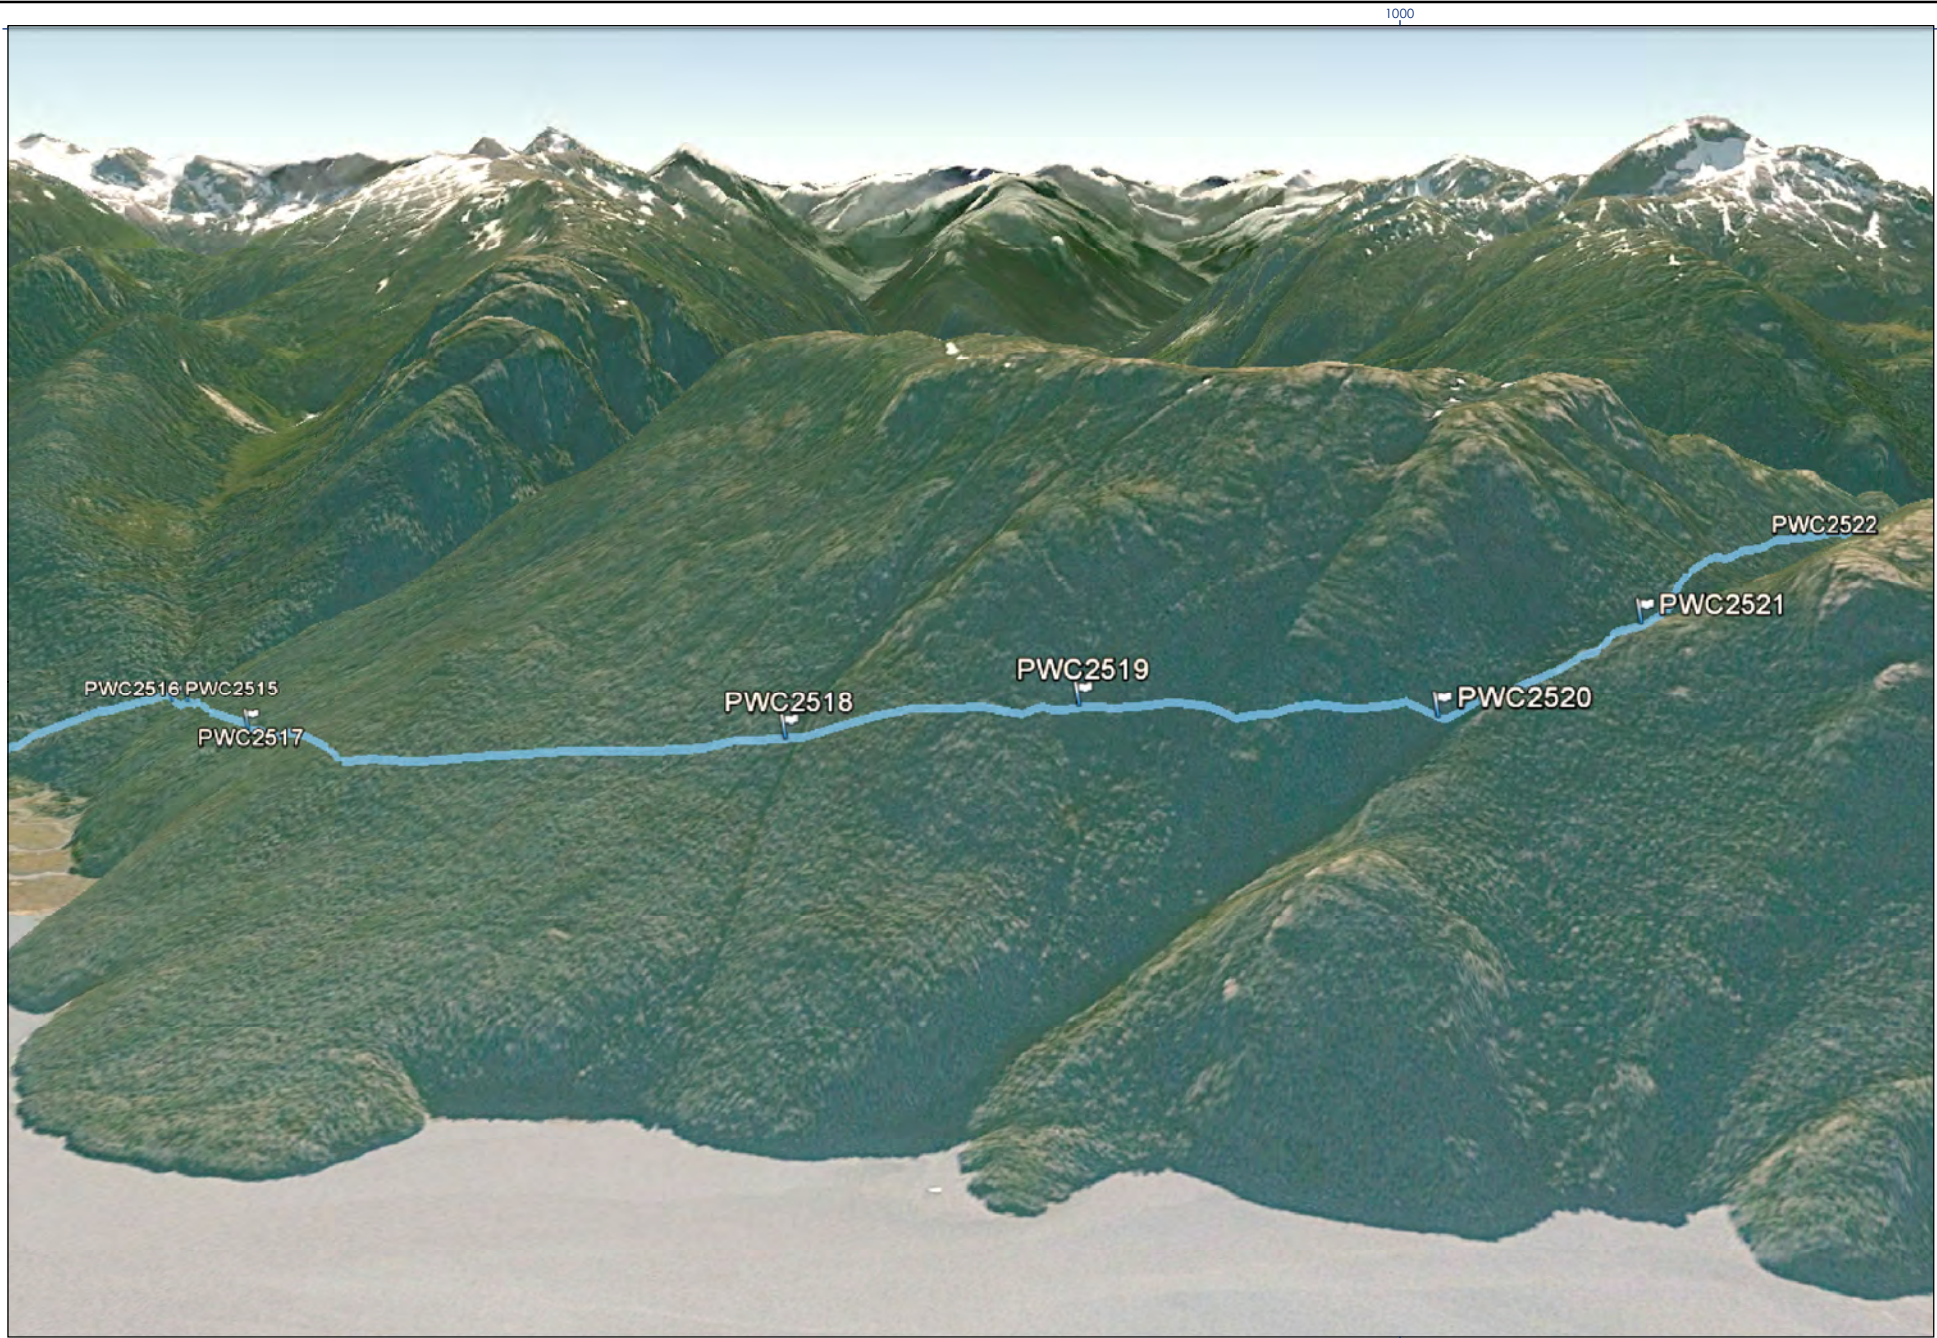
PREPARED BY: Stantec  
 FIGURE NO: **Figure 1**  
 PREPARED FOR: Tera a CH2M Hill Company  
 Date Prepared: 21 July, 2014

**General Comments**  
 As Figure 1 indicates, the pipeline route runs along the northern slope of the mountains, crossing PWCs 2516 through 2522. These watercourses have identified gradient barriers downstream from the PWC which impede fish migration. Inset photos show varying aspects of the mountain where the pipeline route is proposed.

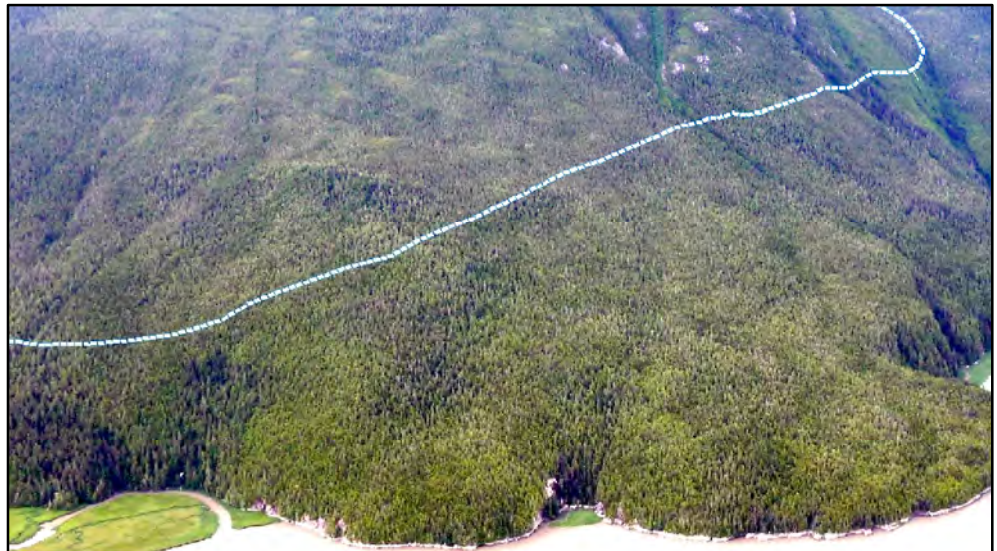
Southwest view, showing route along the mountain and steep gradient slope.

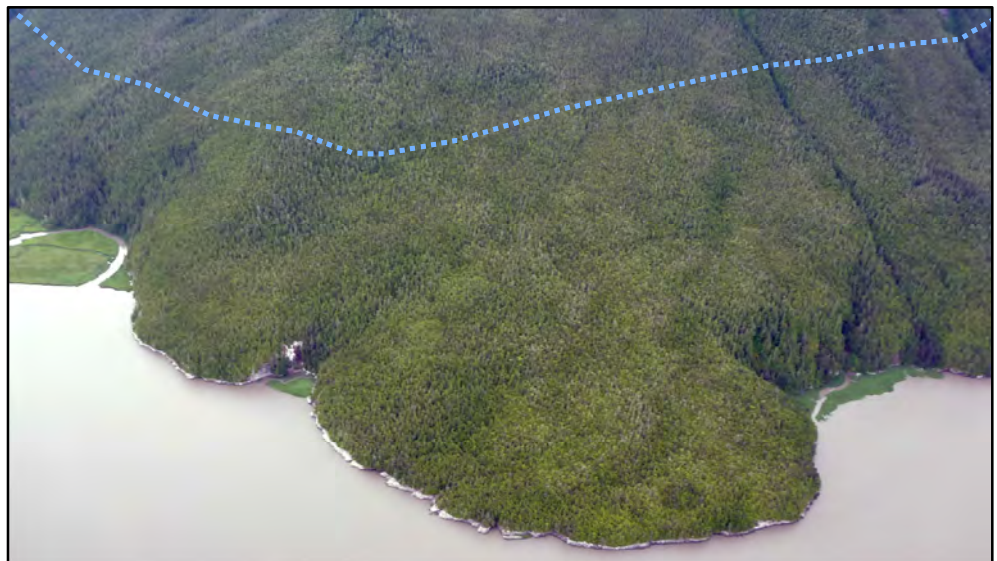
South view, showing gradient barrier from Nass Bay upstream to PWCs 2517-2519.

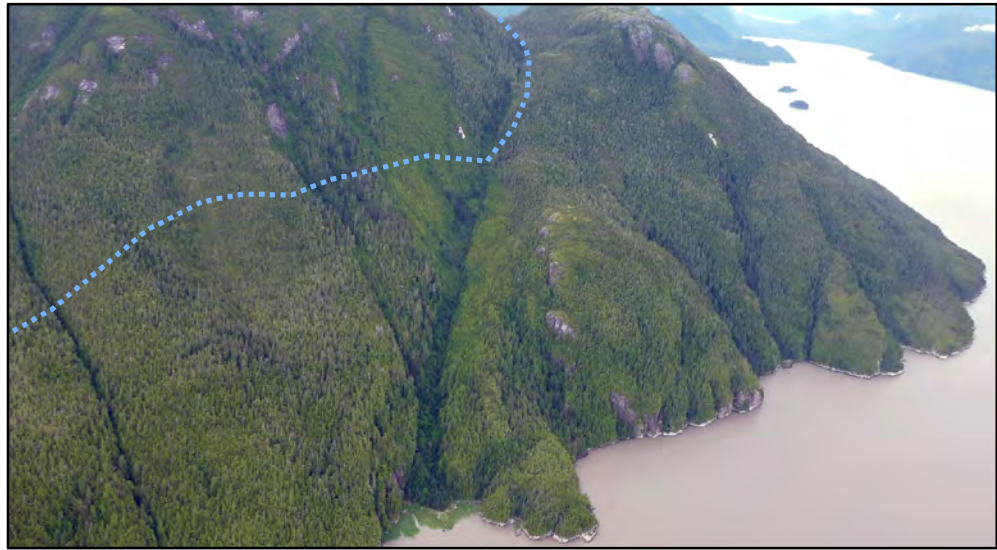
West view, showing gradient barrier from Nass Bay upstream to PWCs 2520-2522.

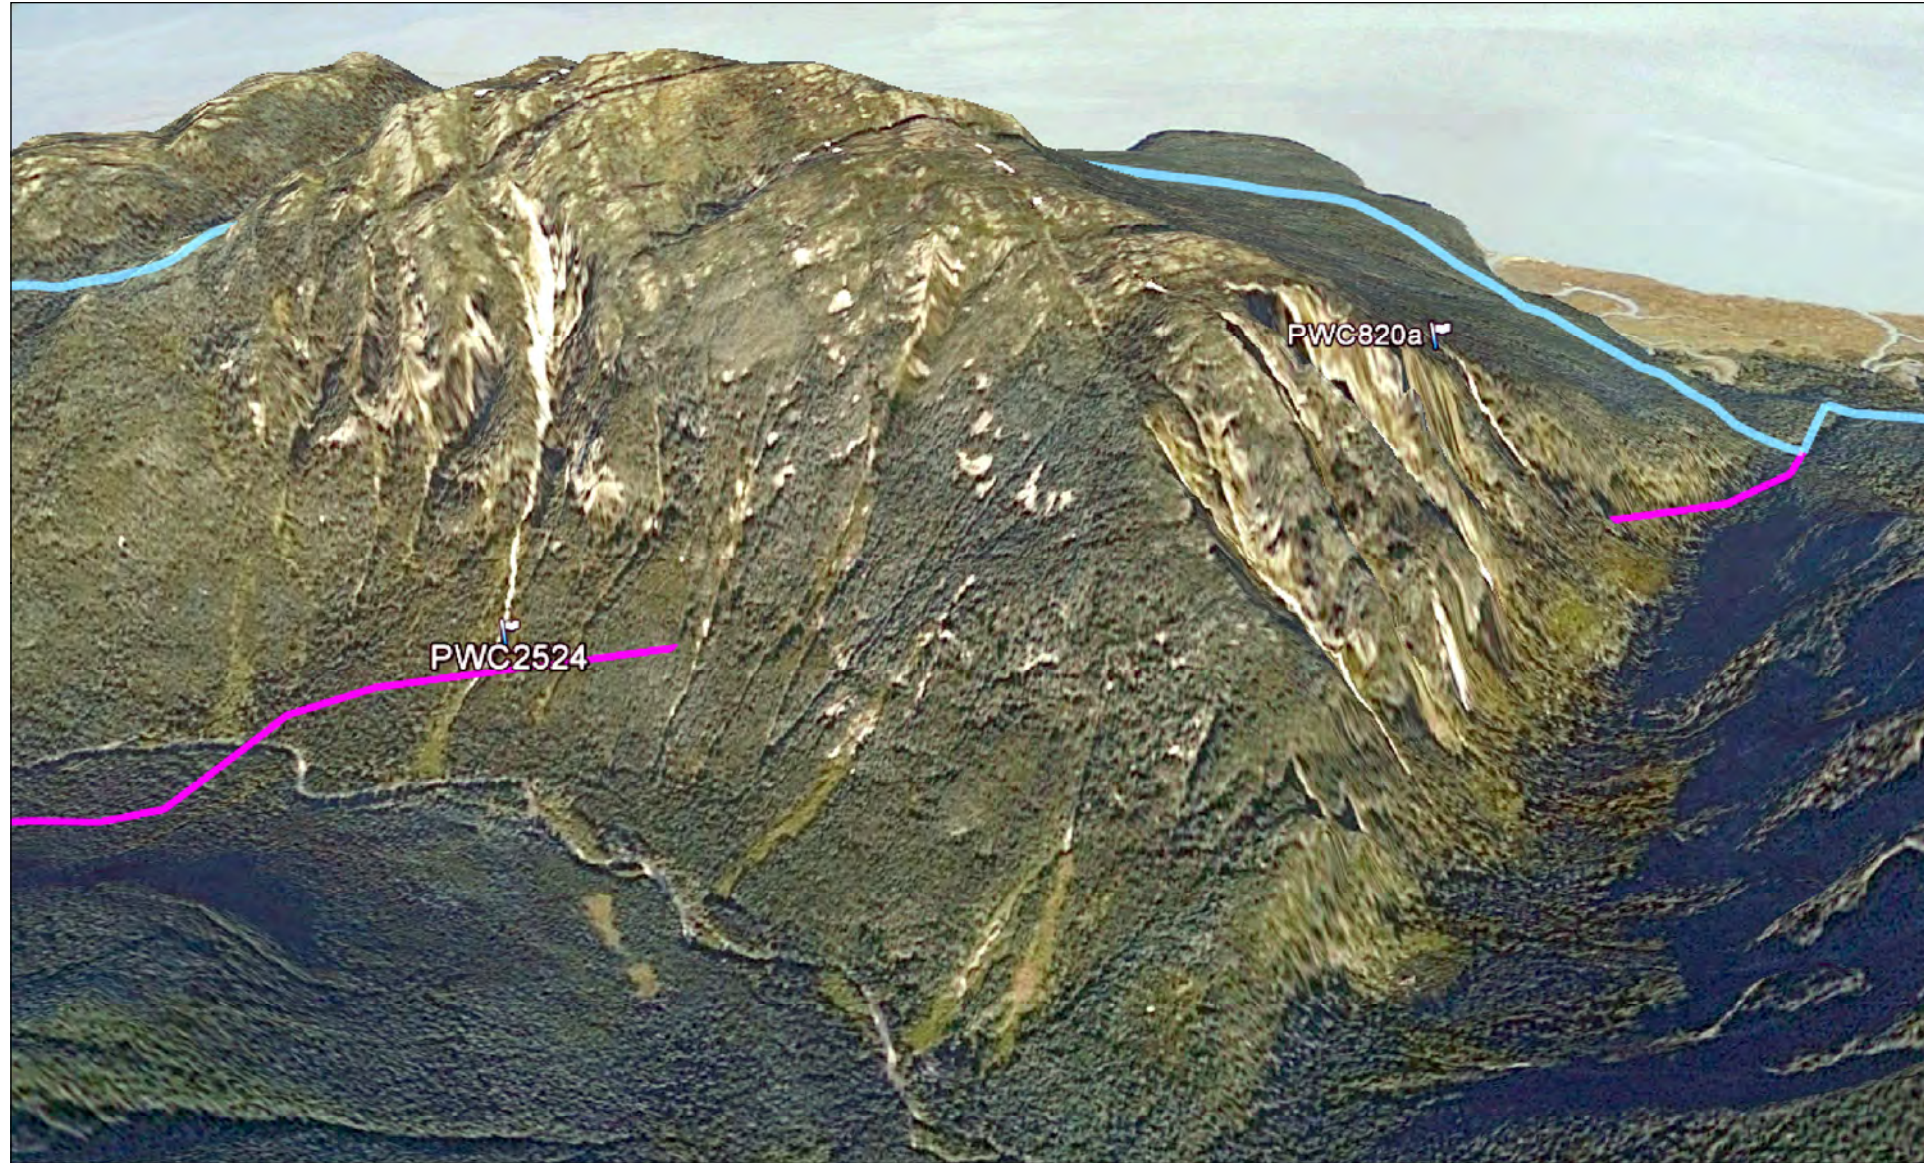
Alternate pipeline route outlined in pink showing steep gradients at PWCs 820a and 2524.

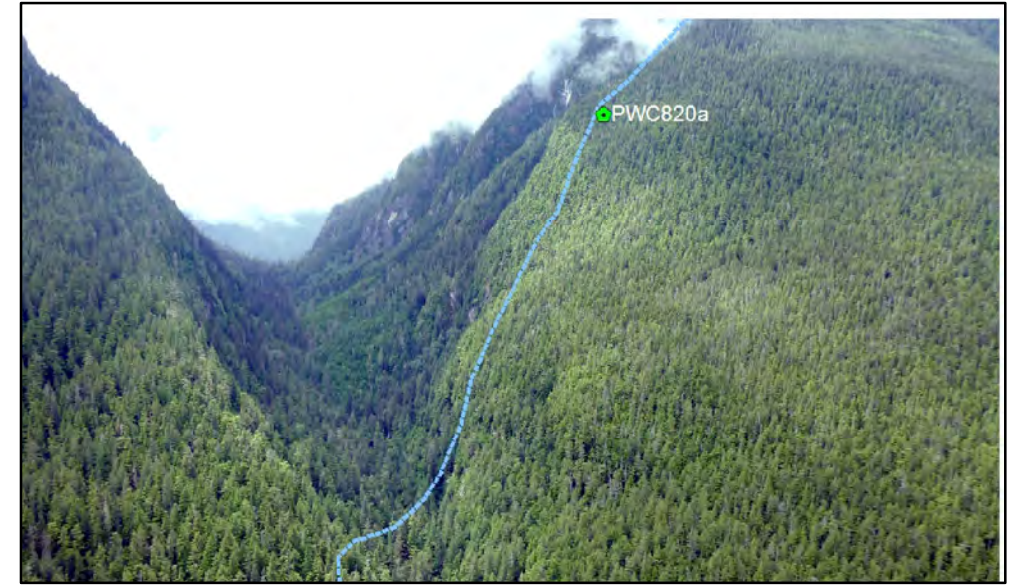
Looking southwest showing alternate pipeline route crossing PWC 820a.

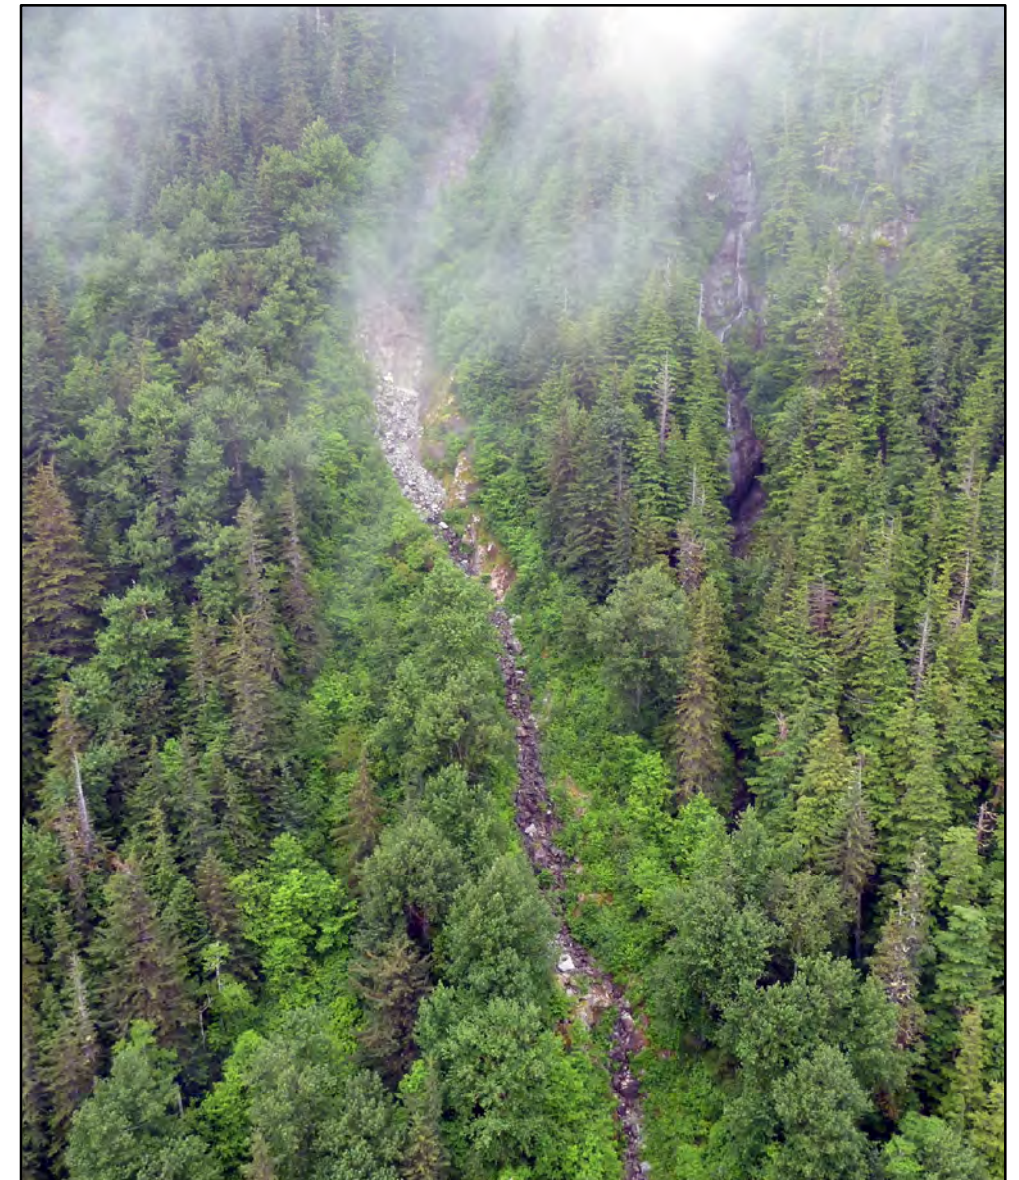
PWC2524. Note steep gradient and lack of fish habitat potential.

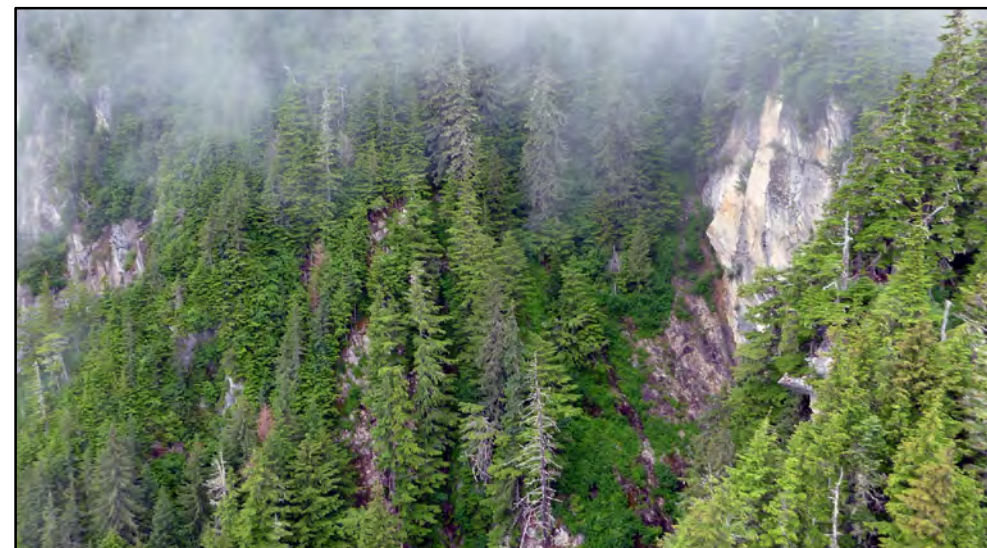
PWC820a. Note steep gradient and rock face near proposed centreline.

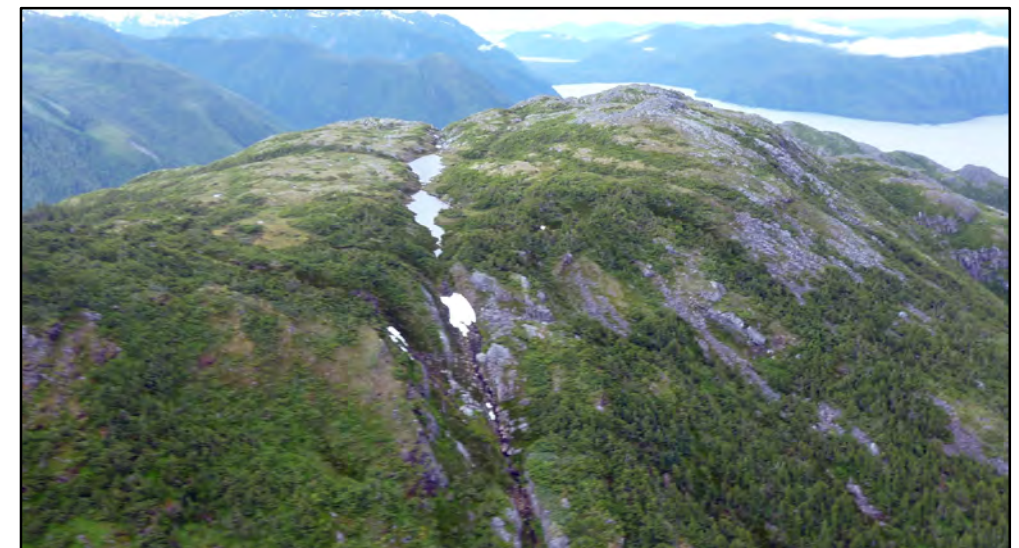
View of the pond outlet connecting to stream on which PWC2518 is located.
