**WINTER MEASUREMENTS OF
DISSOLVED OXYGEN AT SELECTED
SITES IN THE BULKLEY WATERSHED**

DAVID BUSTARD AND ASSOCIATES

**DEPARTMENT OF FISHERIES AND OCEANS
NORTHERN SALMON STOCK ASSESSMENT
PACIFIC BIOLOGICAL STATION**

MARCH 1996

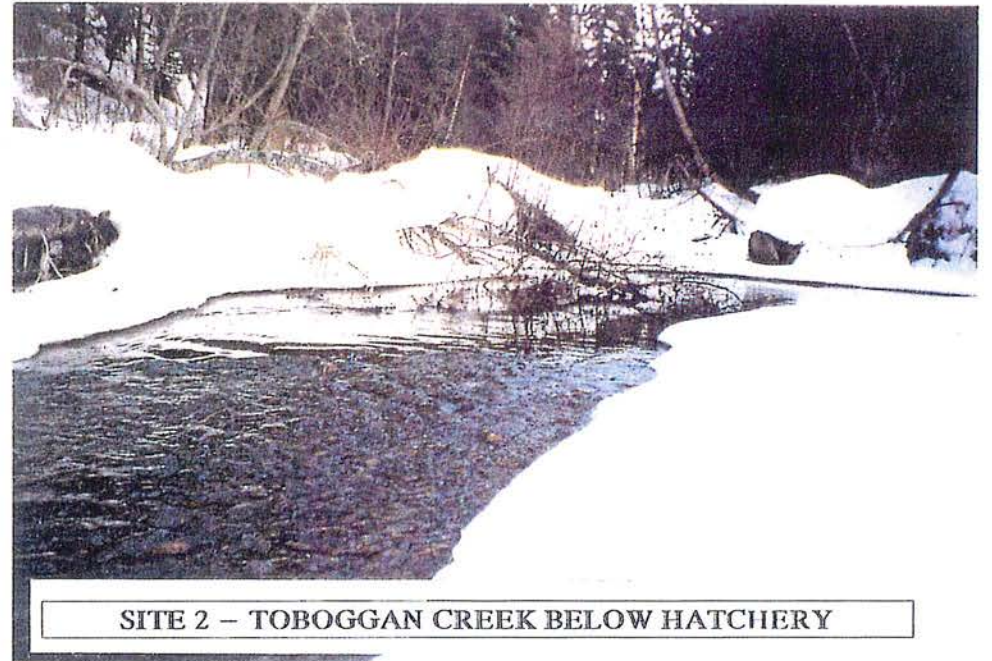
SITE 2 – TOBOGGAN CREEK BELOW HATCHERY

SITE #	LOCATION	COMMENTS
2	Toboggan Creek, 200 m below hatchery.	Sampled approximately 30 m downstream from the rearing channel outlet.
8	McQuarrie Creek between the highway and railway.	Some difficulty experienced in locating the channel due to thickness of ice.
9	Byman Creek 25 m above railway crossing.	Byman Creek was totally iced – over upstream along the highway.
10	Richfield Creek 75 m above railway crossing.	Accessed lower Richfield Creek through a private driveway.
13	Mainstem Telkwa River at Km 11.9 (near DFO ponds).	Telkwa River was only open in fast – running sections.
14	Eastern side of Telkwa River (lower end of seepage trib located at approx Km 8).	Accessed this site across Telkwa R on ice. Deep snow on ground. Could hear flowing water at tributary confluence with Telkwa River. Freshwater shrimp observed at ice hole.
15	Eastern side of Telkwa River (outlet of Km 8 upper pond)	No evidence of flowing water at the outlet of this upper pond (stagnant ?).

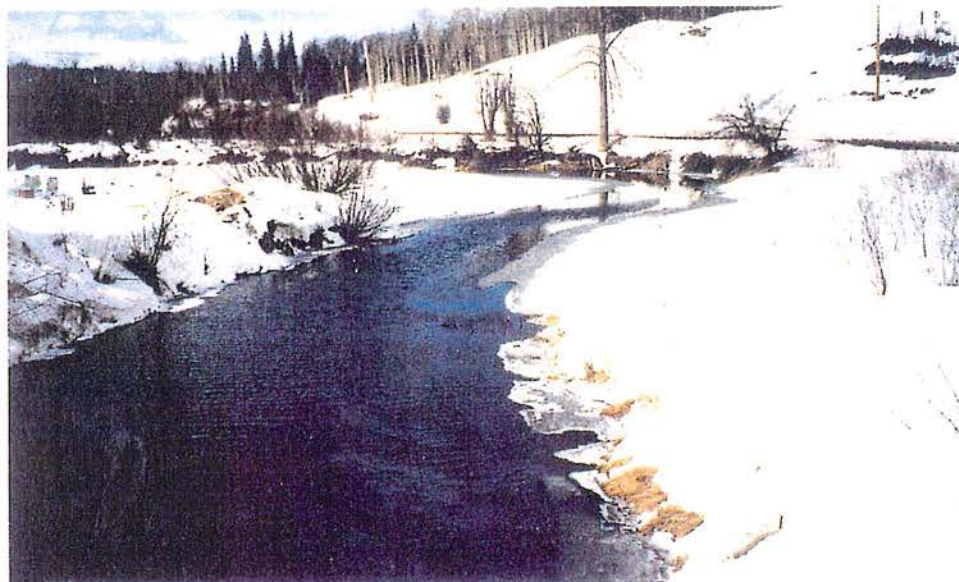
SITE 7 – BULKLEY RIVER BELOW LAKE

7	Bulkley River at the lake outlet bridge crossing.	Mar 13	54 23' 14 N 126 08' 16 W	9	0	clear with shelf ice	1	surface	1.5	11.0
								0.50	1.4	11.4
								1.00	1.4	11.4
UPPER BULKLEY RIVER TRIBUTARIES										
8	McQuarrie Creek between the highway and railway.	Mar 13	54 30' 52 N 126 27' 44 W	6	0.1	1	trickle flow	0.10	0.1	11.6
9	Byman Creek 25 m above railway crossing.	Mar 13	54 31' 03 N 126 26' 24 W	7	0	0.12 – 20% open water	nearly stagnant	0.15	0.9	7.6
10	Richfield Creek 75 m above railway crossing.	Mar 13	54 30' 32 N 126 20' 25 W	8	0.06	0.55	0.12	0.10	0.1	12.2
11	Ailport Creek at private access road.	Mar 13	54 28' 22 N 126 14' 03 W	12	0.1	0.5	0.06 trickle flow	0.05	0.1	12.5
12	Foxy Creek at bridge crossing.	Mar 13	54 18' 50 N 126 07' 30 W	11	0	0.1 – < 10% open water	0.1	0.10	1.0	11.8

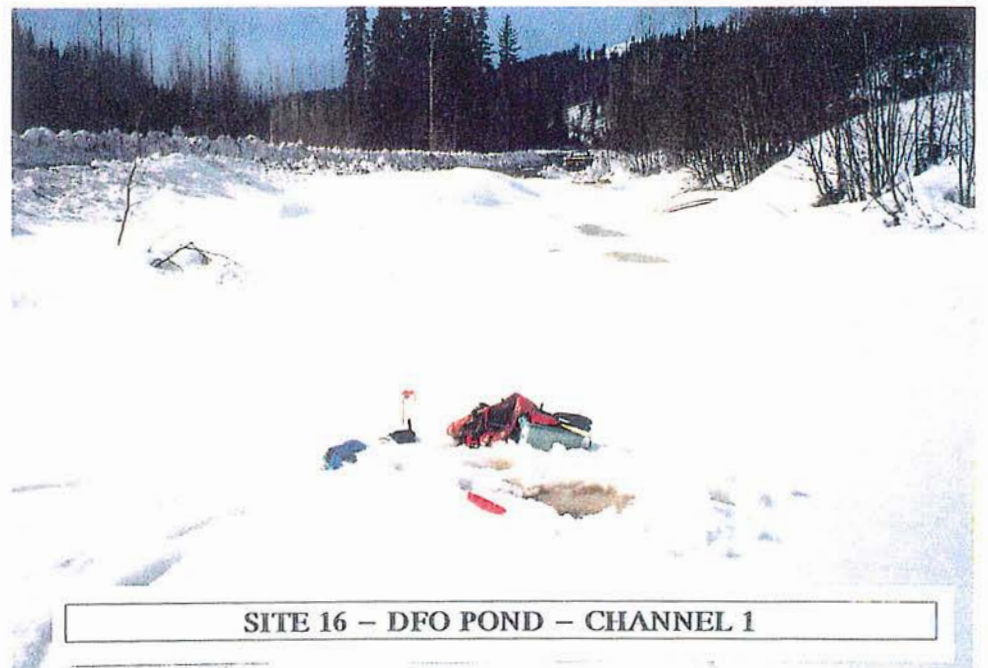
SITE 16 – DFO POND – CHANNEL 1

16	Telkwa River DFO ponds at approx Km 11. (Channel #1)	Surface mud from road – flowing directly into pond area! See Bustard (1995) for channel # location map – Report done for Greg Bonnell – DFO.
17	Telkwa River DFO ponds at approx Km 11. (Channel #4)	Melt has just started – must be careful on ice. Beavers active in this pond.
18	Telkwa River DFO ponds at approx Km 11. (Channel #5)	Small open area at top of this channel.
19	Telkwa River DFO ponds at approx Km 11. (Channel #6)	Smell of decomposition from ice hole.
21	Telkwa River DFO ponds at approx Km 11. (Channel 5a)	New site on PNG channel nearest to hillside. Some open water between this site and Site 5.
22	Telkwa River DFO ponds at approx Km 11. (Channel 5b)	New site on PNG channel nearest to Telkwa River. Clear in top 25 m of this channel.
23	Telkwa River DFO ponds at outlet culvert.	Appeared to be very little flow. Small oil slicks observed on water surface – likely originated from road surface.

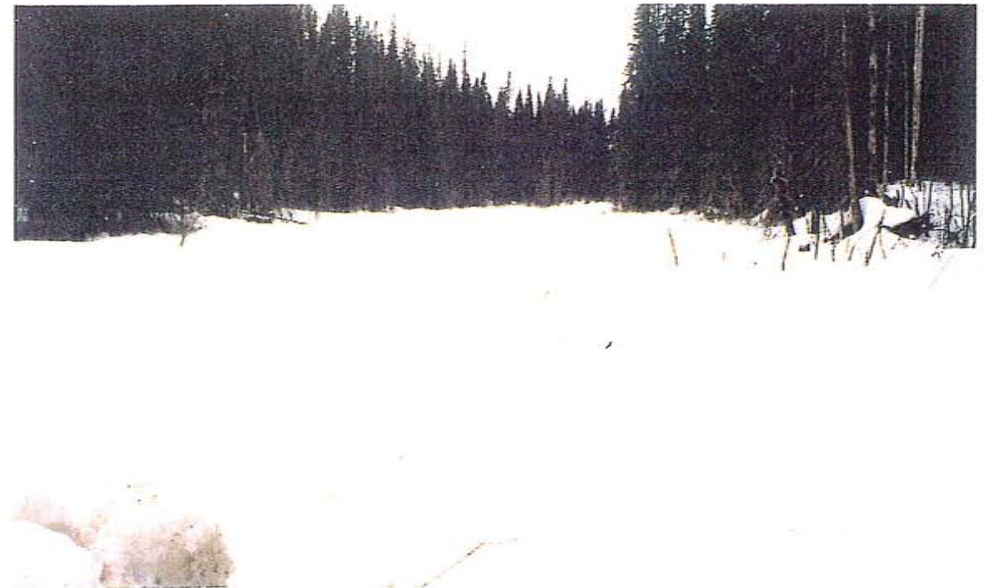
SITE 24 – KM 19 WETLAND

24	Telkwa R – Km 19 wetland right side above road.	Difficult to locate main channel due to snow depth.
25	Telkwa R – Km 19 wetland mid – channel above road.	Suspect this reading is high due to shallow depth.

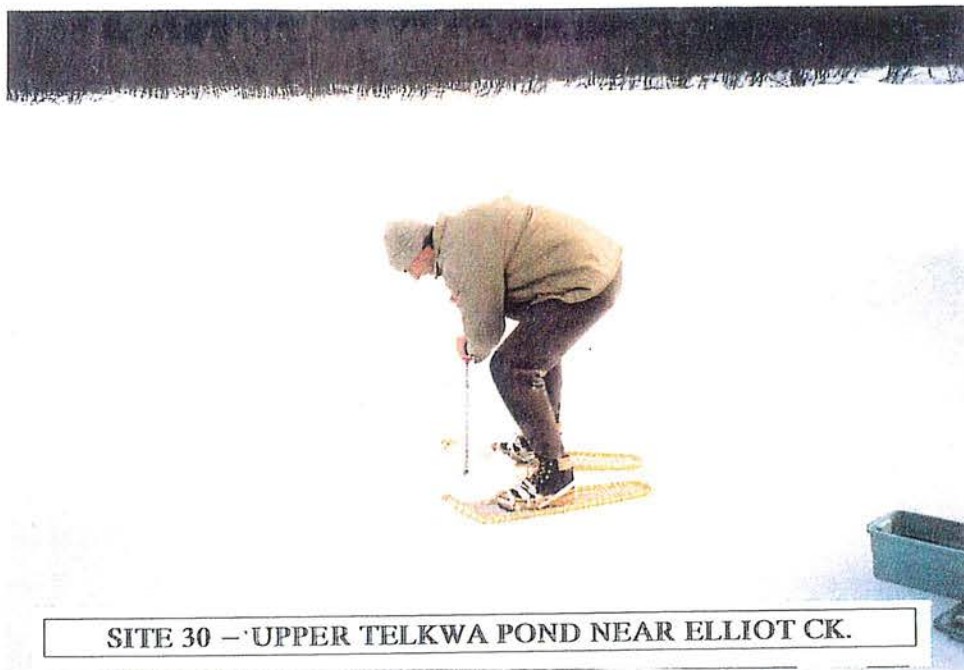
SITE 30 – UPPER TELKWA POND NEAR ELLIOT CK.

SITE #	LOCATION	COMMENT
26	Telkwa R – Km 19 wetland left side above road.	Suspect this reading is high due to the shallow water depth combined with mixing from the ice auger.
27	Telkwa River at Jonas Flat Pond 20 m below road.	Smell of decomposition from ice hole.
30	Telkwa R wetland at base of Elliot Ck, 250 m above outlet	This wetland is connected to the Telkwa with a 50 m long connector channel that has a small beaver dam. Telkwa River was ice-free throughout this upper reach.
33	Telkwa R wetland below Milk Creek, middle of pond.	Small pond on west side of Telkwa – 100 m to river.
35	Owen Creek, 100 m above bridge crossing.	Creek has flowed on surface of ice – caused very thick ice to form.
36	Morice River, Bustard's pond at outlet channel.	Smell of decomposition from ice hole.
39	Morice River Km 33 sidechannel.	Soft snow on hillside below road (must have snowshoes).
40	Morice River Km 38.5 sidechannel.	Appeared stagnant – river right channel was dewatered in upper open sections. Sampled the channel along road above the fork.

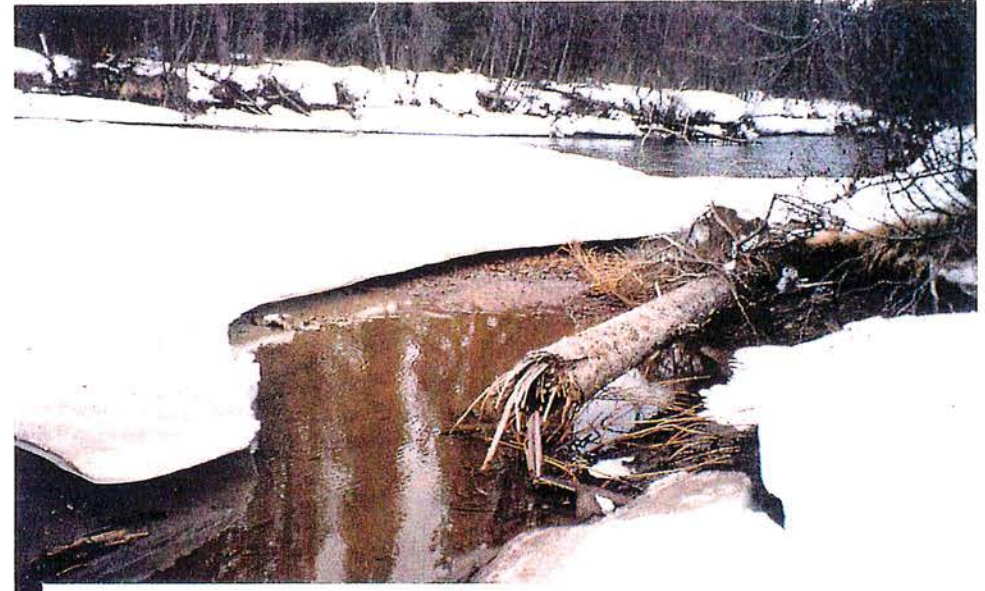
SITE 42 – KM 45.5 OUTLET CHANNEL – MORICE

42	Morice River backchannel at Km 45.5 (outlet channel).	Could hear water running under ice at road culvert.
43	Morice River Km 55.5 sidechannel (upper end).	Sampled approx 100 m from road and upstream from boat launch. Difficult to find any other sidechannels.
45	McBride Creek below Nanika FSR.	Lake is still frozen over.
46	McBride Creek at the Morice Lake confluence.	Creek had sections iced over upstream.
47	Gosnell Creek seepage channel above Shea Creek. (Sampled upstream 100 m).	Sampled 100 m above the Gosnell – beaver dams present – assume accessible.
50	Upper Gosnell Creek backchannel near top end.	Clear of ice in upper section.

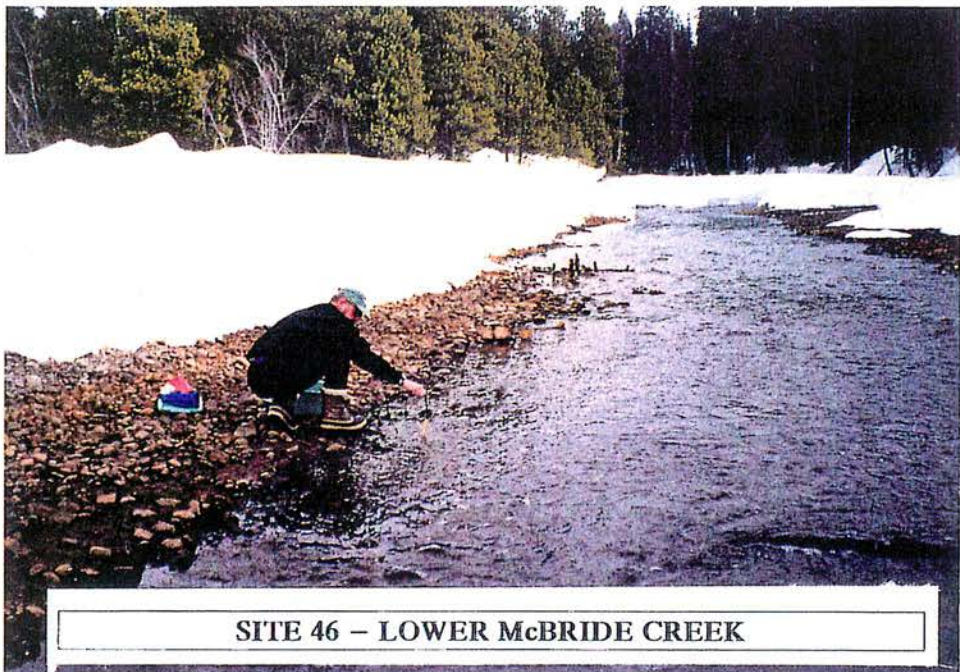
SITE 46 – LOWER McBRIDE CREEK

46	McBride Creek at the Morice Lake confluence.	Mar 18	54 04' 19 N 127 23' 08 W	24	0	clear	est 10 cfs	0.15	1.0	10.2
GOSNELL CREEK										
47	Gosnell Creek seepage channel above Shea Creek. (Sampled upstream 100 m).	Mar 18	54 13' 38 N 127 30' 56 W	19	0.1	0.6	1	surface	0.1	2.6
