**Operational Fish and Fish Habitat Inventory
of
Tributaries to the Fulton River
Watershed Code: 480-6972**

Resampling in the Tanglechain Landsape Unit:
CP 416, CP 439-1, CP 439-2, CP 439-3, CP 439-4

Houston Forest Products
Box 5000
Houston, B.C.
V0J 1Z0

SKR Consultants Ltd.
RR#1, Site 11, Comp. 4
Smithers, B.C.
V0J 2N0

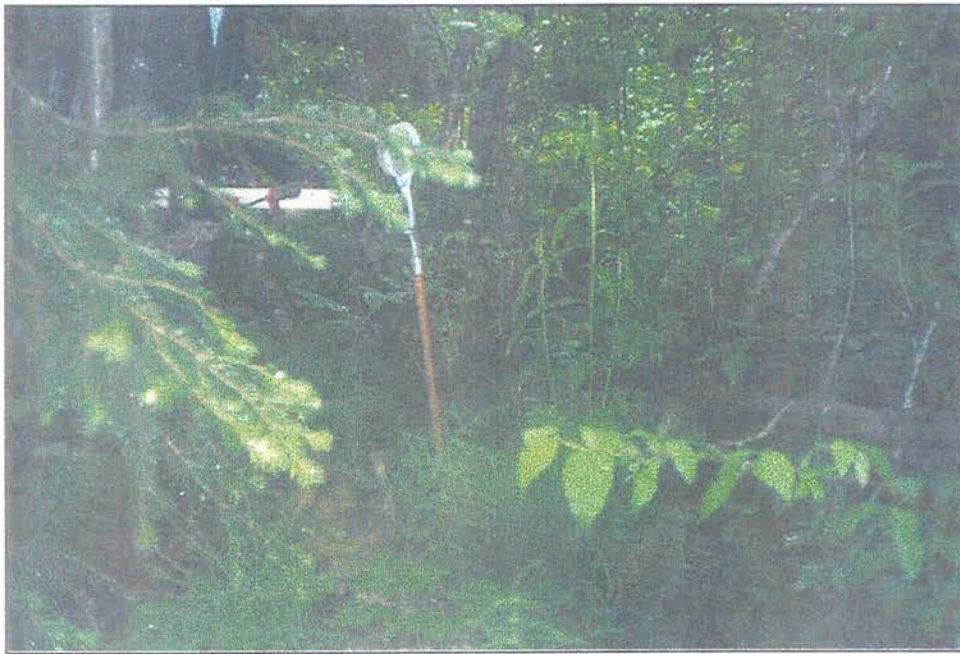
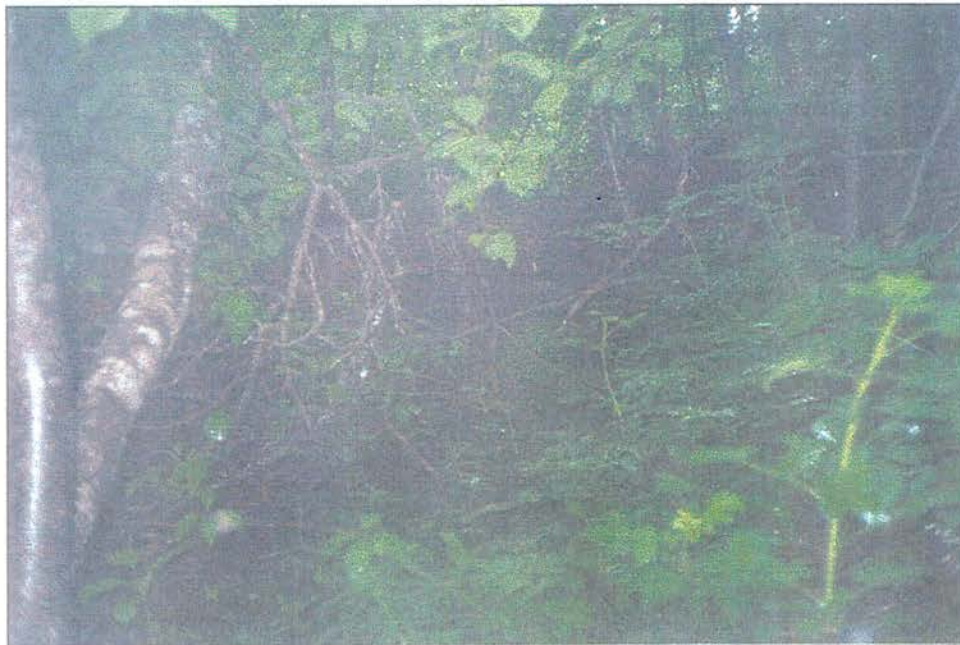
Unnamed Creek (ILP 1400) - Reach 1

Plate 1. Reach 1 - sample site 100. Upstream view (above) and downstream view (below).

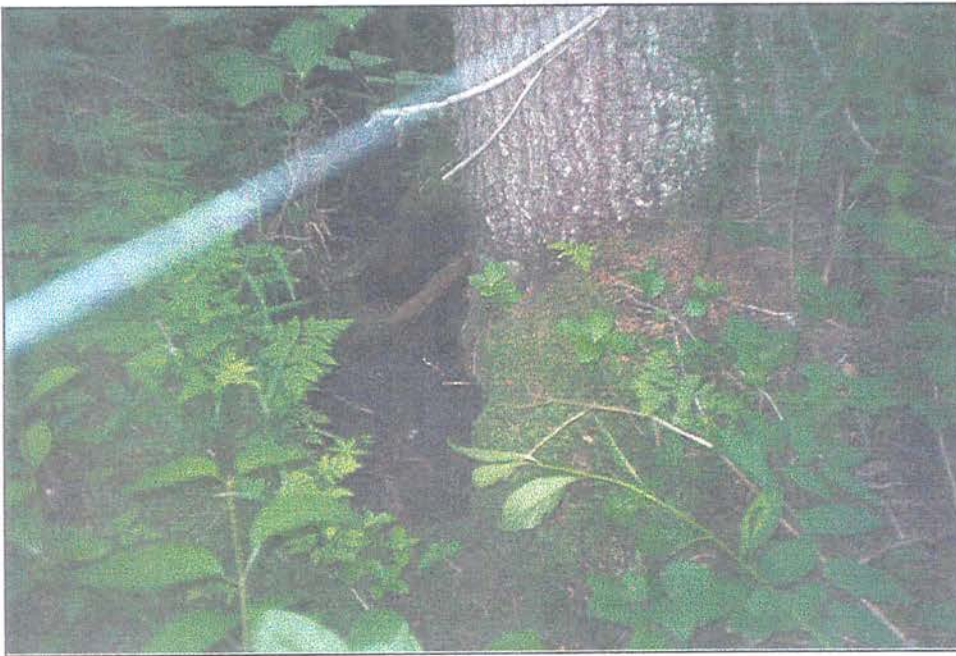
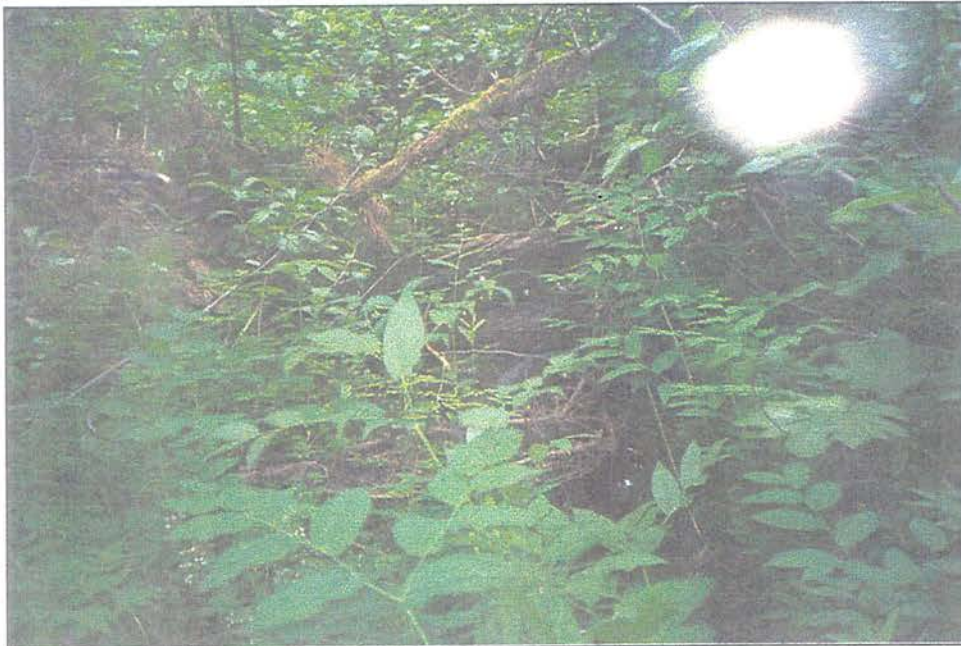
Unnamed Creek (ILP 2022) - Reach 1

Plate 2. Reach 1 - sample site 2. Upstream view (above) and downstream view (below).

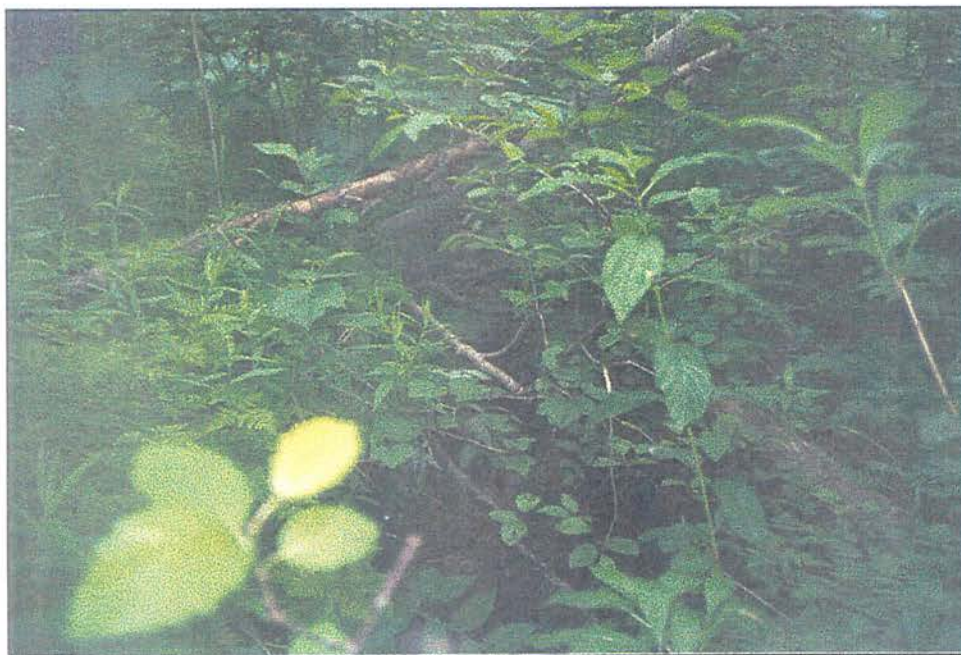
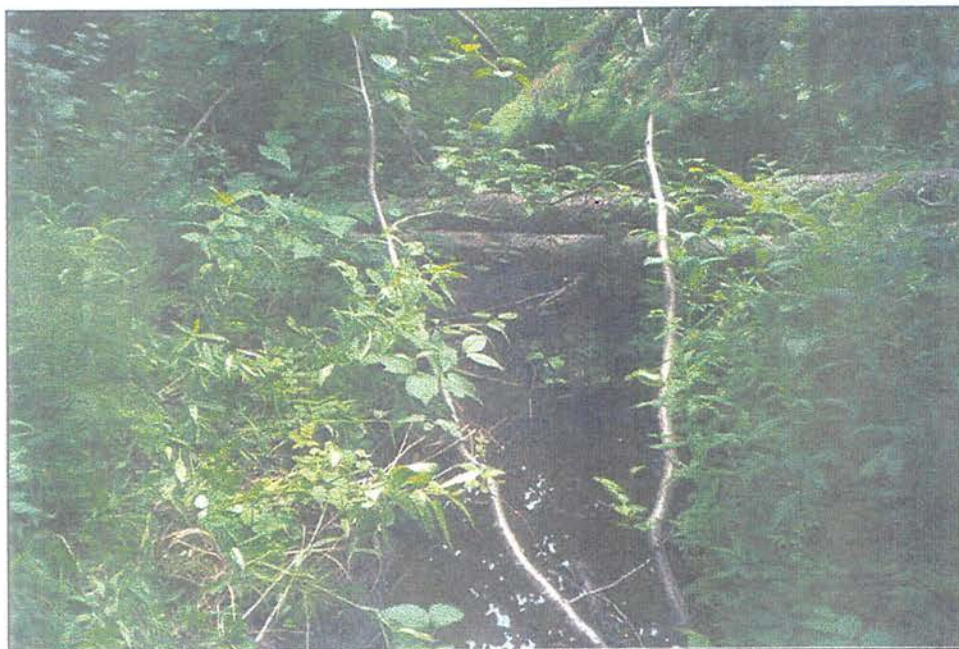
Unnamed Creek (ILP 2022) - Reach 2

Plate 3. Reach 2 - sample site 1. Upstream view (above) and downstream view (below).

Section	Comments
SITE CARD	Site located 100m north of block boundary
SITE CARD	No fish habitat
SITE CARD	Some surface flow at planned road crossing
SITE CARD	Unnatural channel was formed at road crossing in skid tracks
SITE CARD	Some minor discharge; underground seepage
SITE CARD	Stream goes underground 25m d/s from planned road crossing

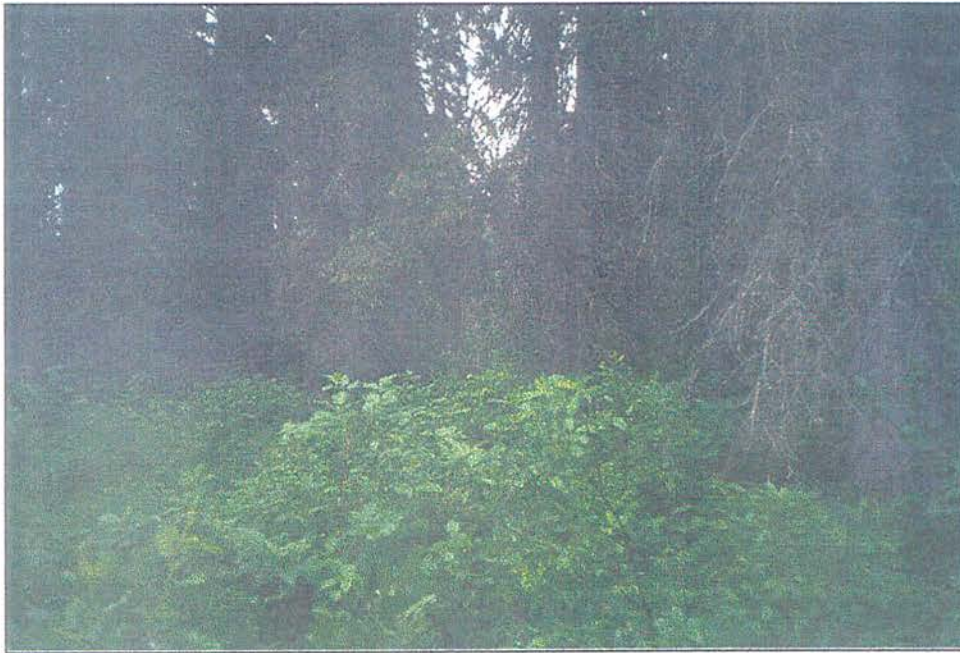
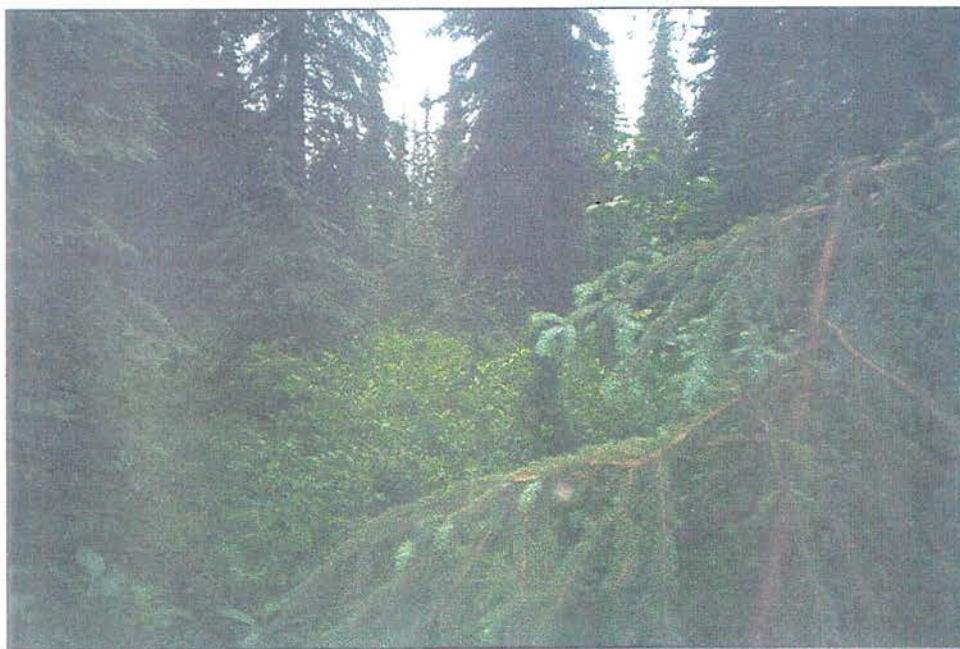
Unnamed Creek (ILP 1405) - Reach 2

Plate 4. Reach 2 - sample site 1. Upstream view (above) and downstream view (below).

Section	Comments
SITE CARD	Channel not well defined in this reach
SITE CARD	Despite moderate flow in reach 2, channel was dry
SITE CARD	No defined channel in upper 80m of this reach
SITE CARD	Limited potential for d/s impacts on f&fh from road crossing in reach 2
SITE CARD	Some potential for minor impacts from sediment loading into Tanglechain C
SITE CARD	Disturbance impacts only occur during flood conditions
SITE CARD	No fish habitat

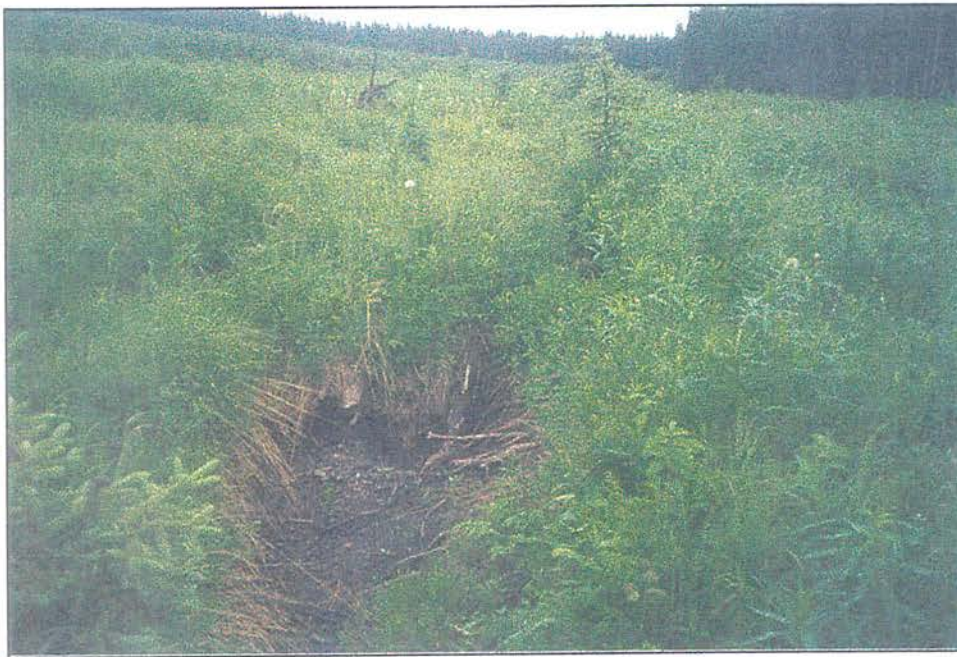
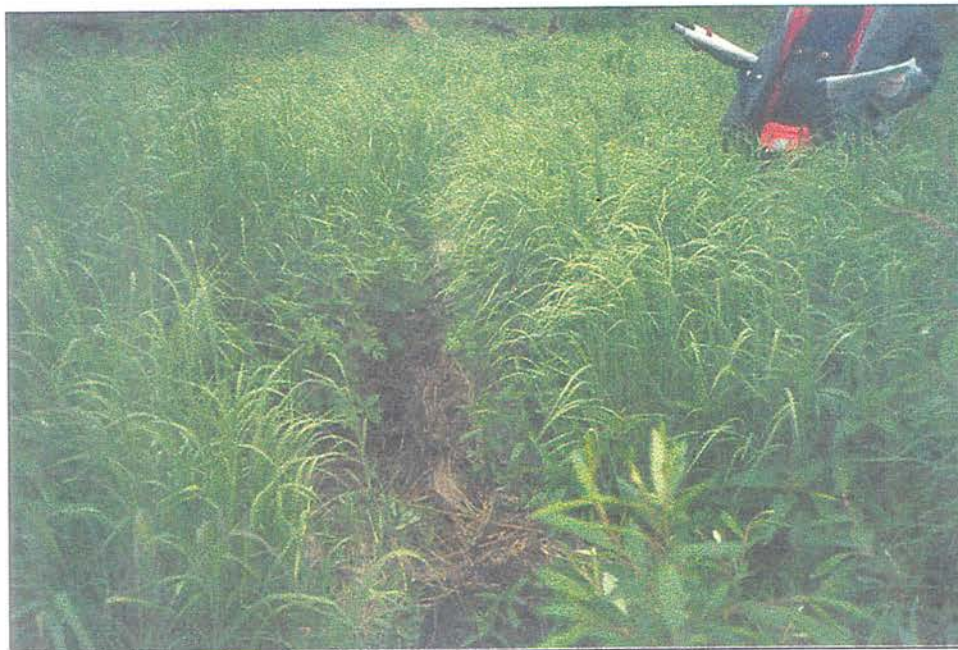
Unnamed Creek (ILP 2015) - Reach 1

Plate 5. Reach 1 - sample site 100. Upstream view (above) and downstream view (below).

Section	Comments
SITE CARD	Site located at proposed road crossing in CP 439-4
SITE CARD	Some potential for d/s impacts due to populations of resident CT in mainste
SITE CARD	Potential sediment loading into fish bearing mainstem due to steep gradient
SITE CARD	Impacts are limited due to small stream size and discharge
SITE CARD	May be important in terms of maintenance of water quality in mainstem

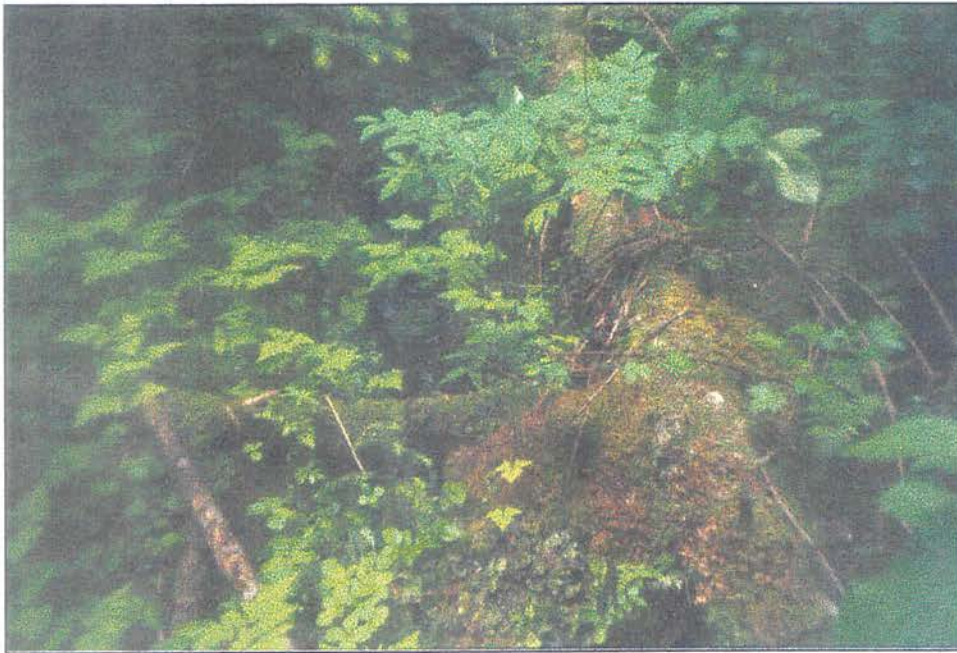
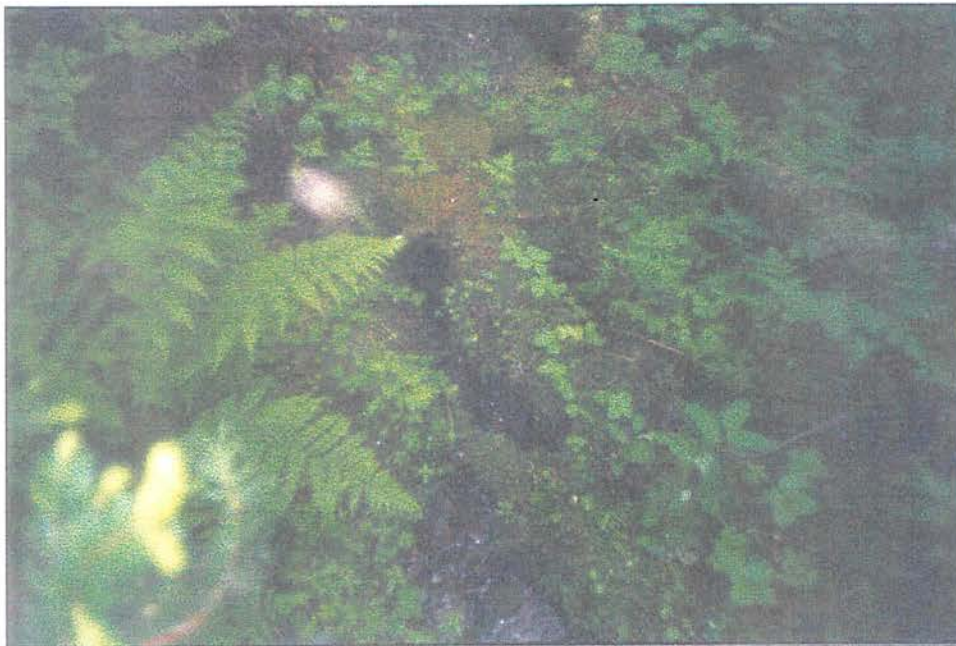
Unnamed Creek (ILP 1402) - Reach 1

Plate 6. Reach 1 - sample site 1. Upstream view (above) and downstream view (below).

Section	Comments
SITE CARD	Site located at proposed road crossing in CP 439-4
SITE CARD	Some potential for d/s impacts due to resident CT in mainstem of this trib.
SITE CARD	Potential for sediment loading into fish bearing stream due to steep gradient
SITE CARD	Sediment impacts will be limited due to small stream size and discharge
SITE CARD	May be important in terms of maintaining water quality in mainstem

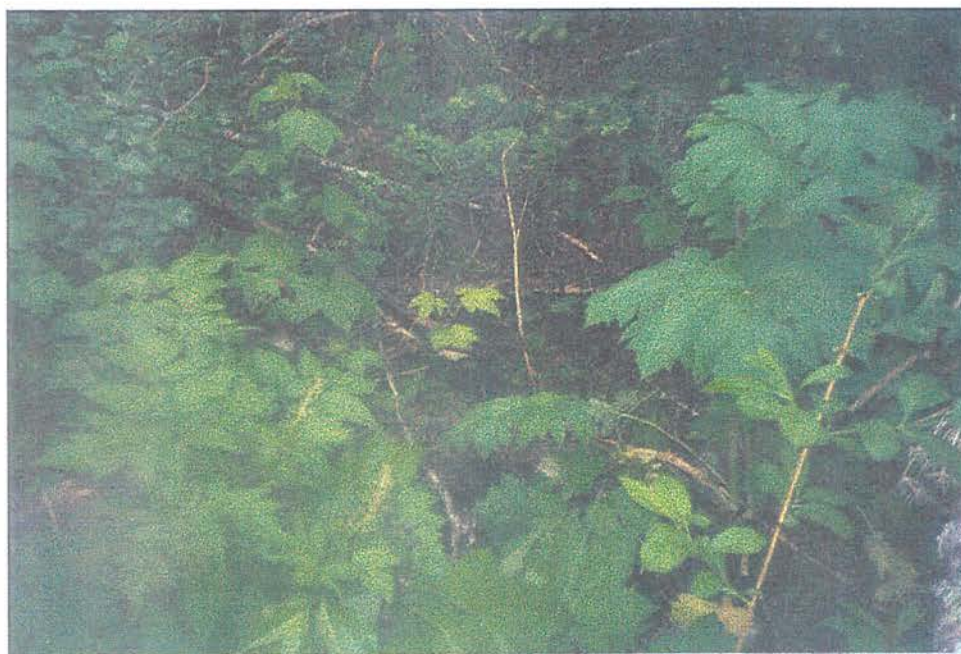
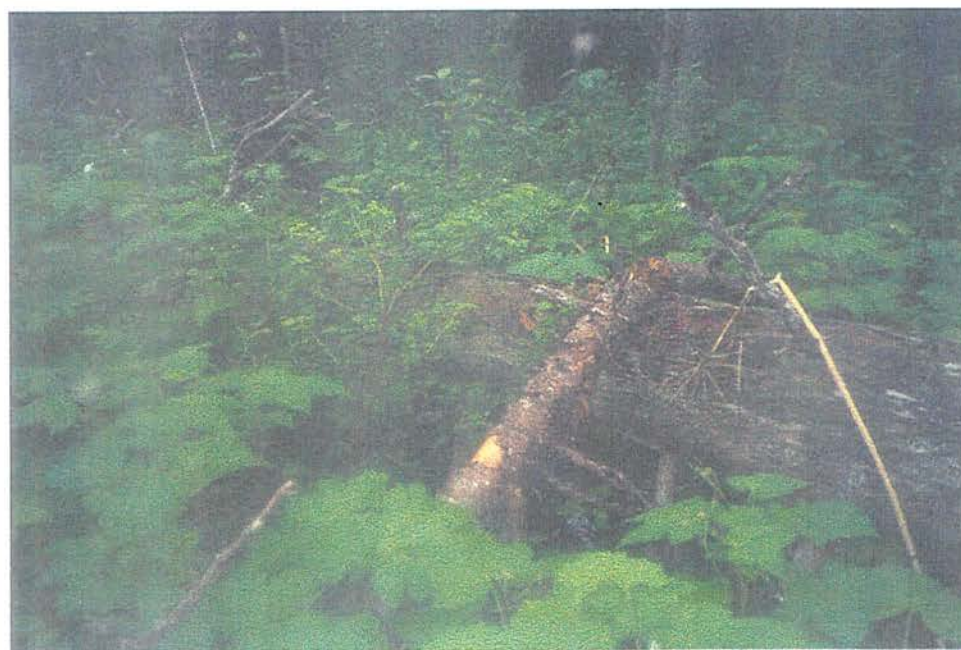
Unnamed Creek (ILP 1401) - Reach 1

Plate 7. Reach 1 - sample site 2. Upstream view (above) and downstream view (below).

Section	Comments
SITE CARD	Stream heavily braided with no well defined channel in lower 30m of reach
SITE CARD	Stream gradient >20%, 30m u/s from confluence
SITE CARD	Some potential for d/s impacts on fish and fish habitat
SITE CARD	Redefining channel in lower section of this reach may assist CT in mainstem

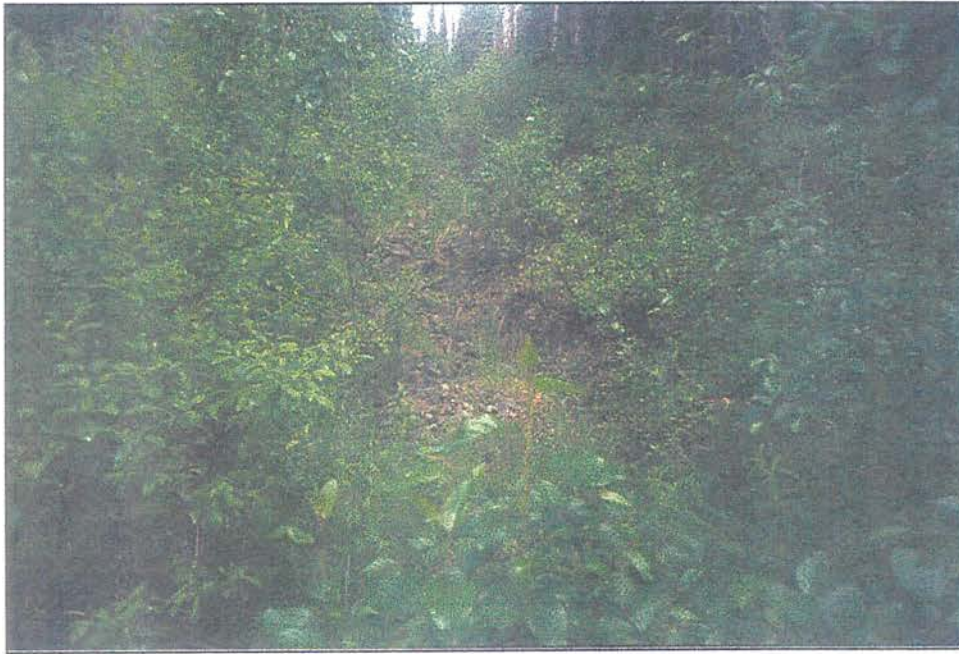
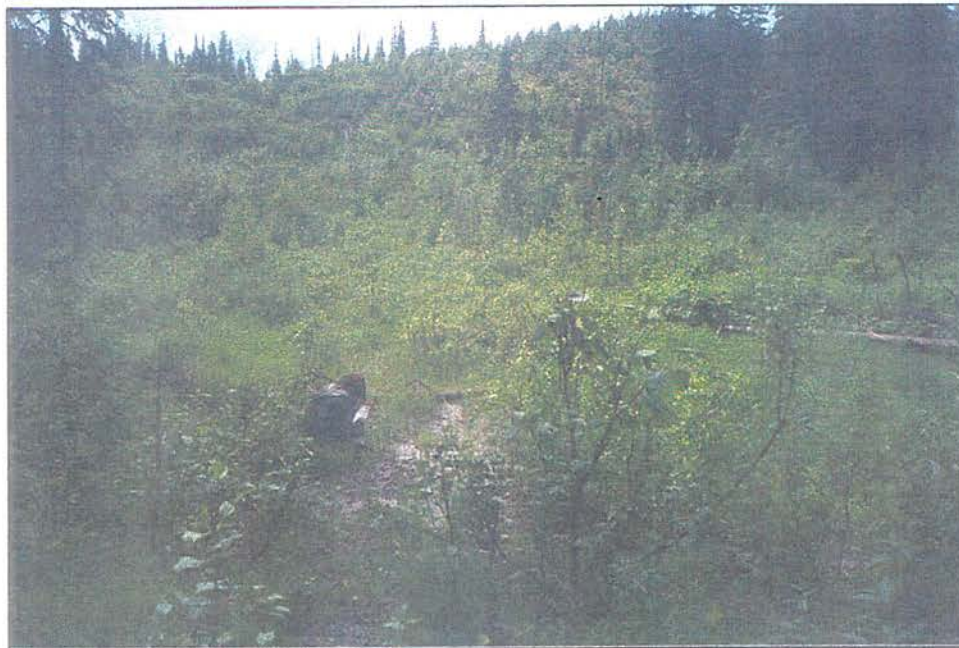
Unnamed Creek (ILP 1403) - Reach 1

Plate 8. Reach 1 - sample site 1. Upstream view (above) and downstream view (below).

Section	Comments
SITE CARD	Poor fish habitat; too steep
SITE CARD	LRV: 3-5 ; alder, ferns
SITE CARD	RRV: 2-5 ; alder, ferns

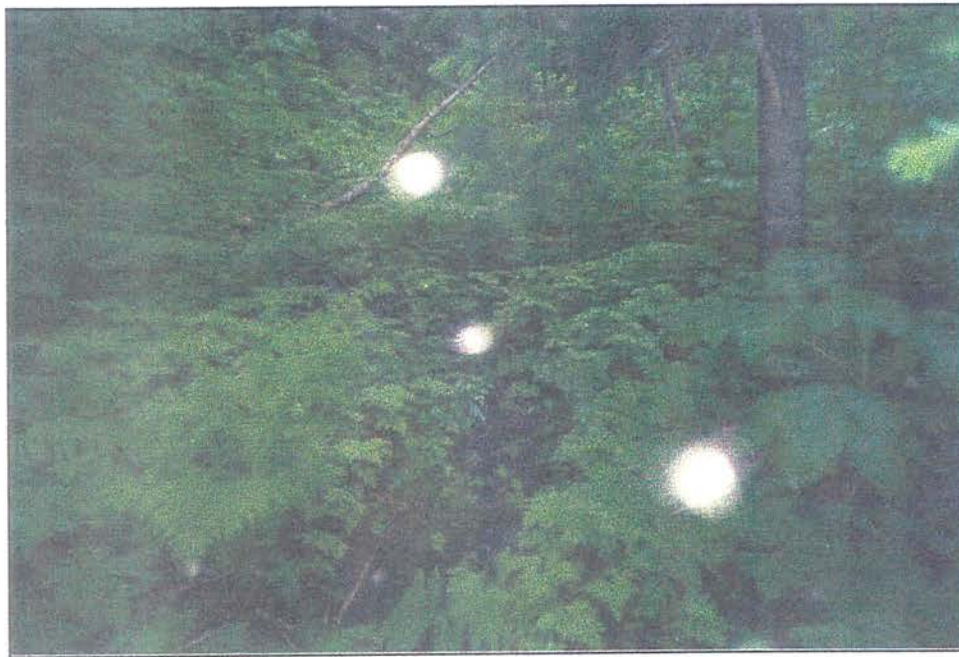
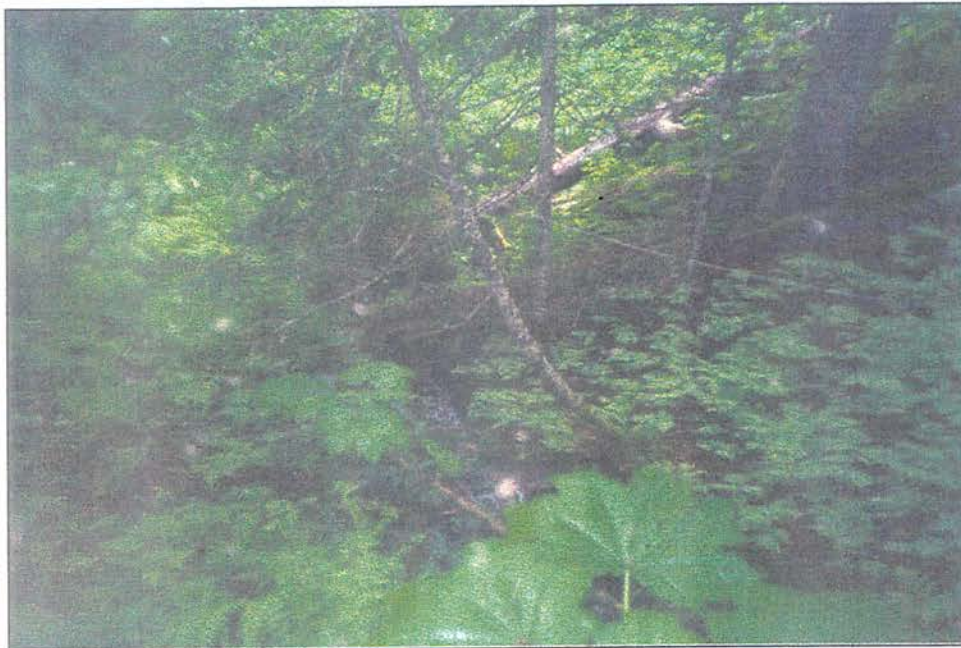
Unnamed Creek (ILP 1404) - Reach 1

Plate 9. Reach 1 - sample site 1. Upstream view (above) and downstream view (below).

Section	Comments
SITE CARD	Site located 100m u/s of confluence with stream #4 inside CP 439-3
SITE CARD	Some potential rearing habitat, limited potential spawning habitat
SITE CARD	Recommend partial retention
SITE CARD	Electroshocked 150 sq. metres for 250 sec.; no fish caught or seen
SITE CARD	Resample - 1998/06/23, caught 1 CT
SITE CARD	Recommend retention to top of gully to maintain bank stability

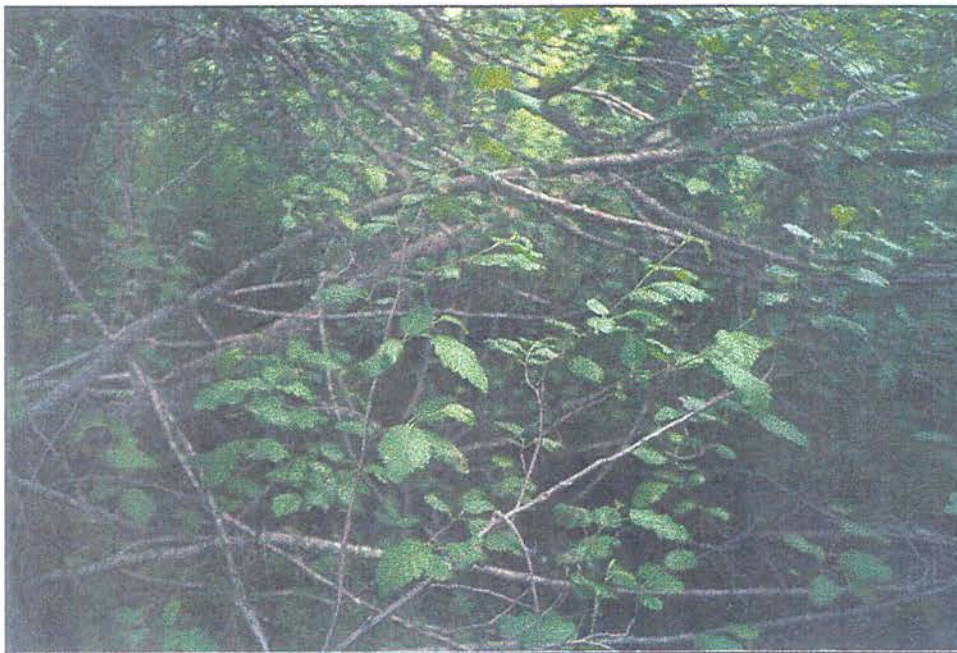
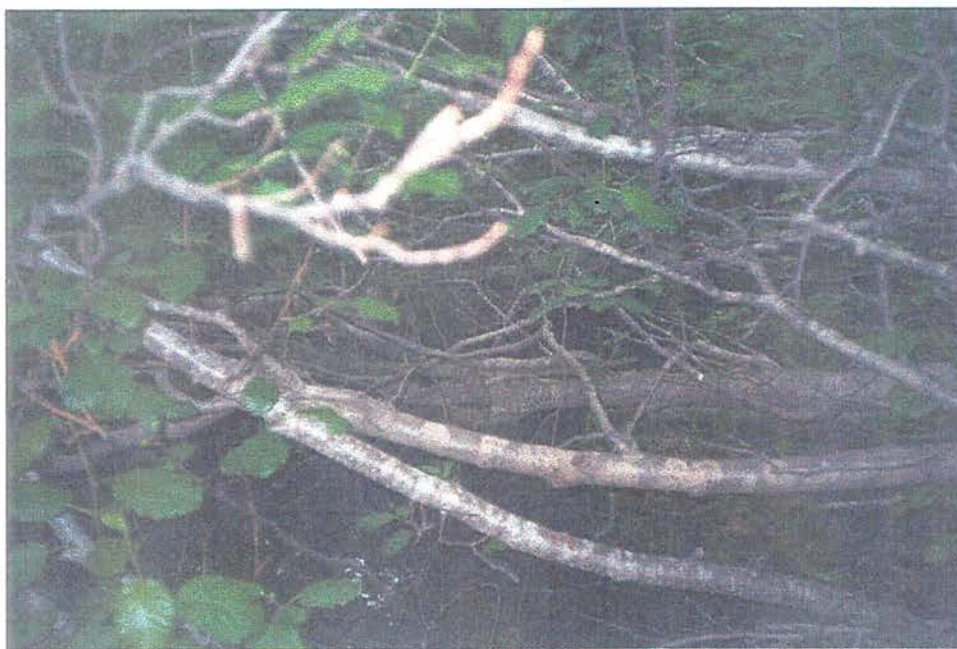
Unnamed Creek (ILP 2013) - Reach 2

Plate 10. Reach 2 - sample site 2. Upstream view (above) and downstream view (below).

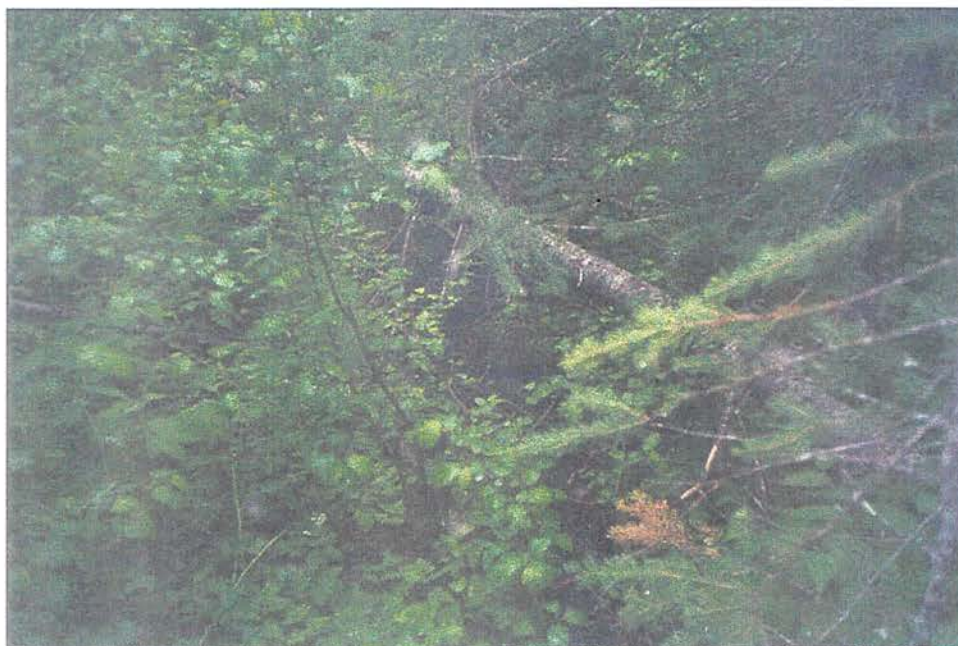
Unnamed Creek (ILP 1406) - Reach 1

Plate 11. Reach 1 - sample site 1. Upstream view (above) and downstream view (below).
