**Ailport Lake  
(460-829700-20600-30400-01)  
01123BULK**

**SECONDARY LAKE INVENTORY  
1997 STUDIES**

**Ministry of Environment, Lands and Parks  
Project No. IVBVS622 (FRBC)**

**APRIL 1998**

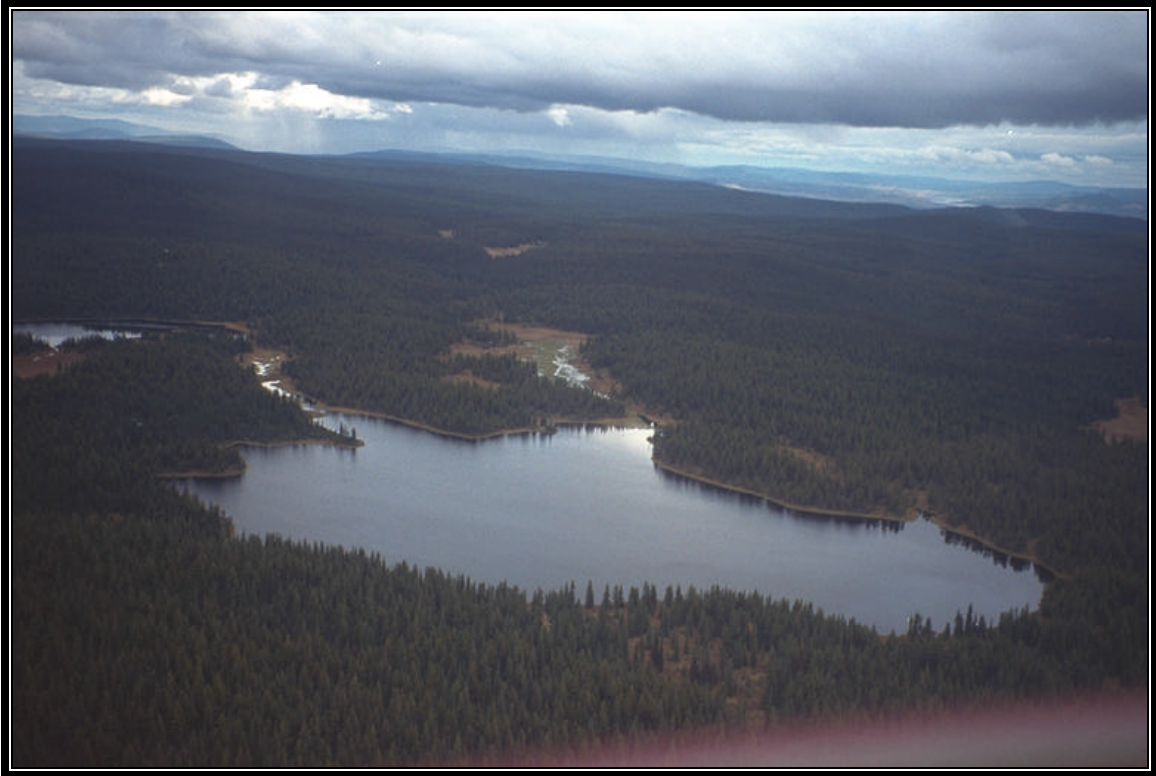
**Plate 1** Aerial view of lake looking northeast.

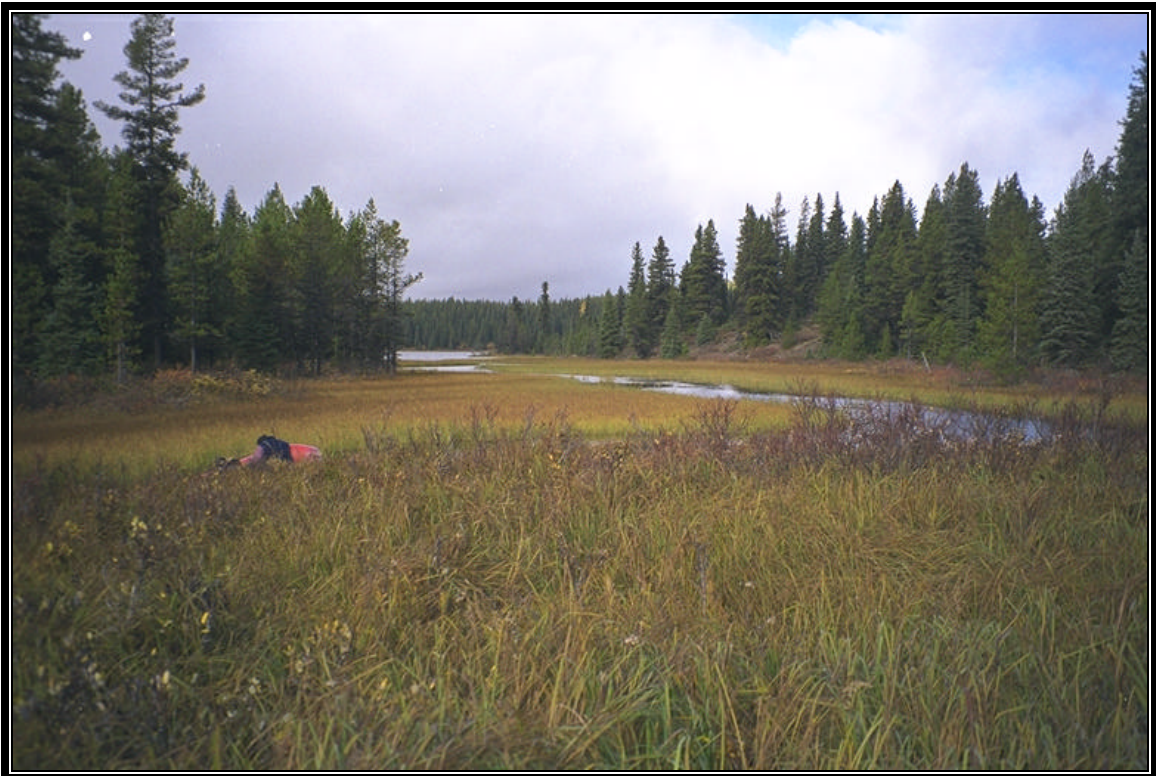
This inlet also flows through a long marsh area towards the lake. The channel width at the lake is approximately 0.5 m. The substrate consists of sand and silt. Rearing habitat was observed close to the lake and spawning habitat may be provided farther upstream.

**Plate 2** View looking west down inlet stream ILP 47 towards lake.
