Operational Fund Year-End Report 2024-25

Salmon Habitat Restoration Centre of Expertise

June 17, 2025

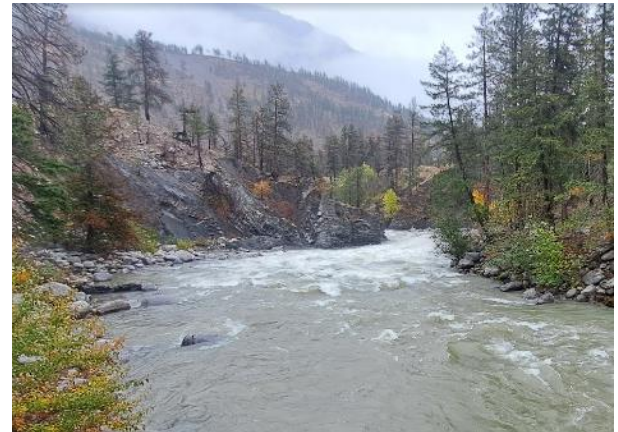
The Stein River (Figure 1) was selected as a proxy watershed for BC interior systems that are snowmelt dominated and semi-arid. The Stein watershed is relatively intact (a small area was burned in 2022 but the majority of the catchment was unaffected), and it has not undergone forestry or other major industrial activities that may alter watershed function.

Figure 1: Stein River, looking downstream of the proposed hydrometric station site.

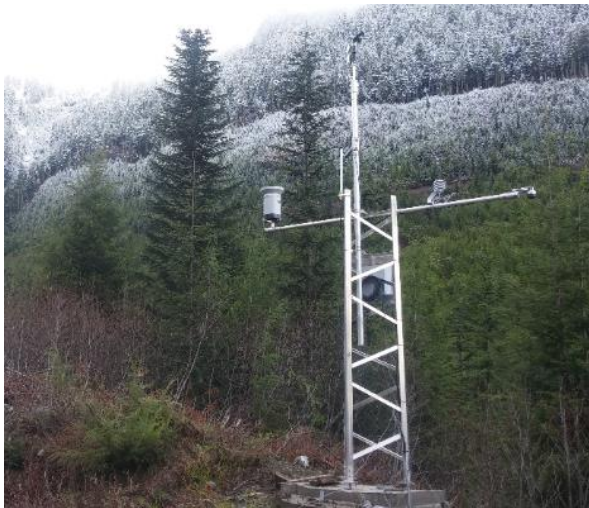
Figure 2. Example of a climate station equipped with real-time transmitting capability (Russel Creek, BC). A similar station will be installed in the Stein watershed to track climate variables alongside hydrological attributes.

committed to installing a real-time climate station at a mid-elevation site within the watershed to complement the hydrometric data. An example climate station is shown in Figure 2. Collectively, these stations provide long-term monitoring of landscape-scale metrics in the Stein watershed.

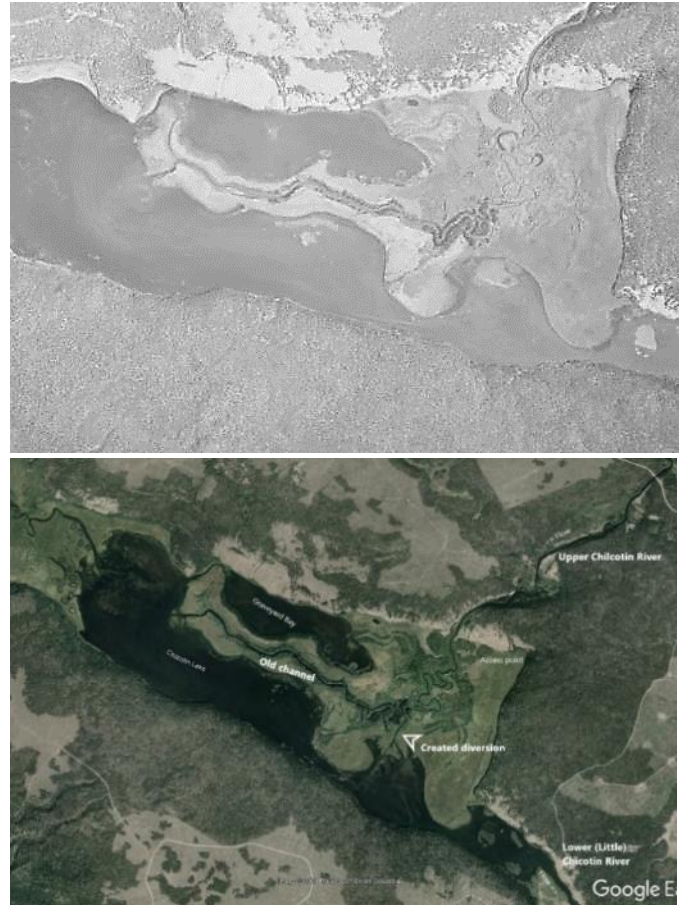
Prior to a 1975 river diversion, the upper Chilcotin River featured extensive delta and marsh habitat extending 3 km into Chilcotin Lake. The 100-m long diversion cut off a 2.5-km length of channel and established a new river outlet directly into Chilcotin Lake, much closer to the lake outlet (Figure 1). The diversion altered migratory and rearing habitat for Chinook and coho salmon. It also reduced water circulation to the east end of the lake, thereby reducing the lake's overall life span and impacting water quality.

Figure 1. Chilcotin Lake prior to the 1975 diversion (top photo) and post diversion (bottom photo).

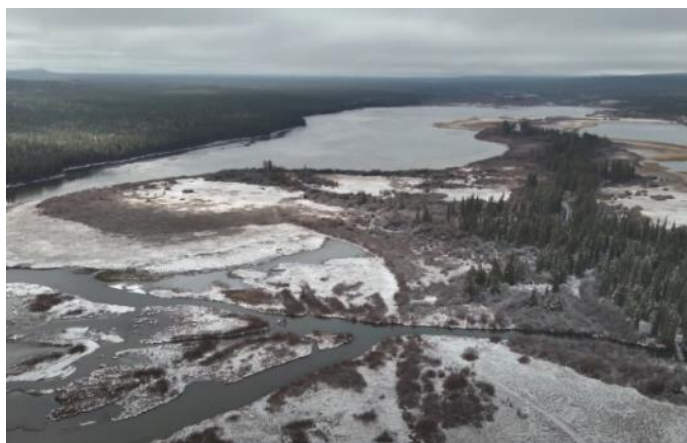
Early fall ice conditions on Chilcotin Lake interfered with October field work, preventing data logger installation (Figure 2). Completed field work included confirming site and boat access locations, fish habitat assessment following provincial reconnaissance inventory protocols in the relic channel and Chilcotin River immediately upstream of the lake, and drone imagery including LiDAR collected by the RCOE.

Figure 2. Lake ice conditions during the October 2024 field visit.

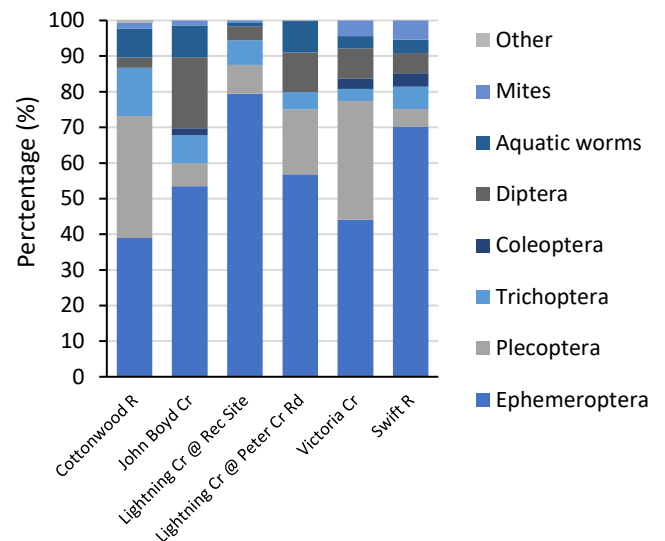
Figure 2. Percent representation of benthic invertebrate taxa in samples collected from placer mining sites in the Cottonwood watershed in October 2024.

Trichoptera (EPT), which are pollution intolerant taxa sensitive to habitat disturbance (Figure 2).

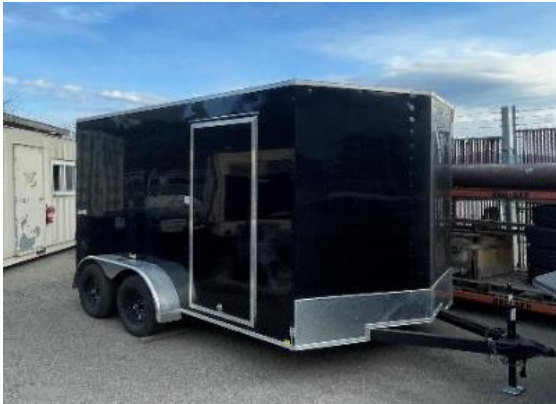
Figure 1. Enclosed trailer securely housing equipment to complete LTPBR projects in Pacific Region.

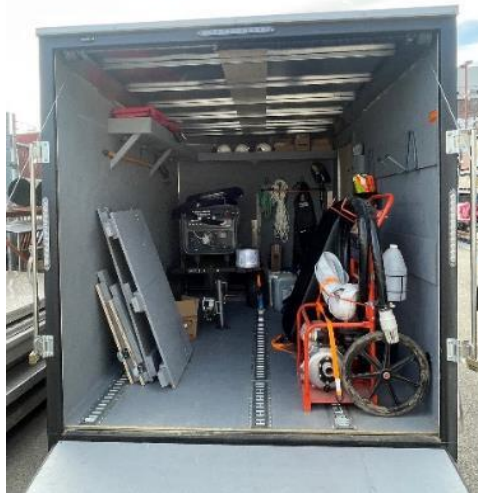
Figure 2. The interior of the trailer displaying equipment and supplies needed to construct LTPBR projects at sites across the Pacific Region.

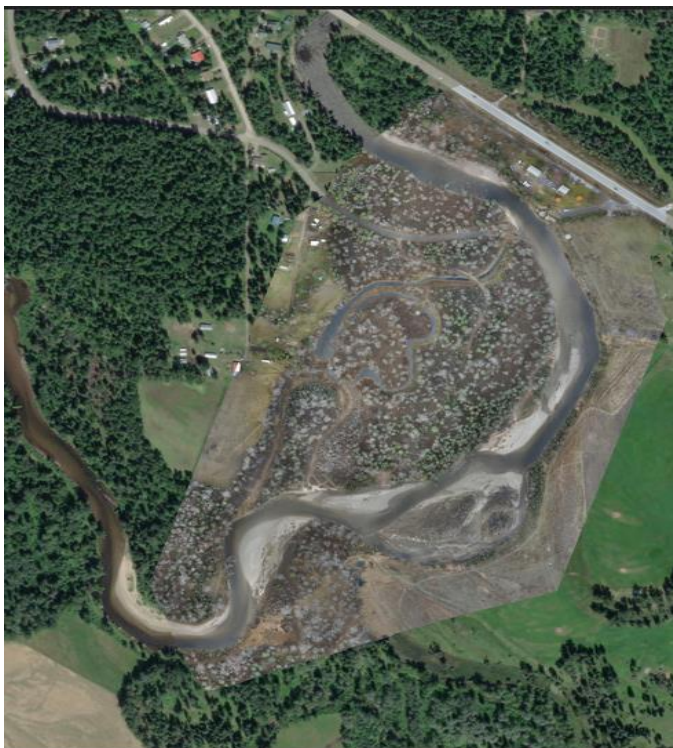
Figure 1. LIDAR acquired in November 2024 for the Raft Channel restoration project.

LiDAR and orthophotos were collected by Rekon Solutions Inc in the fall of 2024. The LiDAR data confirmed that the main operational deficiency of the Raft enhancement channel was lack of connectivity between the channel and Raft River resulting from morphological changes in the Raft River. Specifically, a historic meander cutoff reduced channel length, resulting in river down cutting.

The LiDAR data collected is supporting the implementation of Raft River channel improvements in 2025-26. Next year's work objective is establishing reliable downstream connectivity between the off-channel habitat and Raft River, allowing salmonids to escape seasonally unfavorable conditions.

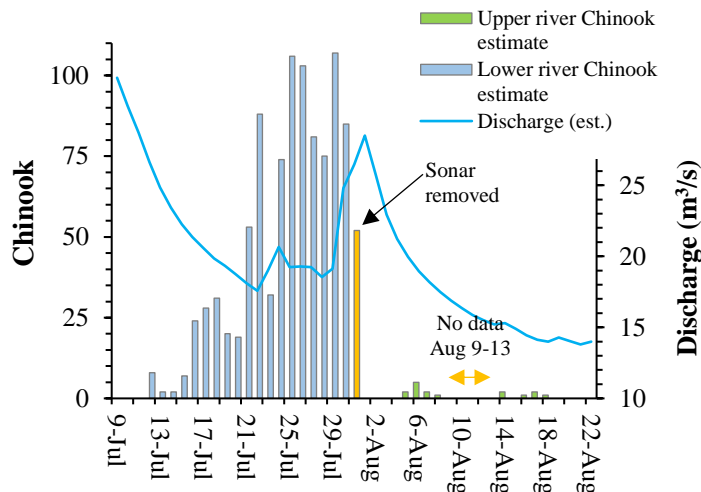
Figure 1. Daily Chinook estimate at the lower (yellow) and upper (green) Willow River sonar sites.

An estimated 997 Chinook passed the lower river site between July 9-31. The ARIS was removed from the lower site early to replace the DIDSON at the upper river site, which experienced constant technical issues. An estimated 16 Chinook passed the upper river site between July 31-Aug 9 and August 13-22, 2024 (Figure 1). The arrival of Chinook at the upper site on the falling hydrograph after a significant rainfall suggests that passage may be restricted above a threshold discharge. However, this relationship remains unclear as factors including equipment problems and fish life history may have also influenced these data.

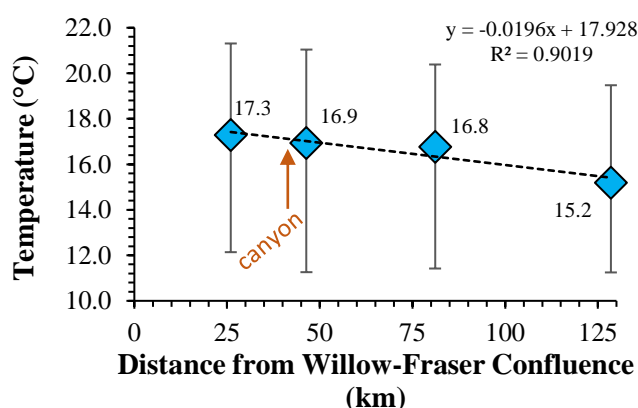
Figure 2. Average Willow River water temperature with distance from the Fraser River confluence (August 2024). Error bars represent maximum and minimum temperature.

Four Hobo MX2203 Tidbit temperature loggers were deployed in August 2024 to collect baseline temperature data along the Willow River. This data is important with respect to climate change, as access to cool water is important to adult and juvenile Chinook. Average temperature decreased incrementally with increased distance from the Willow-Fraser confluence (Figure 2).

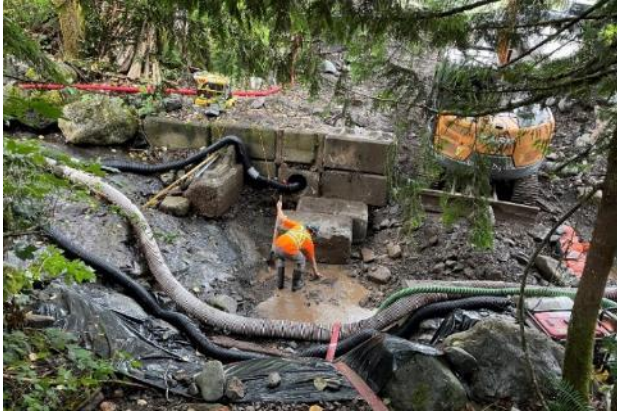
Figure 1. Preparation of the intake foundation, looking upstream.

The steel intake box was designed and fabricated in 2023 (Operational Fund Year 1) and the intake was constructed in summer 2024 as follows. After fish exclusion and flow bypass setup were complete, a lock block water retention structure was built on a gravel foundation. The intake box was placed and hooked up to an existing culvert that diverts flow to the existing spawning channel. Refer to Figure 1 for the dewatering setup and intake foundation preparation, and Figure 2 shows the final intake arrangement.

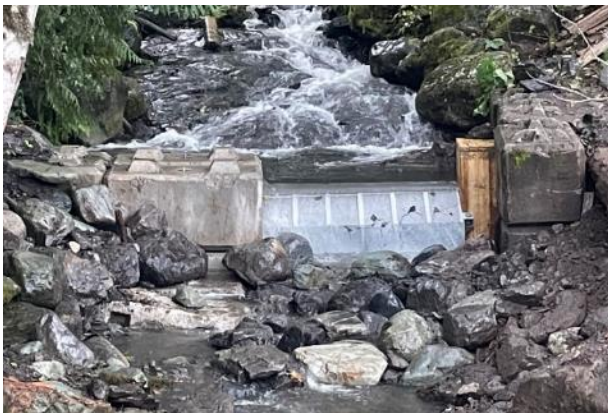
Figure 2. Final intake configuration, looking upstream.

Deer Creek transports a high volume of coarse, angular bedload and fine sediment. The new intake was designed to bypass a wide range of the sediment gradations. Its alignment with the main flow allows coarse bedload to pass naturally over it, preventing sediment from entering the side channel where it could degrade habitat or accumulate at the upstream end and potentially obstruct flow. The downward-facing angle of the intake, combined with a fine grating pattern, encourages fine sediments to pass over rather than enter the intake chamber. These features should greatly reduce maintenance demands and ensure reliable, sediment-free water delivery to off-channel habitat, even under high sediment load conditions.

RCOE staff will monitor the self-cleaning performance of the new intake grates and results will inform future intake designs. A potential design change is to replace the perforated plate intake grates with wedge wire grates, which bypass fine particles more efficiently.

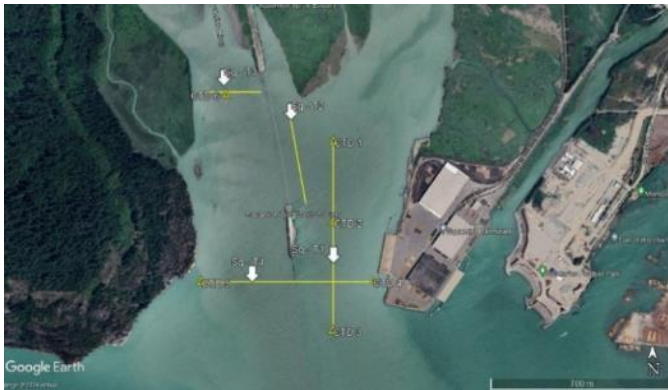
Figure 1. Sampling transects at the Squamish River Jetty.

Project activities in 2024-25 focused on repeating data collection that was initiated the previous year at 3 breach sites². Vessel-based current measurements and CTD profiles were collected on 3 separate occasions to capture a variety of flow conditions: June 10 to 13, September 23 to 27 and December 2 to 6, 2024. Example transect, velocity, and CTD data are shown in Figures 1-3.

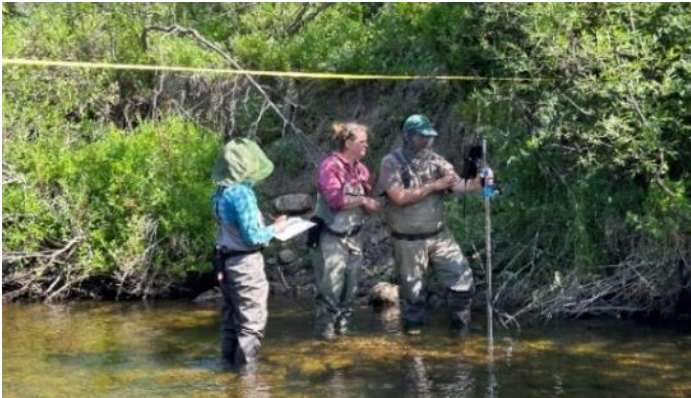
Figure 1. Flow transect acquired at the time of level logger installation on July 17, 2024.

Three site visits occurred in 2024-25, including a site survey, geomorphic assessment, and the installation of a level logger in July 2024, with subsequent flow transects in August and October 2024 (Figure 1). LiDAR for Bii Wenii C'eeek was acquired in October (Figure 2). Supplemental fish sampling and fish habitat reconnaissance occurred in the summer near the proposed Riddick Crossing replacement.

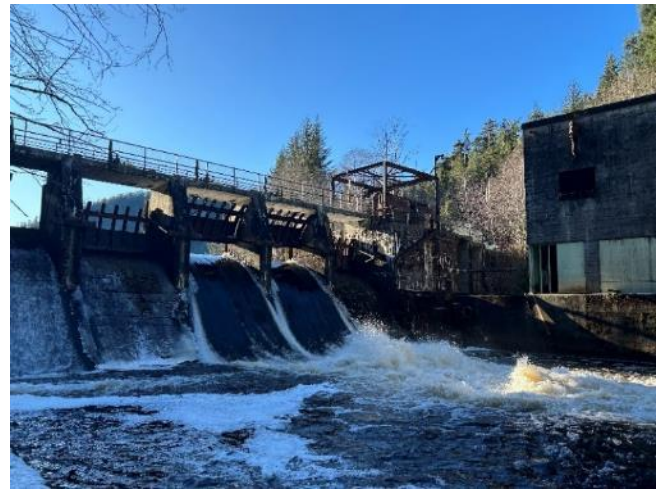
The Kloiya dam and fishway were constructed in the 1940s in a watershed that supports all six species of Pacific salmon (Figure 1). The dam is part of a series of water storage facilities that were built to store and provide water to Skeena Cellulose pulp and paper mill in Port Edward, BC.

The fishway has not been assessed in any detailed way for fish passage effectiveness since its construction in the 1940s, despite annual observations of salmon jumping into the concrete face of the dam unable to find the fishway entrance and sometimes being propelled out of the fishway during high flow events. This project assessed the feasibility of using pit tag technology to assess adult salmon fish passage in the Kloiya fishway.

Figure 1. Photo of the Kloiya dam and fishway.

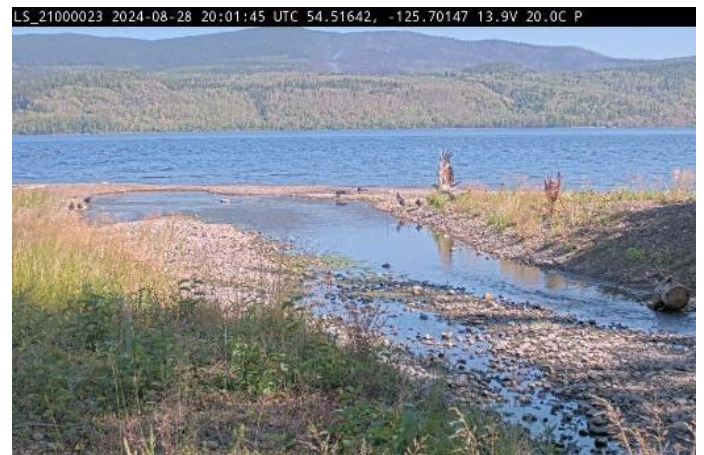
Figure 1. Photo from remote camera system (Aug 28, 2024)

A camera was installed at the confluence of Cross Creek and Lake Babine on July 16, 2024 to monitor water level and habitat connectivity during low flow and drought conditions. For a monthly fee, daily photos at a scheduled time were taken and uploaded to a website via satellite (Figure 1). These photos were used to monitor tributary connectivity to the lake and overall lake/creek mouth conditions.

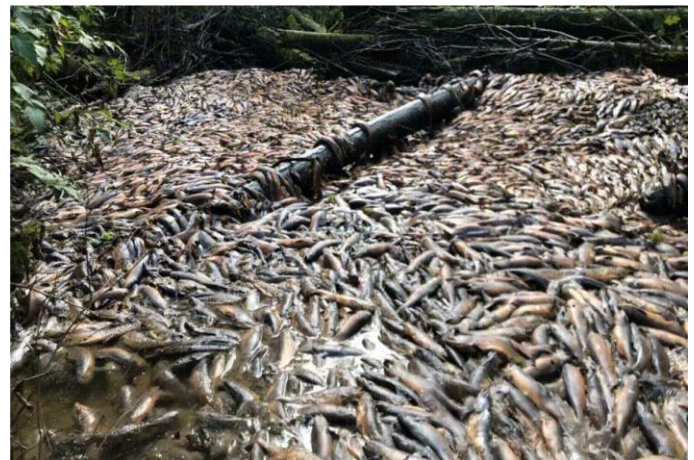
In September 2022, approximately 60,000 pink and chum salmon died before spawning when they were stranded in Neekas Creek during drought conditions (Figure 1).

Figure 1. Photo of pink salmon stranded before spawning in Neekas Creek in Sept. 2022.

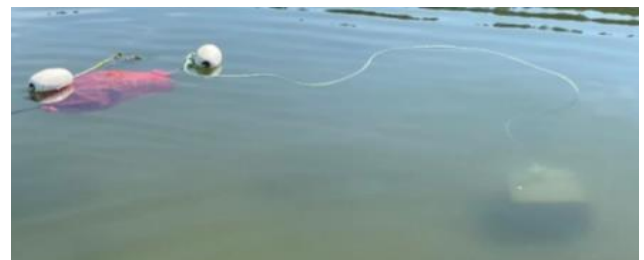
Figure 1. BuDS set: anchor, floating line, and 2 buoys with net bag of reproductive shoots clipped to the line.

Each BuDS set consists of a weight, line, and floats with a net bag of reproductive shoots (Figure 1). 25 BuDS sets were installed at the Gordon River site and 12 installed at the Hankin Cove site. Sets had 5-m spacing in the subtidal zone where eelgrass transplant restoration has also occurred (Figure 2).

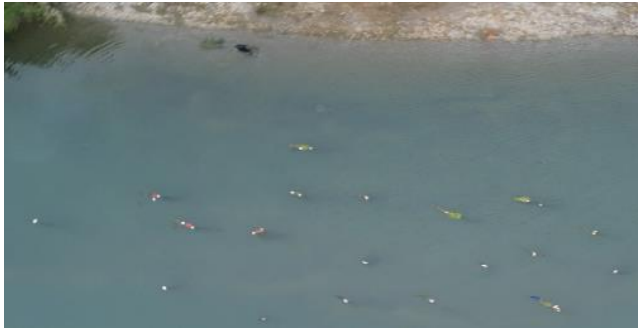
Figure 2. BuDS sets with net bags being attached by snorkeler overtop an eelgrass transplant project (Gordon River).

Reproductive shoot collection took place in the second week of seed release (monitored by field crews from partnering Nations). Readiness times varied across sites from early July to late August. Reproductive shoots were collected by snorkel using mesh bags and were snapped off near the substrate without disturbing rhizomes. Shoots were divided into mesh onion-type or clam bags. Boat or snorkel deployment of mesh bags to the pre-set BuDS floats occurred within 24 hours.

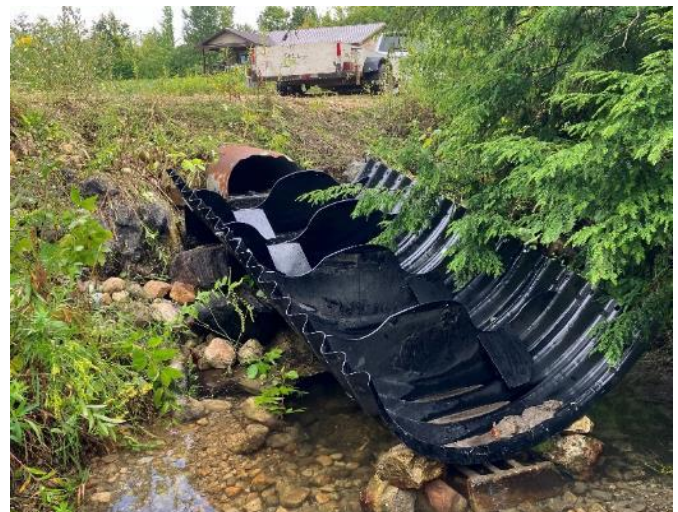
Figure 1. Example polymer-coated steel Fishculvert fishway with baffles installed at a perched culvert to restore fish passage.

2024-25 was the first year of this 2-year pilot project to evaluate the feasibility and performance of the Fishculvert fishway to restore fish passage at perched culverts. For 2024-25, the RCOE team procured the 2 x 12' fishway sections to be installed in 2025. An example fishculvert is shown in Figure 1.

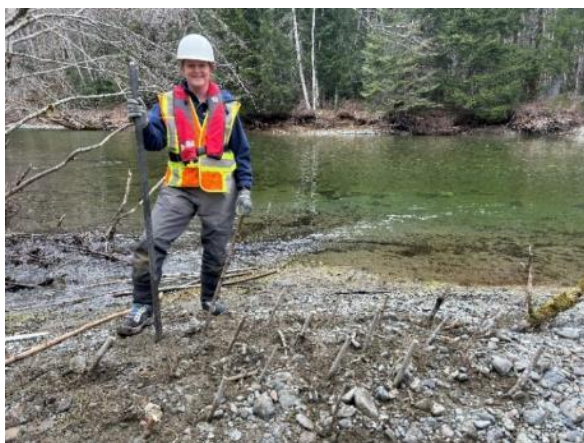
All of the projects cited above are multi-year projects. In 2024-25, equipment and supplies to support all projects were acquired. Planning is underway for implementation of the Deadwood Creek LTPBR and sediment transport study, and the First Lake limnological study. The Green Creek riparian planting project was designed, permitted, and implemented in 2024-25 (Figure 1).

Figure 1. Live willow stakes shown in the foreground, planted in river right bar at the confluence of Green Creek and the Nanaimo River (photo taken March 7, 2025).

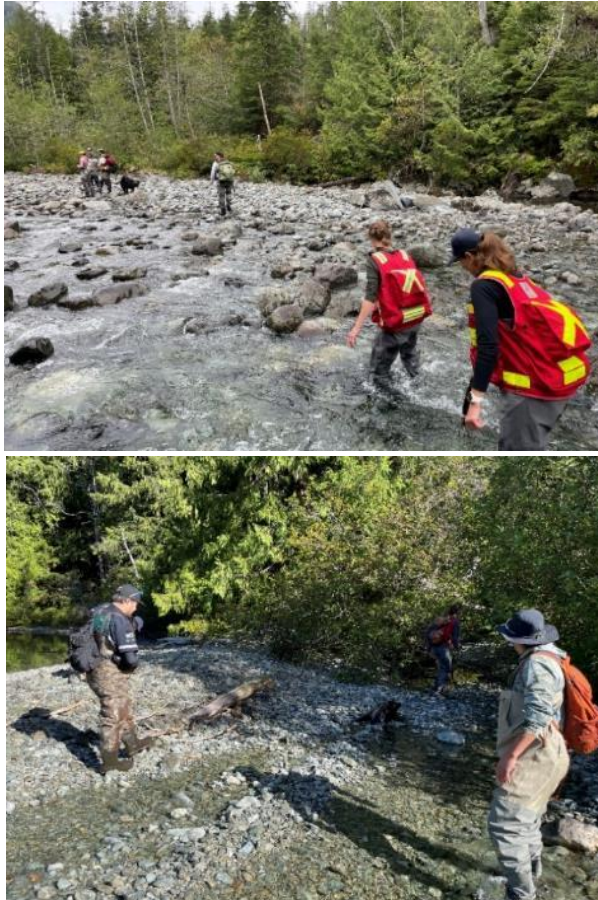
Work began on implementing the River Styles Framework on Tranquil Creek (Figure 2). Field work and analyses to determine river character and behaviour (River Styles Stage 1), and river condition (River Styles Stage 2) were completed from September 2024 to March 2025 by RCOE staff and a contract with Interfluve.

Figure 2. Field validation for River Styles mapping with Tla-o-qui-aht First Nation, Redd Fish, and RCOE staff (September 2024).

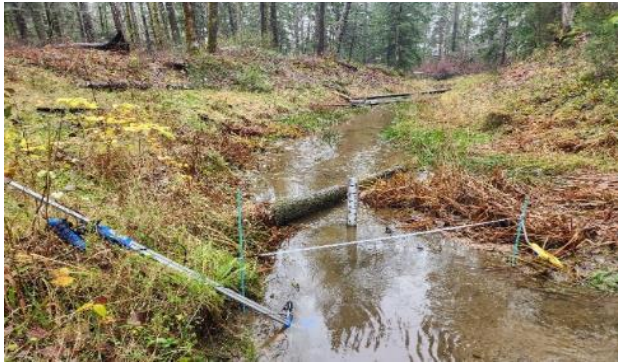
Based on 2023 assessments, the Arthur Mayse Side Channel on the Oyster River was selected as the pilot site for decommissioning due to its poor functionality as fish habitat. Funding from the Operational Fund supported the acquisition of water quality monitoring equipment for this site during 2024-25 (Figure 1, 2).

Figure 1: Arthur Mayse side channel, Oyster River. Upper monitoring site for water level, flow temperature.

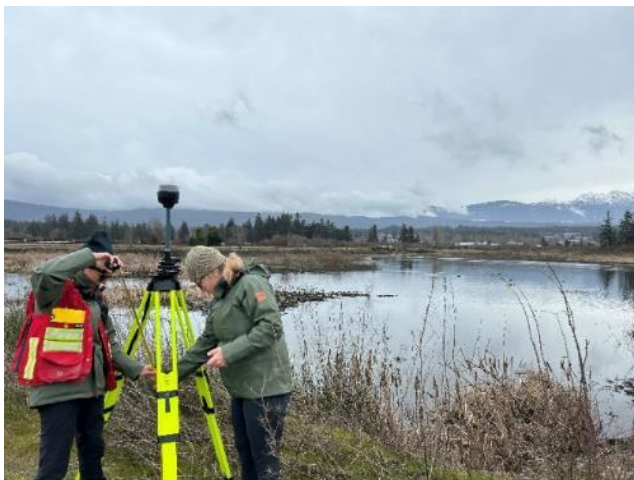
In parallel to the development of the action plan, the South Coast area and regional RCOE staff worked to fill data gaps identified by the working group through 3 studies (Figure 1):

Figure 1. DFO RCOE staff assessing effectiveness of restoration actions at the Somass Estuary in 2024.

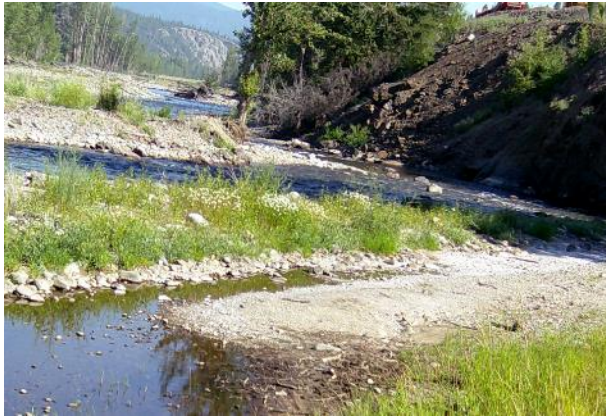
Figure 2. Onset of drying captured on Voght Creek near the confluence with the Coldwater River.

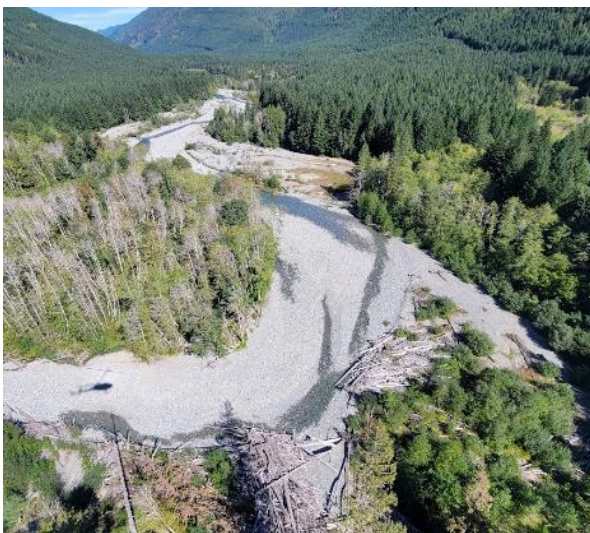
To document drying along larger stream systems, 3 helicopter flights were conducted. The first flight occurred on August 28th and covered the North Thompson watershed north of Kamloops as far as Clearwater. The second flight occurred on August 30th and covered most of Nootka Sound including the Conuma River (Figure 3). The final flight occurred on October 8th and covered tributaries of Quesnel Lake. All flights were intended to capture low flow conditions in drought-prone areas previously identified as having flow disconnection issues.

Figure 3. Example helicopter shot of the nearly-disconnected Conuma River, draining into Nootka Sound

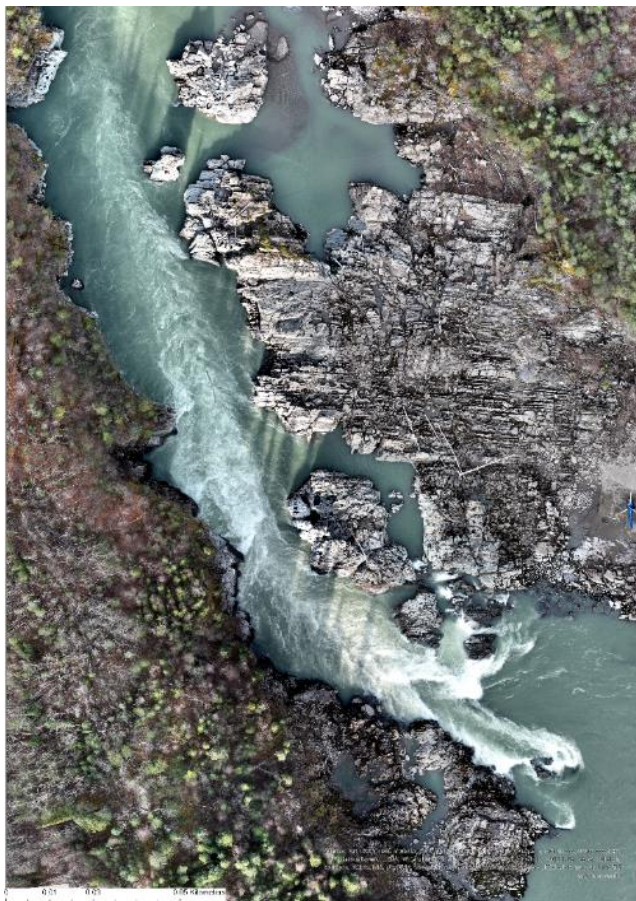
Figure 1. Drone Imagery of Fraser Falls. Blue helicopter on far right for scale.

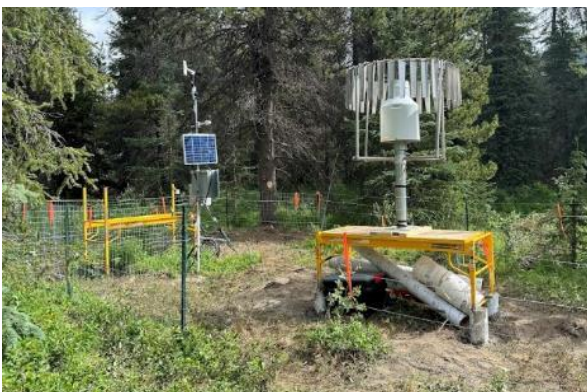
Figure 2. Operational weather station after structural upgrades in June 2024.

2024-25 work also focused on continued hydrological monitoring with spring and fall acoustic doppler current profiler (ADCP) and level logger maintenance, drone surveys, and operation and structural upgrades of the Taku River Tlingit First Nation meteorological station (Figure 2).

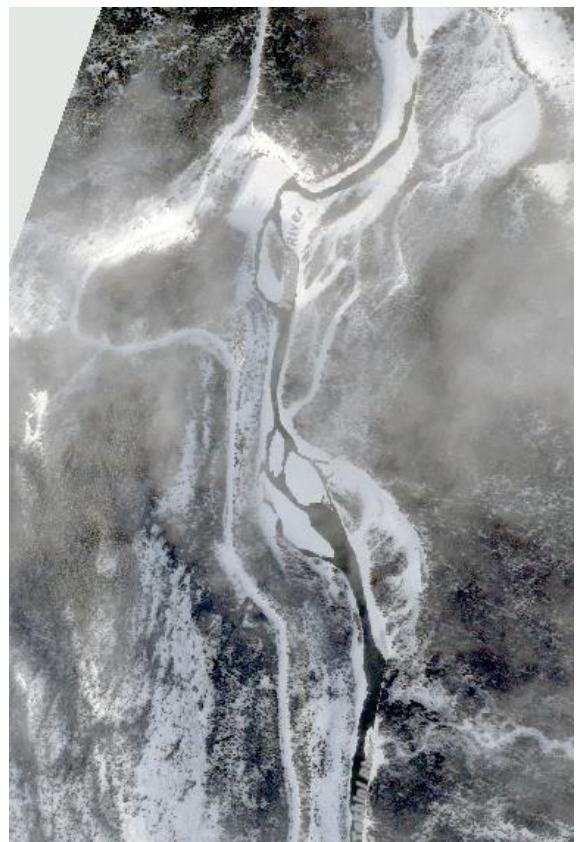
Figure 1. Takhini River open water habitats (imagery Feb 20, 2025).

The 2024-2025 work plan focused on the application of *Planet* satellite imagery to assist juvenile overwintering habitat research for Yukon River Chinook salmon. Using 3-5 m resolution imagery, key hydrological features such as groundwater upwelling zones and aufeis distribution were identified (Figure 1,2).

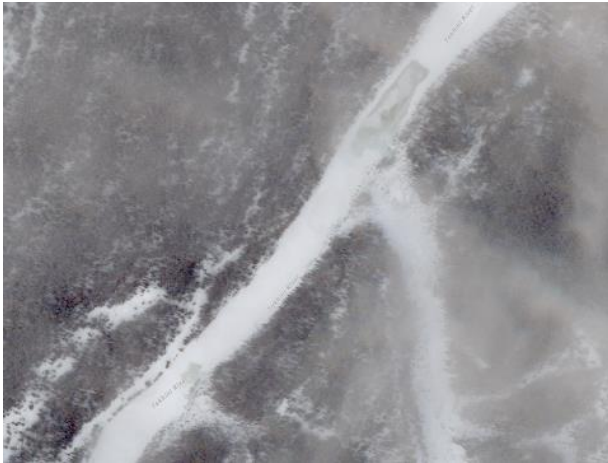
Figure 2. Takhini River suspected icing locations (imagery Feb 20, 2025). Aufeis locations to be confirmed with spring imagery.
