**The Suskwa Watershed
Restoration Program
Assessment and Prescriptions,
Surveys and Design, and Works**

**prepared by M. Jacobs
for
The Suskwa Restoration Society
March 1998**

**Suskwa Watershed Restoration Program 1997
Assessments and Prescriptions,
Surveys and Design, and Works**

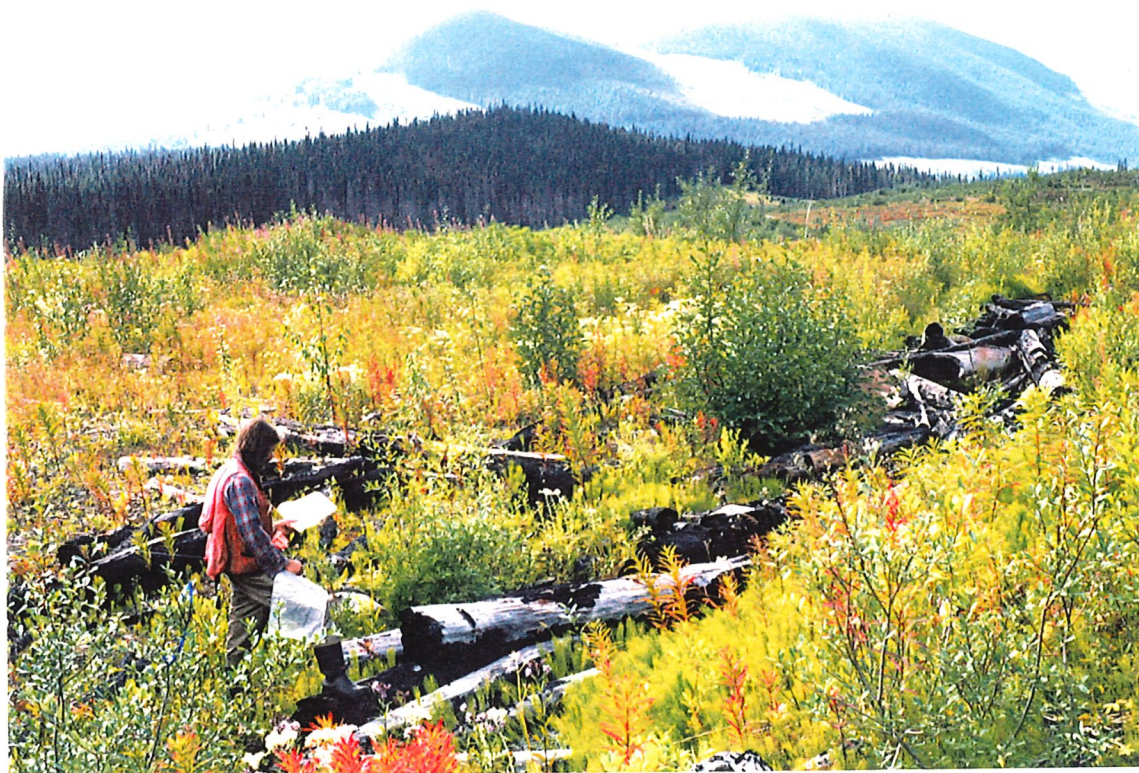
Photo. 1 This headwater section of Jumbo Creek, within block 93M 035-01, originally flowed to the left of the technician in this photo. The channel is presently diverted down the ditch-line (at right). No fish were found on this upland bench however this diversion may seasonally effect water supply, water quality and fish habitat downstream.

Prescription : The cross-ditching of the landing along spur B of branch 6-16 in block 93M035-001 is required to return flows to their original channel (figure 1). This may accomplished with a mid-sized excavator within one hour. The berm retaining water within block 93M035-004 should also be breeched to dissipate the large pond which presently exists (figure 2). This aswell may be accomplished with a mid-sized excavator within one hour. The berm will have to be approached from below the road grade as the stream channel, at the eastern end of this pond, has flooded the access road. Considerations should be made, if these works proceed, to include deactivations of these two blocks, as prescribed within the level 2 upslope report of 1996 for the Ministry of Forests, within the Roads, Hillslope and Gully portion of the Suskwa WRP. Riparian assessments of these channels is also recommended for 1998.

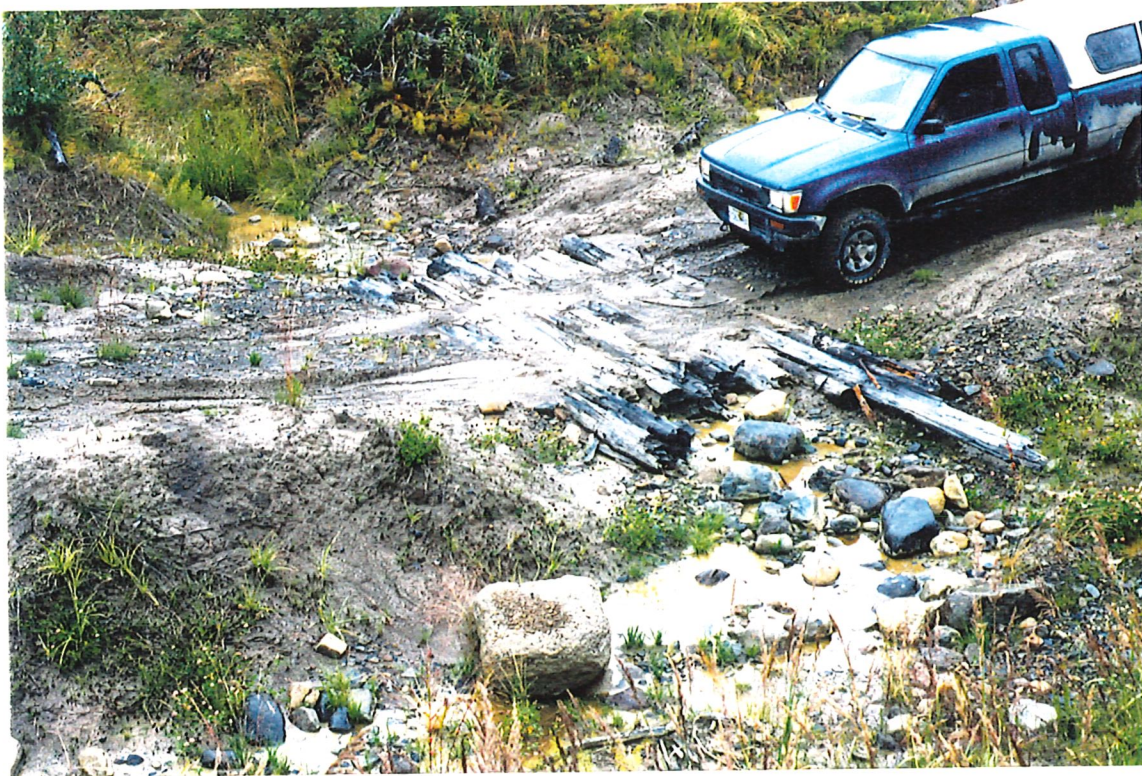
Impacts : A total of 38 cross ditches along the Netalzul forest road have been infilled with debris for vehicle access. The infilling of these drainage structures has led to the erosion of the existing road prism (Photo. 2) and unnecessary sediment transport to the upper Suskwa River. The extent of erosion varies from site to site and efforts should be made to limit further degradation of these structures. Despite being deactivated several metal pipe culverts remain installed along this road and should also be pulled during clean-up if possible.

Photo. 2 This infilled road crossing is typical of 36 fords located, along the Netalzul forest road, between the pulled bridge site at trib. 46-700-137 and the western boundary of block 93M 035 -016. These obstructed fords contribute fine sediment to the above mentioned stream and the Suskwa River through the erosion of the road prism. These crossings should be cleared and properly forded to ensure silvicultural and recreational access.

Prescription : The cleaning of 38 cross-ditches along the Netalzul road is recommended to ensure proper drainage of this area and limit sediment deposition downstream. This should be dealt with in the R,H&G portion of the Suskwa WRP. An effort should be made during clean-up to provide adequate fords for vehicle access, silviculture and recreation. Clean-up of these structures may be accomplished with a mid-sized hoe in one day and considerations should be made to remove remaining culverts at that time. A list of obstructed cross-ditches and remaining culvert locations was noted as part of the 1997 assessment. The following sites were chained from a point of commencement located at the pulled bridge site at trib.46-700-137 on the Netalzul road proceeding east-southeast.

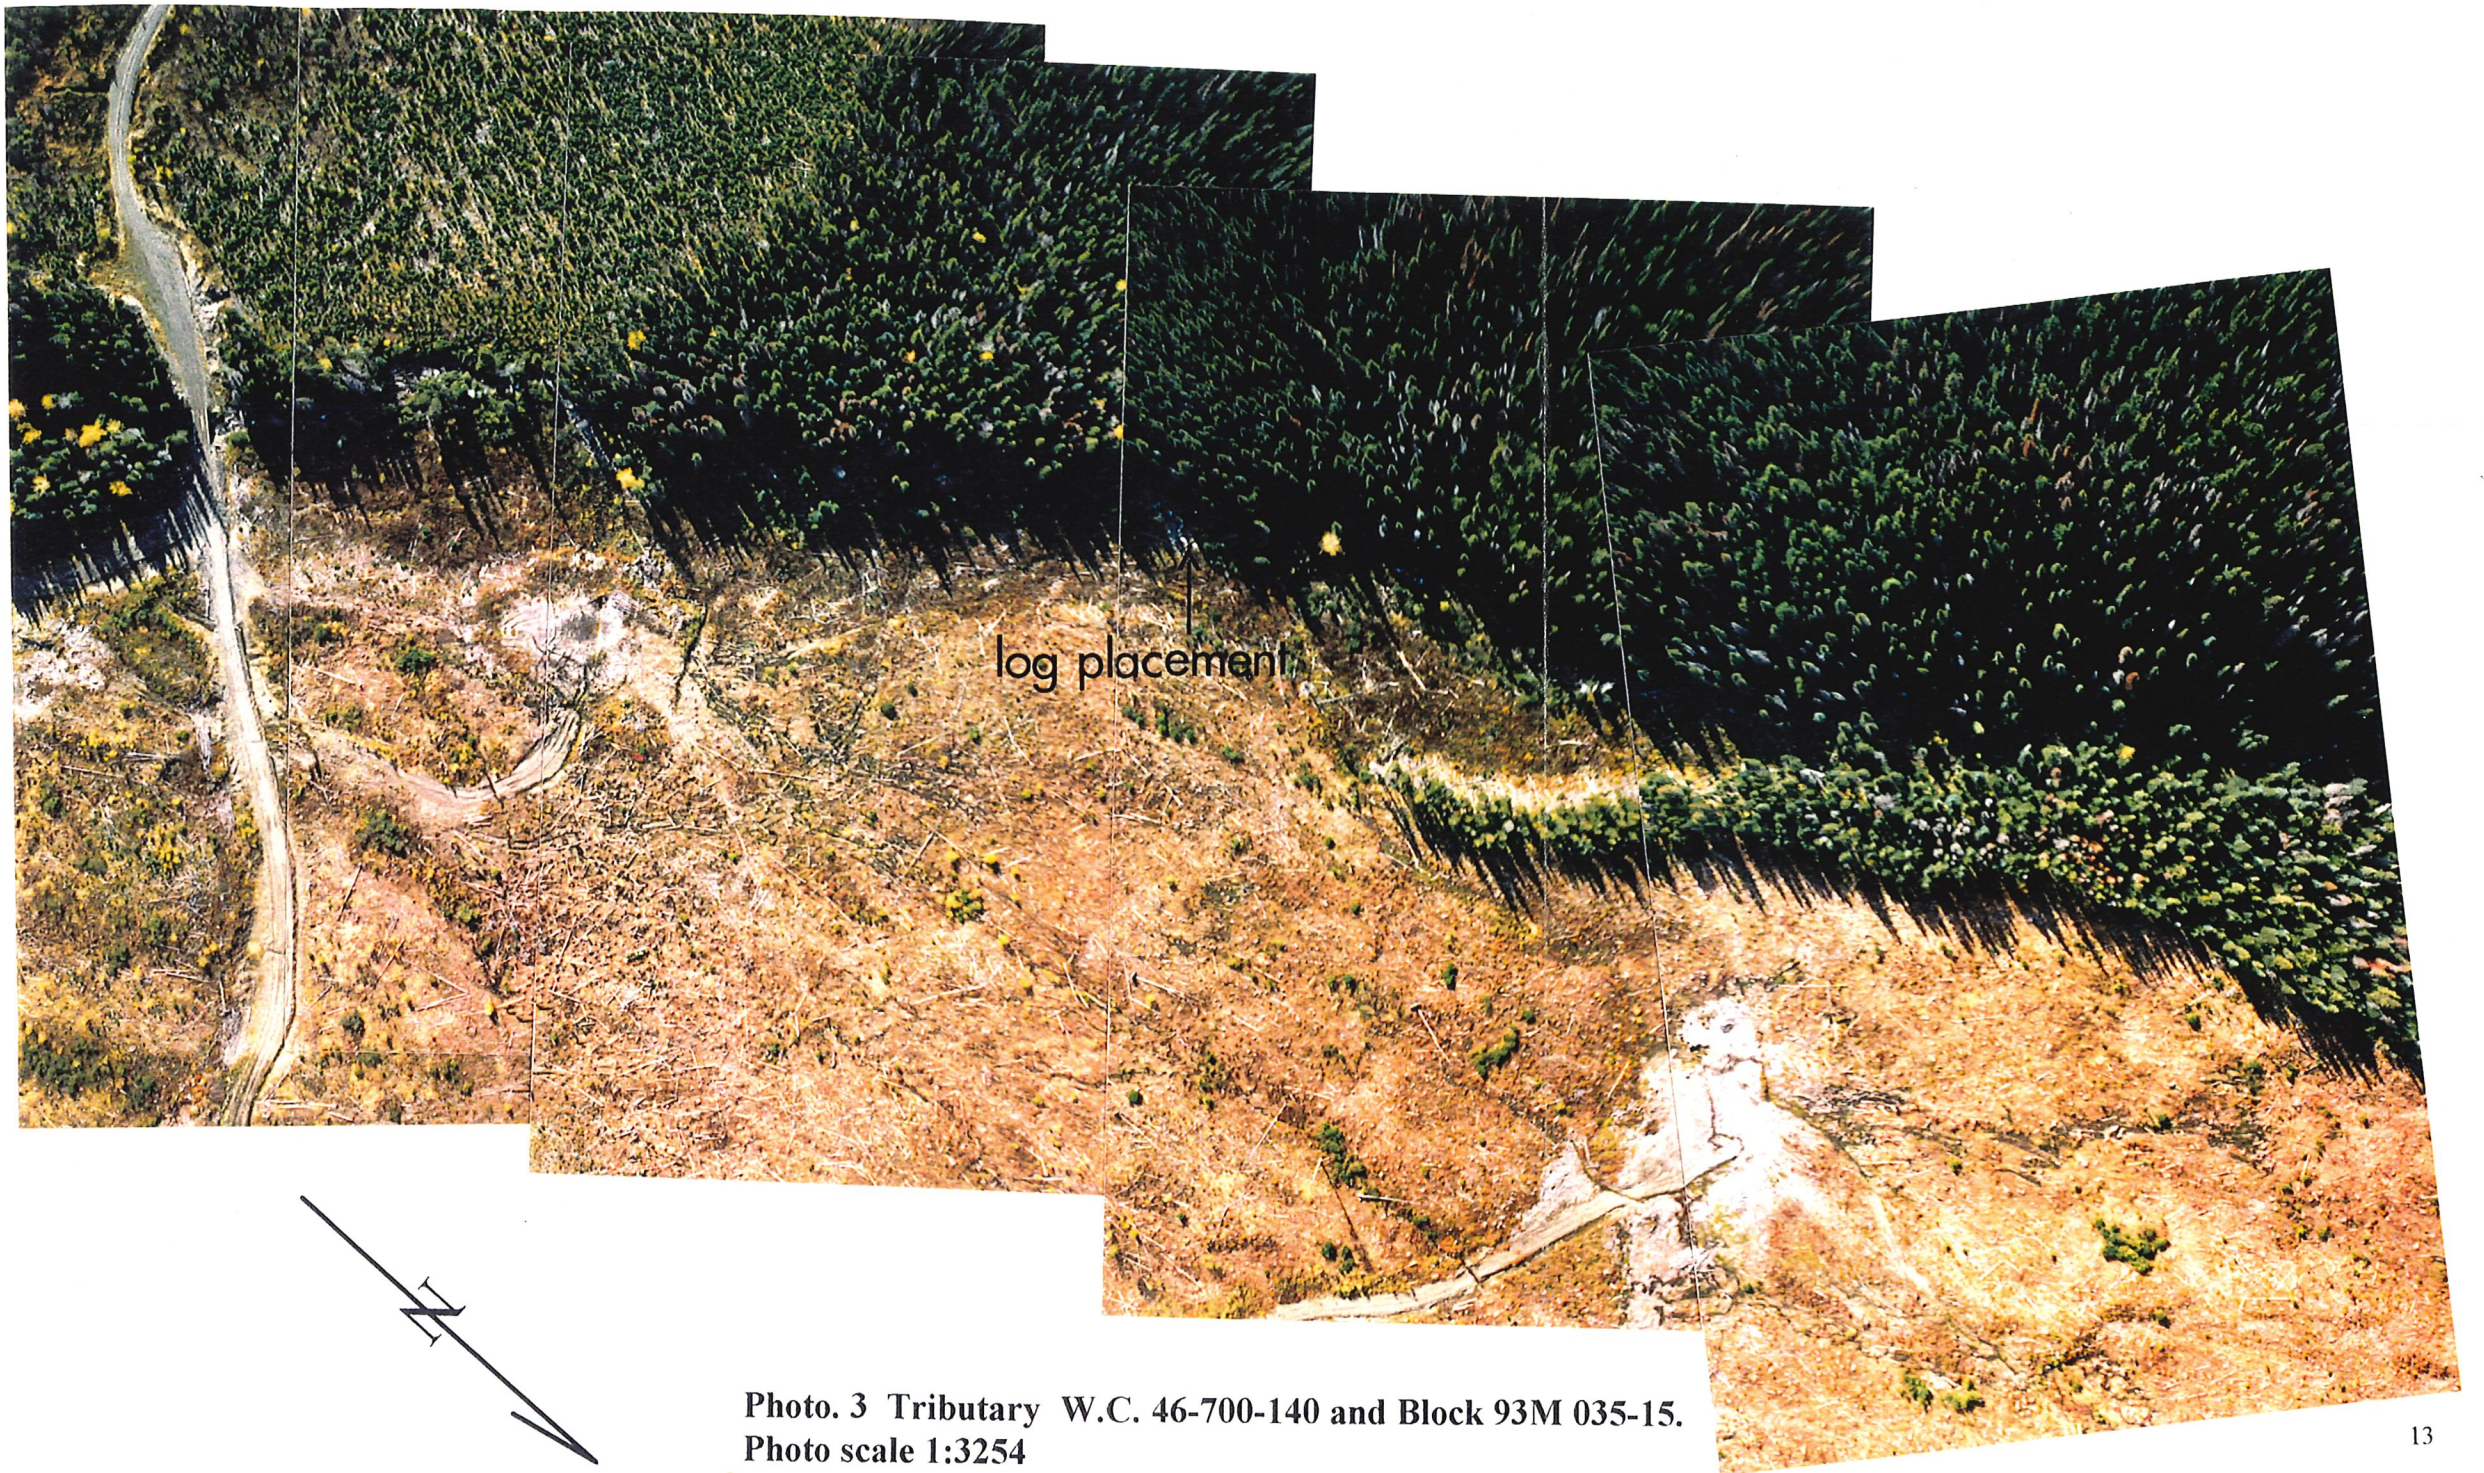
Photo. 3 Tributary W.C. 46-700-140 and Block 93M 035-15.
Photo scale 1:3254

Prior to instream work, completed in 1997, a field visit to the prescribed site was made with a geomorphologist to determine possible impacts to the stream channel as a result of the prescription. This was conducted as a survey and design of the proposed work site and subsequent instream activities resulted from this planning process (Section 4.2.2).

It was determined that one large balsam log could be removed from the stream channel to reduce erosion of the eastern streambank bordering block 93M035-015. A site along this bank was also chosen to accommodate log deflectors to maintain bank stability until riparian vegetation is re-established (see site "B"/photo. 5 of section 4.0). A series of 35mm aerial photographs was taken prior to 1997 work to assist in the survey and design of instream works and provide a reference for future monitoring (Photo. 3). A detailed description of instream activities is included in the "works" section of this report (Section 6.1.4).

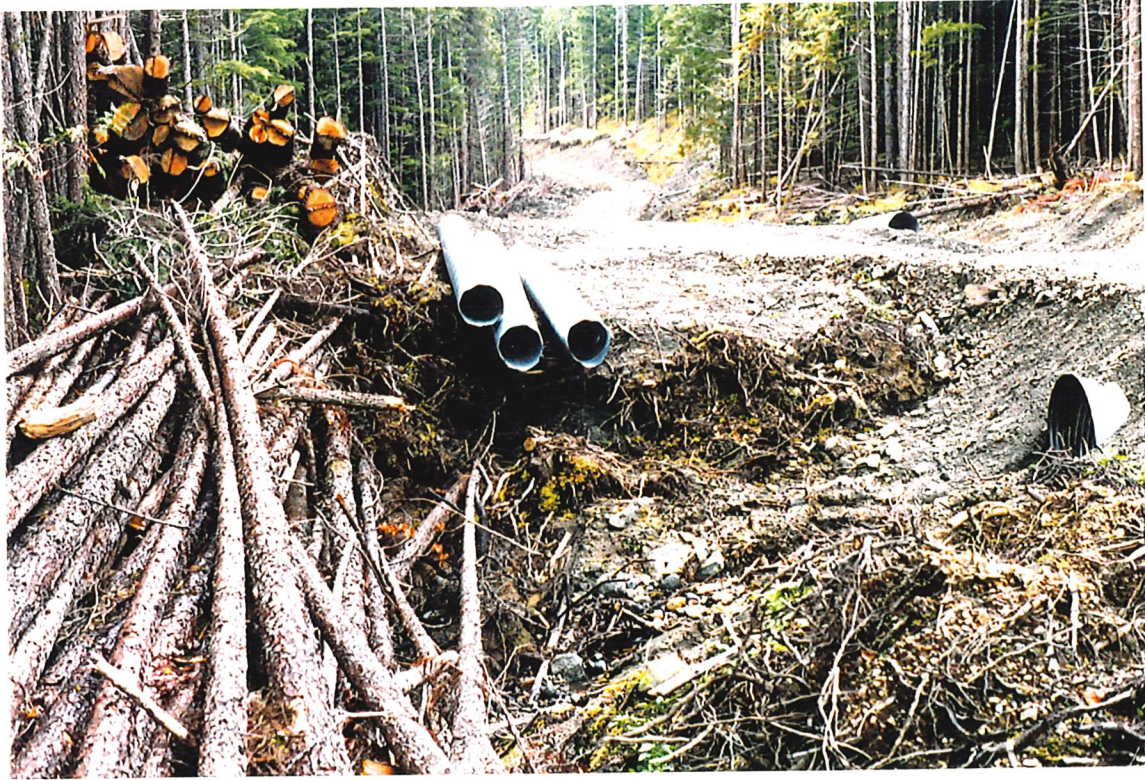
A total of 19 metal pipe culverts, two of which are damaged and 17 of which have harvested "right of way" wood stacked on top of their outlets (Photo 4), were eroding the road prism, impeding drainage and delivering fine sediment to the lower fish-bearing sections of these tributaries at the time of assessment. A significant amount of ponding water was also observed on the roads surface, downcutting of sidecast material was apparent as this water drained. One side-channel exhibited an apparent reduction in discharge with upper portions void of water. The lower section sustains rearing rainbow trout and coho salmon from a sub-surface water supply. Although this may be attributed to ephemeral conditions with low flows at the time of assessment, unnecessary structures impeding discharge to this high-value rearing area should be addressed along this recently developed section of road and may be possible through MOF compliance and enforcement activities as per Forest Practices Code (FPC) of B.C. guidelines.

Photo. 4 The "right of way" wood stacked at the outlet of this culvert is typical of 17 culverts between 9.35 km and 12.04 km along the Hamblin forest road. These blockages exacerbate sediment loading and effect discharge to high-value salmonid rearing areas located within side-channels adjacent to Harold Price Creek (reach 1). This has also contributed to degradation of the road prism at some sites.

Prescription : Most of the outstanding road related problems above these side-channels can be remedied, if not yet addressed, by the collection of the "right of way" wood stacked at culvert outlets. Two other culverts may need replacement. At the time of assessment, inspections by the Ministry of Forests of the Hamblin road work was incomplete and it was suggested (Garry Wallace of M.O.F. pers. comm.) that existing road problems would be the legal responsibility of the current forest licensee developing this site and therefore funding for remedial work should not be required through the Watershed Restoration Program(see following page for list of culverts and locations).

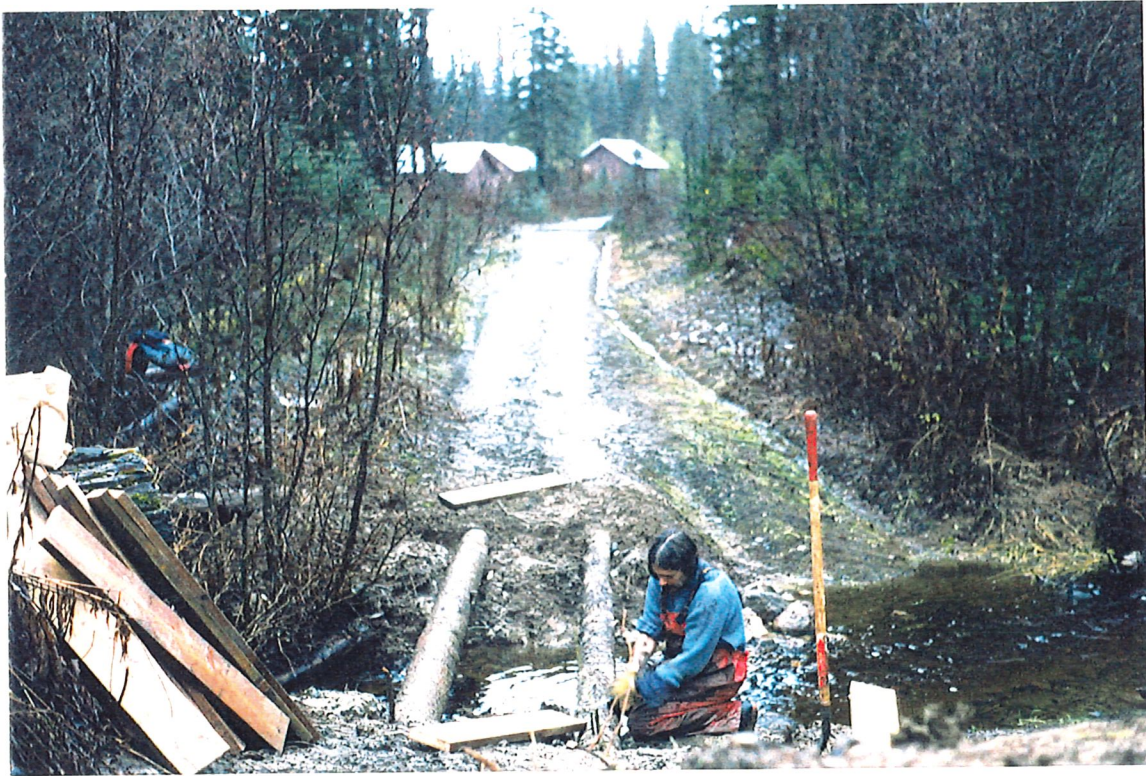
Photo. 5 This road crossing, of the main tributary to Camp Lake, has been modified to eliminate vehicle traffic from the stream channel. A footbridge has replaced the previous ford at this known spawning site of cutthroat trout. This bridge will accommodate ATV's and pedestrian traffic to block 93M 025x2 and an outfitters camp (background). A berm has also been constructed to limit larger vehicle access and a notice posted to indicate the importance of this fish bearing stream.

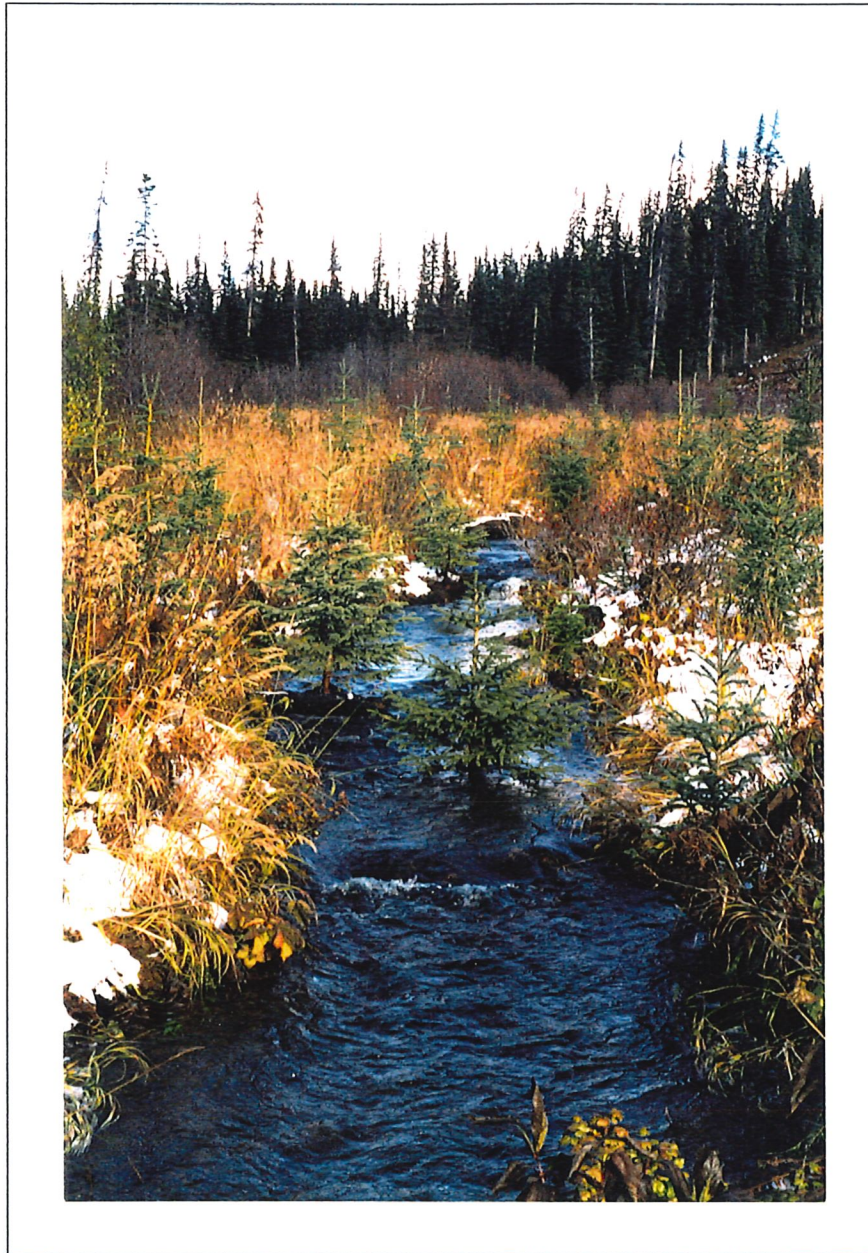
Upon visiting this site in Sept. 1997 it became obvious that a channel diversion had occurred into block 93M 016-10 (see photo. 6) probably during spring runoff. Channel substrate was now flush with the stream bank at the proposed worksite, and a new channel extends from that point through the entire length of block 93M 016-10 to the southwestern block boundary. The new channel runs parallel to the mainstream of Luhk Creek and was discharging 0.01 cubic meters of water per second when visited (geomorphic description - Section 4.2.5).

Photo. 6 This side-channel into block 93M016-010 (note crop trees midstream) originates from a channel diversion of Luhk Creek near the northeastern block boundary. Riparian vegetation (primarily hardwoods) will be required to help maintain channel stability and cover for roughly 2 kilometers of streambank.

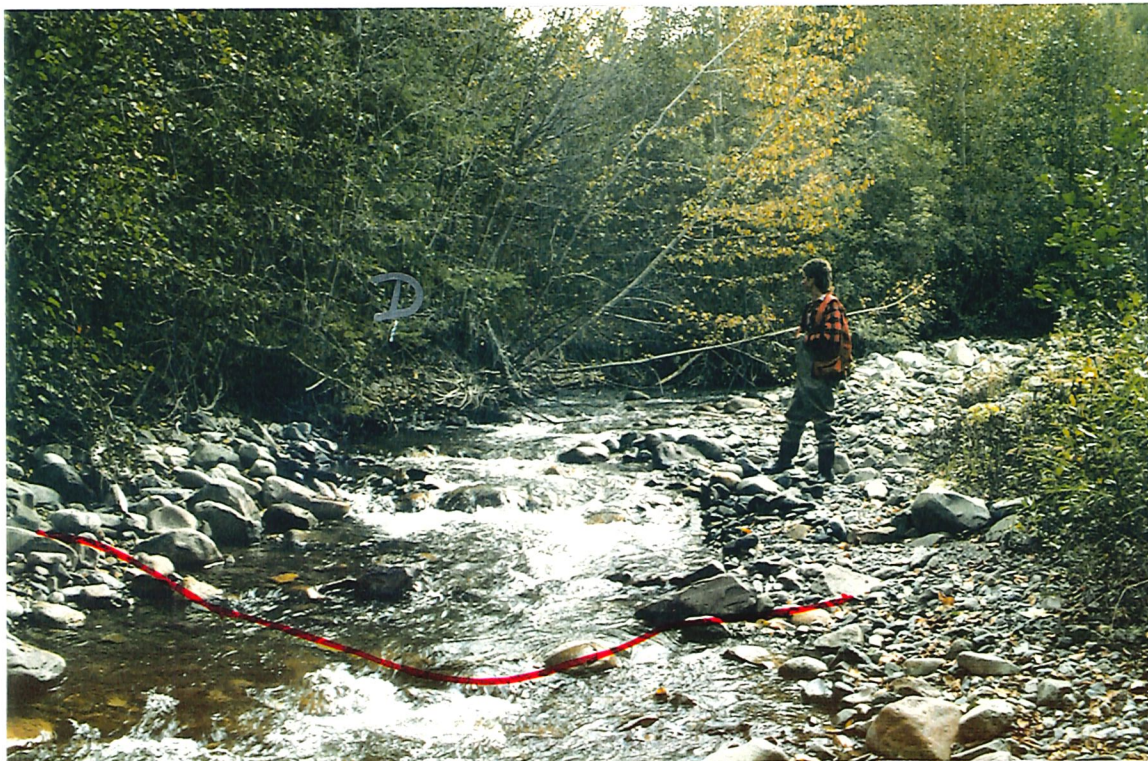
Photo 1: Skilokis Creek, Reach 1; looking upstream towards the sloughing bank above site D. Red line marks site suitable for creating stone line.

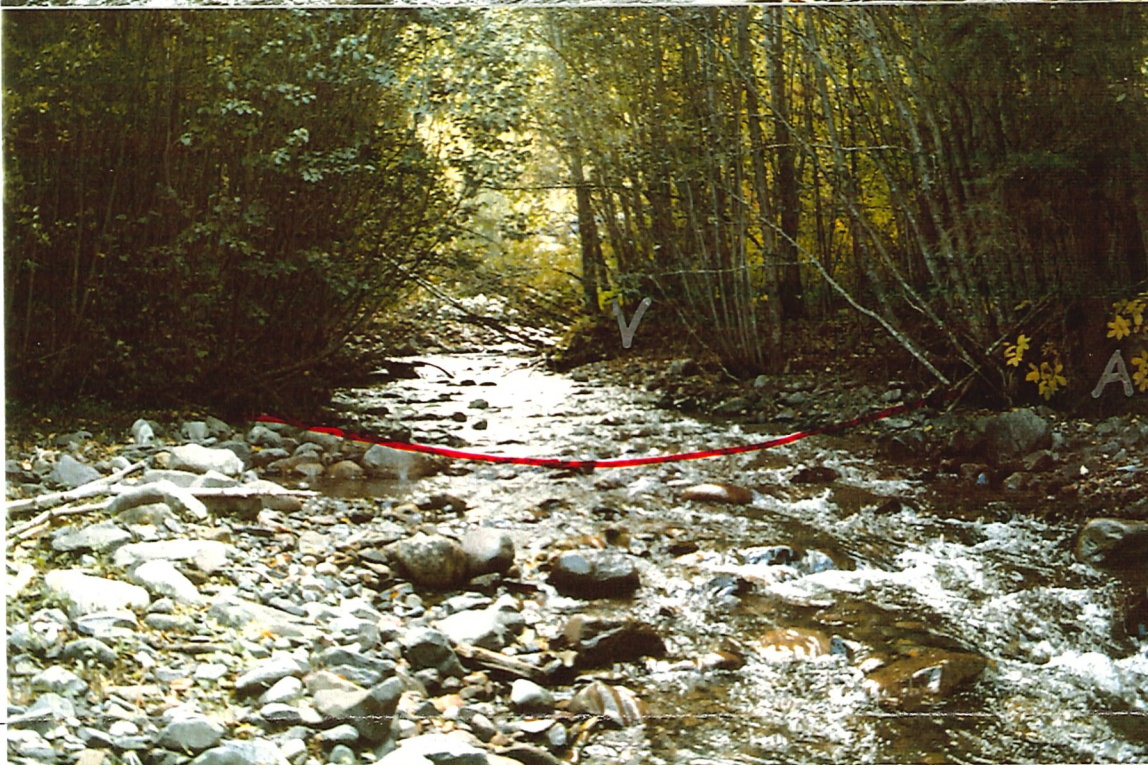
Photo 2: Skilokis Creek, Reach 1; looking upstream from site A to the natural V-weir. Red line marks site suitable for building a stone line to create a cascade-pool complex.

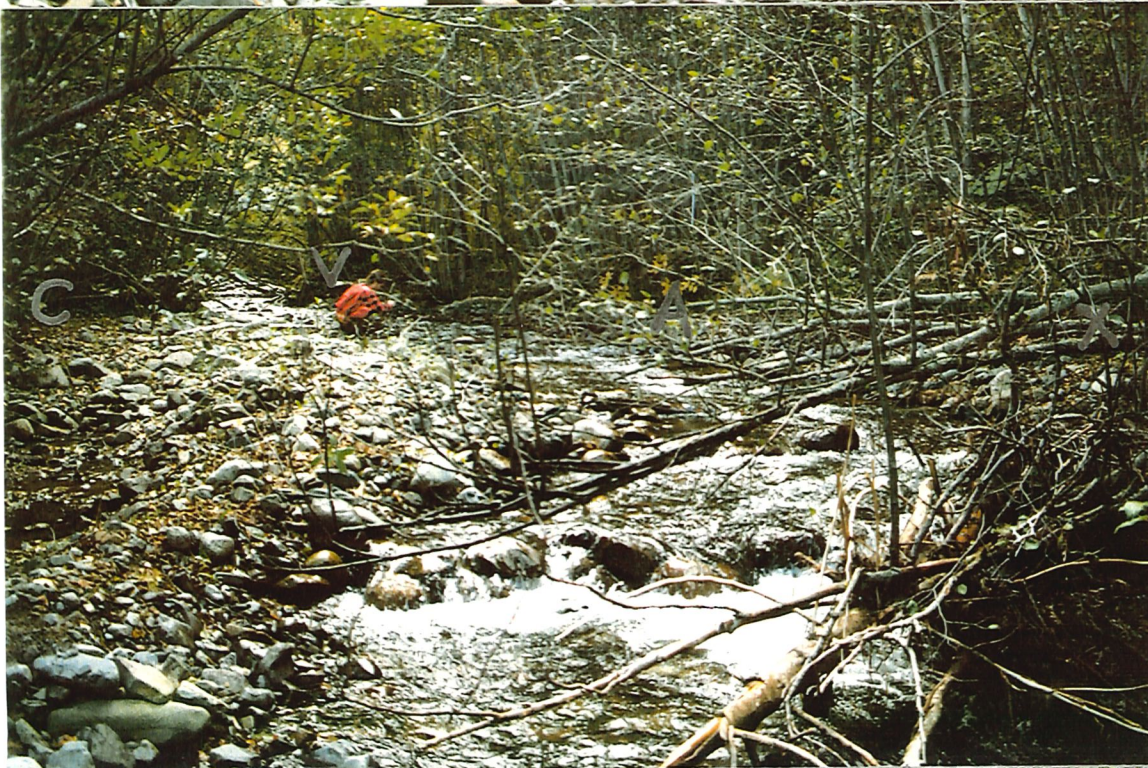
Photo 3: Skilokis Creek, Reach 1; looking upstream from site X to site A and site C where the small flow of surfaced groundwater enters the channel.

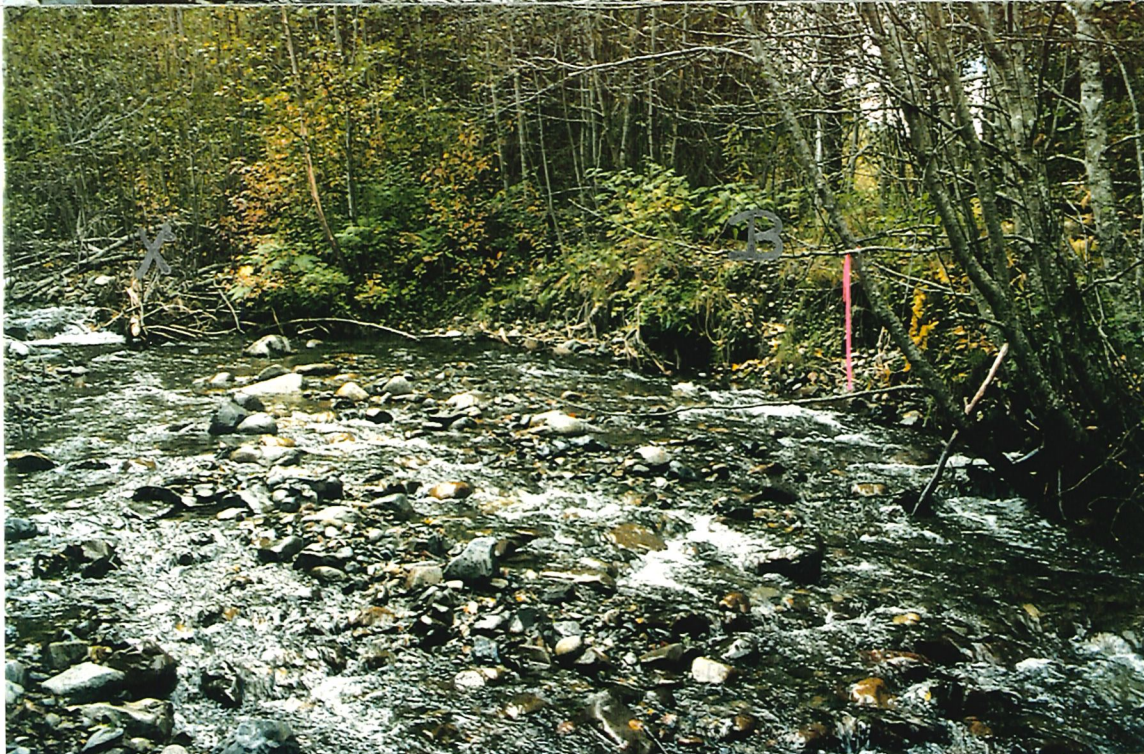
Photo 4: Skilokis Creek, Reach 1; minor bank erosion at site B, the crossing of the overgrown road.

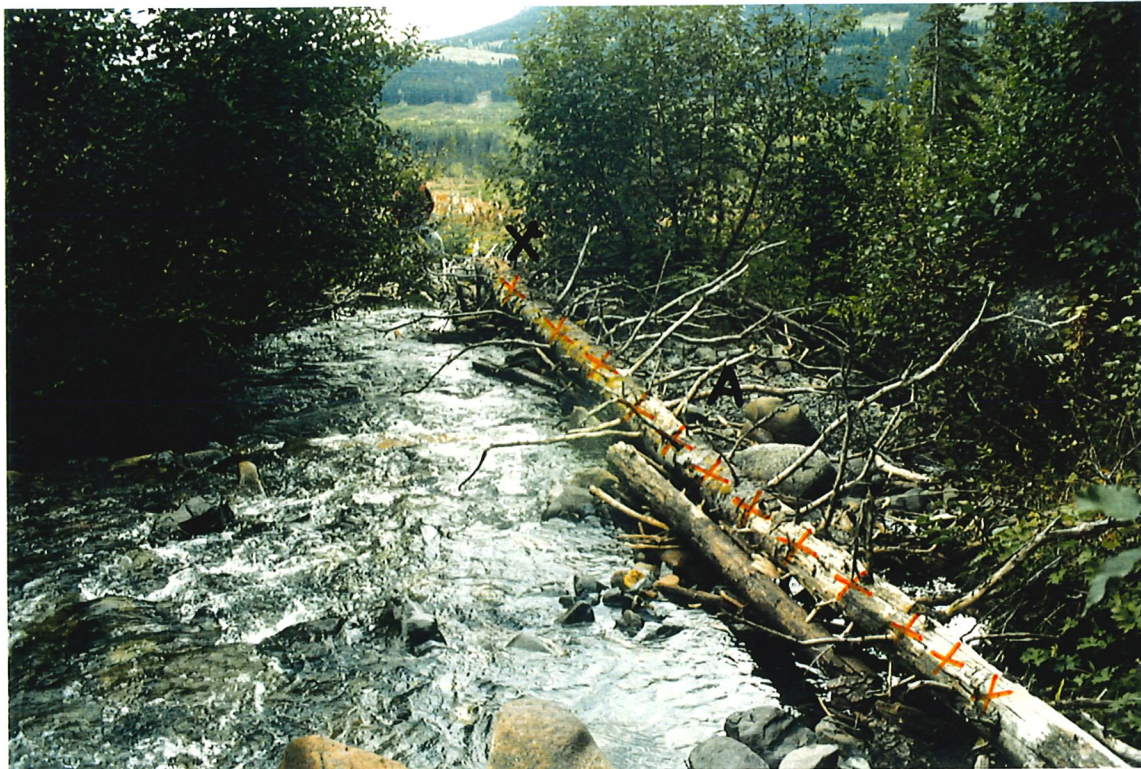
Photo 5: W.C. 46-700-140 (0 km Grizzly Main FSR). Looking downstream along the new channel and along the log to be removed (red Xs). The old channel, now filled with gravel, turns right at point A.

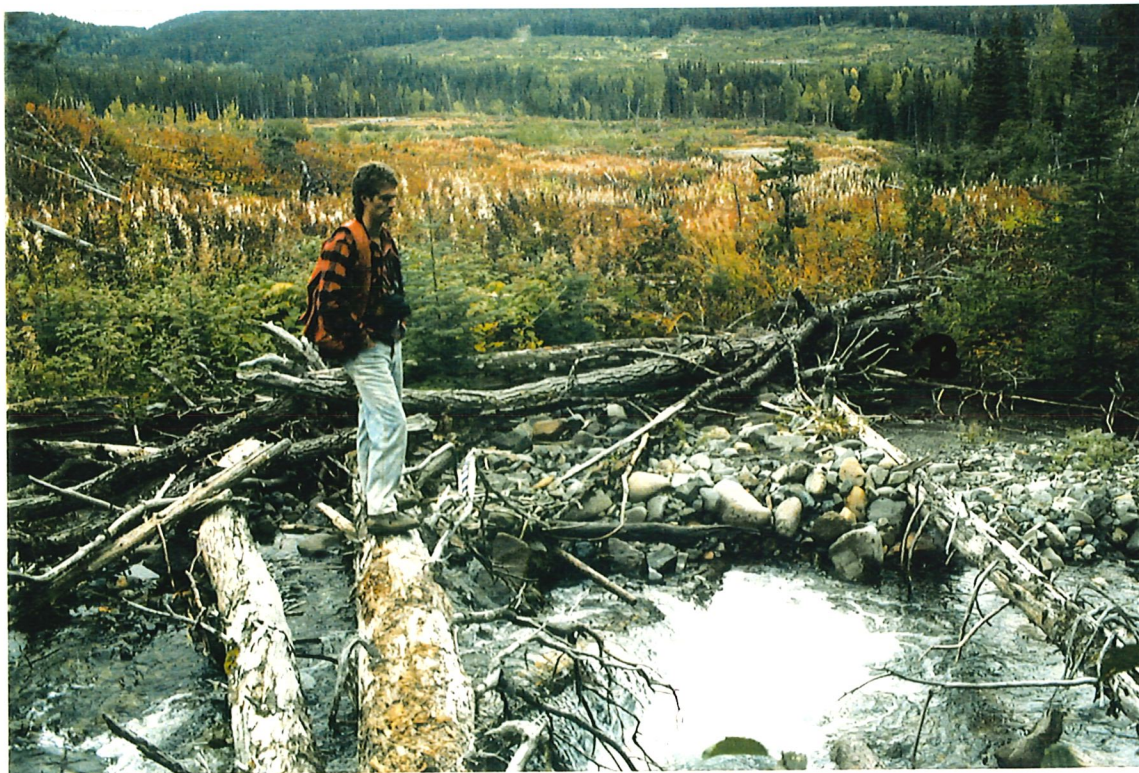
Photo 6: W.C. 46-700-140 (0 km Grizzly Main FSR). Looking downstream from point X towards the eroding meander bend apex left of point B (behind cottonwood log). 15 % sloping fluvial fan on block 93M.035-15 in the middle-ground.

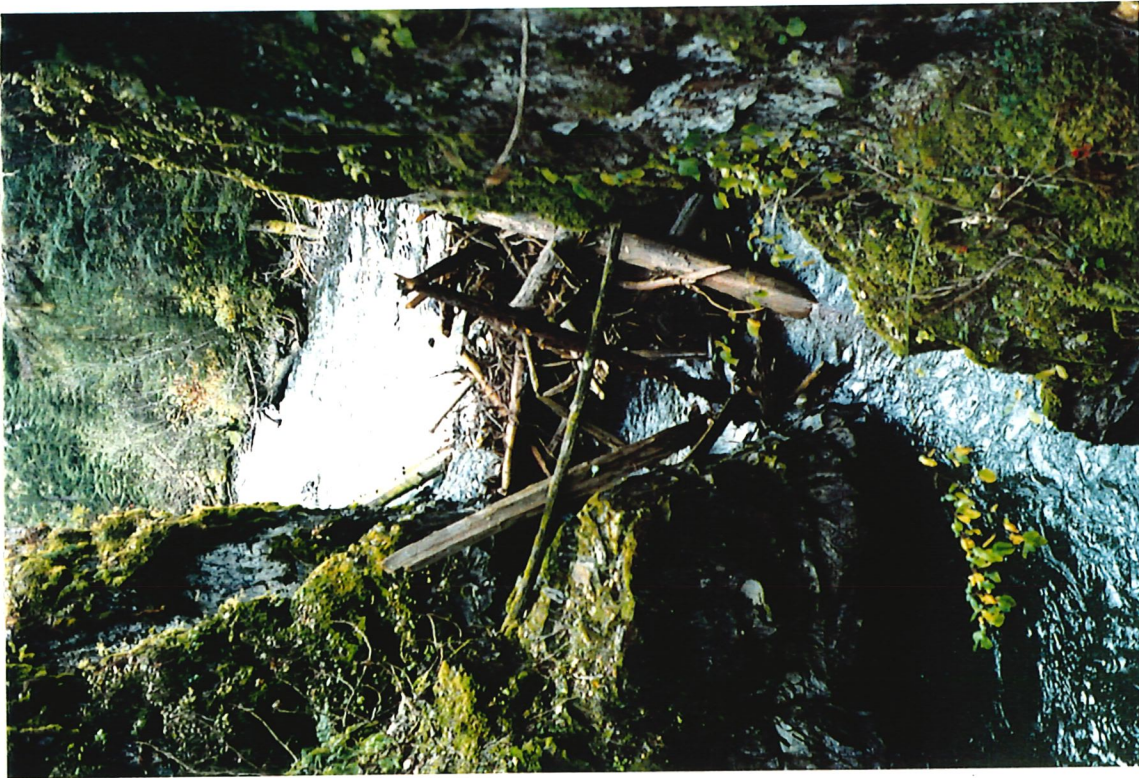
Photo 7: Natlan Creek (Reach 3); narrow bedrock canyon, partially blocked by logjam. (looking upstream)

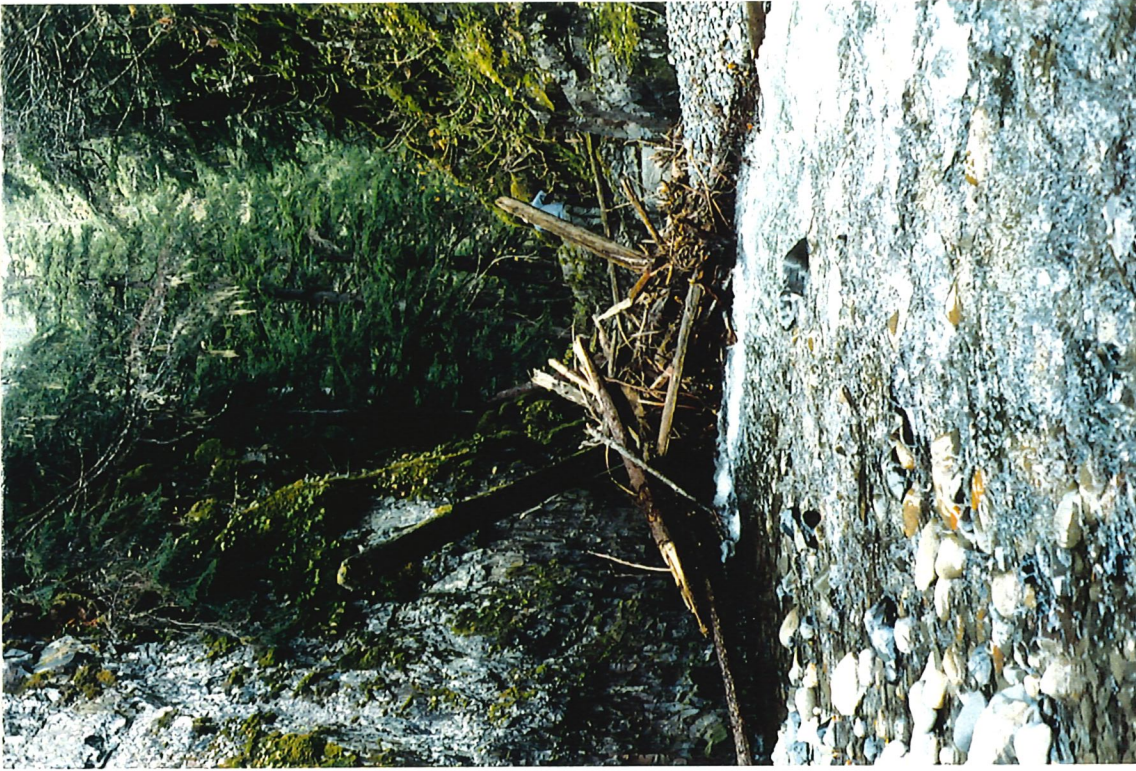
Photo 8: Natlan Creek (Reach 3); looking downstream into the narrow bedrock canyon. Flow and sediment passes under the logjam along the left stream bank.

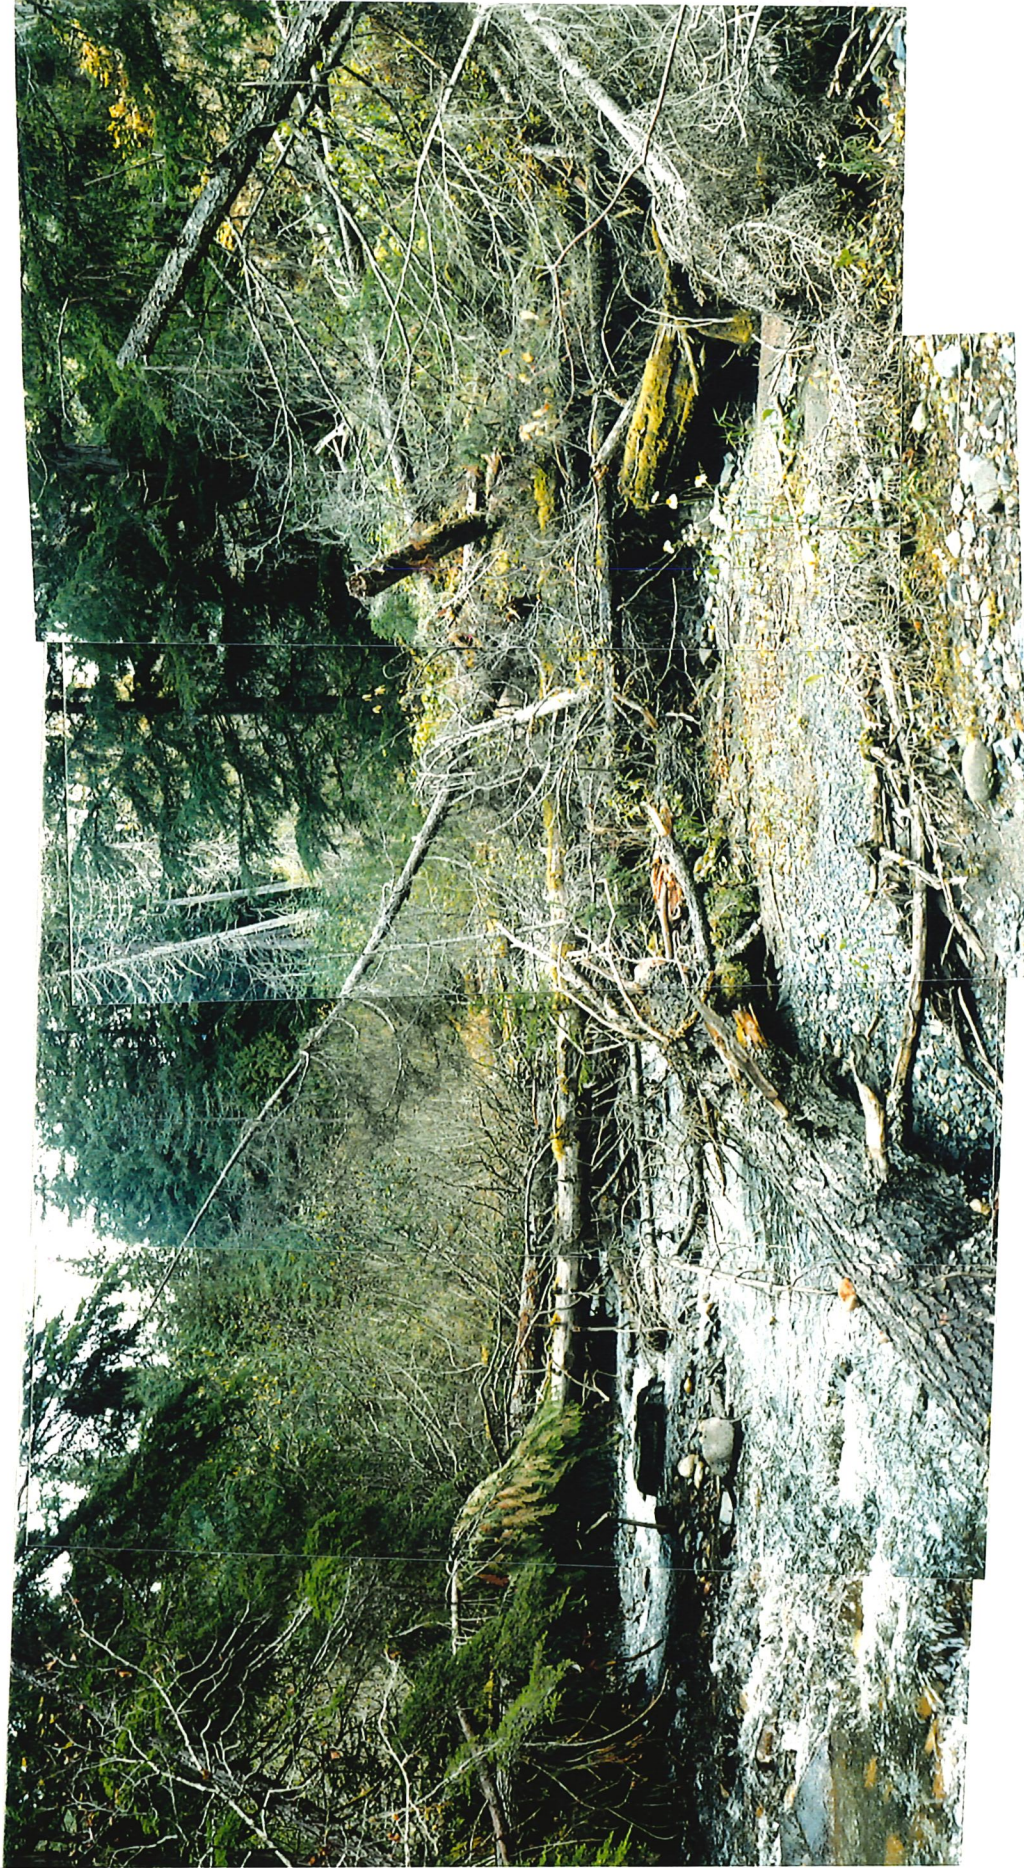
Photo 9: Denison Creek, Reach 1; looking upstream at logjam at toe of scarp slope failure (entered from the right of photo mosaic).

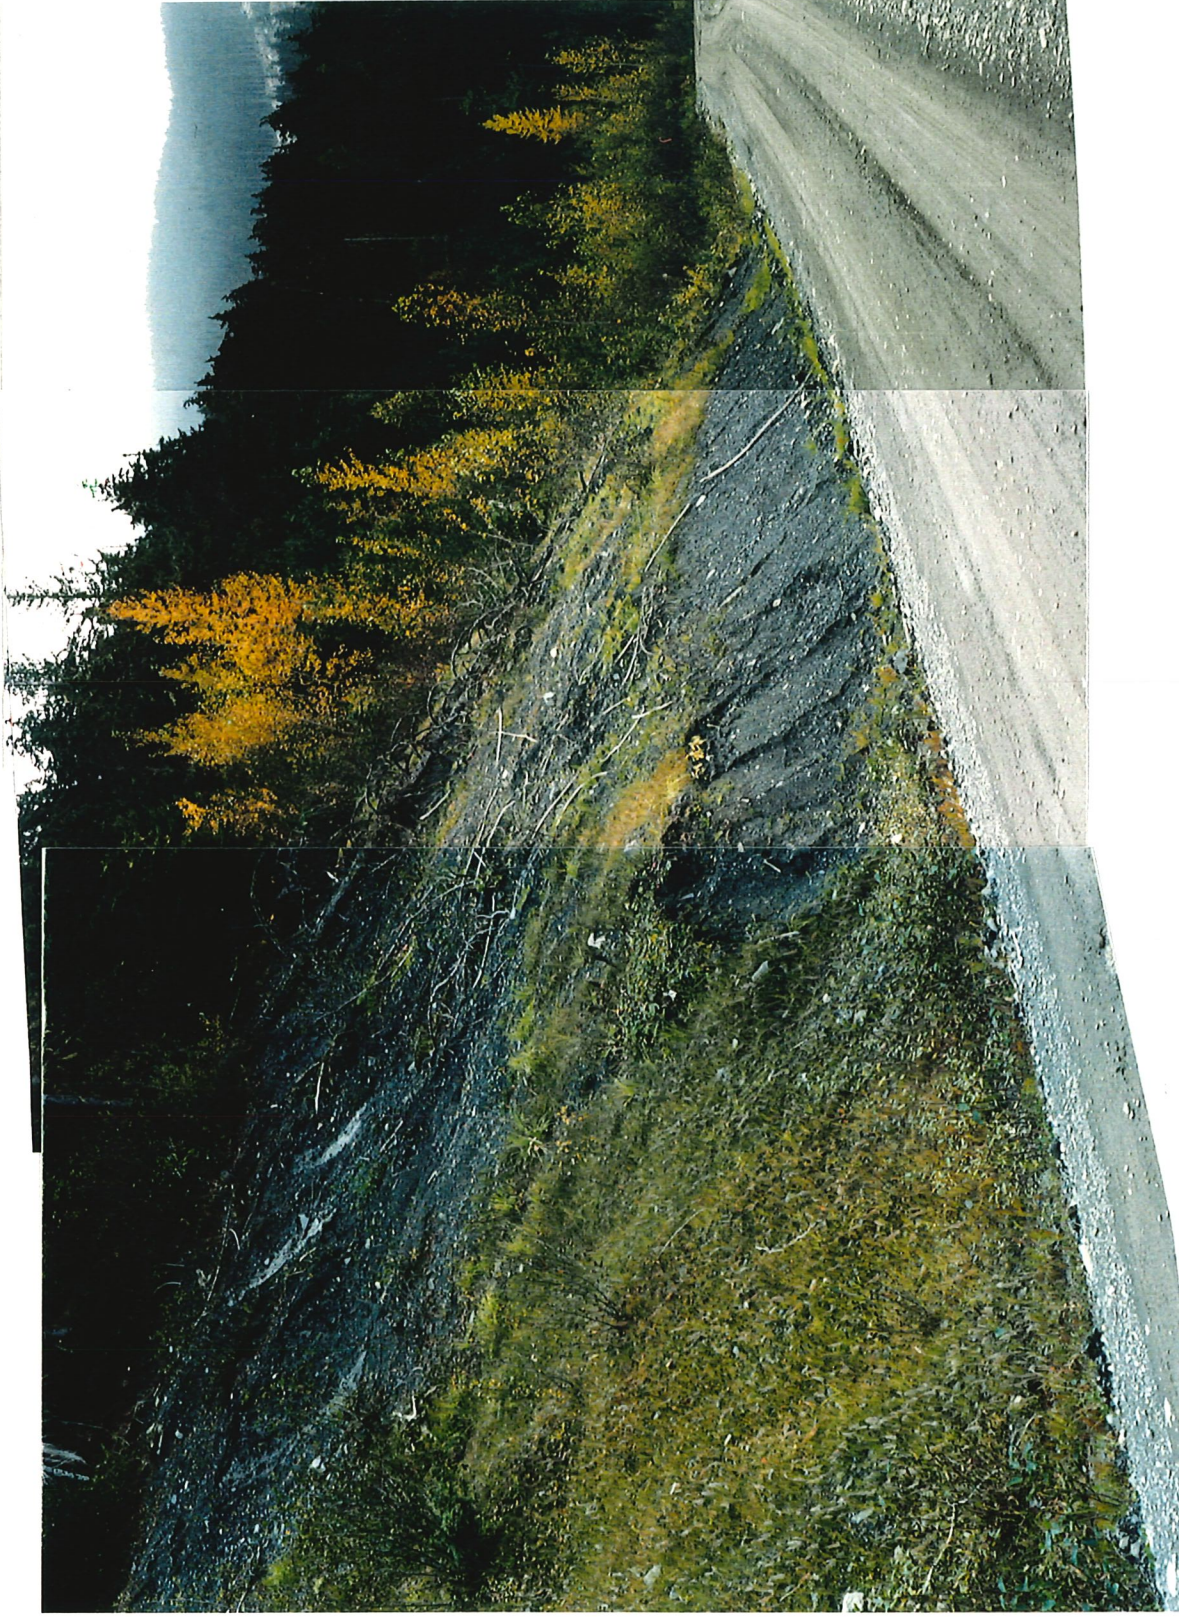
Photo 10: Creeping and sloughing cut slope along Suskwa FSR near km 21. Failure below the road runs to Denison Creek.
