**The Suskwa Watershed
Restoration Program
Assessment and Prescriptions,
Surveys and Design, and Works**

**prepared by M. Jacobs
for
The Suskwa Restoration Society
March 1998**

**Suskwa Watershed Restoration Program 1997
Assessments and Prescriptions,
Surveys and Design, and Works**

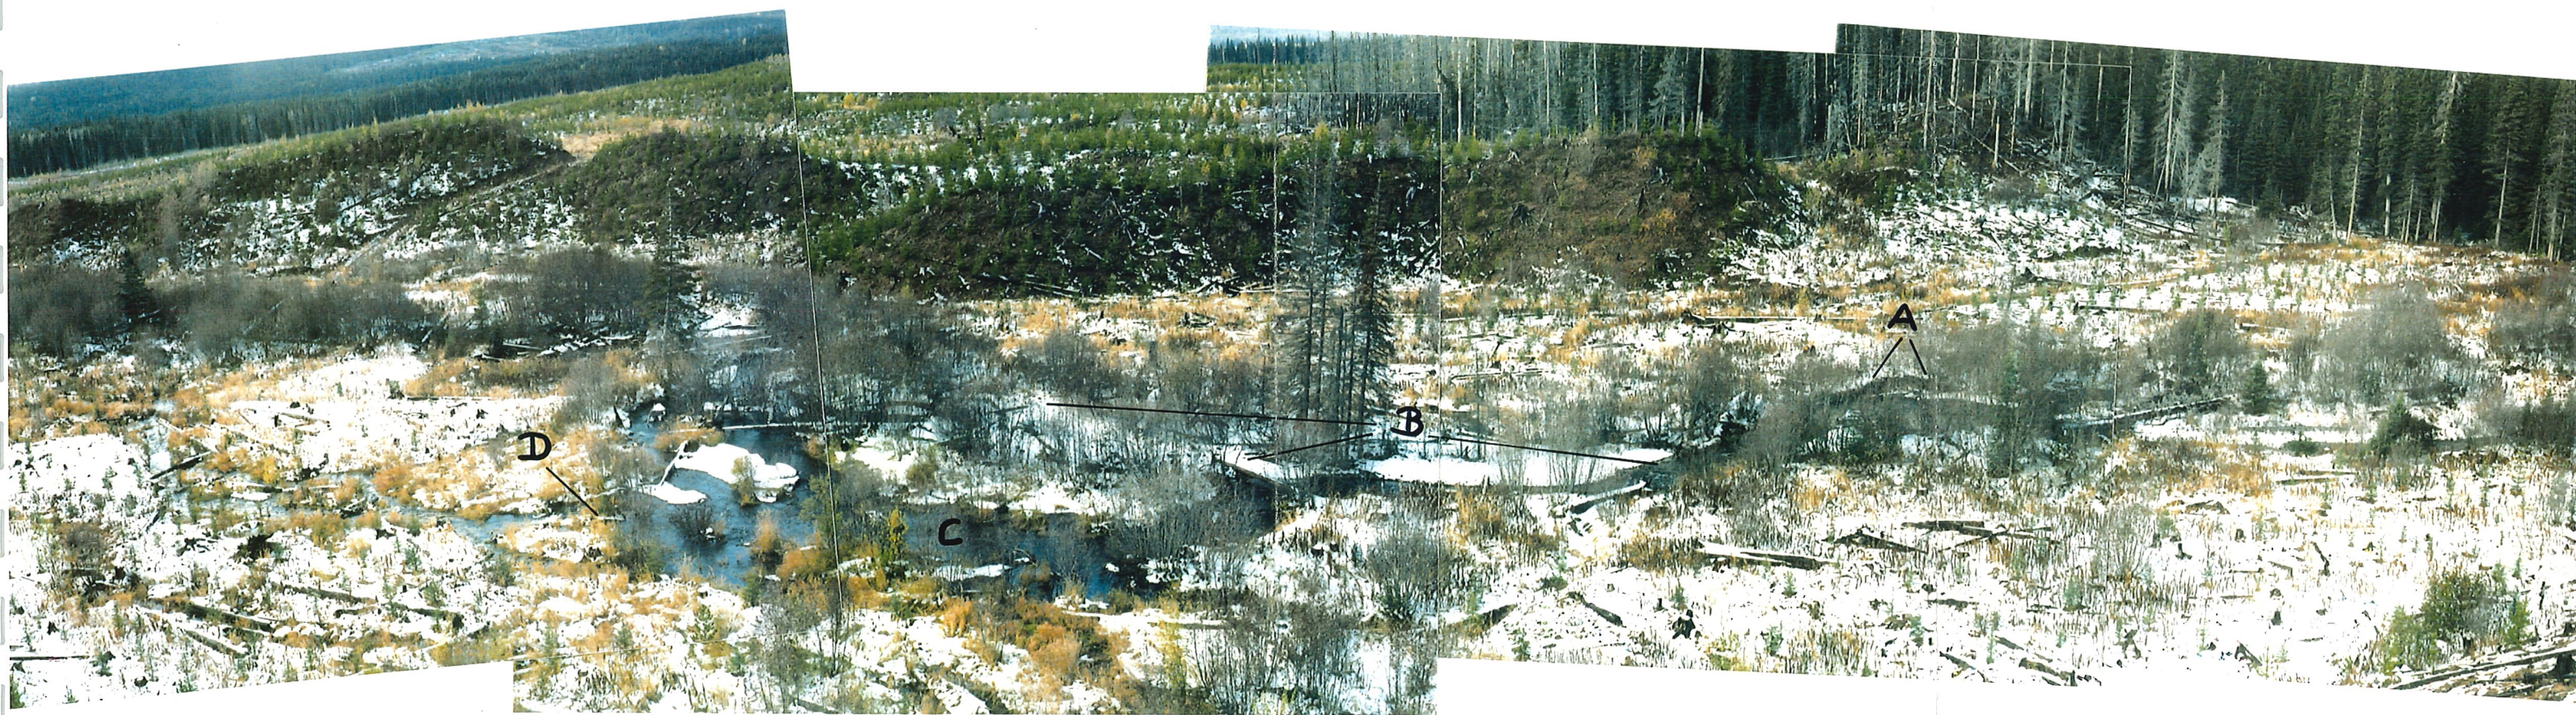
Photo 11: Luhk Creek (flow from R to L); looking at the diversion site. A: Bank erosion, 5 m long, 2 m bank retreat. B: Gravel deposition in original main channel. C: New main channel being established. D: Overflow inot secondary channel.

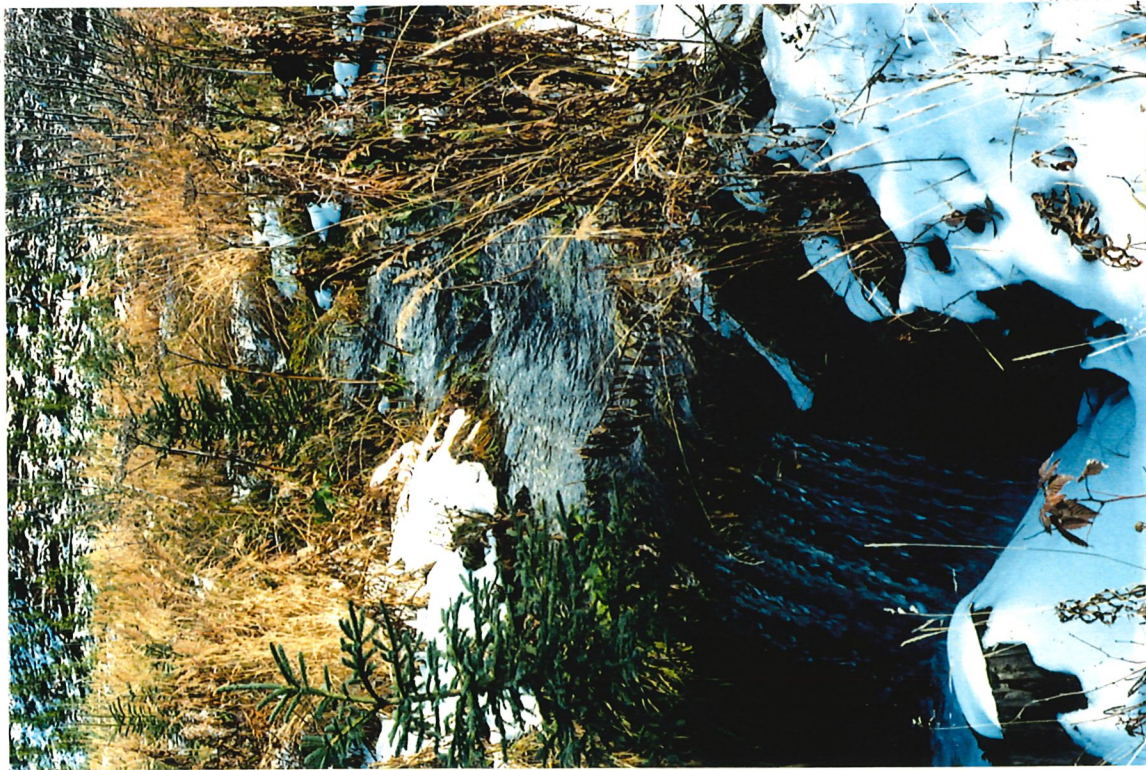
Photo 13: Luhk Creek.; 7 m drop a branch of secondary channel into main channel.

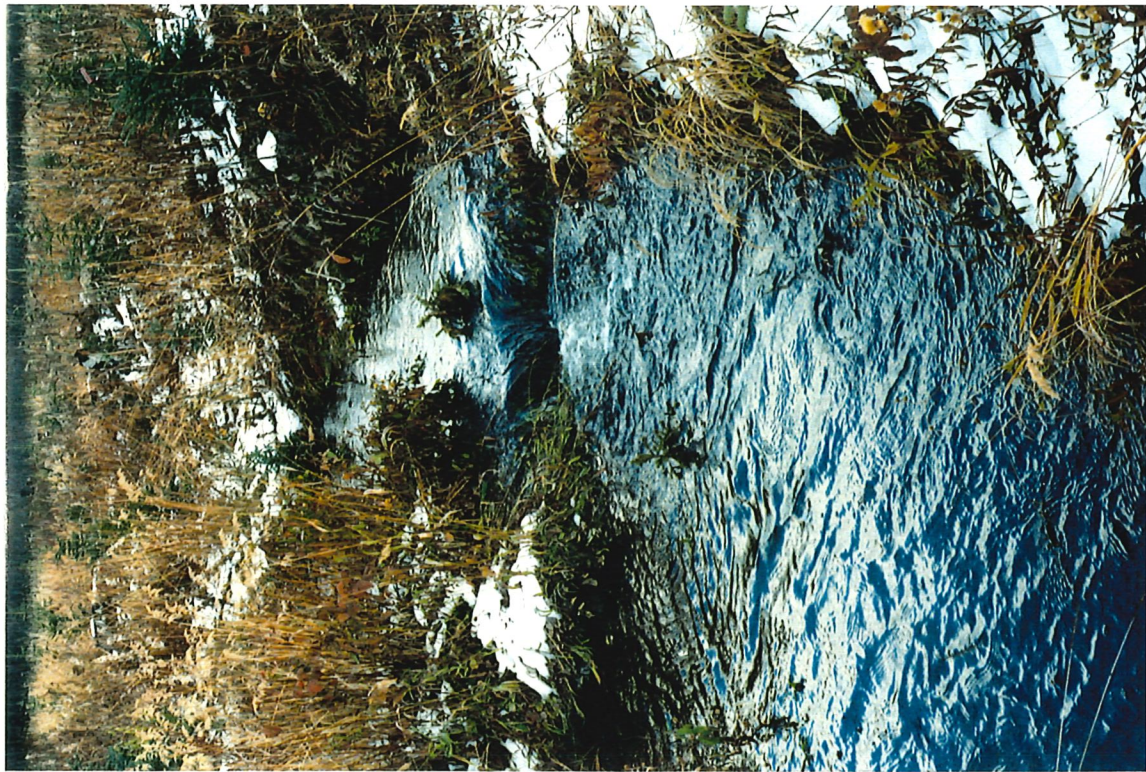
Photo 14: Luhk Creek, secondary channel, near downstream part of block 93M.016-019

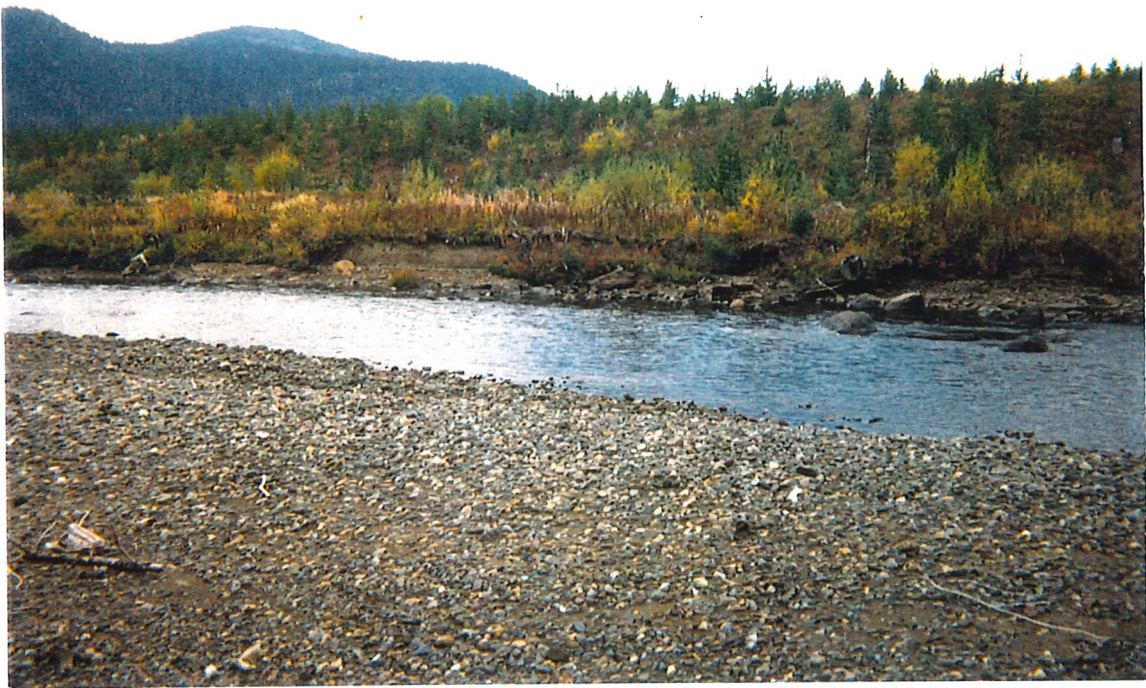
Photo. 1 Harold Price Creek (reach 6) along block 93M 016-16. Riparian planting is recommended for 9.57 hectares within the 50 meter RRZ over 4 kilometers, primarily at locations prone to erosion.

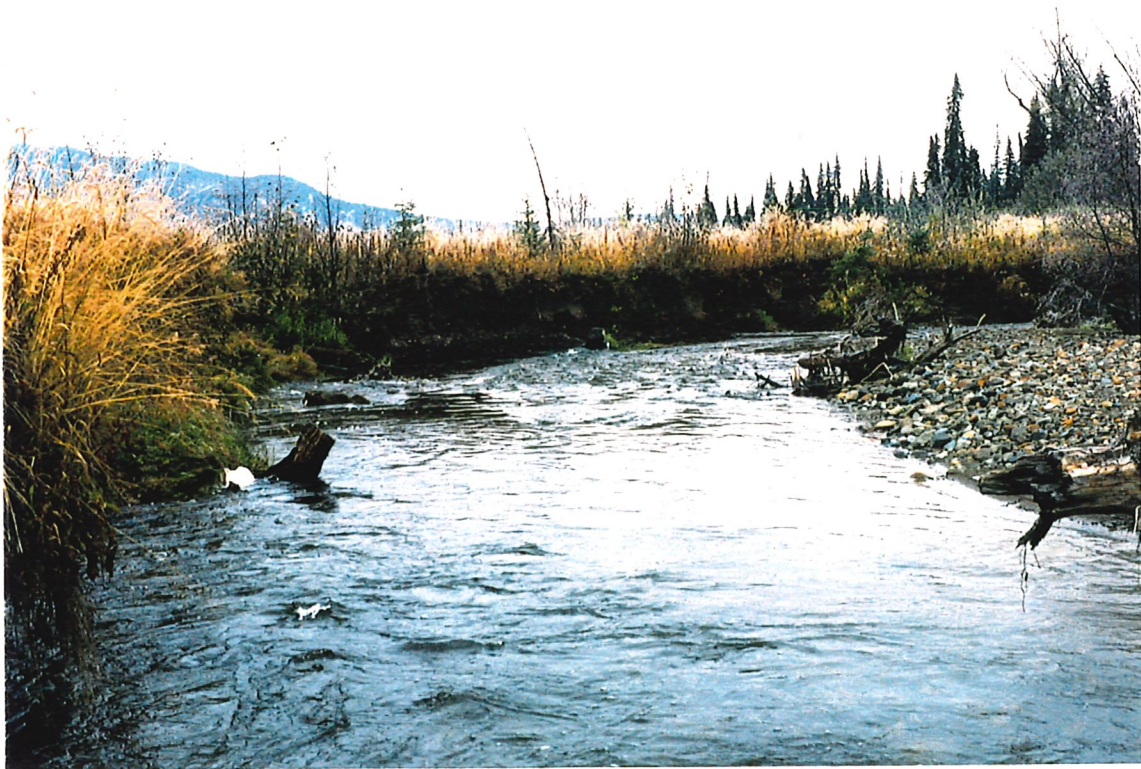
Photo. 2 Harold Price Creek (reach 9) exhibits extensive erosion through block 93M 007-101.

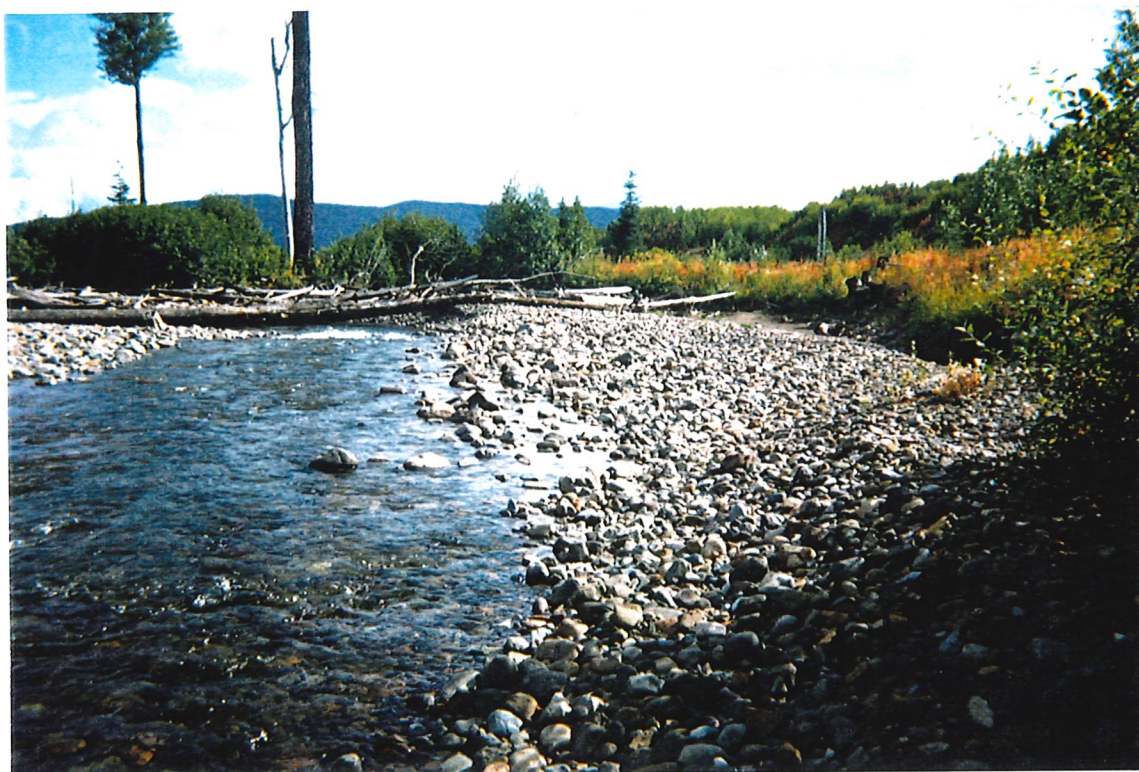
Photo.3 Harold Price (H.P) Creek (reach 10) along block 93M 006-6. A total treatment area of 2.88 hectares is prescribed at outside meanders throughout this eroded reach to help maintain bank stability.

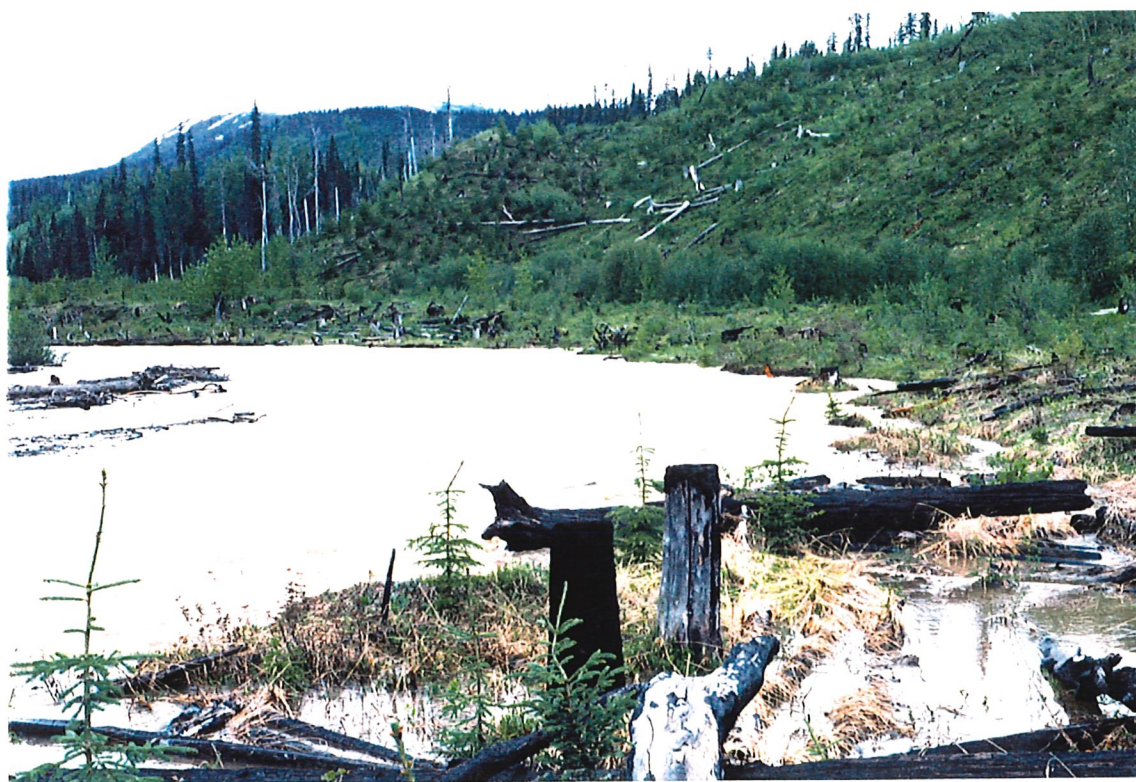
Photo.4 H.P. Creek (reach 11) along block 93M006-4. Vegetation is needed to help retain streambanks.

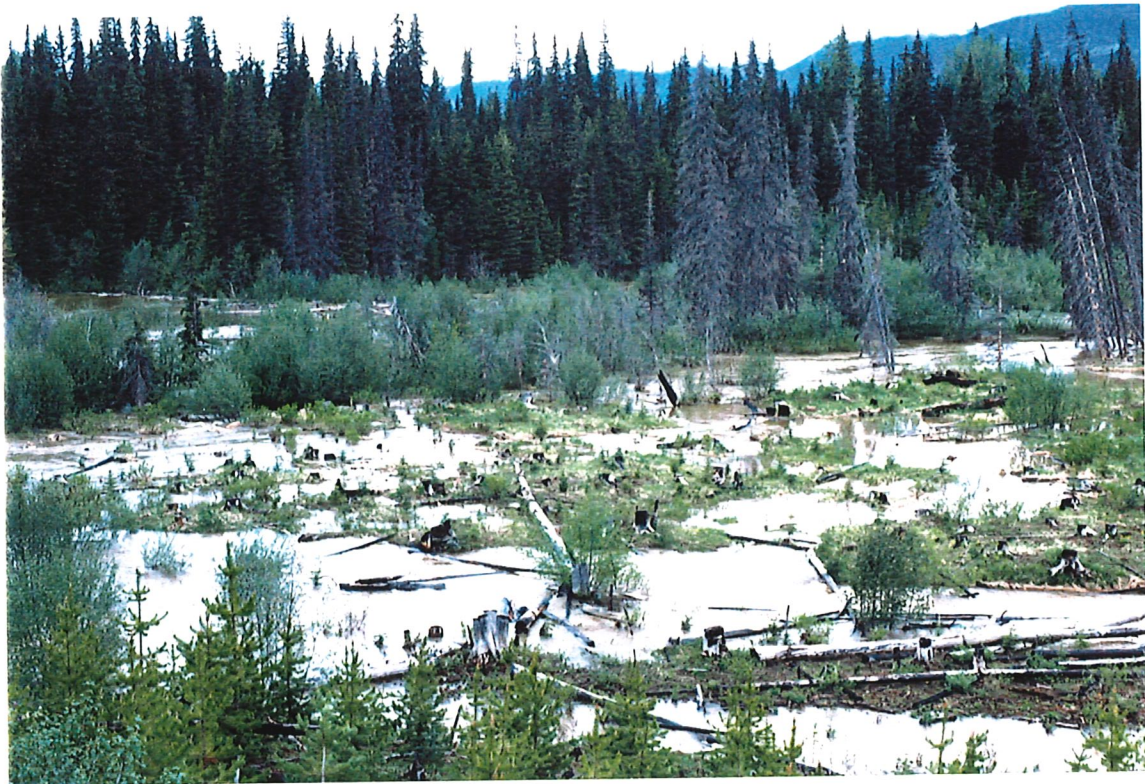
Photo. 5 Blunt Creek (reach 1) through block 93M 016-32. Hardwood species, primarily willow, have been prescribed at this site to help stabilize this eroding floodplain. The channel avulsion into this cutblock continues to degrade off-channel fish habitat that was being utilized by rearing coho salmon during 1995 and 1996 WRP assessments.

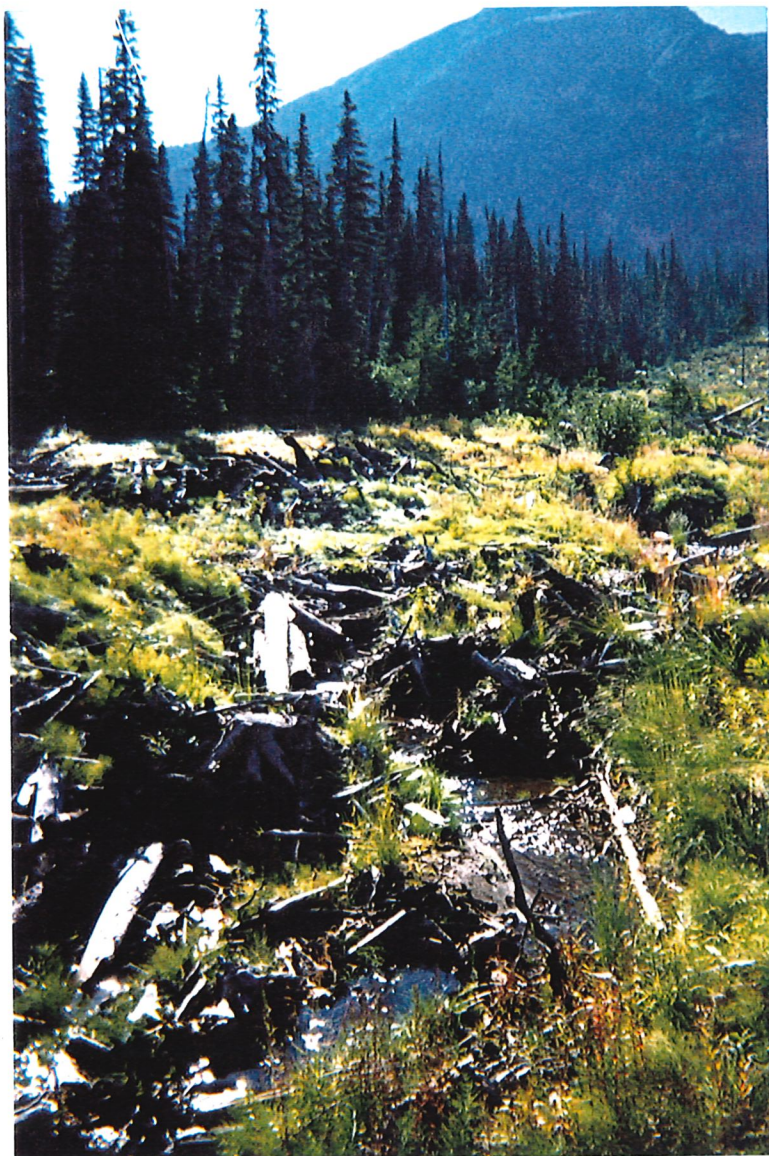
Photo.6 Tributary 1 to Wan Lake, at the entrance to block 93M 016-29, flows through a landing and logging waste that requires riparian vegetation to help maintain the stream channel and provide cover for this fish -bearing creek.

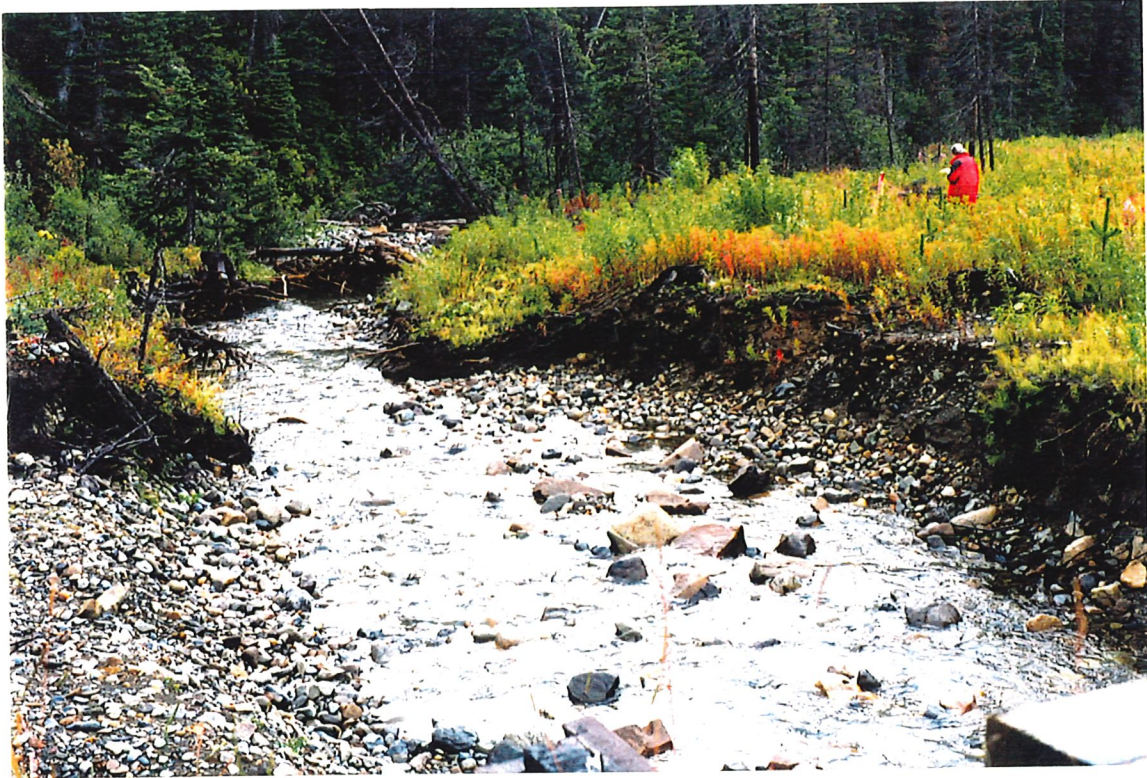
This small "S3" stream to Blunt Creek exhibits extensive erosion along block 93M015-002 especially downstream of the bridge crossing at 21.3 km along the Blunt 2500 rd. Bedload deposition has resulted in the infilling of pools and channel avulsions into the cutblock. The treatment area prescribed is 1.64 hectares along the 20 meter RRZ and focuses on trying to stabilize the stream channel and the mixed planting of the fireguard that borders the creek downstream of the road crossing (Photo. 7 and Appendix 9.2).

Photo.7 Tributary W.C. 46-700-50-30-115-10 to Blunt Creek along block 93M 015-002. This small stream exhibits extensive erosion, especially downstream of the road crossing at 21.3 km along the Blunt 2500 Rd. The riparian prescription focuses on stabilizing streambank along this tributary.

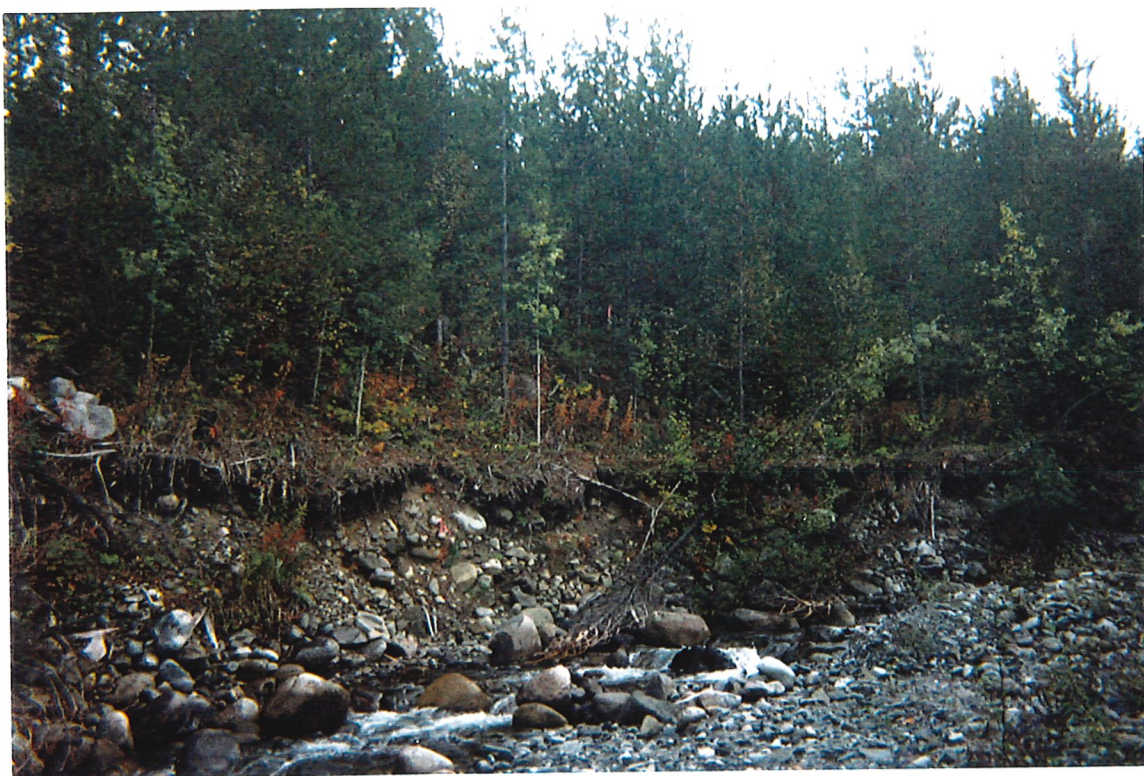
Photo.8 Skilokis Creek (reach 1) within block 93M 024-18. Erosion, especially upstream of the 0.28 km bridge crossing along the Hamblin Rd, continues to deliver bedload and crop trees to the stream channel. Riparian planting of this reach and some selective release of the understorey, downstream of the road crossing, has been prescribed to speed recovery of this harvested reach.

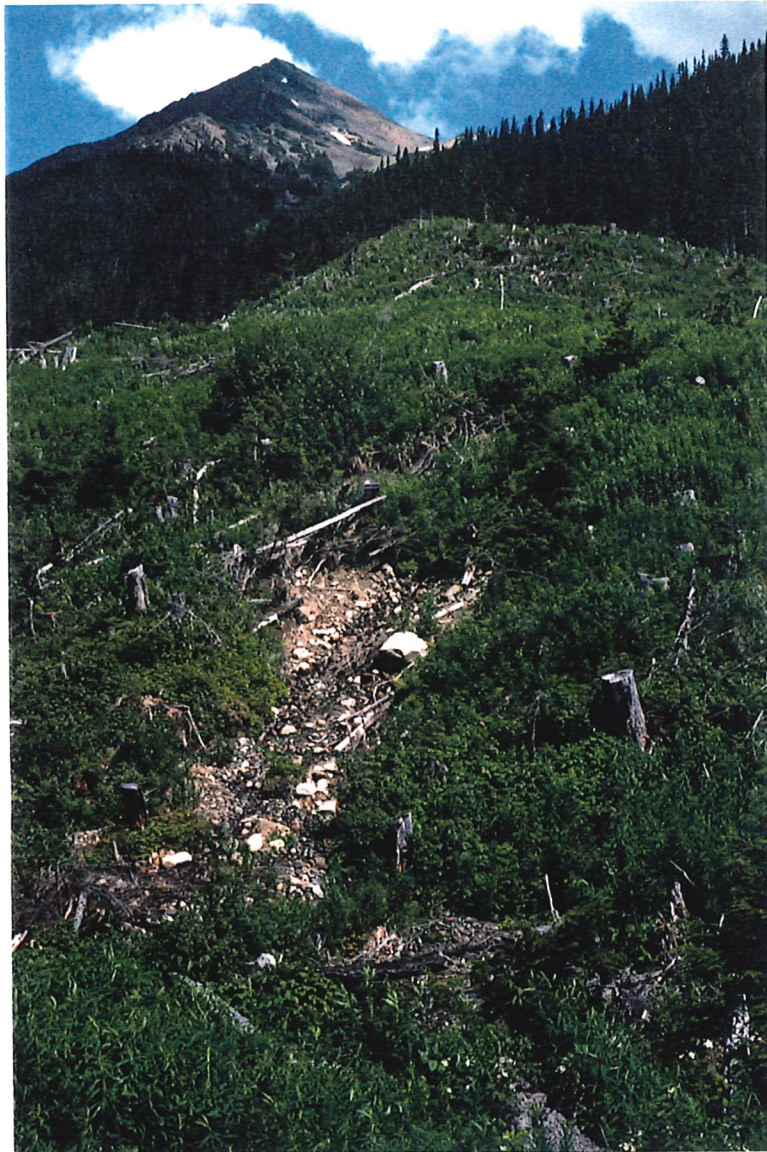
This "S2" stream through block 93M035-11 exhibits erosion problems associated with the former logging of its floodplain. The planting prescriptions focus on maintaining channel stability and reestablishing a riparian corridor along this unstable reach of Denison Creek. Two avalanche chutes from Thoen Mountain presently extend to Denison Creek as a result of the harvesting of block 11 (Photo. 9 and Appendix 9.2).

Photo.9 Denison Creek, reach 3; (looking upslope from the stream channel) through block 93M 035-11, exhibits erosion problems associated with the former logging of the streams edge. Mixed planting of areas prone to erosion has been prescribed for 1998.

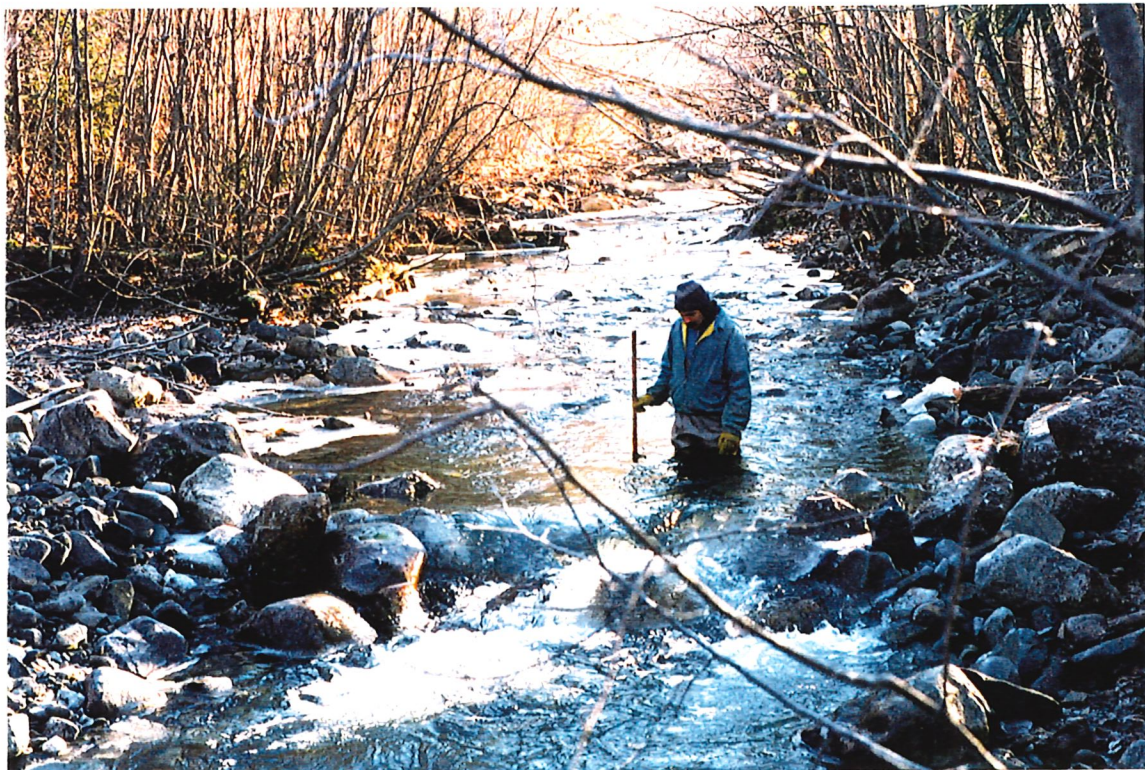
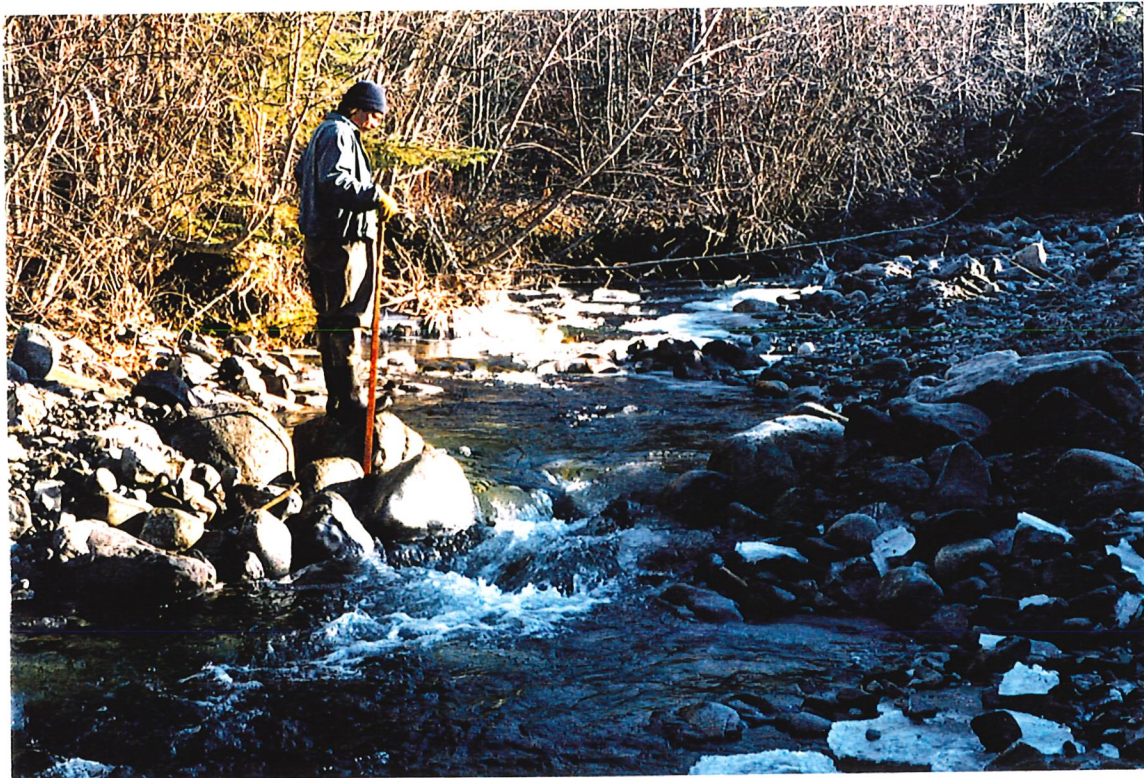
Photos 2 and 3. Skilokis Creek fish habitat rehabilitation site "A" before treatment (top) and after treatment (bottom). The two pools created on either side of this rock line (lower photo) increased pool habitat, at this site, by 5.2 cubic meters. Post-treatment fry densities and habitat measurements should be monitored in 1998 after spring runoff.

The two rock lines at sites "A" (Photos 2 and 3) and "D" (Photos 4 and 5) were installed within 4 hours. A total of 9.5 cubic meters of pool habitat was created between the two chosen sites. These sites should be sampled for post-treatment fry densities and monitored for structural integrity in 1998.

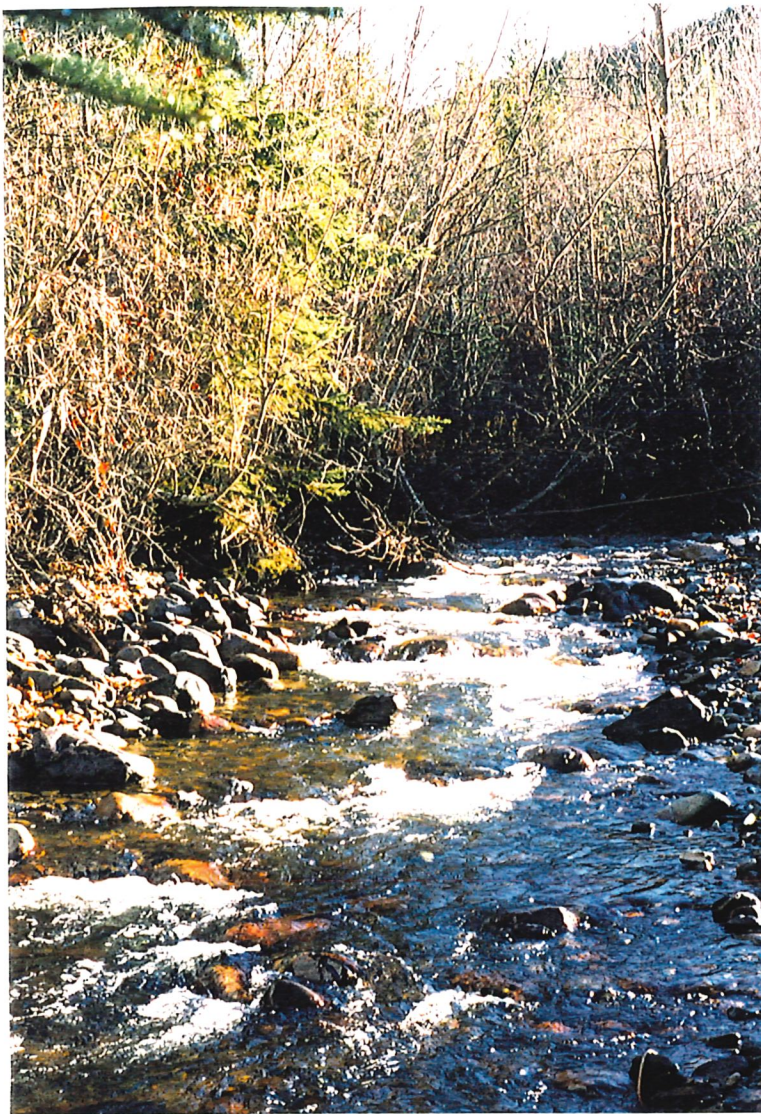
Photos 4 and 5. Skilokis Creek fish habitat rehabilitation site "D" before treatment (top) and after treatment (bottom). The two pools created on either side of this rock line (lower photo) increased pool habitat, at this site, by 4.3 cubic meters. Post-treatment fry densities and habitat measurements should be monitored in 1998 after spring runoff.

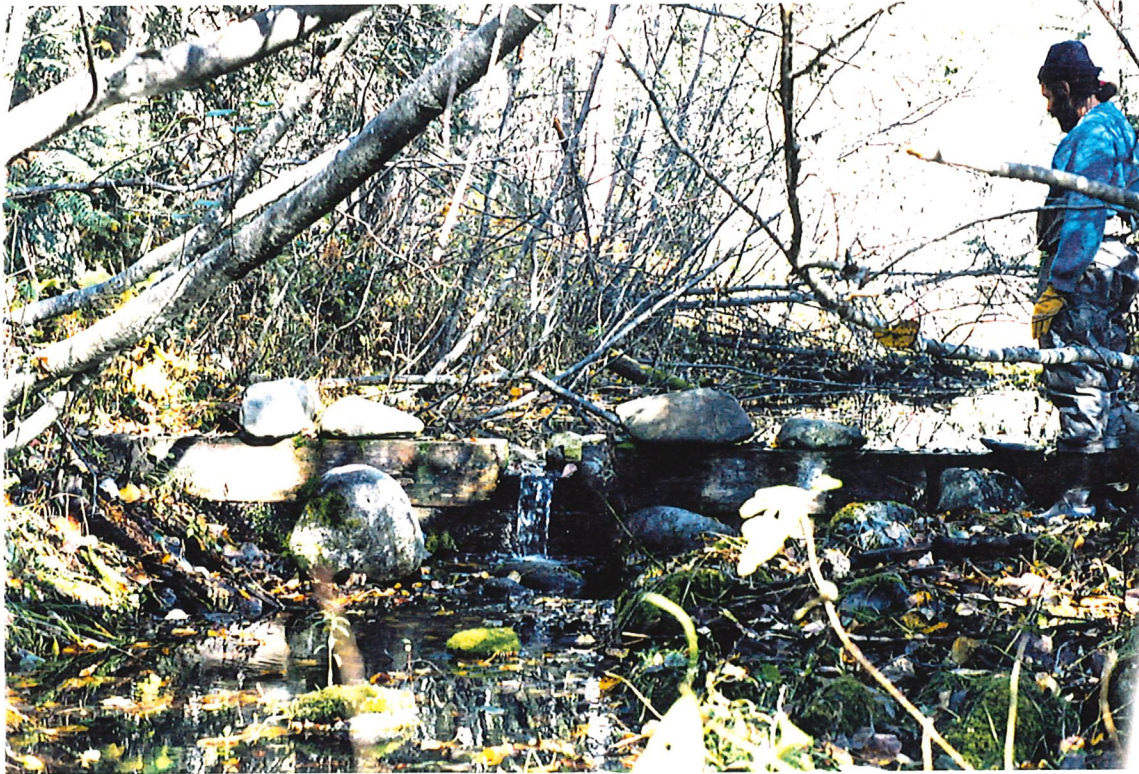
Photo 6. This structure was installed in 1990, within this groundwater channel, as part of the Salmonid Enhancement Programs (SEP) attempt to rear coho at this site. This project was subsequently abandoned and this structure was removed as part of 1997 WRP works. As a result, an additional 112 meters of fish habitat was made available within this groundwater site.

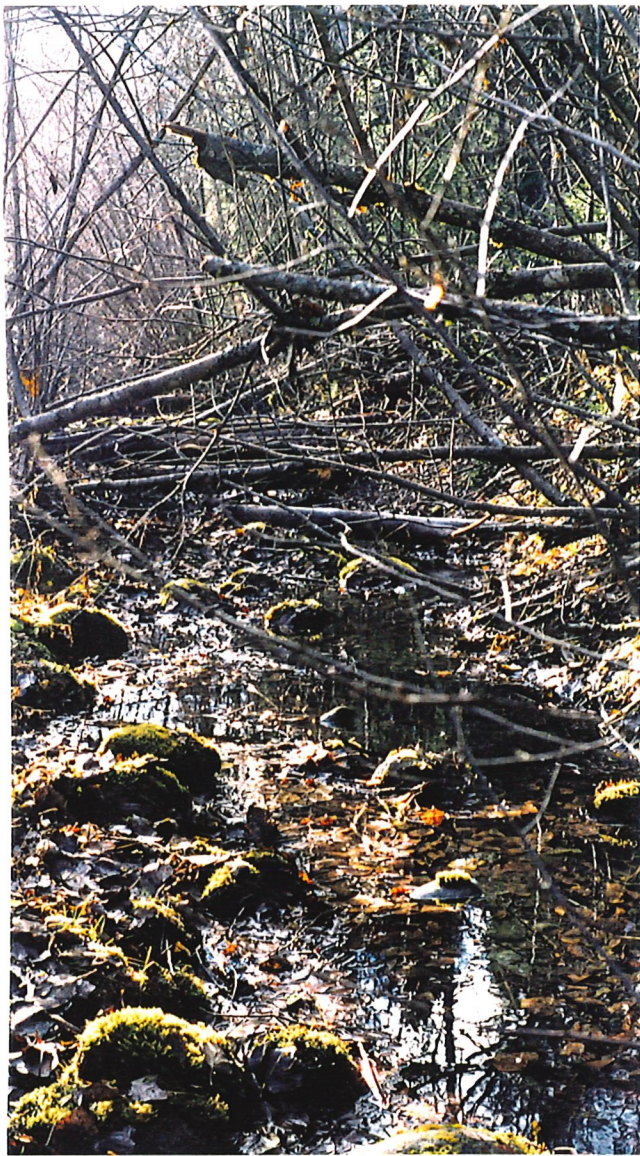
Photos 7 and 8. This groundwater channel enters Natlan Creek, in reach 1, immediately upstream of the Natlan Cr. bridge at 15.1 km along the Suskwa FSR.

This site was enhanced by adding LWD (at left, background) and then excavating pools (below, foreground) within the initial 90 meters of the channel. Monitoring of post-treatment fry densities is recommended for 1998.

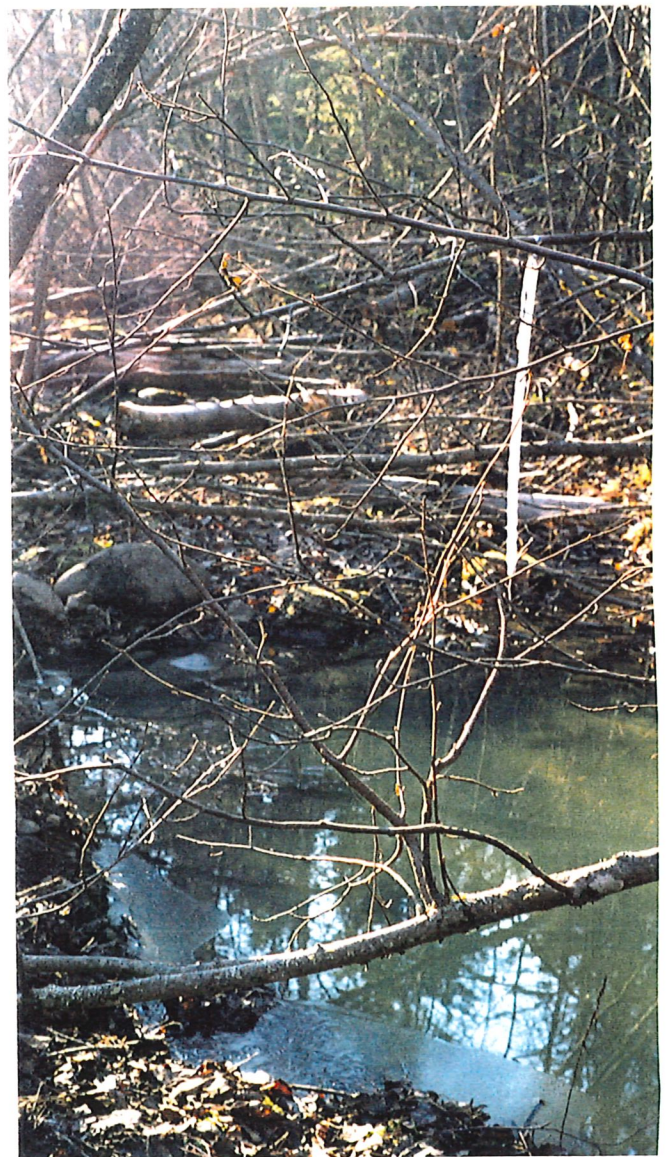
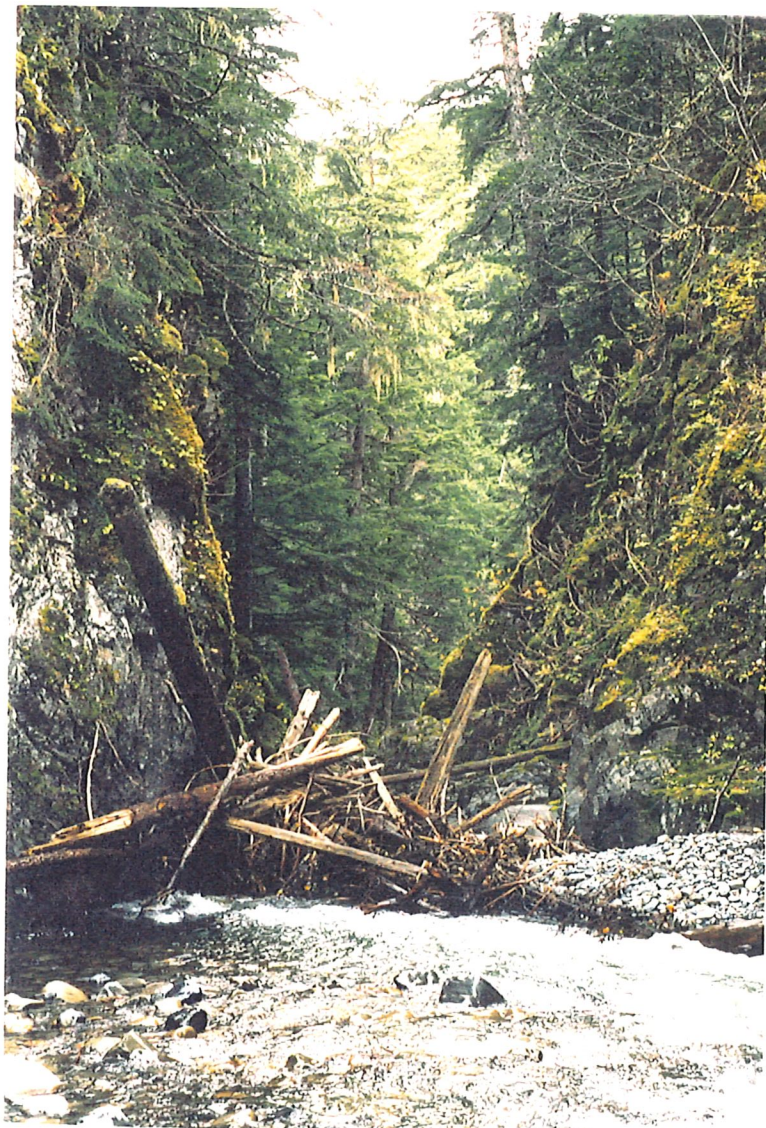
Photos 9 and 10. This bedrock constriction and logjam appeared to be the limiting factor for fish (Rb, Bt and Mw) distribution to the upper reaches of Natlan Creek after assessments in 1995/96 (at left). This obstruction was partially removed (lower photo) to accommodate fish passage upstream. Monitoring of this site and fish distribution upstream, after trout fry have emerged, is recommended for 1998.

The partial removal of this logjam was accomplished over two days with a 2-man crew using chainsaws, a pry-bar and "come-alongs" (Photo. 10, previous page). It is estimated that more than 20 kilometers of viable fish habitat has been made accessible to anadromous and resident species as a result of the breaching of this obstruction.

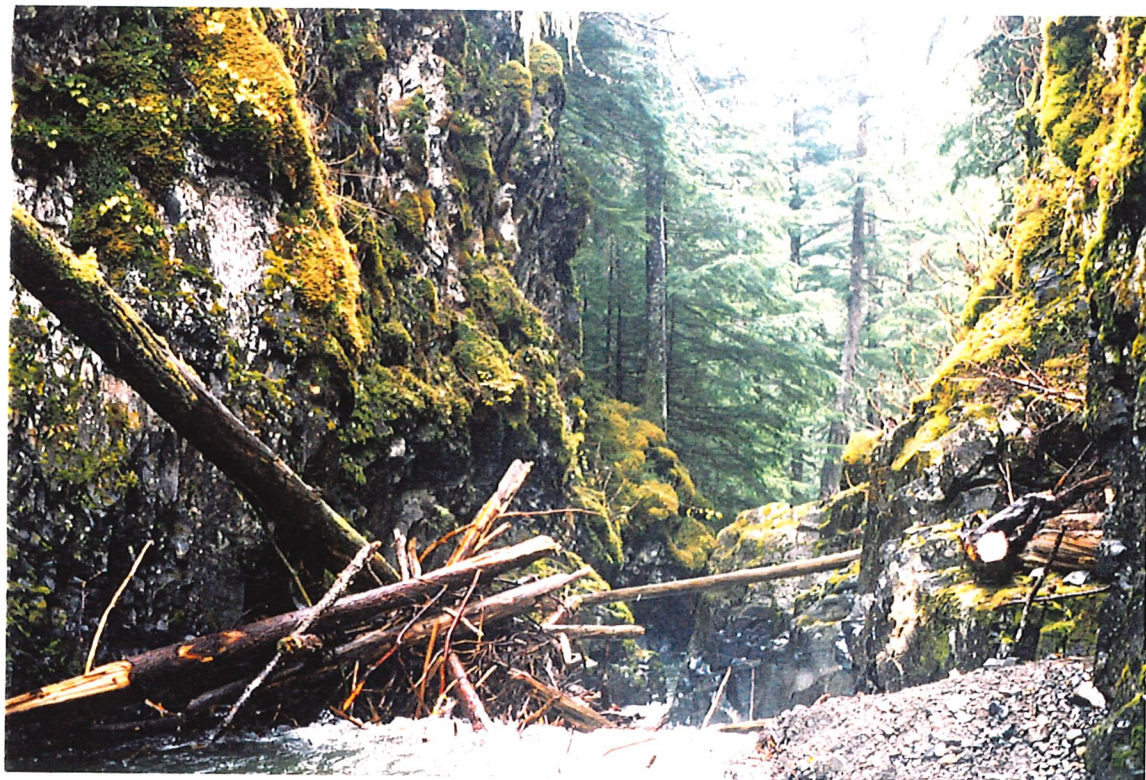
This site was viewed as a mitigative measure allowing access to viable fish habitat by fish species impacted by forest harvesting and road development elsewhere in the watershed. This site should be monitored for debris accumulation after spring highwater and fish distribution upstream, preferably in late summer, after trout fry have emerged in 1998.

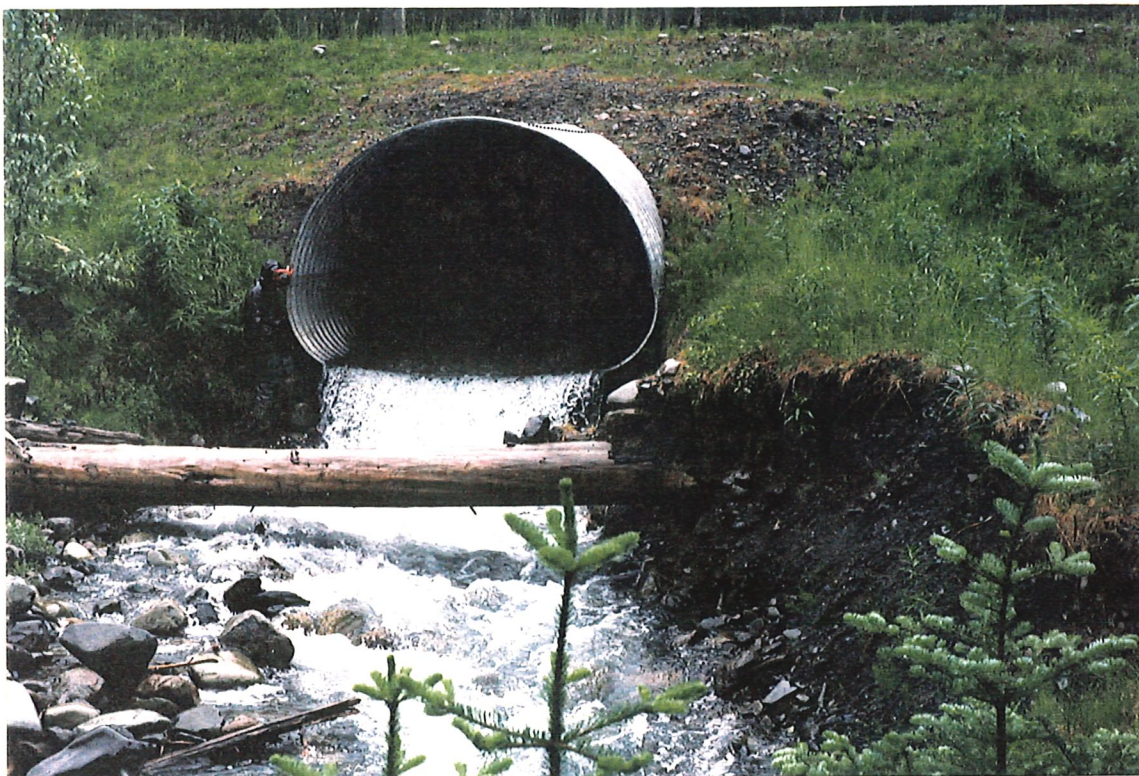
Photo 11. This road crossing, located at 34 km along the Suskwa FSR, was noted as an obstruction to fish passage during 1996 assessments. The initial prescription to establish a jump pool here was revised due to the threat of exacerbating erosion and unassured passage. This site has been budgeted for replacement within 1998 fiscal works.

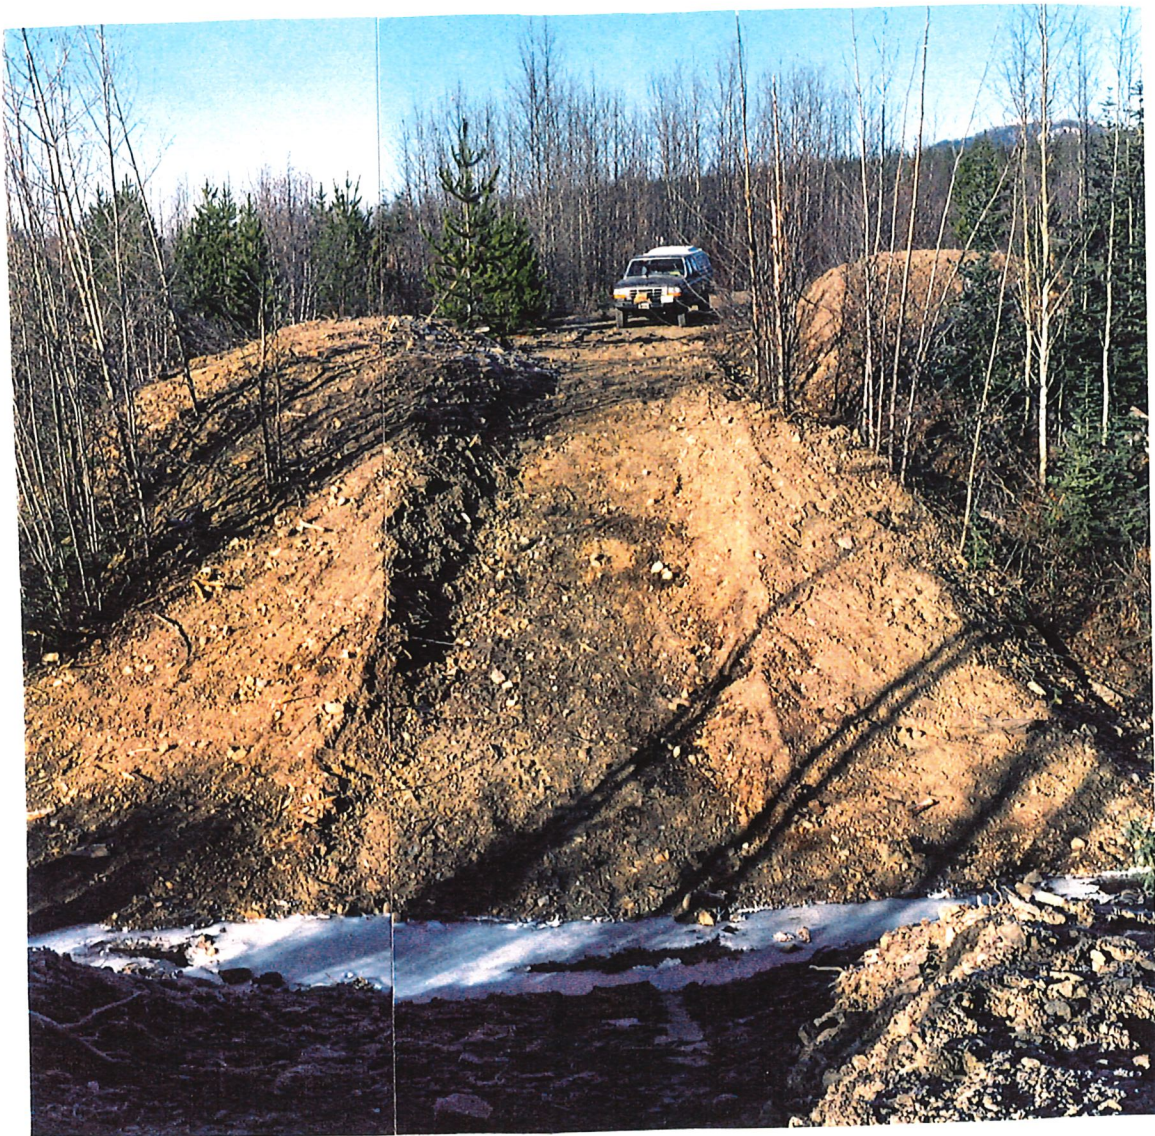
Photo 12. This first of two road crossings was excavated along trib. W.C. 46-700-50-14-15 to ensure resident fish passage through blocks 93M 005 and 006. This crossing was grass-seeded after modification.
