**The Suskwa Watershed
Restoration Program
Assessment and Prescriptions,
Surveys and Design, and Works**

**prepared by M. Jacobs
for
The Suskwa Restoration Society
March 1998**

**Suskwa Watershed Restoration Program 1997
Assessments and Prescriptions,
Surveys and Design, and Works**

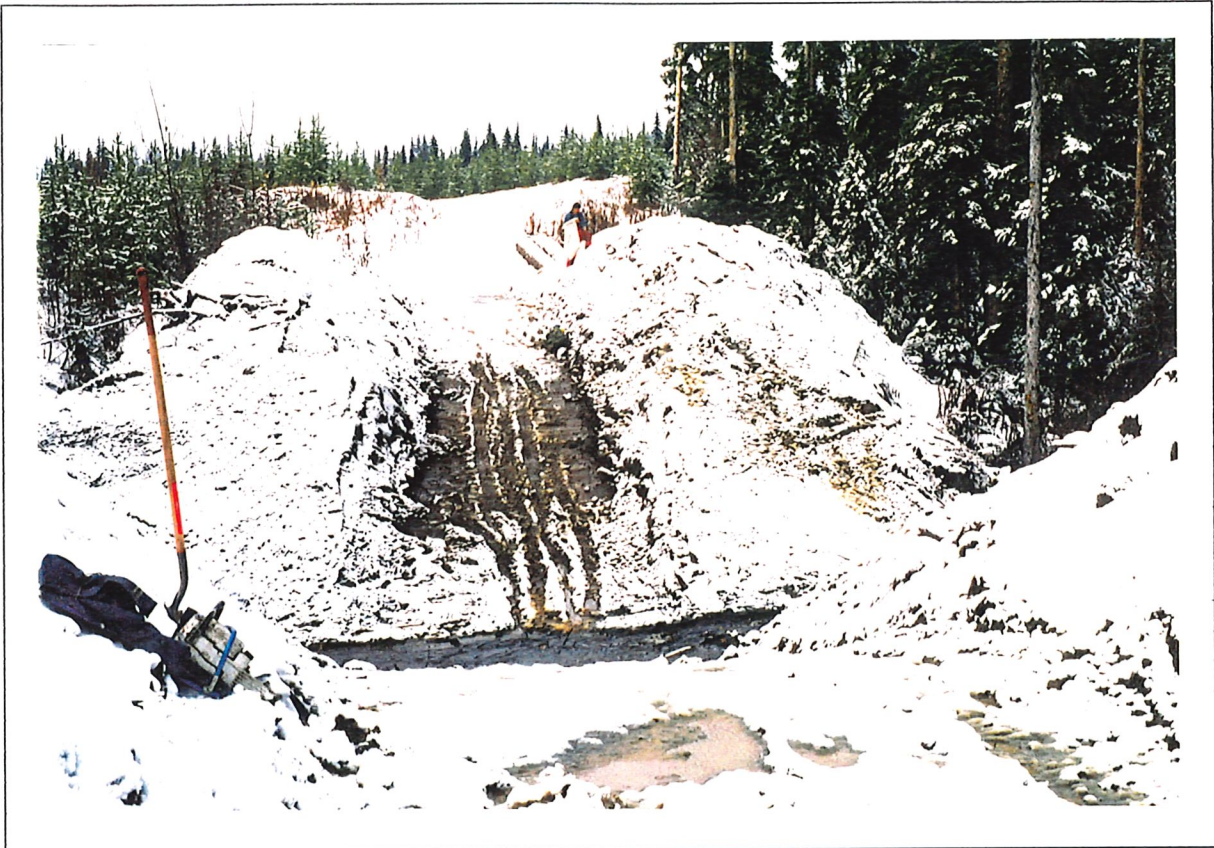
Photo 13. This ford has replaced a decomposed corduroy crossing previously obstructing this fish-bearing tributary (W.C. 46-700-50-40) to Harold Price Creek. This site was grass-seeded after excavation.

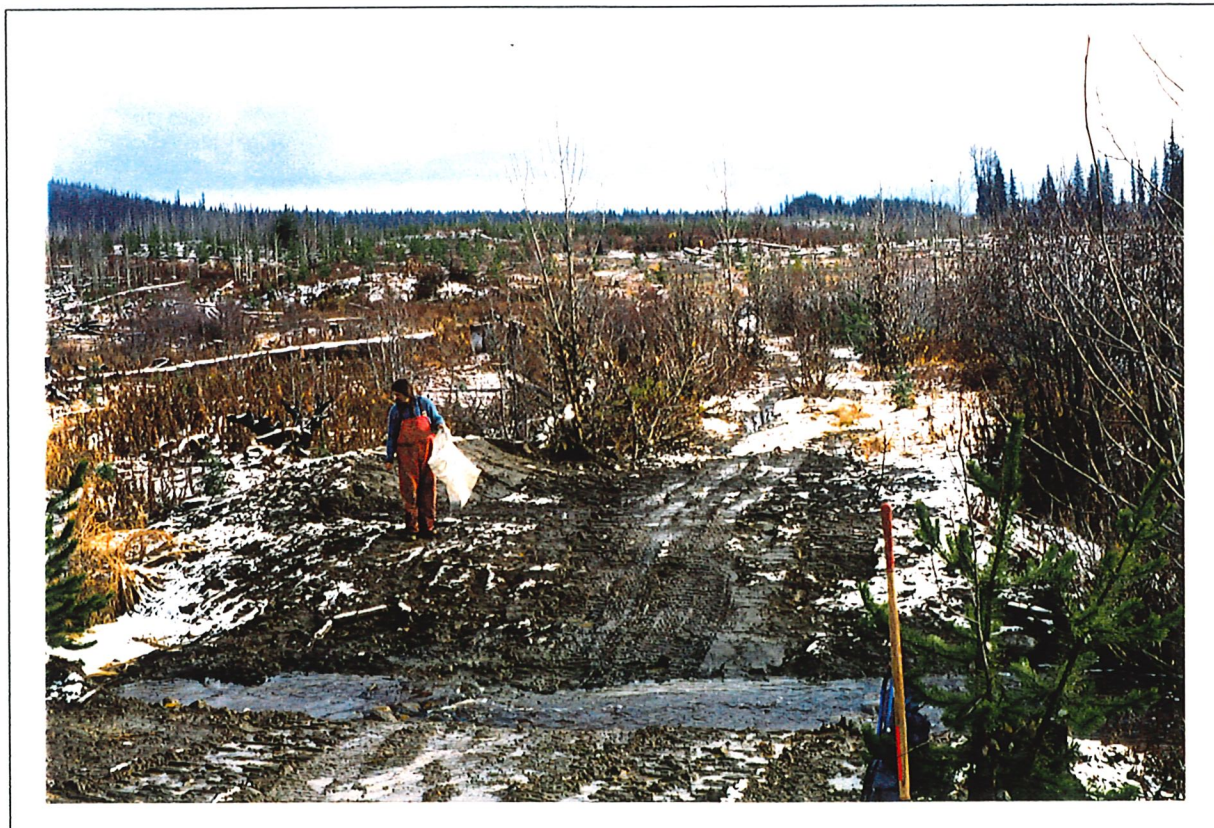
Photo 14. W.C.46-700-50-45. This ford has replaced a damaged culvert for fish access in block 93M16-10.

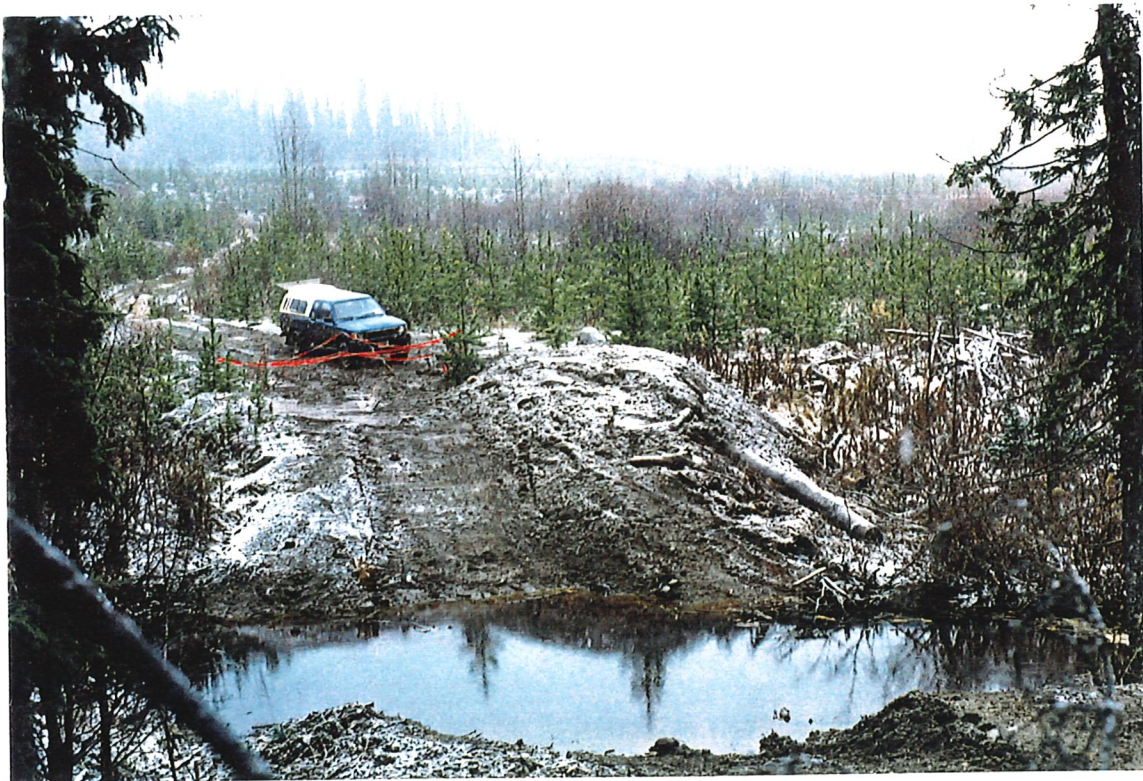
Photo 15. W.C. 46-700-50-85. The collapsed wooden box culvert at this road crossing was removed to ensure resident fish access upstream along block 93M 017-31. This site was grass-seeded after excavation.

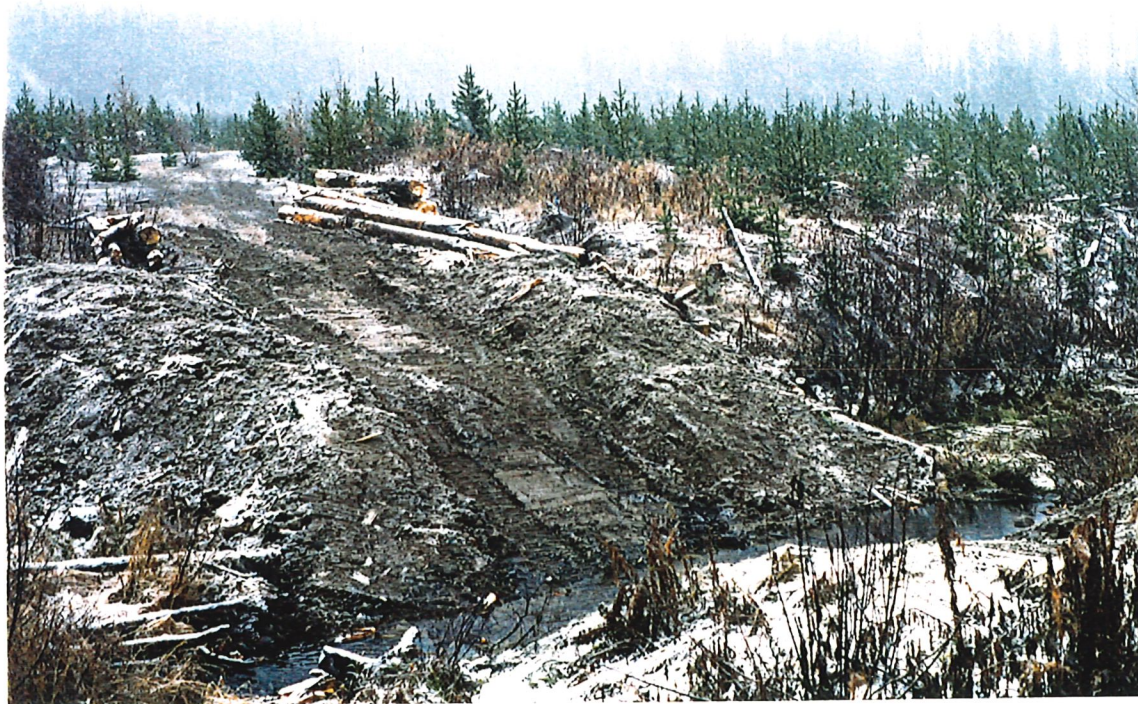
Photo 16. W.C.46-700-50-115-10. One of 2 sites forded to ensure fish access in blk. 93M17-16 & 24.

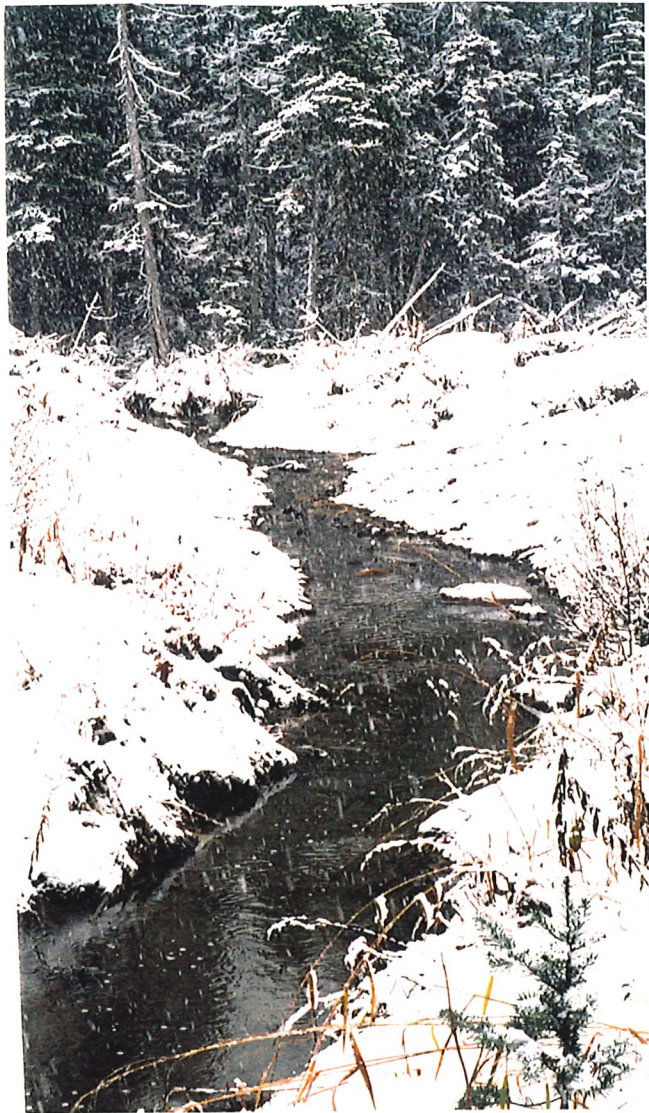
Photos 17 and 18. Tributaries 1 (at left) and 2 (lower photo) to Wan Lake. These stream channels were both dry, prior to treatment, downstream of the Kuelsh Rd. as a result of channel diversions at the road crossings (43.1 km and 42.6 km respectively). Both crossings were forded and ditchblocks were reinforced after a fry salvage of adjacent drainages. These channel reinstatements should be monitored in 1998 to assess the effects of spring runoff to Kuelsh Rd. ditchlines from the natural diversion of trib. W.C. 46-700-50-30-35 on Goat Mountain. Both road crossings were grass-seeded after excavation.

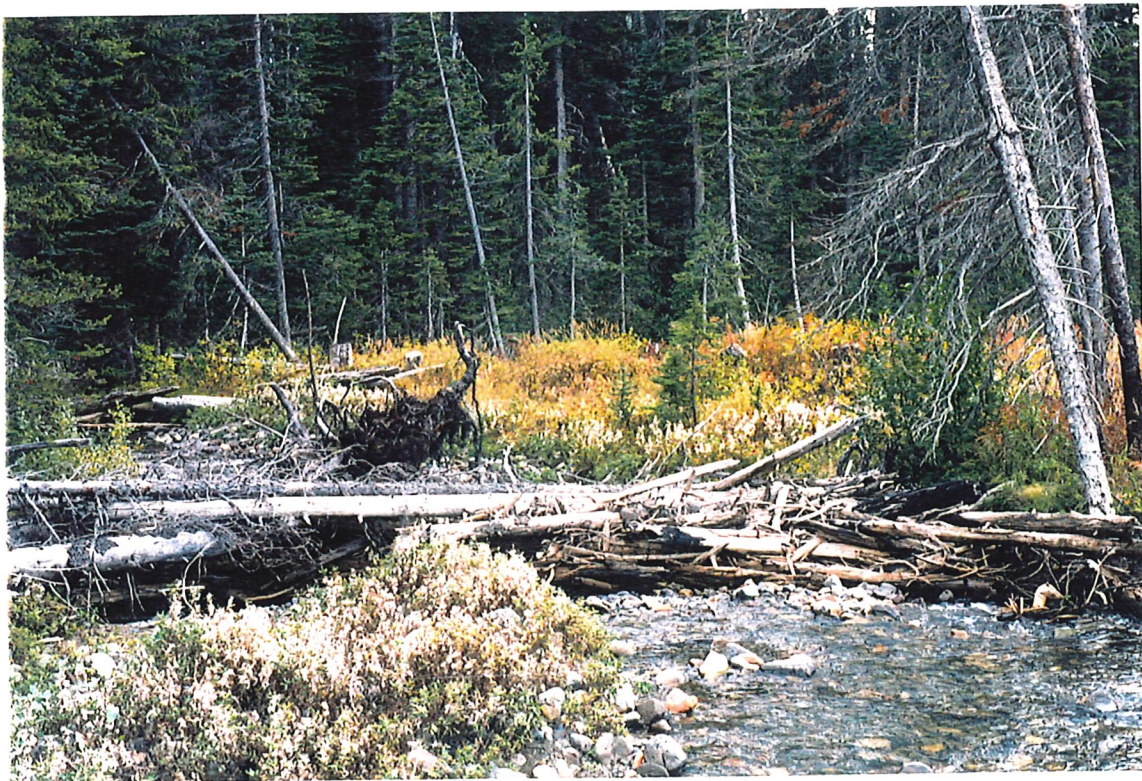
Photo 19. Tributary W.C. 46-700-50-30-115-10 (pre-treatment). This debris jam, 259 meters downstream of the bridge site at 21.3 km Blunt 2500 Rd., appeared to be diverting seasonal flows to block 93M 015-002 and was selectively removed with chainsaw and hand tools (lower photo).

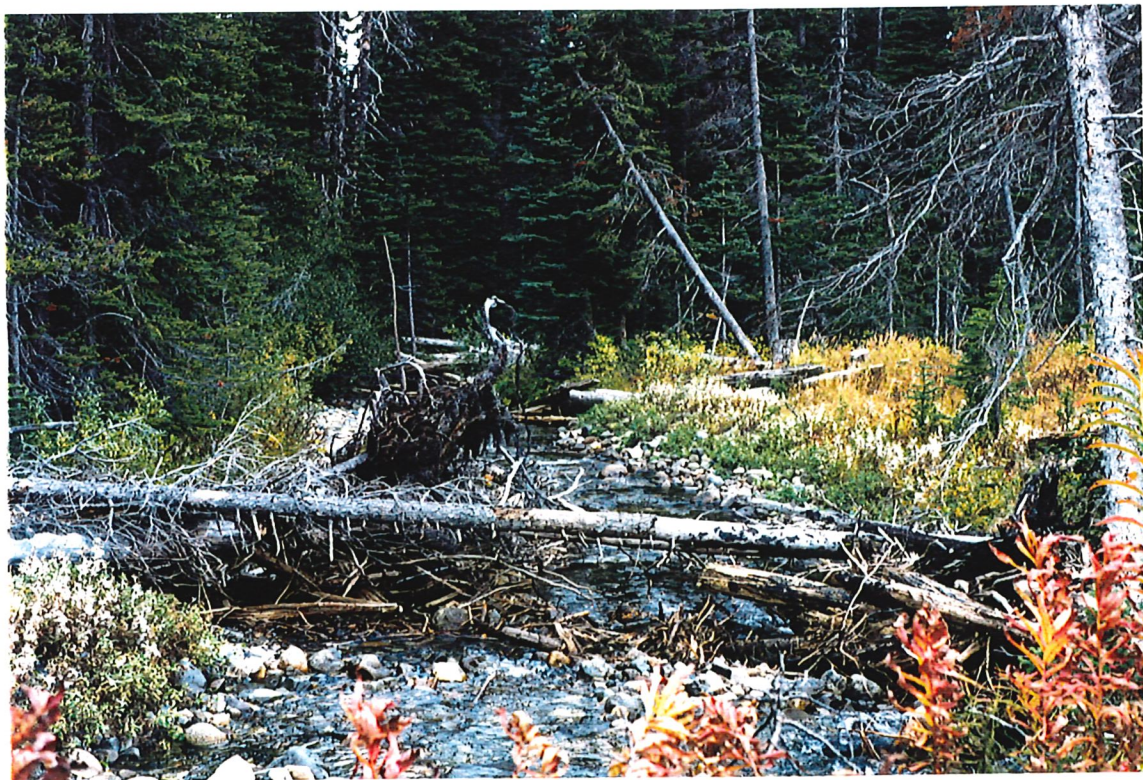
Photo 20. W.C.46-700-50-30-115-10 (post-treatment) with dismantled debris jam.

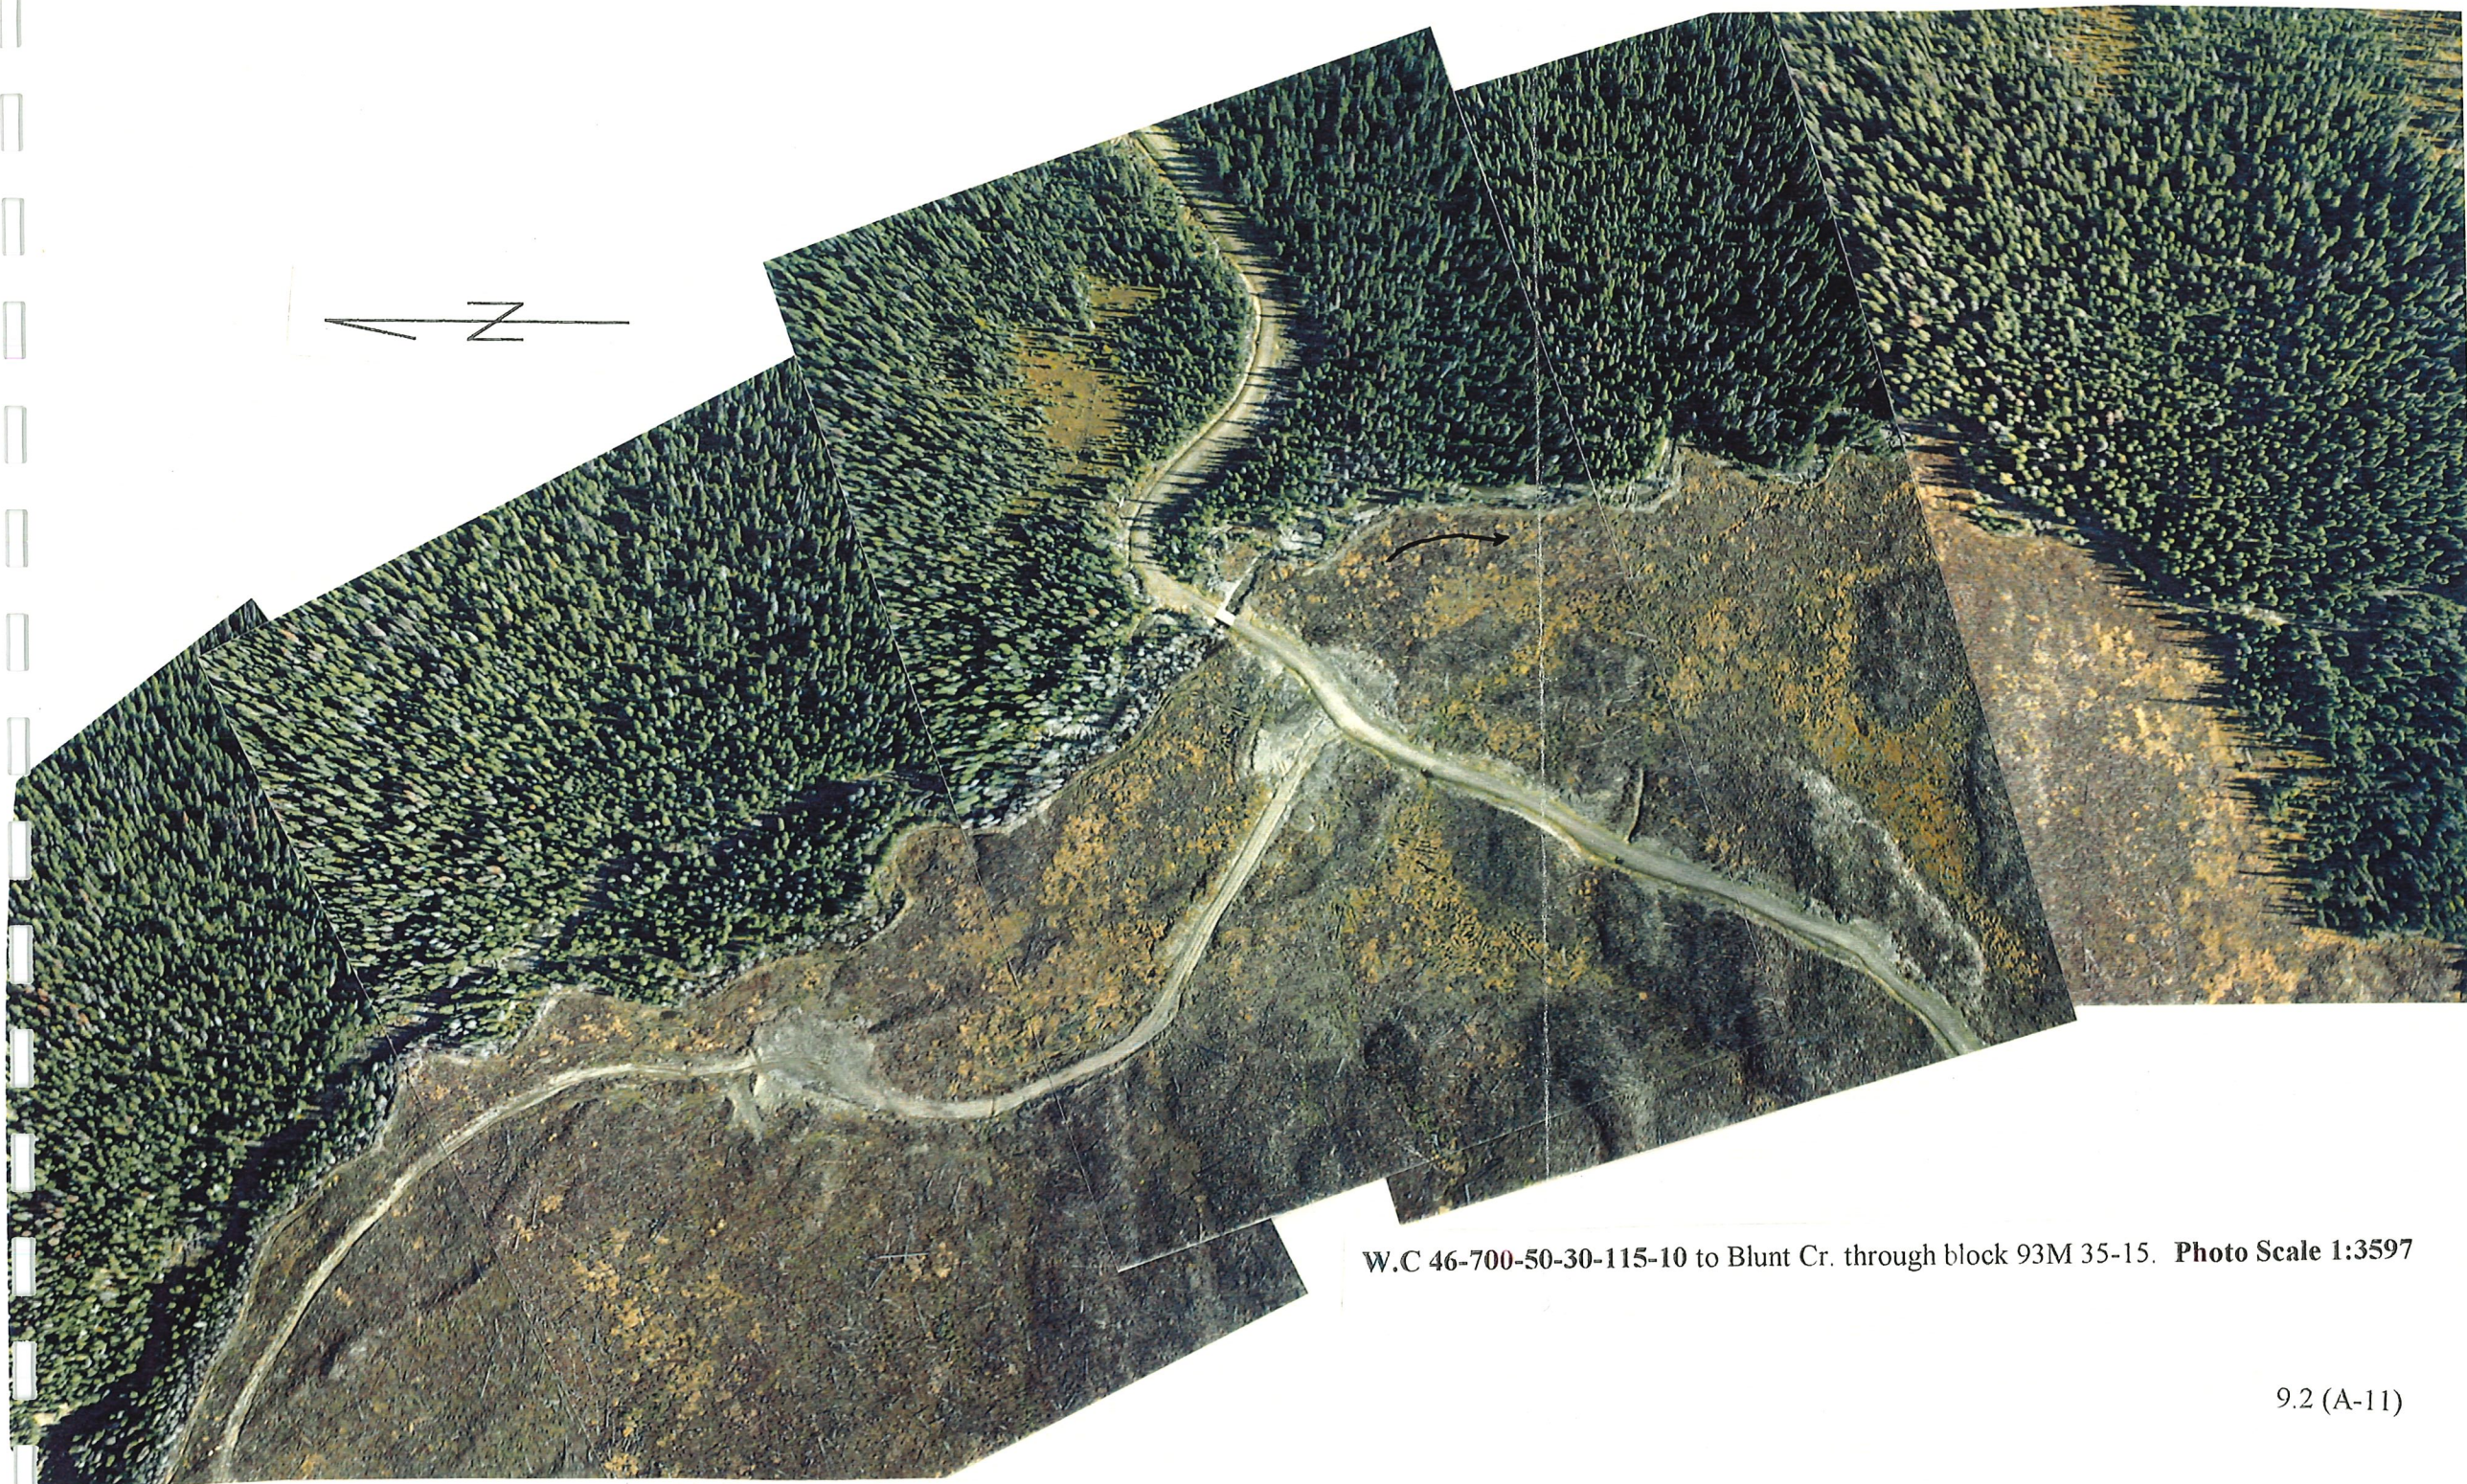
W.C 46-700-50-30-115-10 to Blunt Cr. through block 93M 35-15. Photo Scale 1:3597

During 1996 assessments two debris jams were noted 259m and 357m downstream of the road crossing at 21.3 km Blunt 2500 Rd. in block 93M015-002. Both appeared to be diverting seasonal flows into the cutblock (Suskwa WRP 1996 Fiscal Report).
