**LAKELSE SOCKEYE SPAWNING HABITAT  
REHABILITATION FEASIBILITY  
PROJECT 2007—08**

**REVIEW DRAFT**

Ken Rabnett  
© Suskwa Research  
March 2008

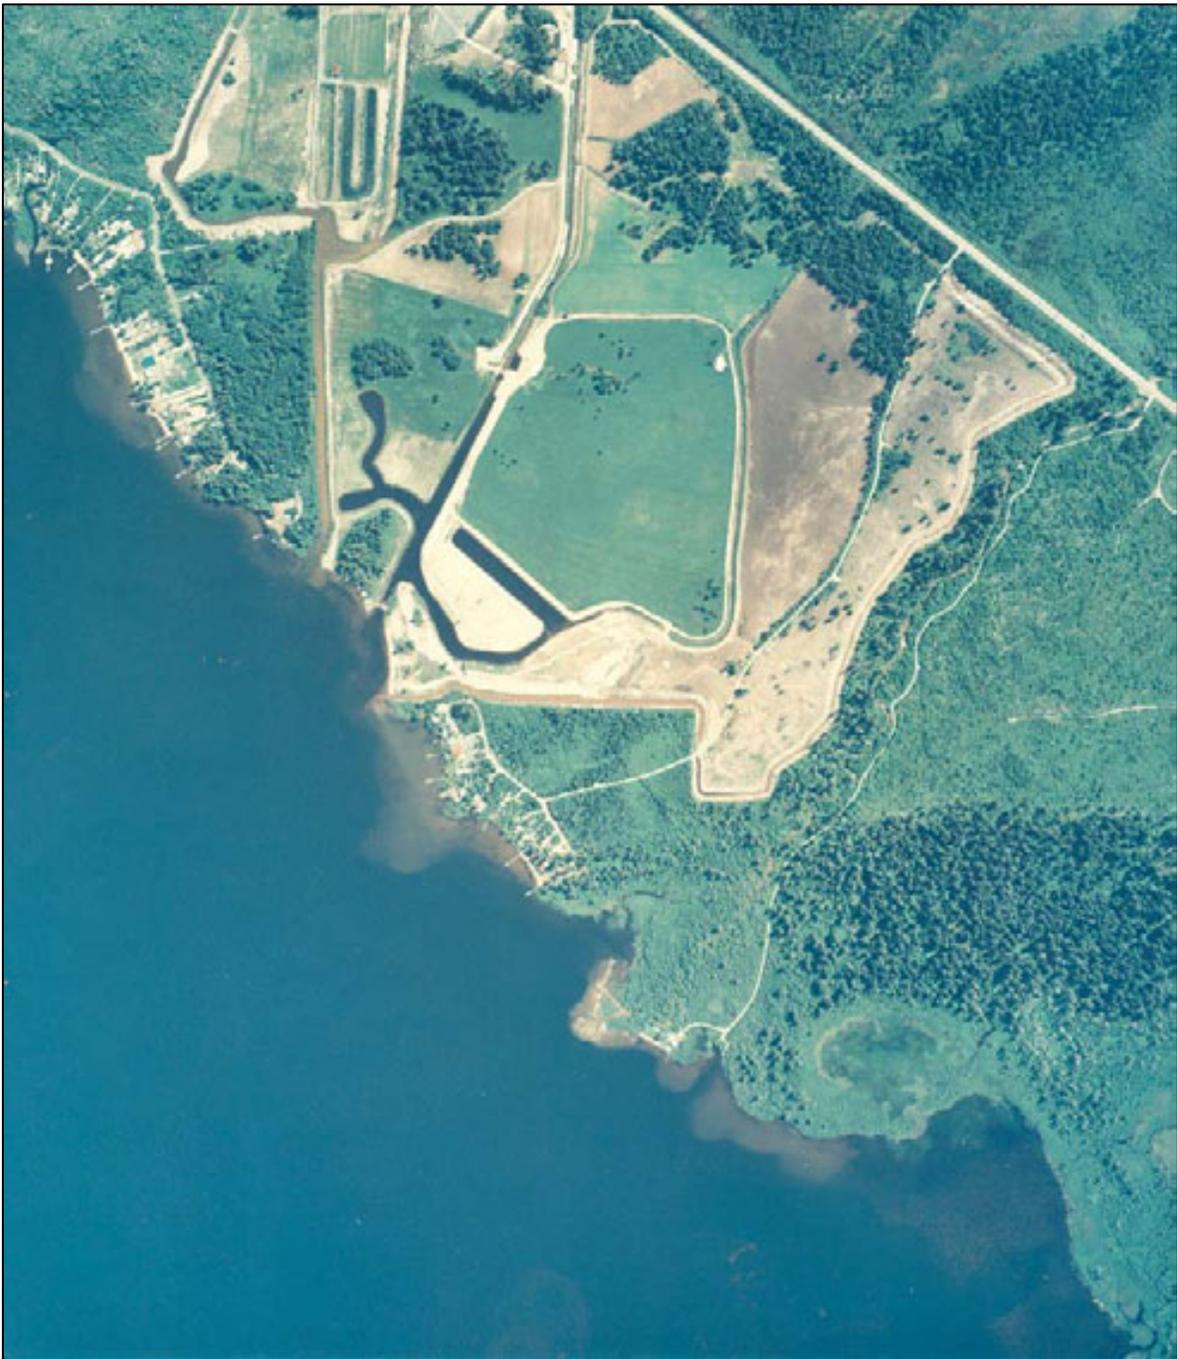
**Figure 1. Aerial view of the Hotsprings area showing the modified Scully south, center, and north creek channels at Lakelse Lake and Highway 37S in the top right.**

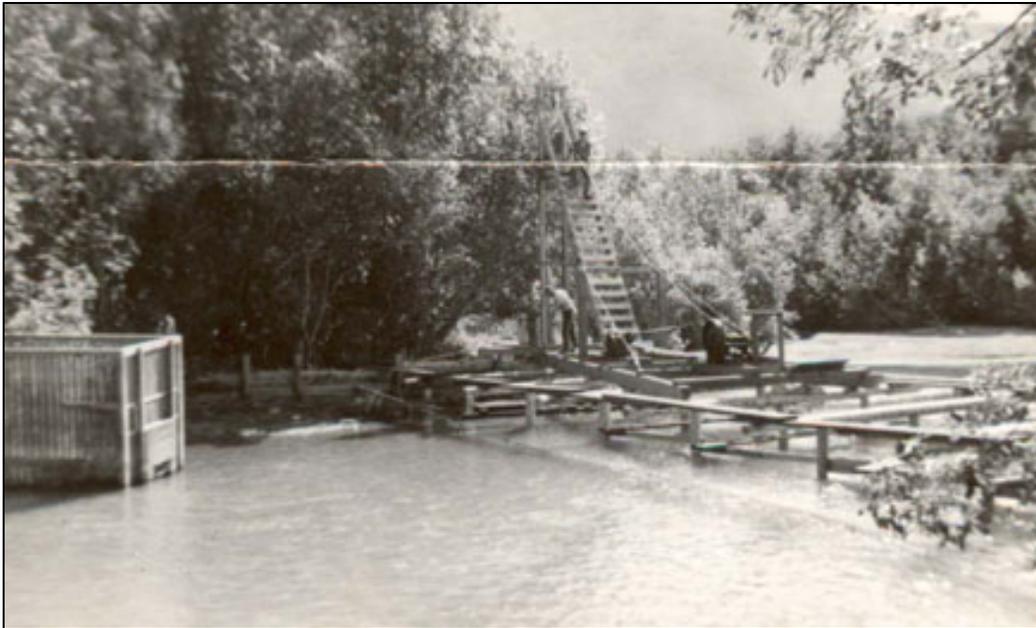
**Figure 11. Construction of the Williams Creek counting fence, 1950.**

Figure 11 shows construction of the new Williams Creek counting fence in 1950 following the flash flood on September 21, 1949, which destroyed the earlier fence. The fence was located on the west channel of the island at the mouth of Williams Creek and constructed using a pile driver assembled on-site and "A" frames instead of rock-filled pylons. The east channel fence remained unchanged except for minor modifications. Figure 12 below shows the fence across the west channel and the road coming down from the highway adjacent to the east channel. Figure 13 shows the Lakelse River counting fence that was located downstream of the lake. At the time, these fences were the major stock assessment tools determining the status of Lakelse sockeye.

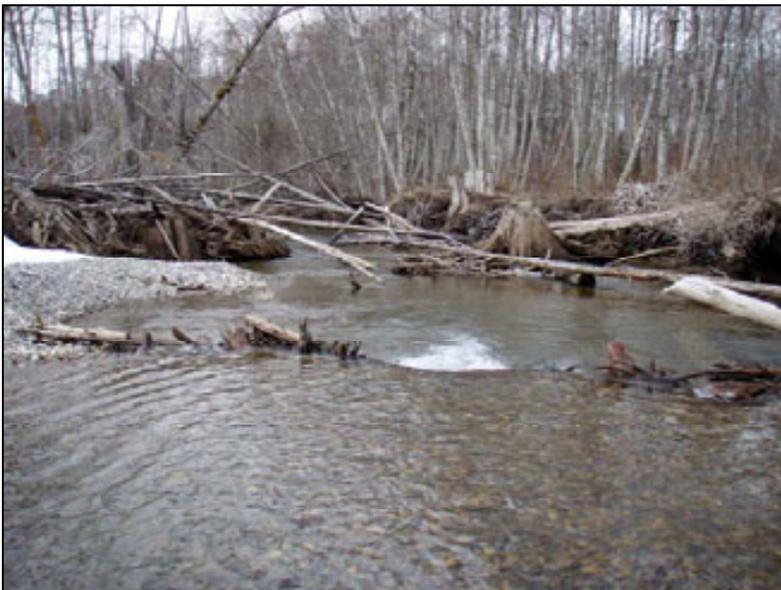
**Figure 17. Downstream view in mid-Reach 2.**

stability is currently rated as moderately stable with slight aggradation. Figure 17 shows a segment of Reach 2; note the stumps in mid-channel indicating prior coniferous riparian forest. Between 1986 and 1993, Reach 2 has moved into and been active in its more northerly channel. Presently the southerly channel is a succession of beaver impoundments with little flow and infilling characteristics.

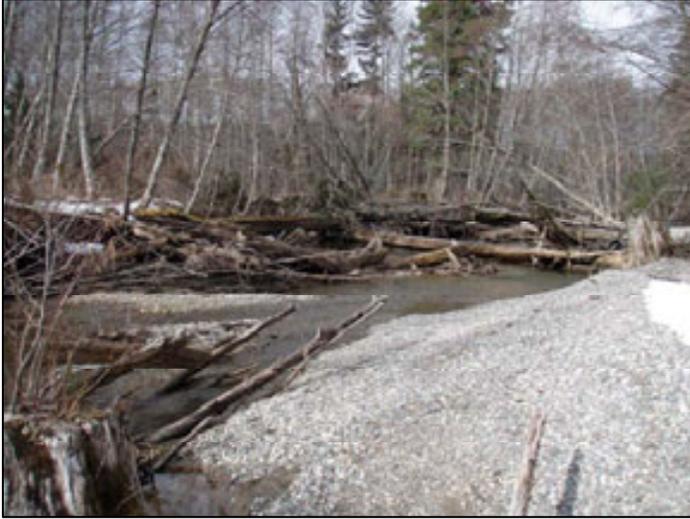
**Figure 18. View across Reach 2 showing LWD, elevated gravel bar, and stumps in mid-channel.**

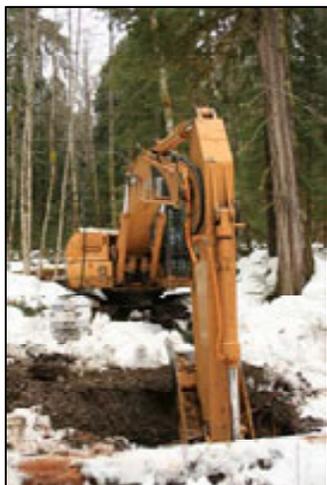
**Figure 27. R3-1 test pit excavation.**

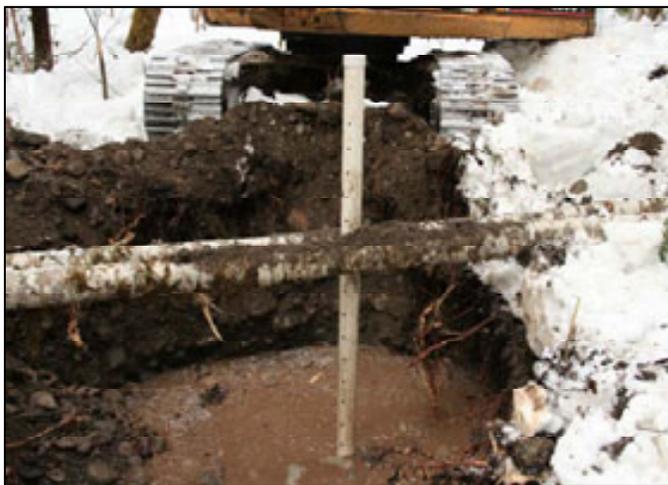
**Figure 28. Standpipe back-filling.**

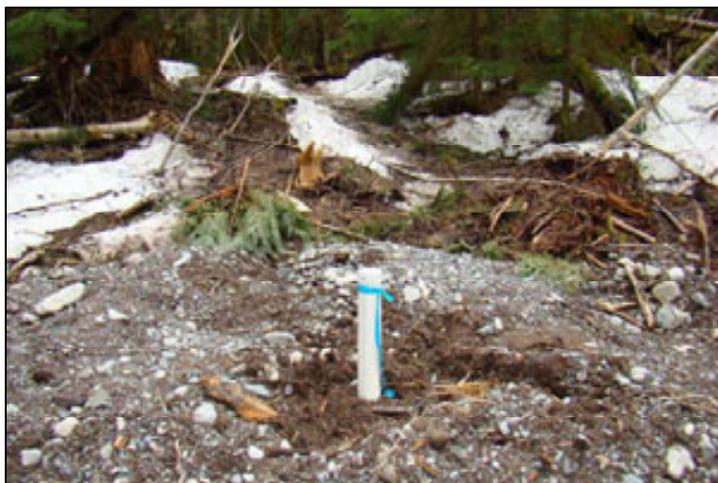
**Figure 29. Standpipe installed.**

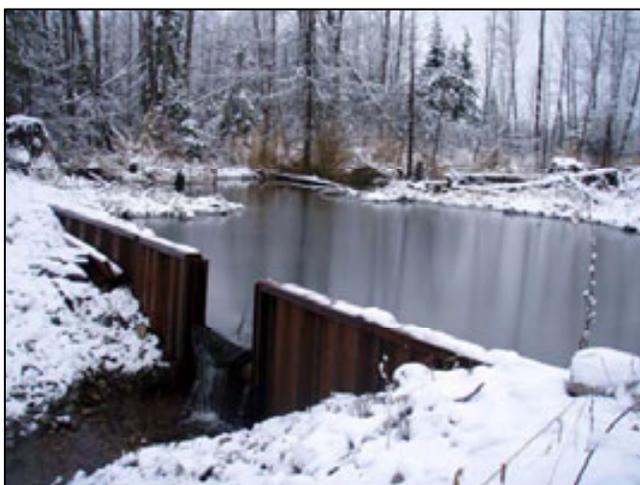
**Figure 42. Water augmentation dam and supply for the spawning channel shown above.**

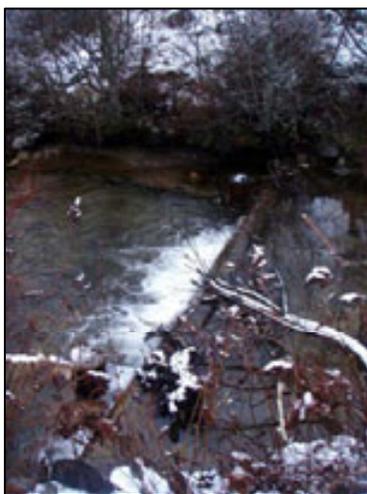
**Figure 43. Perpendicular log weir spanning Scully Center Channel.** **Figure 44. View downstream on Scully Center Channel.**

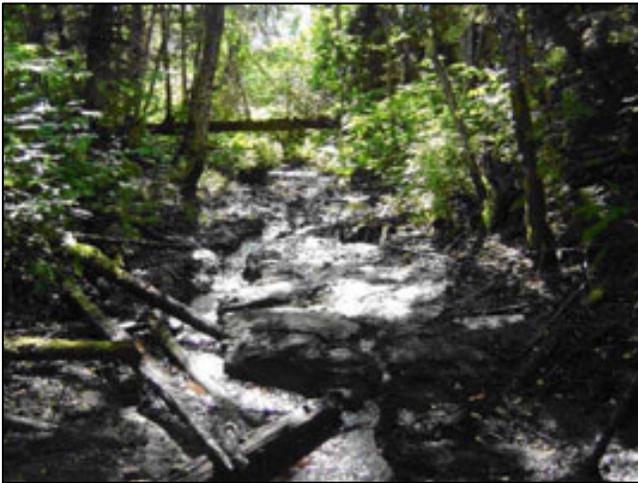
**Figure 51. View downstream on Hatchery Creek stream habitat improvements.**

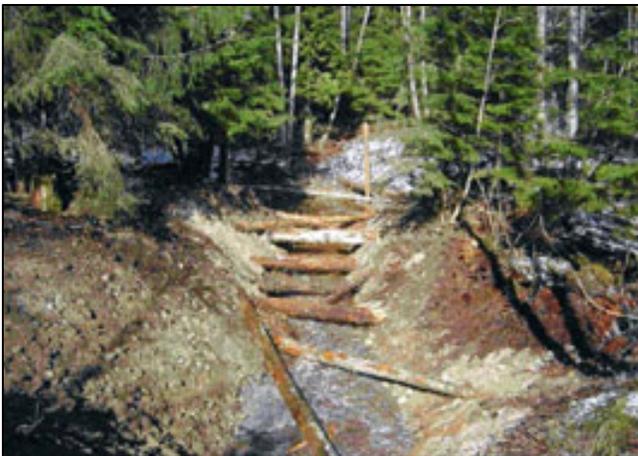
**Figure 52. Hatchery Creek Groundwater channel with LWD placements.**
