**Fish Passage - Culvert Inspection where  
Yellowhead Highway 16 crosses Flint Creek**

**Contract 356CS0561**

March 2006

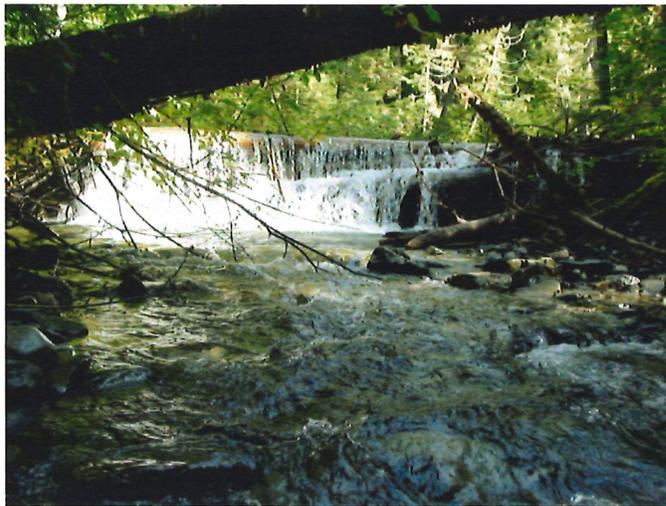
**Figure 2.** Upstream view of 1.4 metre high sediment wedge located approximately 300 metres upstream (left) and 14 meter waterfall located about 580 meters upstream (right) of where Highway 16 crosses Flint Creek.

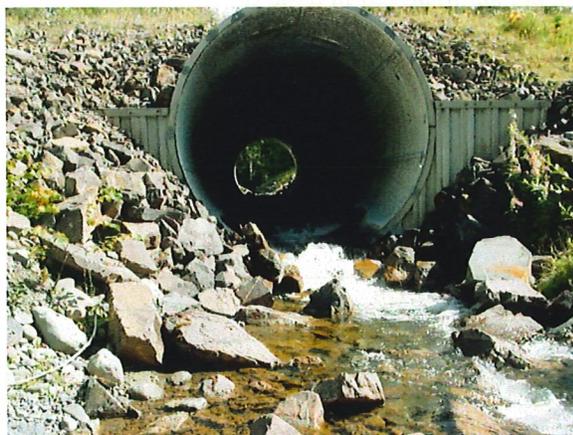
**Figure 3.** Upstream view at culvert outlet (left) and upstream view through culvert showing baffles (right).

The gradient of the culvert (5%) was not suitable for fish passage, but baffles in the culvert at approximately 4 metre intervals created a cascade pool morphology. The baffles were creating shallow and turbulent pools and were reducing water velocities through most of the culvert at the time of survey. However, water depth within the culvert was 0.28 metres, which is not optimal for adult fish migration (Parker 2000) and the lack of adequate backwatering has caused a high water velocity below the last baffle (3.2 m/sec) (Figure 5) that is greater than burst swimming abilities reported for juvenile salmonids (Table 2). This water velocity is within the range of burst swimming velocities reported for adult salmonids (1.8-4.3 m/s), indicating at least some fish would be able to swim through this four metre section at some flows.

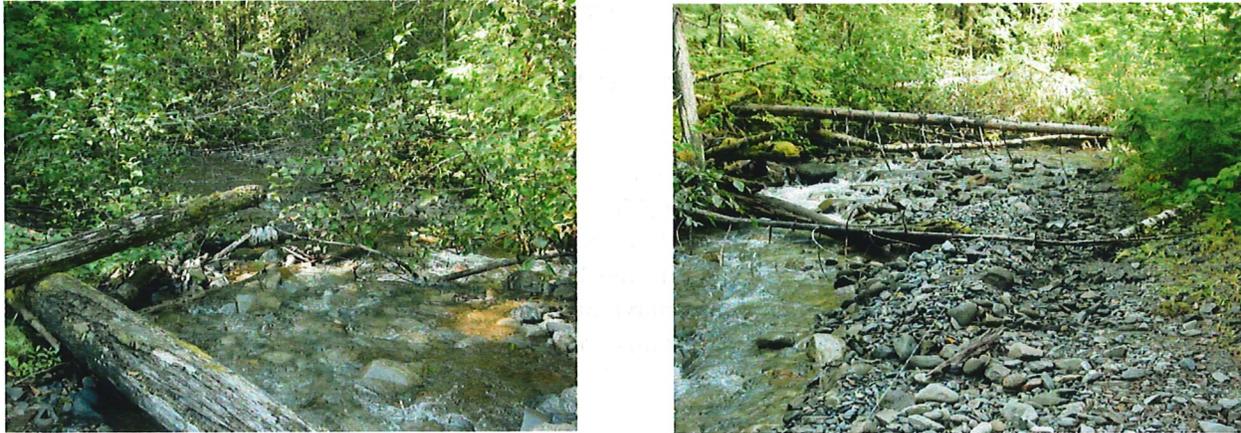
**Figure 4.** Downstream view of Flint Creek downstream of Highway 16 (left) and upstream view of Flint Creek upstream of Highway 16 (right).

For FPCI scoring and ranking, the habitat value for Flint Creek was assessed upstream and downstream of Highway 16 (Figure 4). Flint Creek, in conjunction with other stable, non-glacial tributaries to the Skeena River, provide important refuge habitat during peak flow events when discharge and turbidity in the mainstem present marginal conditions for fish. The moderate gradient (2% to 6%) downstream from the culvert provides some good potential rearing habitat for juvenile fish (e.g. rainbow/steelhead), but only limited pockets of habitat appeared suitable for spawning. The moderate gradient of the creek may deter some species from using this system, however, the reported presence of pink carcasses (Drewes 2005) indicates that adults of all salmonid species present in the Skeena River have access to fish habitat in Flint Creek downstream of the culvert. Upstream of the culvert, habitat suitability for spawning further declines due to the moderate gradient (4% - 7%), relatively large substrate size, and the apparent instability of the channel (i.e. gravel/cobble wedges). A 1.4 metre high gravel wedge behind large woody debris was identified approximately 300 metres upstream of the culvert and appeared to be a barrier to fish migration at the time of survey (*see* Figure 2). Rearing habitat upstream of the culvert appears suitable for Dolly Varden and cutthroat trout due to the presence of small pools, but the moderate gradient (4% to 7%) and only small pockets of suitable gravels limit the availability of potential spawning habitat. In agreement with a previous culvert assessment in 2004 (Rabnett and Williams 2004), fish habitat upstream and downstream of the culvert was rated as moderate for the FPCI scoring matrix, largely due to the moderate gradient, the relatively large substrate size, and evidence of channel instability. More detailed breakdowns of habitat value for the Fisheries Priority Score are provided in Section 3.6.

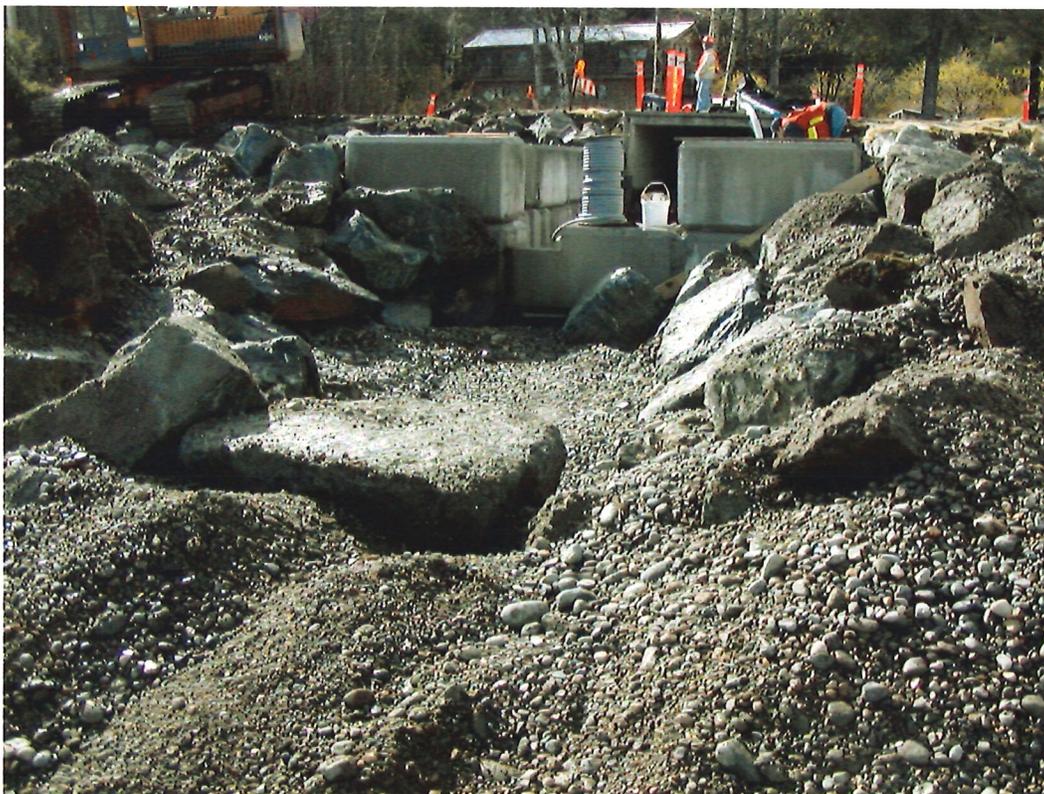
**Figure 7.** Example of lock block weir construction (courtesy of Don Hjorth).

Fisheries and Oceans Canada has conducted a site survey and provided a conceptual design (Figure 6) and example photos (Figure 7) for the improvement of fish passage at Flint Creek (Hjorth 2005). This conceptual design suggests the placement of four lock block weirs to eliminate the 0.5 metre drop from the culvert outlet. This design would be intended to last the remaining lifetime of the existing culvert, with the intent to allow adult fish to spawn and larger juveniles to migrate upstream of the culvert in order to adequately seed the available rearing habitat. Depending on the available funds, placement of some additional rock weirs or boulder clusters upstream of the culvert to improve juvenile fish migration, or perhaps improvement of spawning habitat immediately upstream or downstream of the culvert are some additional options that could be considered. Depending on the estimated structural integrity of this culvert, it may also be possible to consider increasing the number and height of the lock block weirs to backwater and partially embed the existing culvert in order to reduce the stream gradient to less than one percent through the entire length of this culvert. Although Parker (2000) does not recommend embedding round or elliptical culverts for streams of this size (i.e. the culvert width should be no less than the mean bankful width) or with high 100 year flood events (FPCI  $Q_{100}$  estimate for Flint Creek = 10.30, *see* Appendix 3), this 5 metre diameter culvert appears to be large enough to consider further investigation and engineering of backwatering in conjunction with modification or replacement of the existing baffles to restore both juvenile and adult fish migration at this location. These temporary improvements of fish passage may be a practical short-term approach as it would be more cost-effective than structure replacement for the relatively small amount of moderate quality habitat available upstream. However, given the amount and quantity of habitat available upstream, limited funds available for this type of work may be better spent at other sites eligible to any applicable funding sources.
