**Toboggan Creek Groundwater Channel Monitoring Project  
January – March 2001**

**B. Donas, T. Joe and R. Grebliunas**

**Department of Fisheries and Oceans  
North Coast Division  
Habitat and Enhancement Branch - Smithers**

**March 31, 2001**

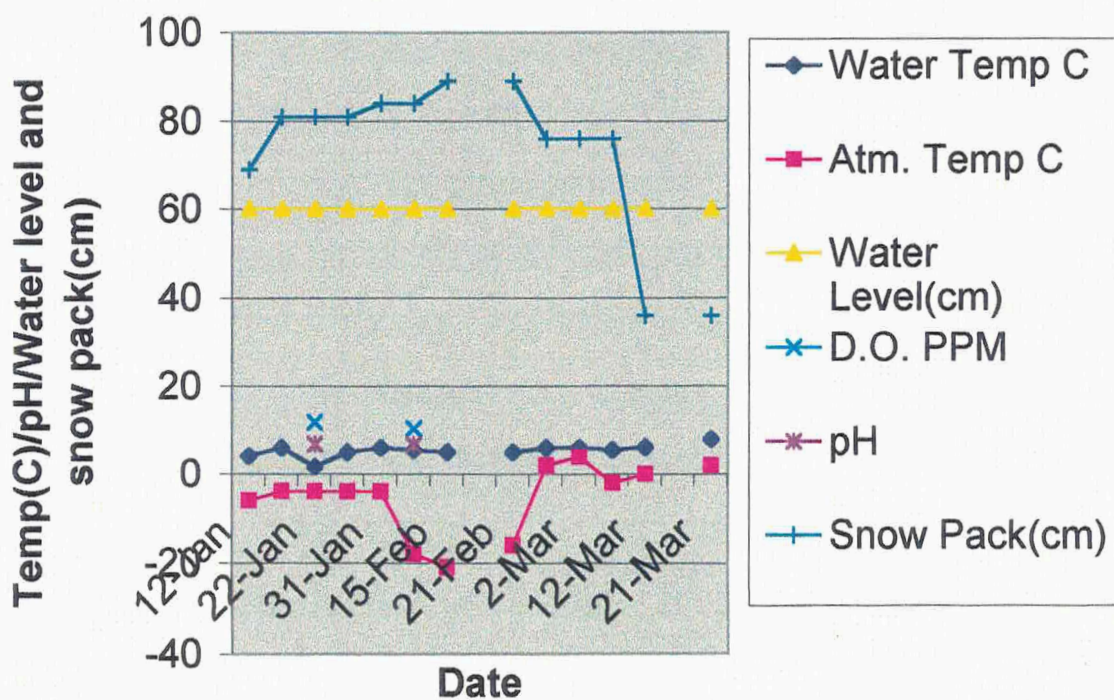
## Water Quality Data for Site 1

Water level within the pipe remained constant at 60 cms. water depth. Despite sub zero atmospheric temperatures, the water temperature at Site 1 remained fairly warm (Refer to Water Temperature for Sites 1 and 2 and Toboggan Cr. Mainstem and Water Level for Site 1, Toboggan Cr. and Toboggan Lake).

Water temperature remained well above freezing except on Jan 22<sup>nd</sup> where water temperature was recorded as 1.8 degrees C. While clearing the top of the pipe, some snow was dropped into the pipe which created some slush within the pipe. This may have led to the colder water temperature on that date.

Water quality parameters measured at Sites 1 and 2 fall within safe limits for fish. Water level within the pipe at Site 1 remained constant throughout the winter months. Typically groundwater level does remain constant i.e. there is minimal fluctuation in water level (Bonnell 1991). Given the warmer water temperatures and the constant water level at Site 1, this water source is most likely a groundwater source.

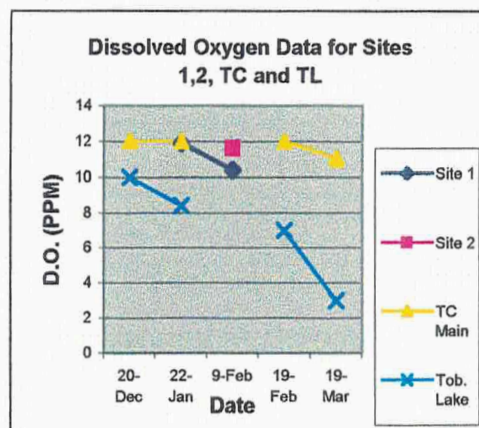
## **Dissolved Oxygen Data for Sites 1 and 2, Toboggan Cr. Mainstem and Toboggan Lake**

Groundwater can be low in dissolved oxygen. Two dissolved oxygen measurements were taken at Site 1 and both readings were within safe limits for fish i.e. over 8.5 PPM for hatching eggs.

One dissolved oxygen reading was taken at Site 2 and this reading was also within safe limits for fish.

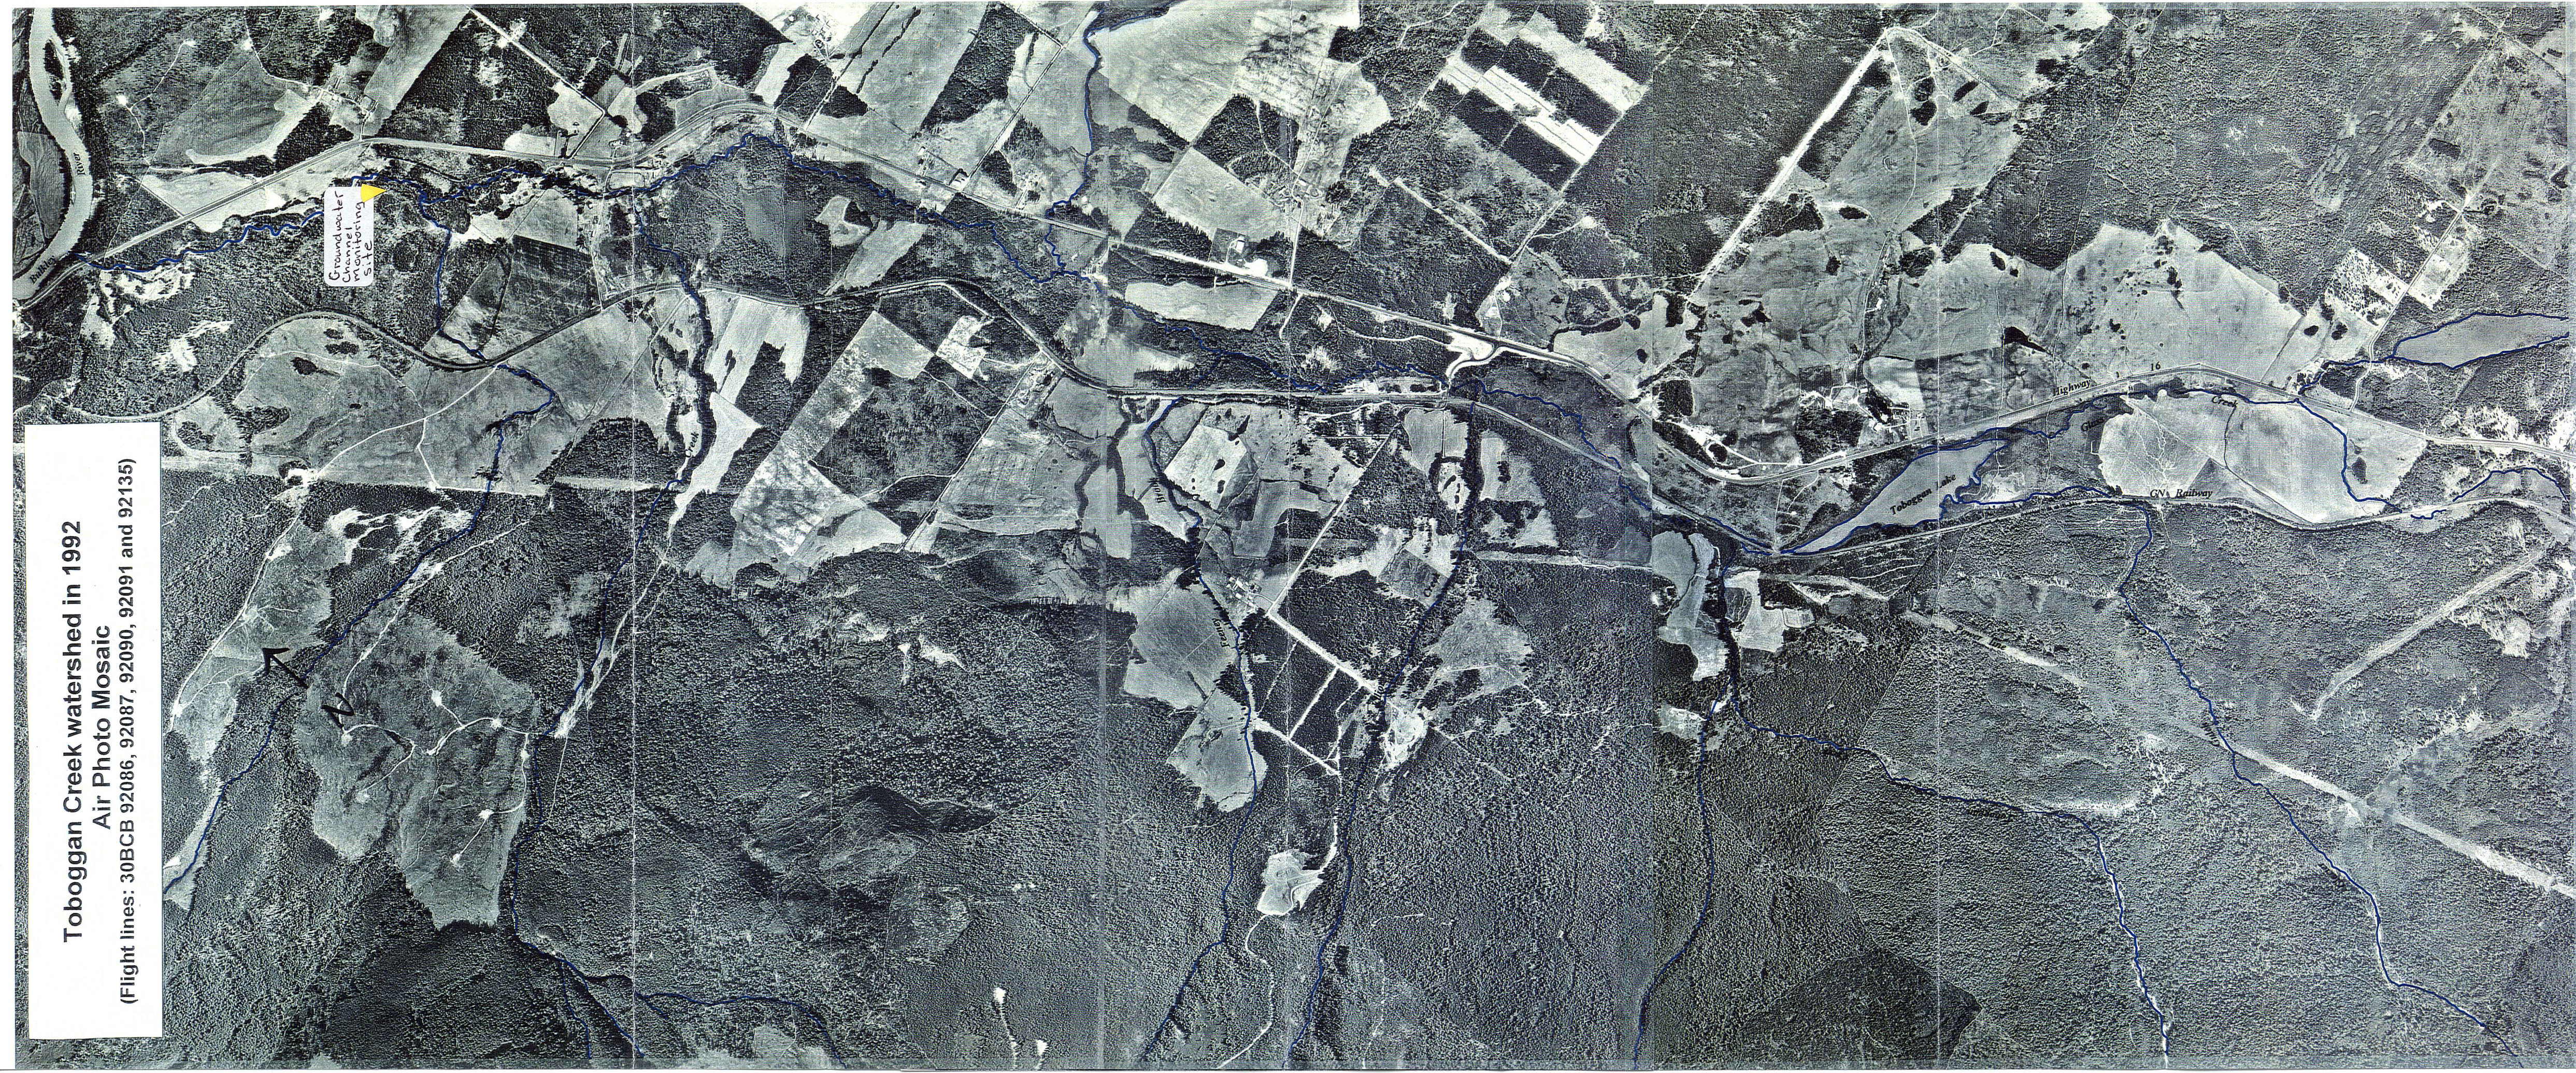
Toboggan Creek watershed in 1992  
Air Photo Mosaic  
(Flight lines: 30BCB 92086, 92087, 92090, 92091 and 92135)

A quick foot survey was conducted and a remnant stream channel was located. The stream channel currently has some surface and some sub-surface water flow. Aerial photographs (1992 – Map 2) show what appears to be an old stream channel which originates in the northerly cutblock and enters Toboggan Creek upstream of the Grebliunas bridge crossing. At several locations along this old(remnant) stream channel, water is bubbling up from the remnant channel stream bed.
