Routine Effectiveness Evaluation

Off-channel ponds and debris structures

FRBC ACTIVITY NUMBER: 725138

MARCH 2002

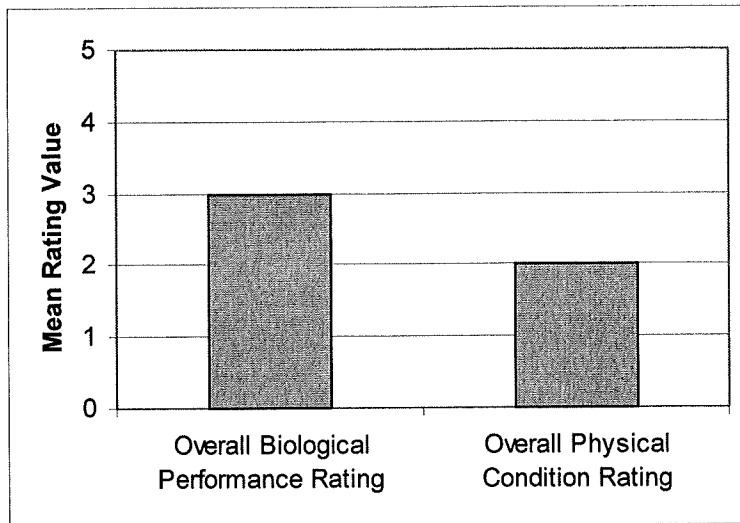
Figure 2. Summary of performance and condition ratings for the access project at Site 77.

The Site 77 off-channel site was rated three for overall performance which implies that the site has not become less productive or less stable overall (Figure 2). Overwintering habitat conditions were adequate with abundant cover, adequate depth and good physical conditions. The new culvert was functioning well and fish passage is possible when not frozen. Fishing under ice at two pond sites above the culverts produced 12 juvenile coho that appeared to be 2+ years in age, ranging in fork lengths from 68 to 105 mm. Juvenile coho captured before the replacement of the culverts in 1999 were considered to be 3+ years of age, with fork lengths ranging from 160 to 180 mm. The fish captured in 1999 were likely prevented from migrating downstream by the dispersed flow and perched culverts. The culvert and new channel built in 2001 enabled the smaller, and therefore younger fish, into the off-channel habitat from the river. The project was successful in meeting the primary objective of providing access to juvenile coho.

The overall rating for the culvert and channel was meeting expectations for off-channel habitat. The results of the quantitative evaluation on the REE Form are summarized in Figure 2. The need for additional cobble armouring along the outlet channel between the pond and the culvert inflow reduced the overall physical rating to 2.

1. Routine monitoring of Site 77 is recommended in 2002 to confirm fish access throughout this system and stability of the outlet channel after over topping flows in spring runoff.
2. A truckload of pit run gravel could be deposited into the channel immediately downstream from the culvert and spread downstream to fill interstitial spaces in the porous cobble and encourage the formation of a few refuge pools.
3. The beaver grating intended (Triton 1999) for the upstream end of the culvert should be installed.

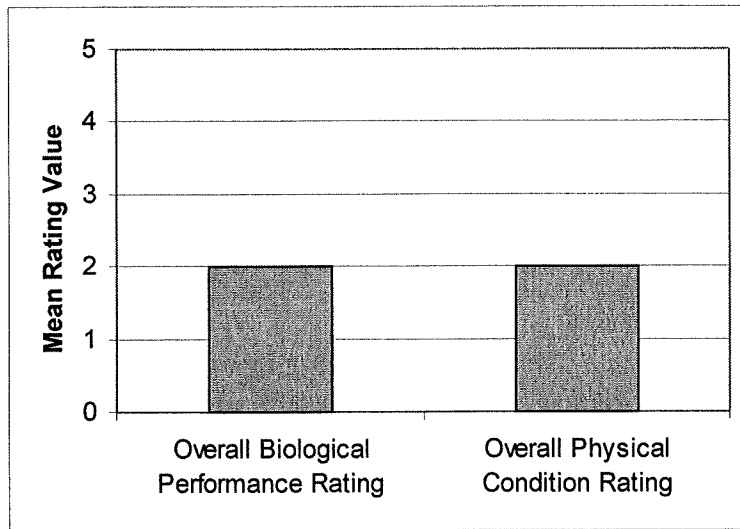
Figure 3. Summary of performance and condition ratings for the off-channel project at the 3 km Site.

Overall, the performance of this structure was slightly lower than expectations due to the dewatering. The results of the quantitative evaluation on the REE Form are summarized in Figure 3.

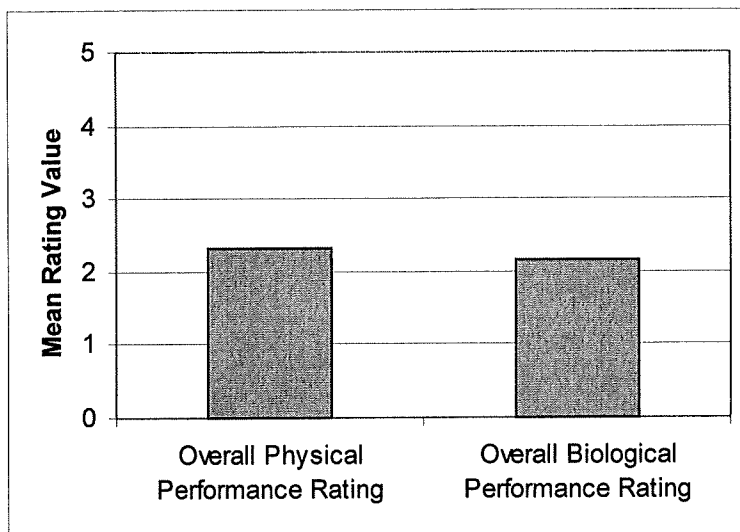
Figure 5. Summary of performance and condition ratings for the off-channel project at the Debris Catcher Site.

Summary REE records are presented in Appendix A. Overall physical and biological performance summaries are illustrated in Figure 5. The three catchers are performing adequately and no significant change in structural condition or stability was observed since construction.

Overall, the performance of this structure was meeting expectations. The results of the quantitative evaluation on the REE Form are summarized in Figure 5.
