Fish Passage Assessment of Kispiox Forestry Road Stream Crossings

Ken Rabnett & Tim Wilson
Gitksan Watershed Authorities
January 2007

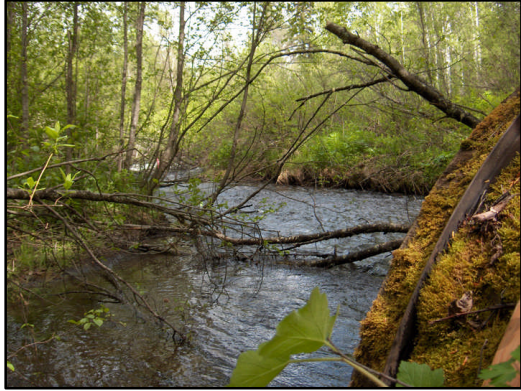
12. Clifford Creek culvert inlet
View upstream from inlet.

Clifford Creek culvert restoration is rated High Priority with a matrix score of 46. A concrete bridge is recommended to restore suitable flows, ease fish passage, and provide low maintenance efforts. The original channel, with an average gradient of 1% and several bedrock outcrops controlling base levels, should be reestablished.

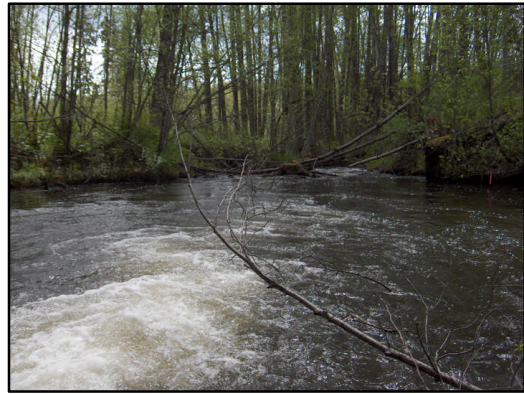
Figure 13. Clifford Creek culvert outlet.
View downstream from outlet.
