# Reconnaissance (1:20,000) Fish and Fish Habitat Inventory in the Morice River Watershed

**TRITON**

Environmental Consultants Ltd.

Project Name Morice River Fish Inventory - 1999

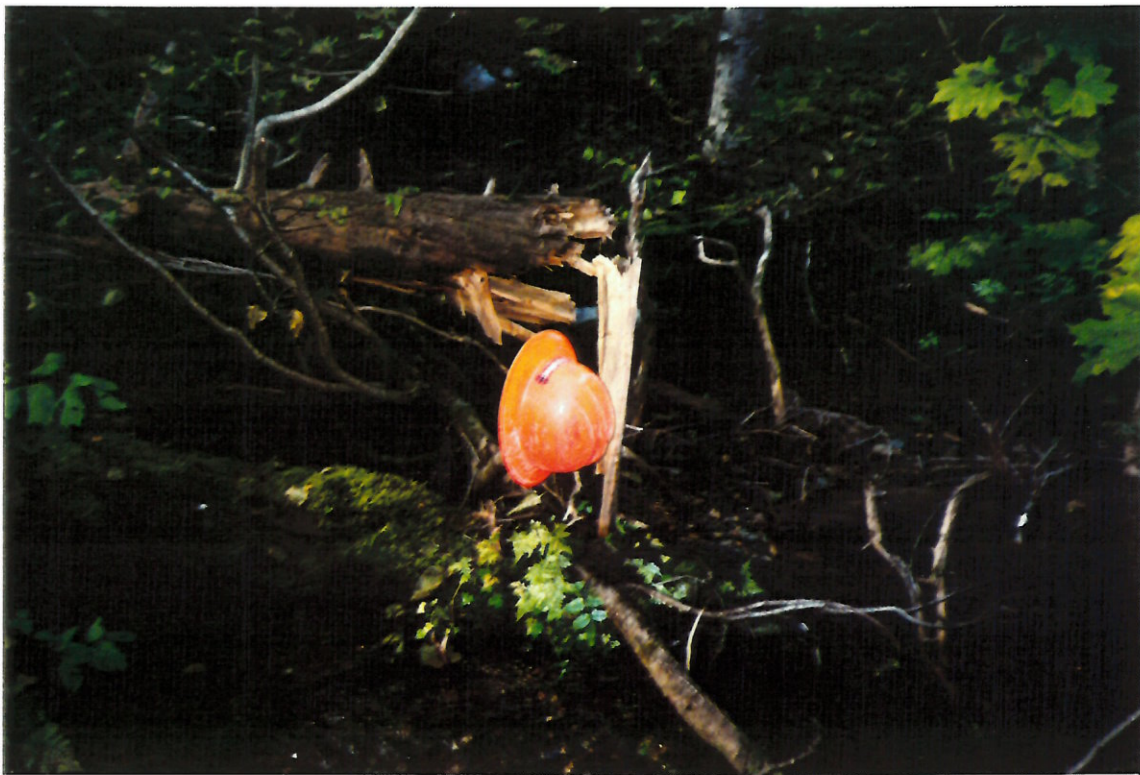
Photo #: 23 - 17  
Site 245, upstream view of high gradient section within machine free zone.

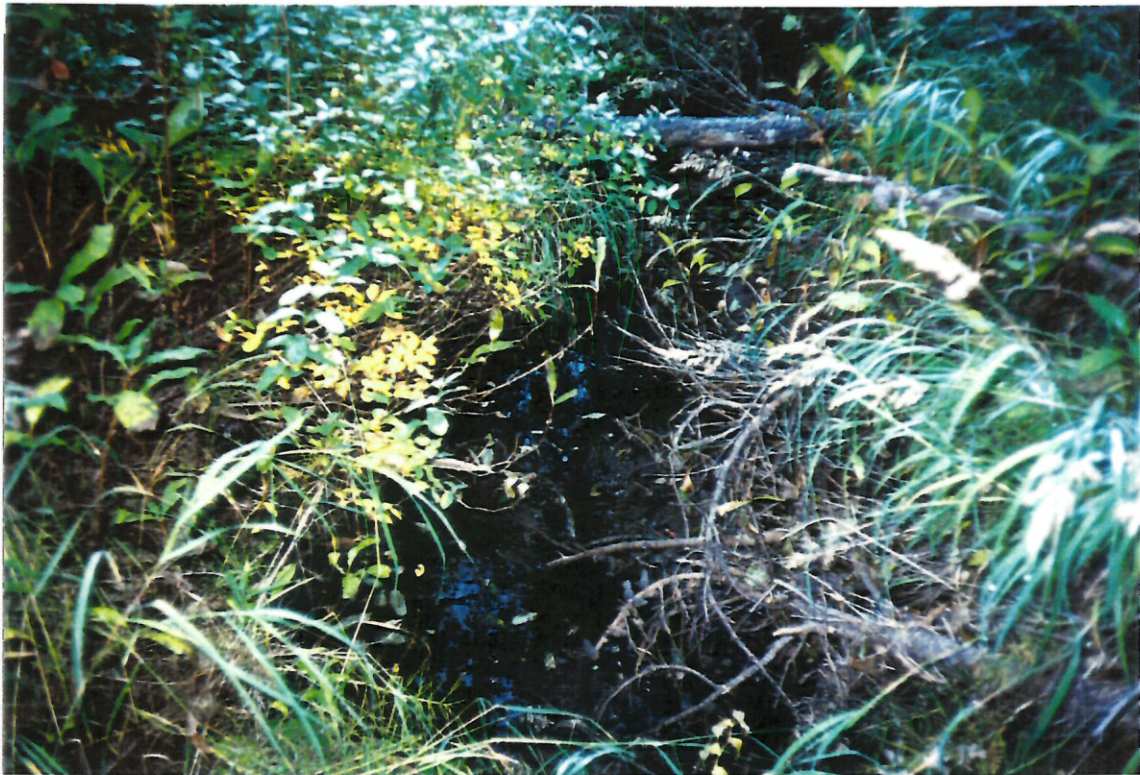
Photo #: 24 - 5  
Site 250, downstream view of stagnant pool with SWD.

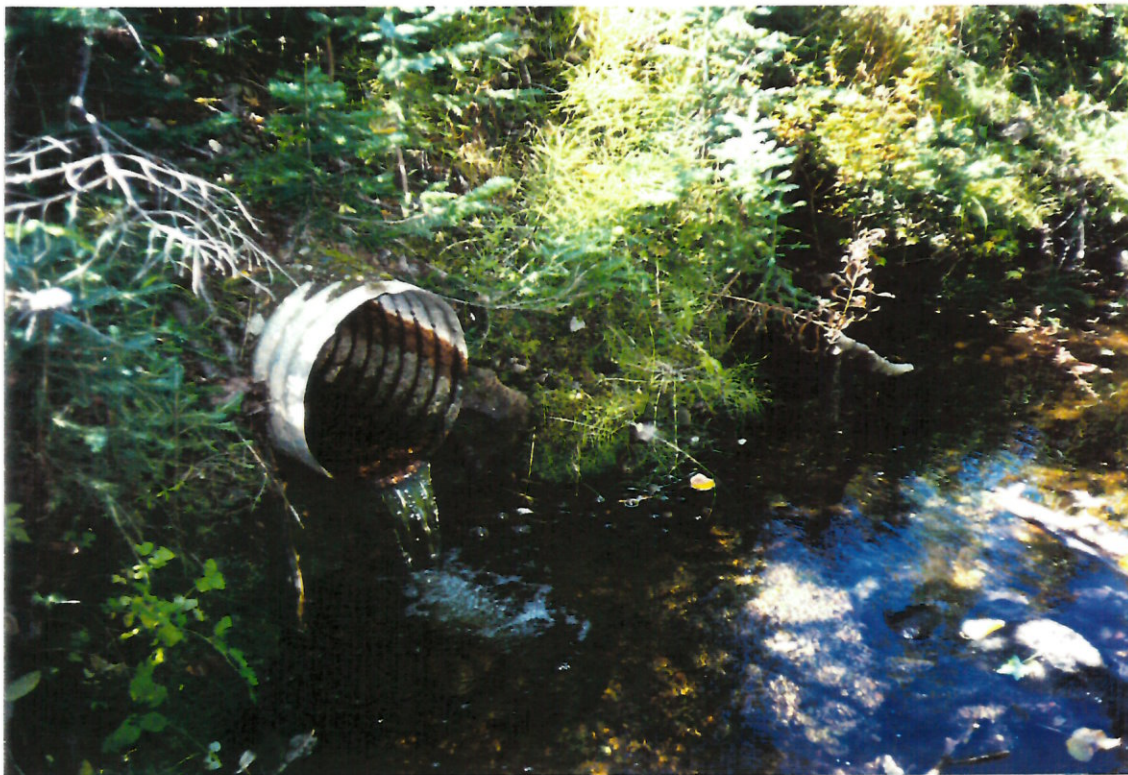
Photo #: 24 - 10  
Site 253, upstream view of perched culvert (30 cm) with large pool downstream.

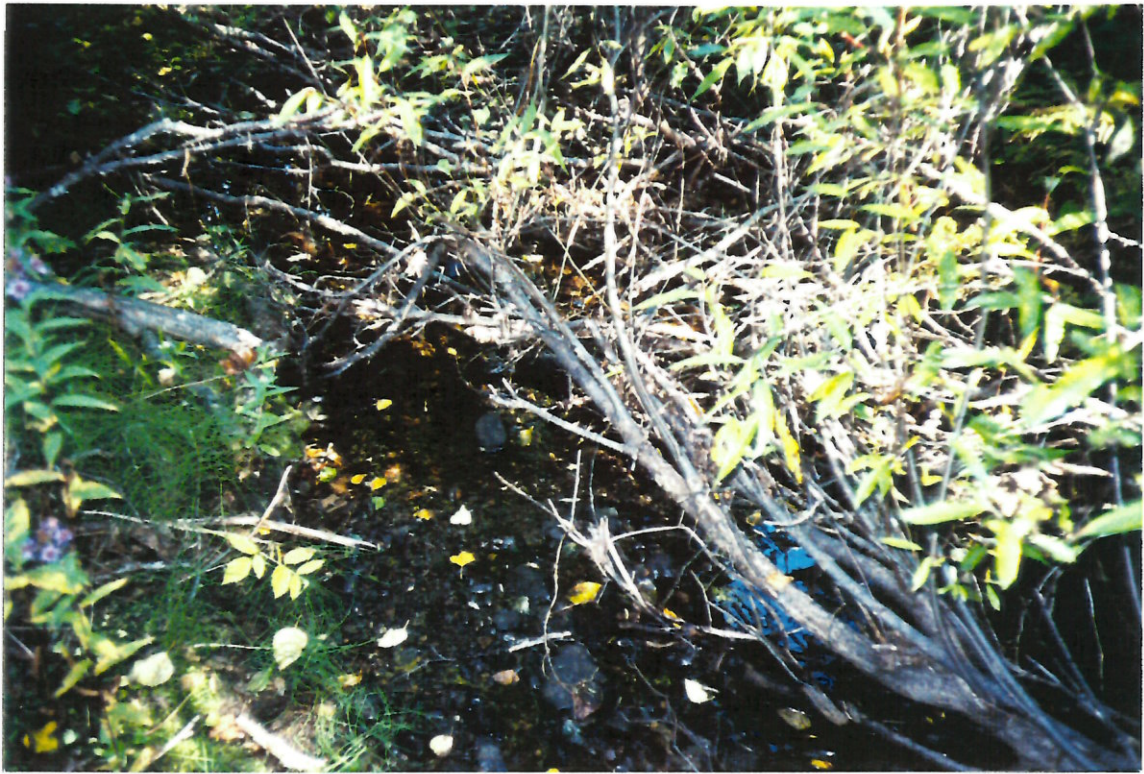
Photo #: 24 - 12  
Site 253, downstream view of channel through willow swale.

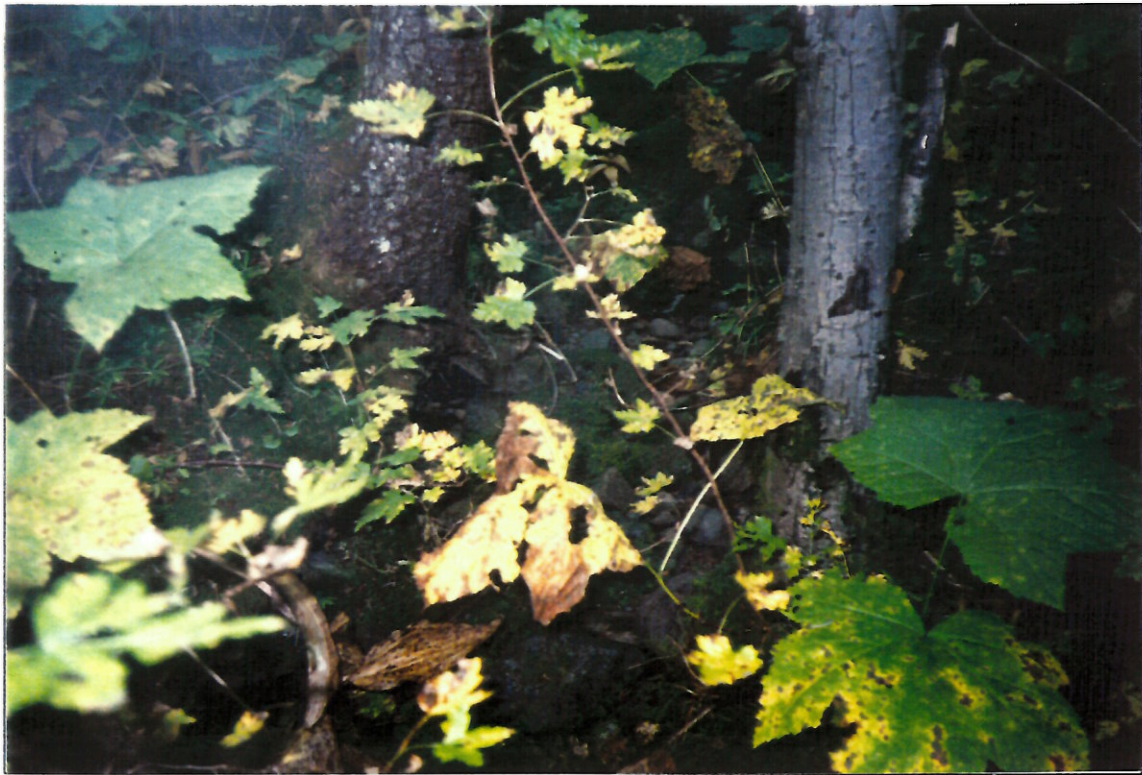
Photo #: 24 - 15  
Site 255, upstream photo of high gradient section.

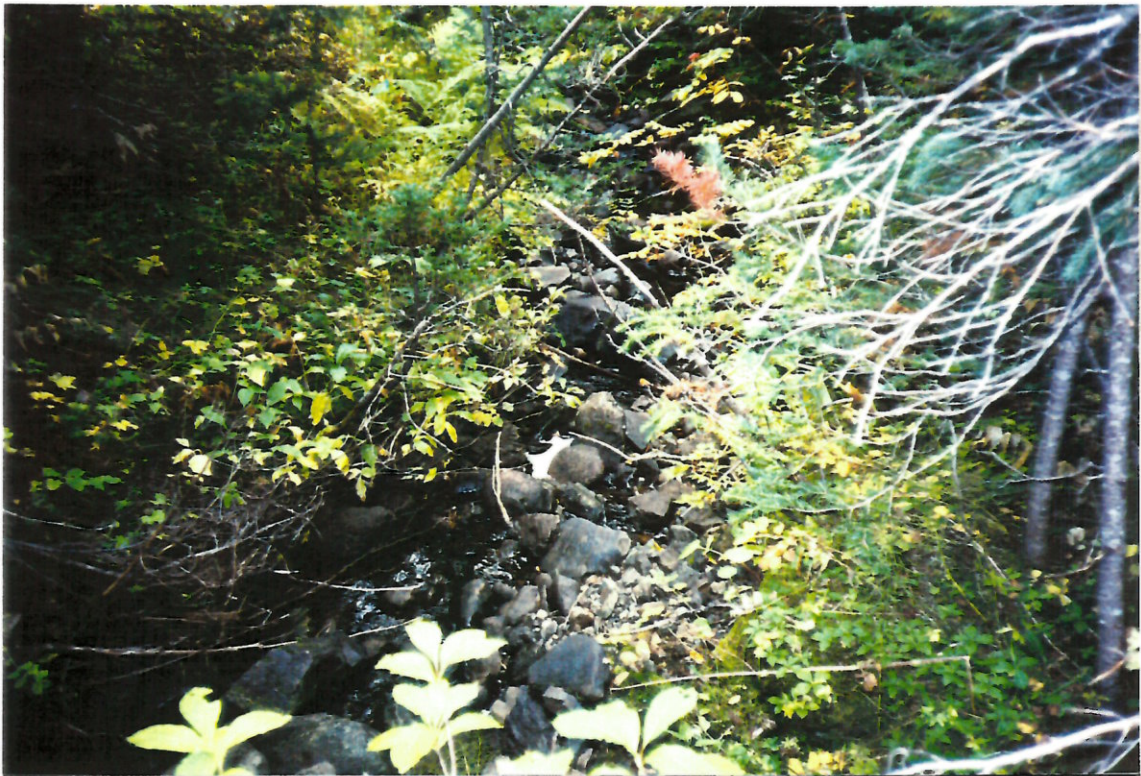
Photo #: 24 - 23  
Site 258, downstream view of boulder strewn section of stream.

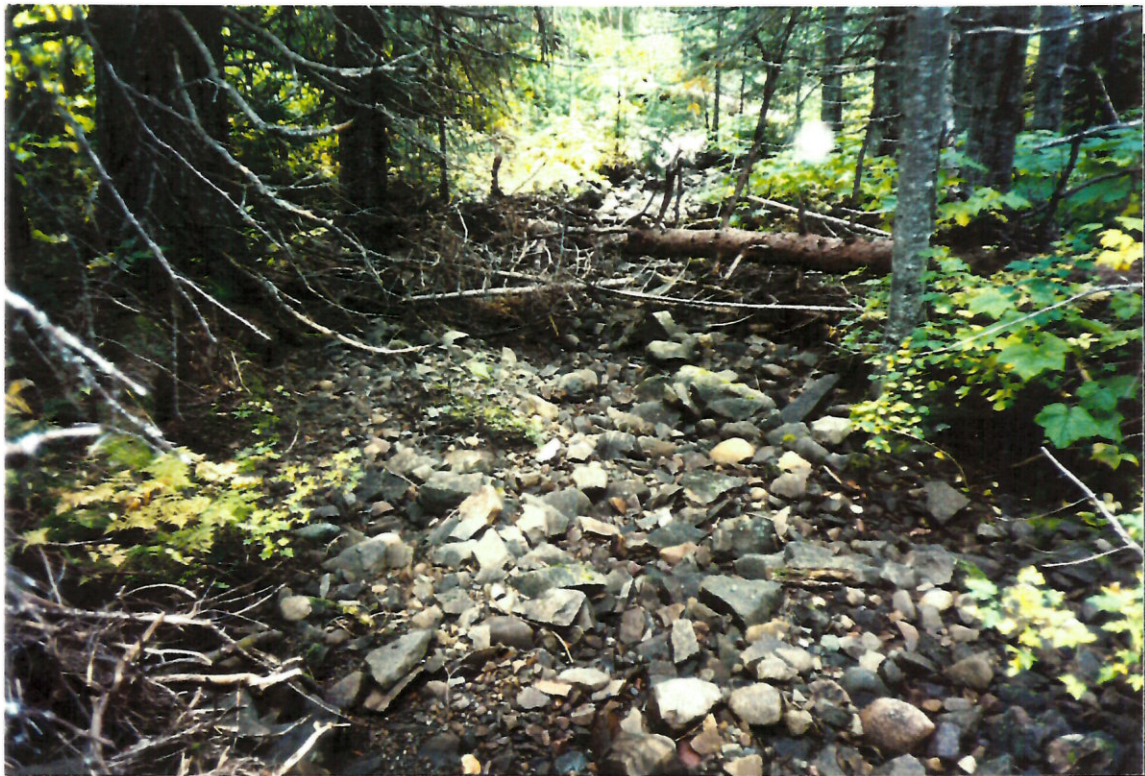
Photo #: 24 - 24  
Site 258, downstream view of dry section of stream, downstream of canyon.

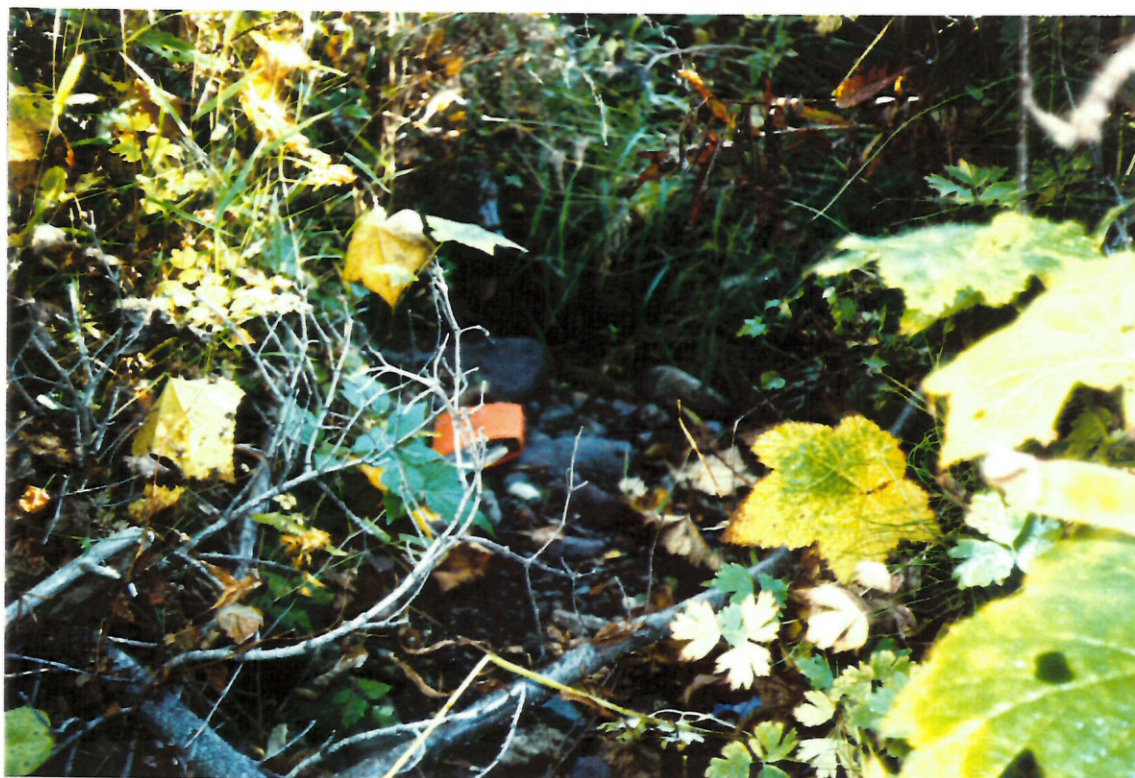
Photo #: 25 - 22  
Site 265, looking upstream at the right bank.

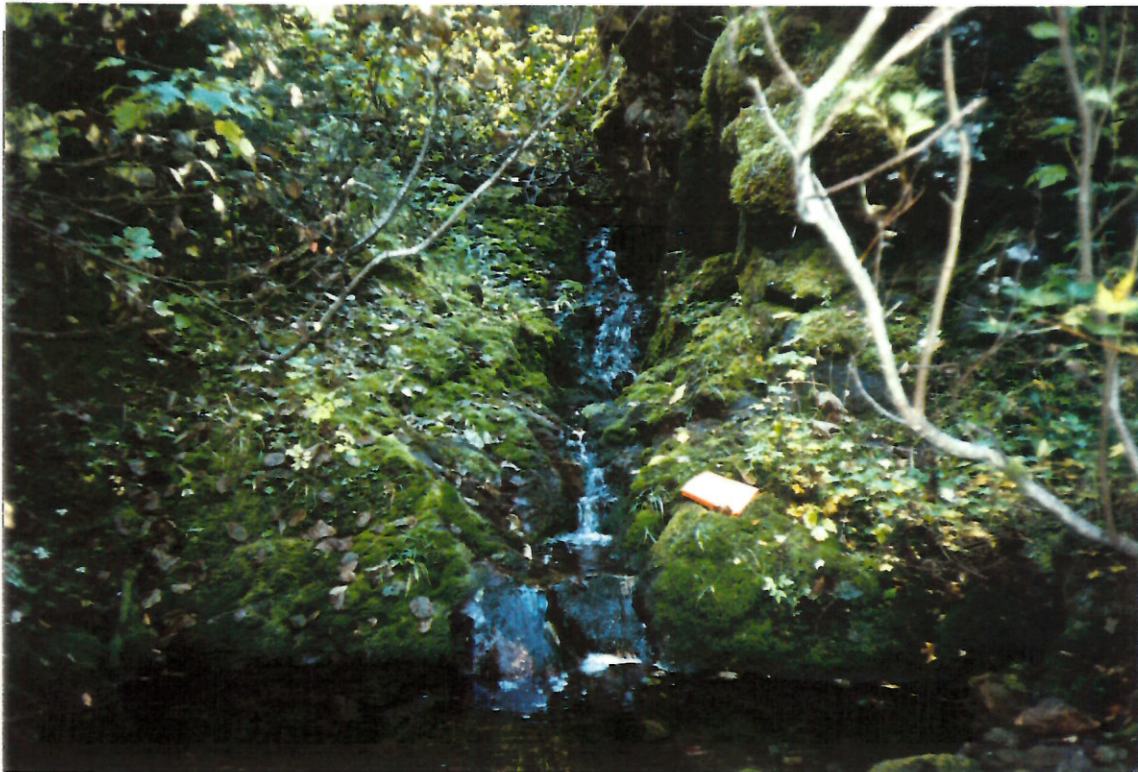
Photo #: 26 - 7  
Site 266, looking upstream at a 2.0m cascade in the sampling area.

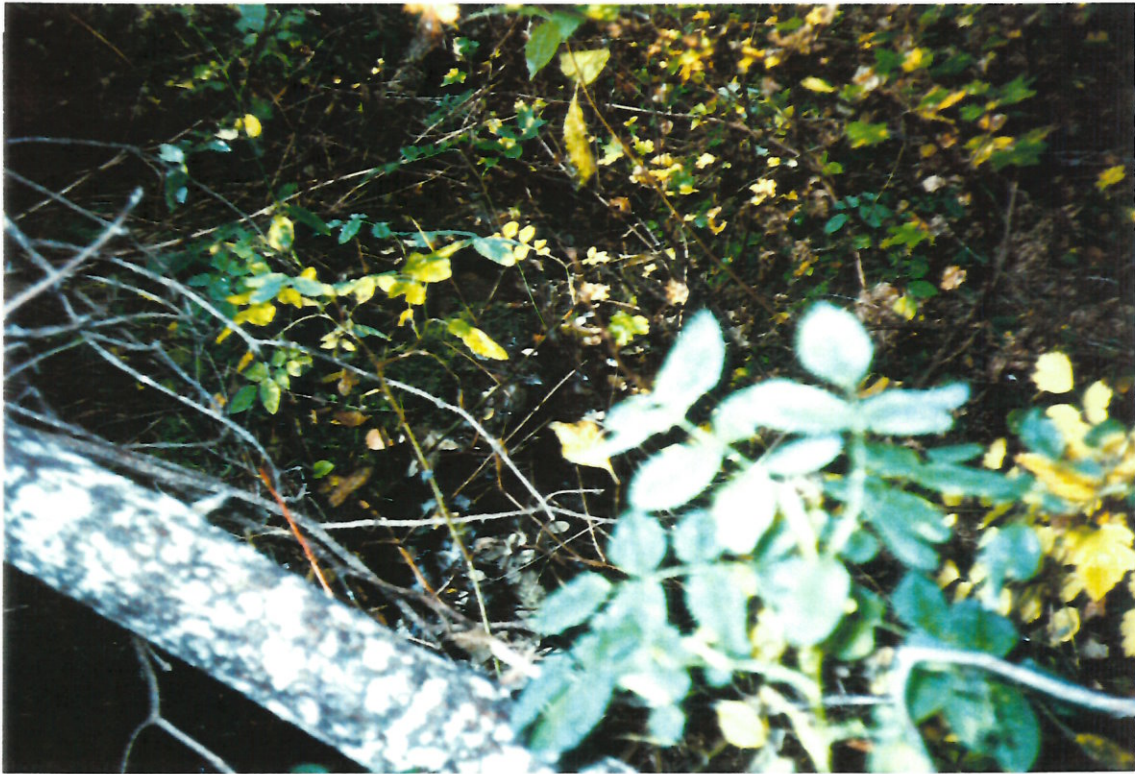
Photo #: 26 - 23  
Site 270, looking downstream at the channel, note the cobble substrate.

| Form | Section | Comments |
|---|---|---|
| SITE | CHANNEL | C5, the channel is dry in the bottom 20-30m, upstream of the road, abundant debris noted, no pool connectivity observed. |

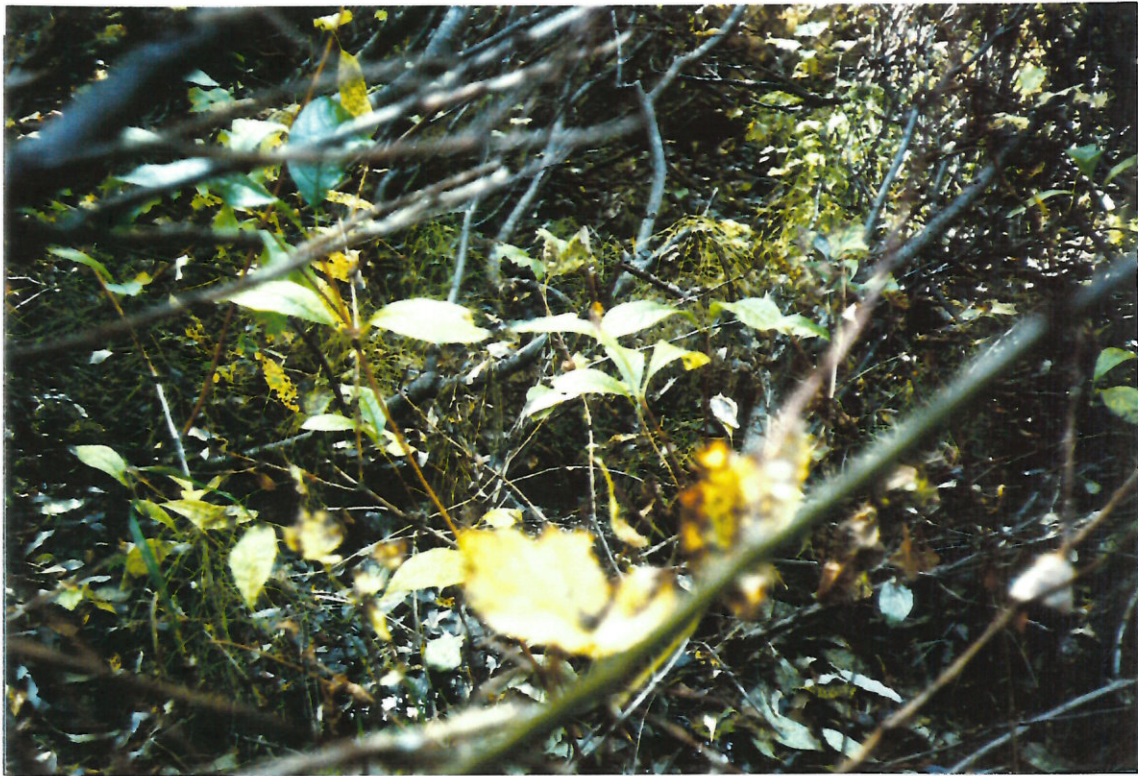
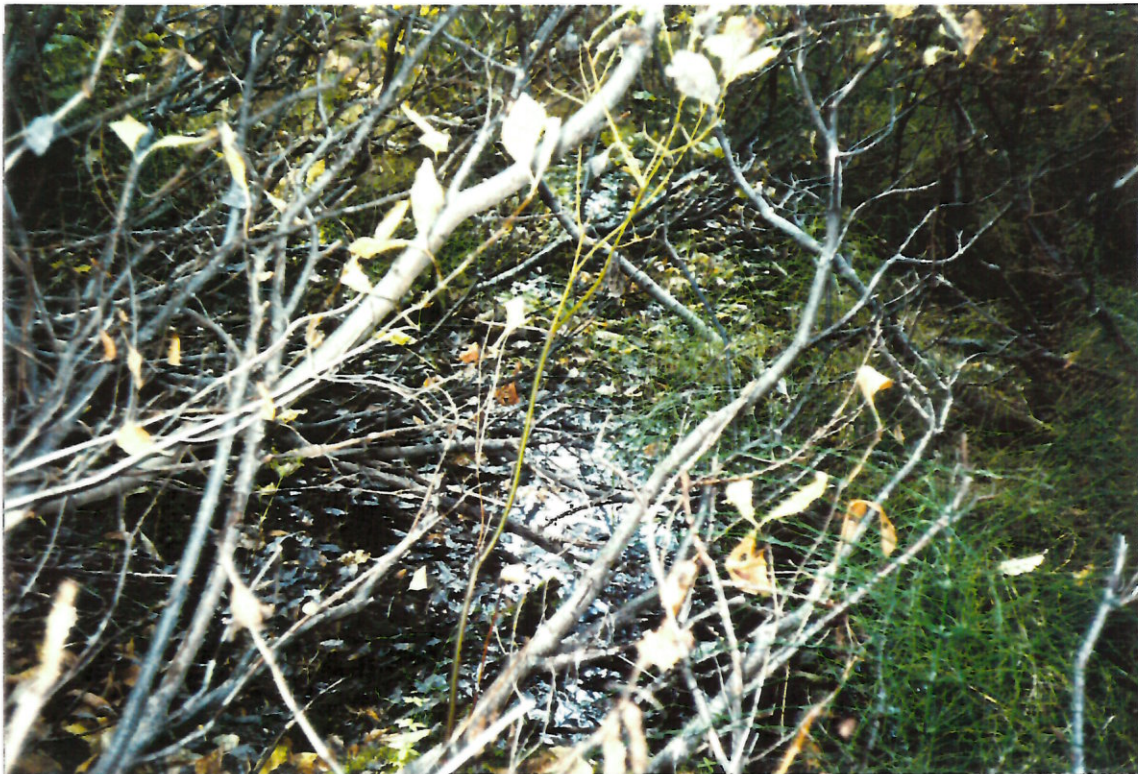
| Form | Section | Comments |
|---|---|---|
| SITE | CHANNEL | C2, no connectivity, just mosses, willow and seepage. |
| SITE | CHANNEL | C5, no bed scour, no substrate. |

Photo #: 26 - 11  
Site 276, looking downstream at seepage in a willow swale.

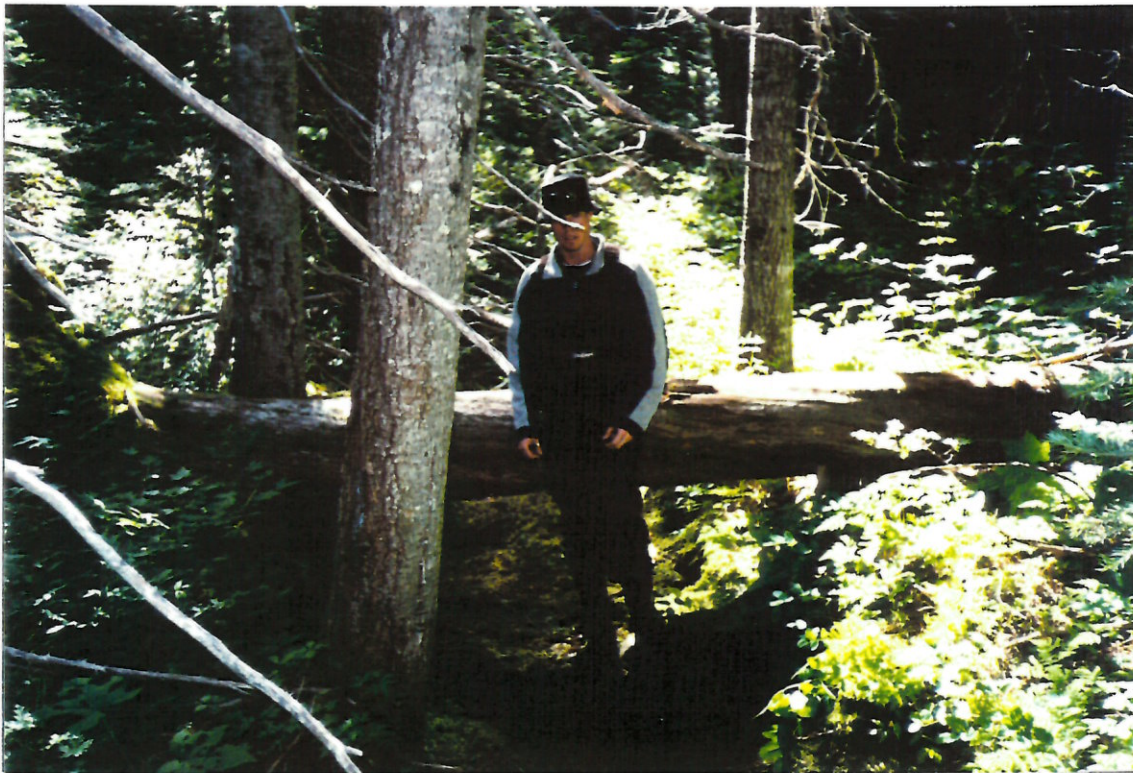
Photo #: 1 - 8  
Site 303, looking downstream at Jesse in moss covered channel.

| Form | Section | Comments |
|---|---|---|
| SITE | CHANNEL | C2, no connection, ephemeral, no water |

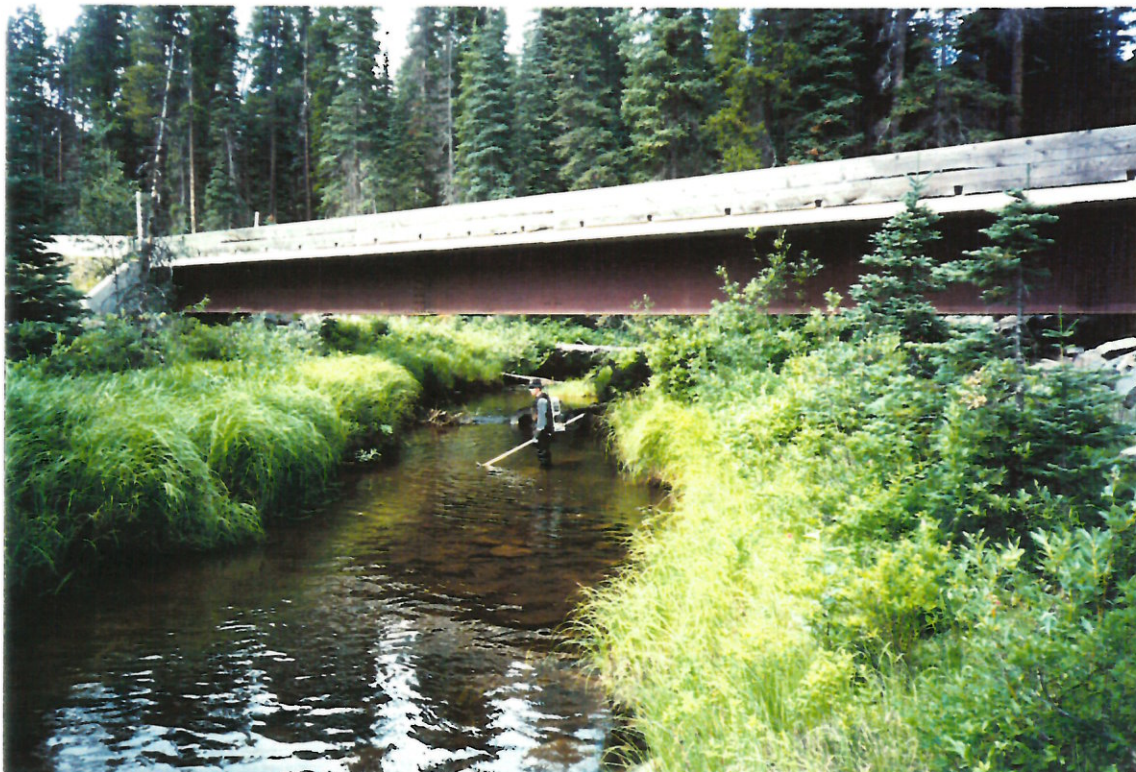
Photo #: 1 - 14  
Site 305, looking upstream at bridge.

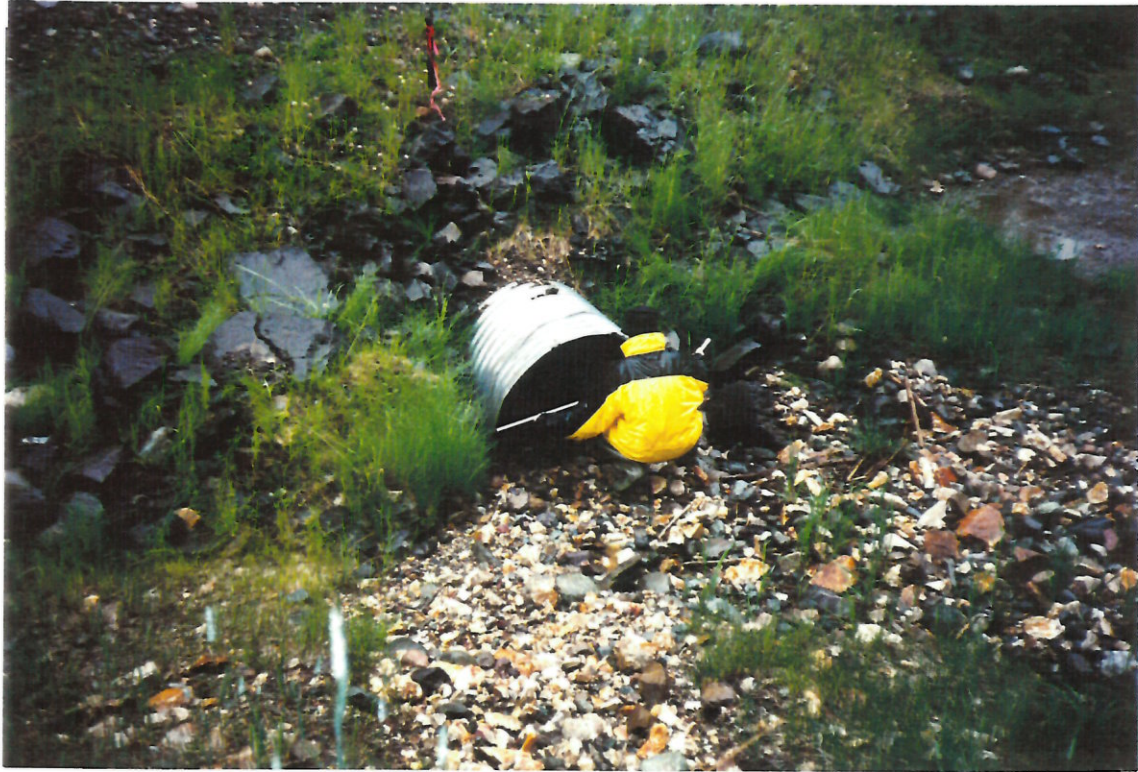
Photo #: 1 - 24  
Site 309, culvert (1000m) well placed.

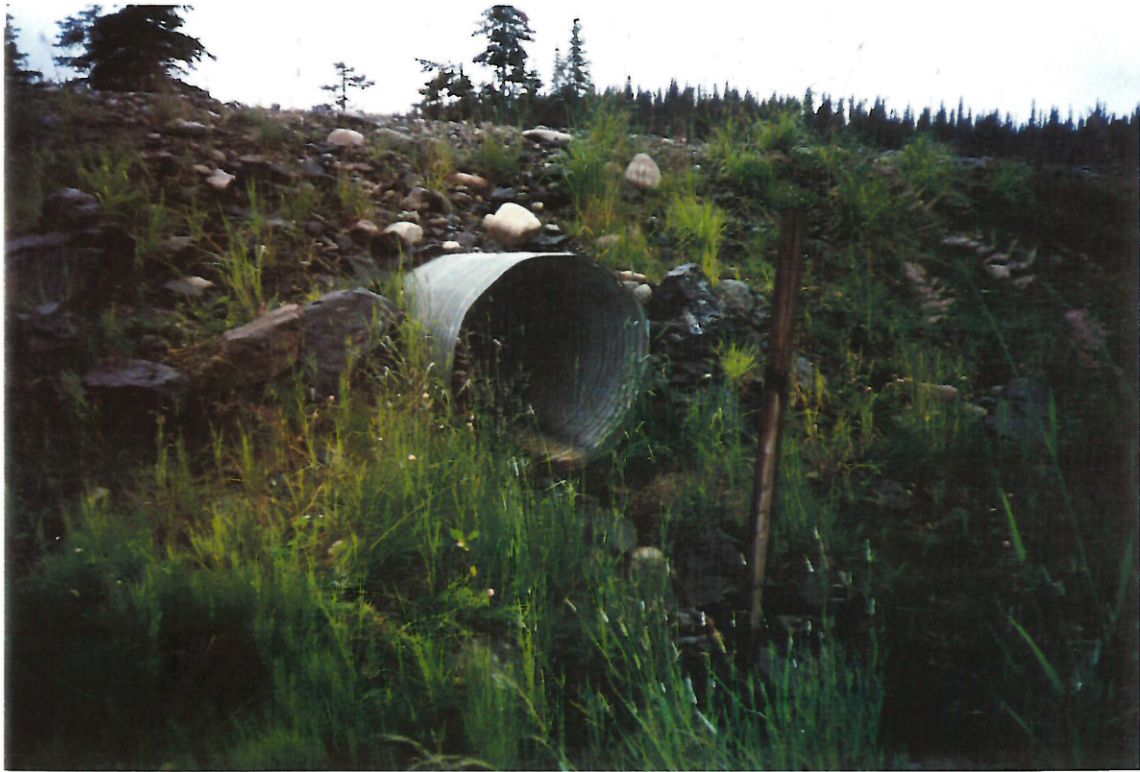
Photo #: 2 - 7  
Site 312, looking upstream at a culvert crossing.

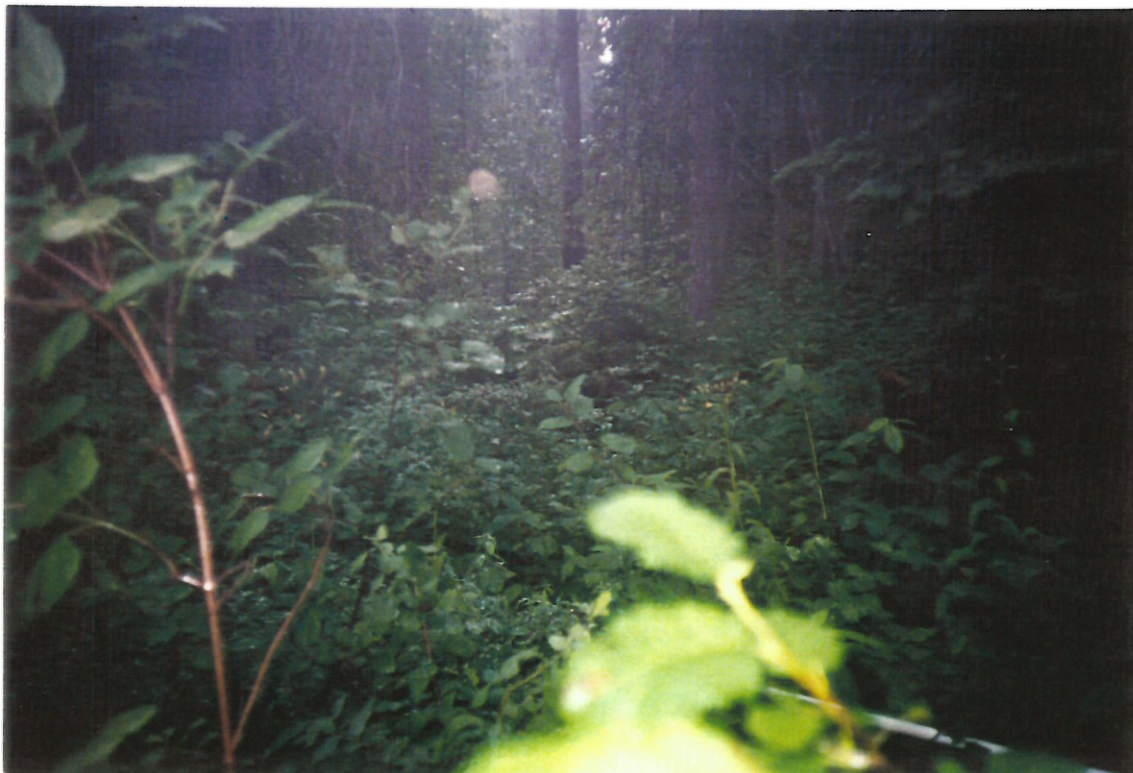
| Form | Section | Comments |
|---|---|---|
| SITE | CHANNEL | C2, vegetated seepage, no evidence of surface scour |

Photo #: 2 - 9  
Site 313, looking upstream - no visible channel.

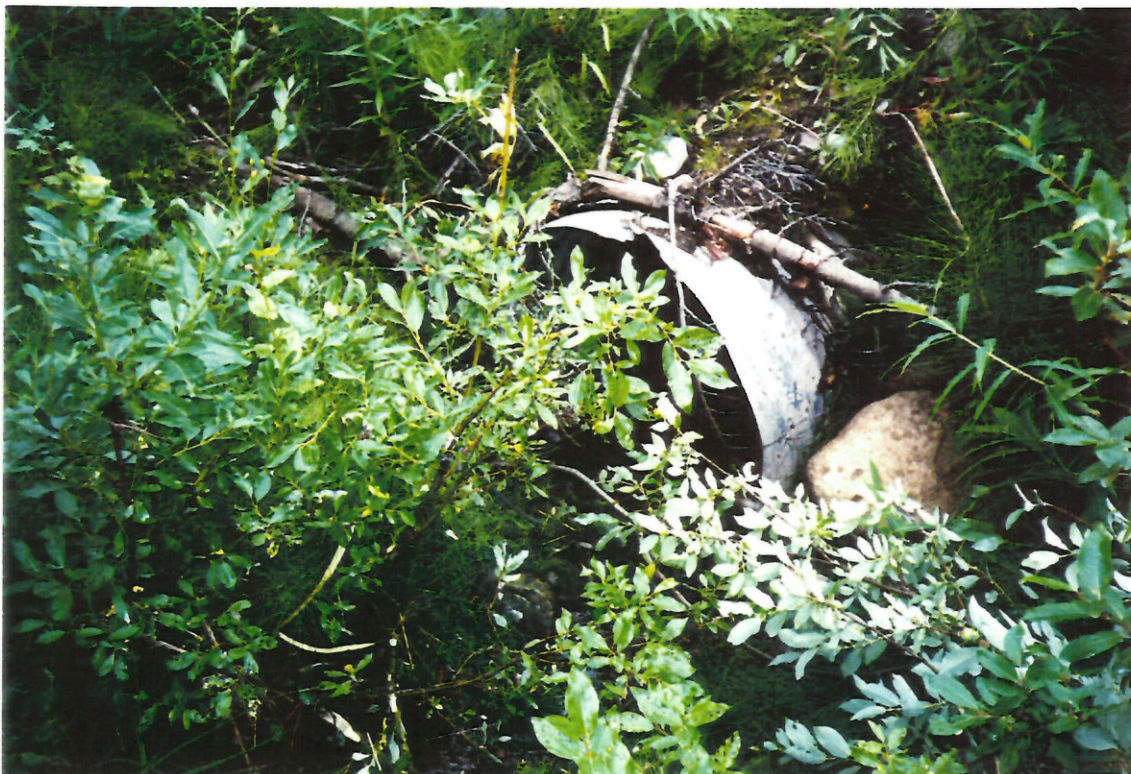
Photo #: 2 - 21  
Site 317, looking downstream at culvert inlet (800 mm).

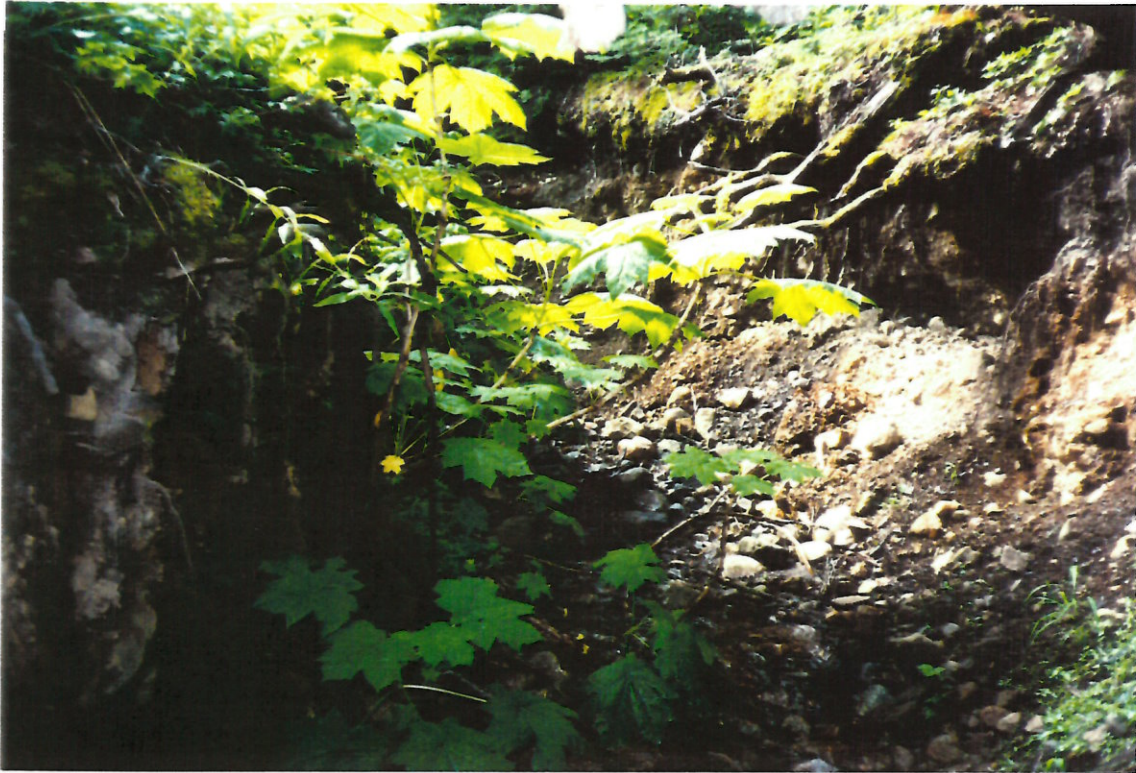
Photo #: 2 - 27  
Site 319, looking upstream at entrenched, eroding banks.

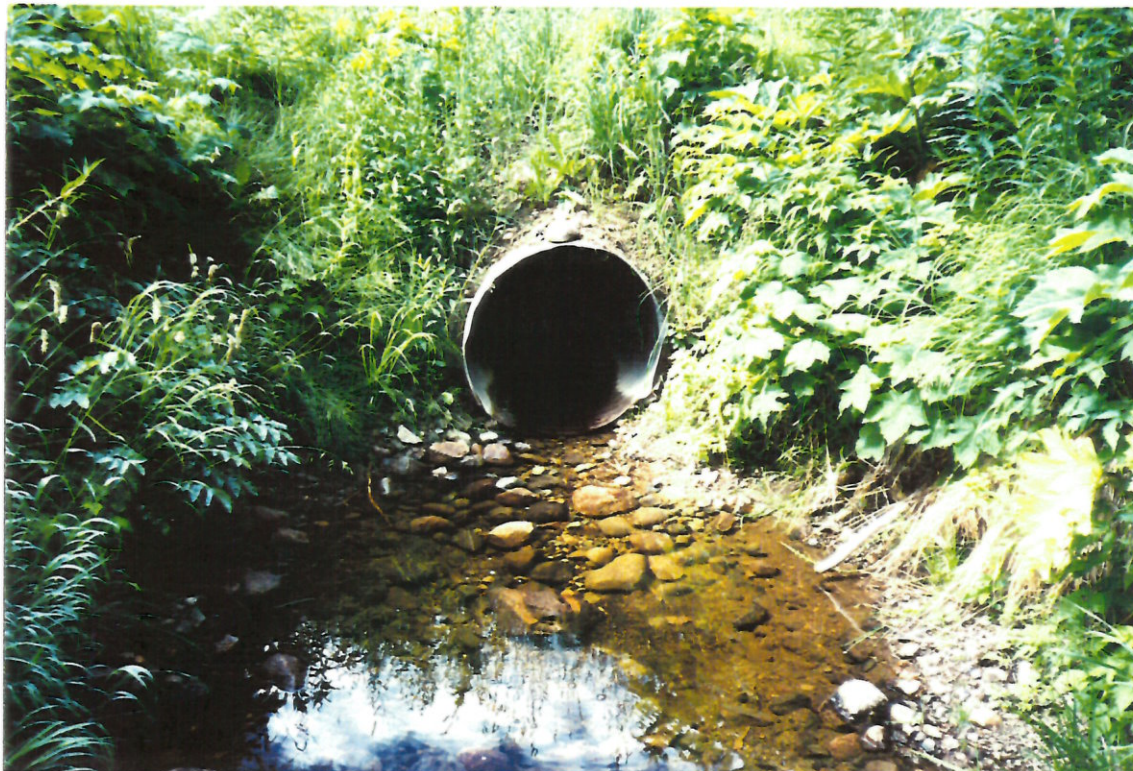
Photo #: 2 - 31  
Site 320, looking upstream at well placed culvert (1000m).

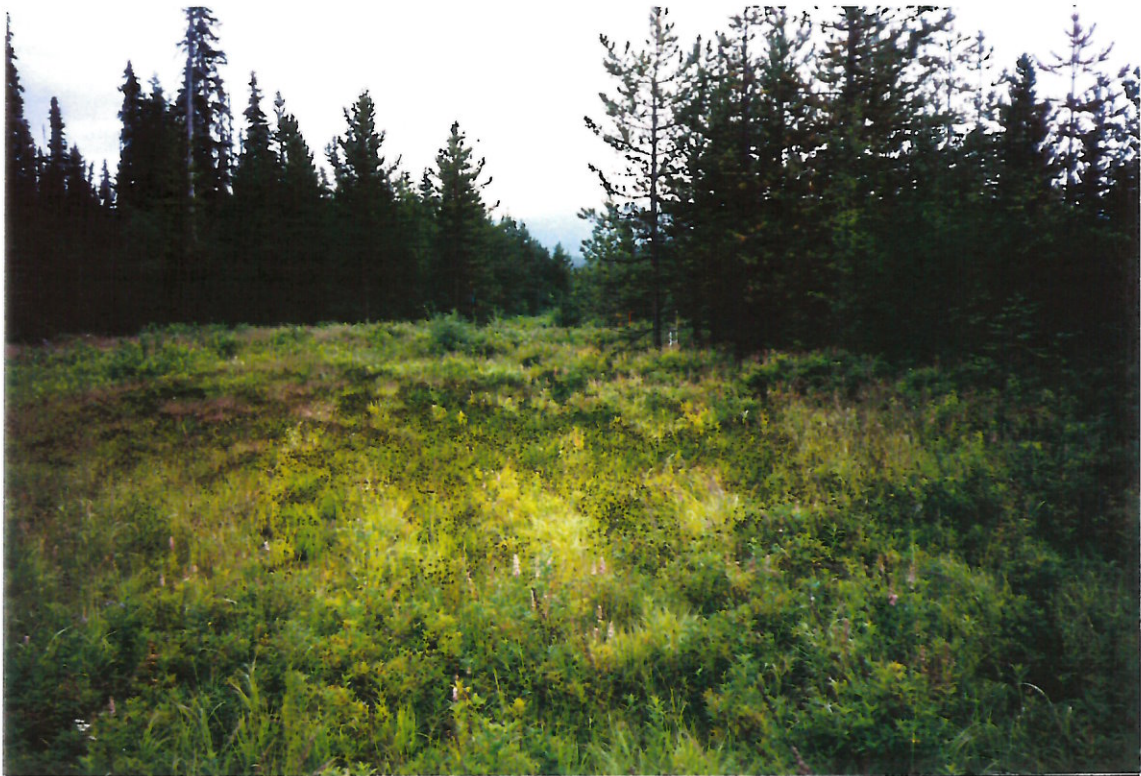
| COMMENT | | | | | | | | | |
|---|---|---|--|--|--|--|--|--|--|
| SITE | CHANNEL | C1, NVC | | | | | | | |
| SITE | CHANNEL | C2, vegetated seepage, no evidence of bed scour. | | | | | | | |

Photo #: 3 - 3  
Site 324, photo of a vegetated skidder trail.

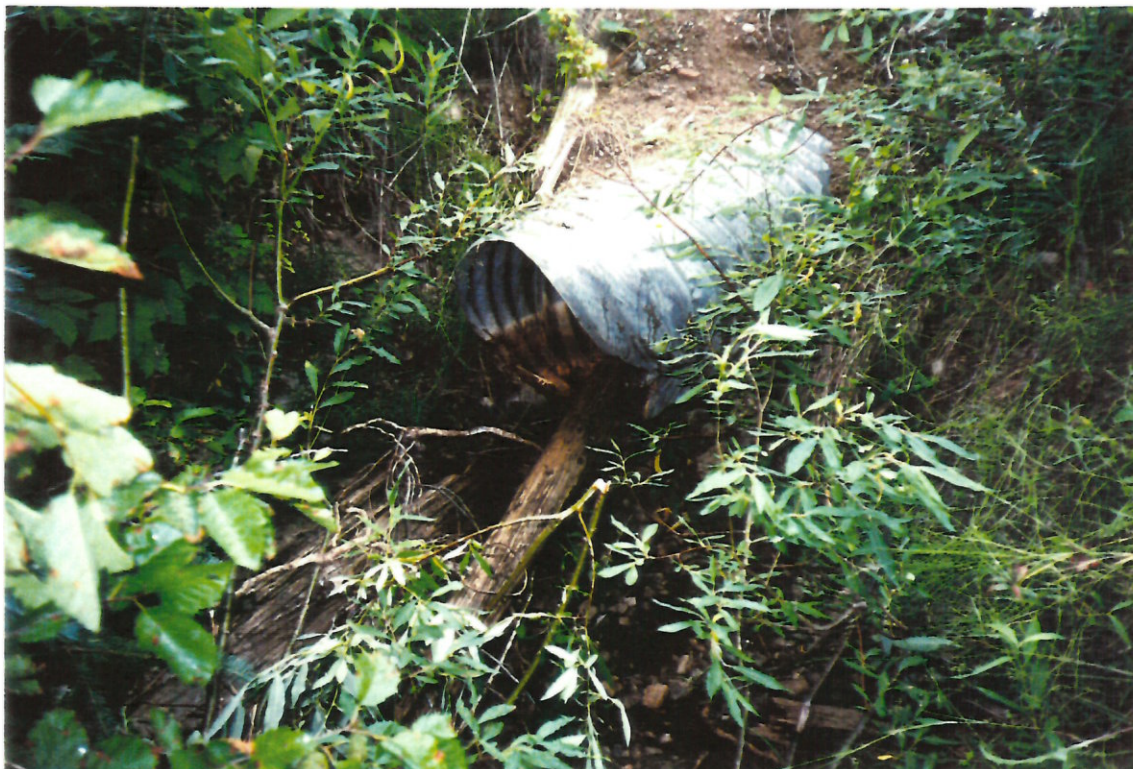
Photo #: 3 - 4  
Site 325, looking upstream at a 600 mm culvert.
