Level I Detailed Field Assessment of Aquatic and Riparian Habitat for Coldwater Creek in the Lakelse River Watershed

Prepared for Ministry of Environment

BioLith Scientific Consultants Inc.

March 31, 1999

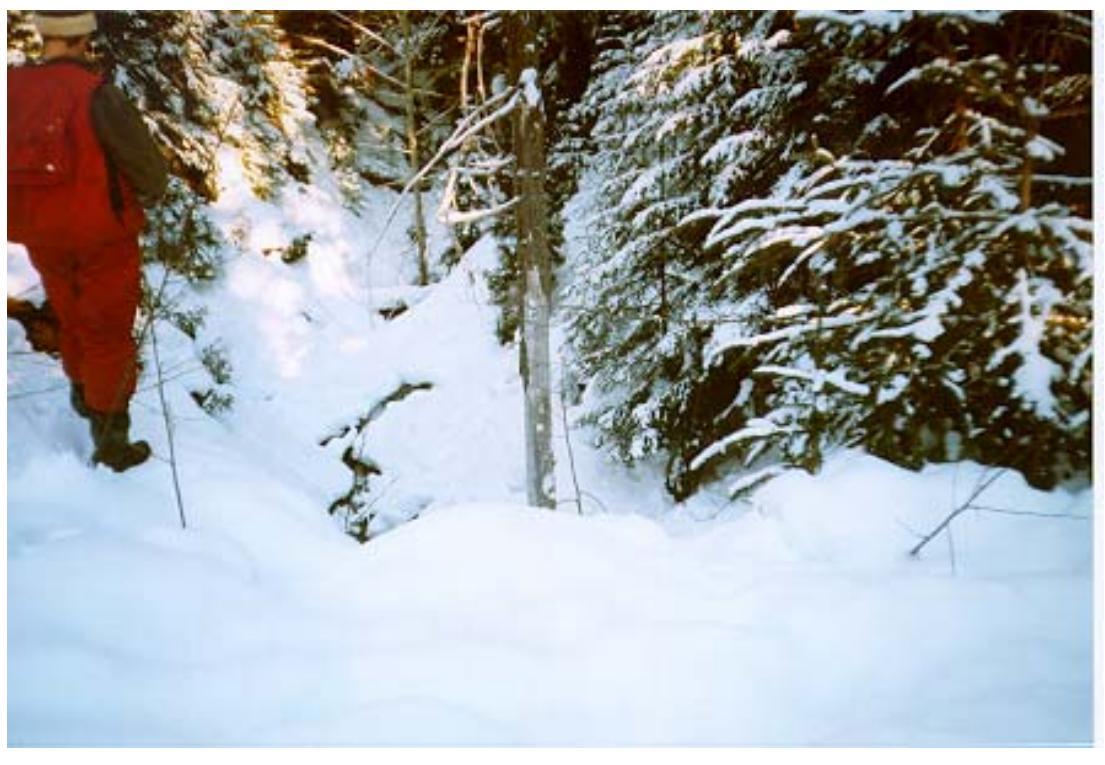
Tributary 710E was a very small stream with a bankfull width of approximately 1 m. This stream passed through an intact old growth forest through its entire length and was considered to be in pristine condition except at the Middle Johnstone Creek Road crossing. The channel gradient was steep at the Middle Johnstone Creek Road crossing and its substrate was mainly boulders and cobble. At this point the stream was confined by bedrock. The stream drained a small lake at its headwaters. The road crossing appeared stable.

Photo 25. Looking north and upstream in Trib 710E. This stream passed through an intact old growth forest.

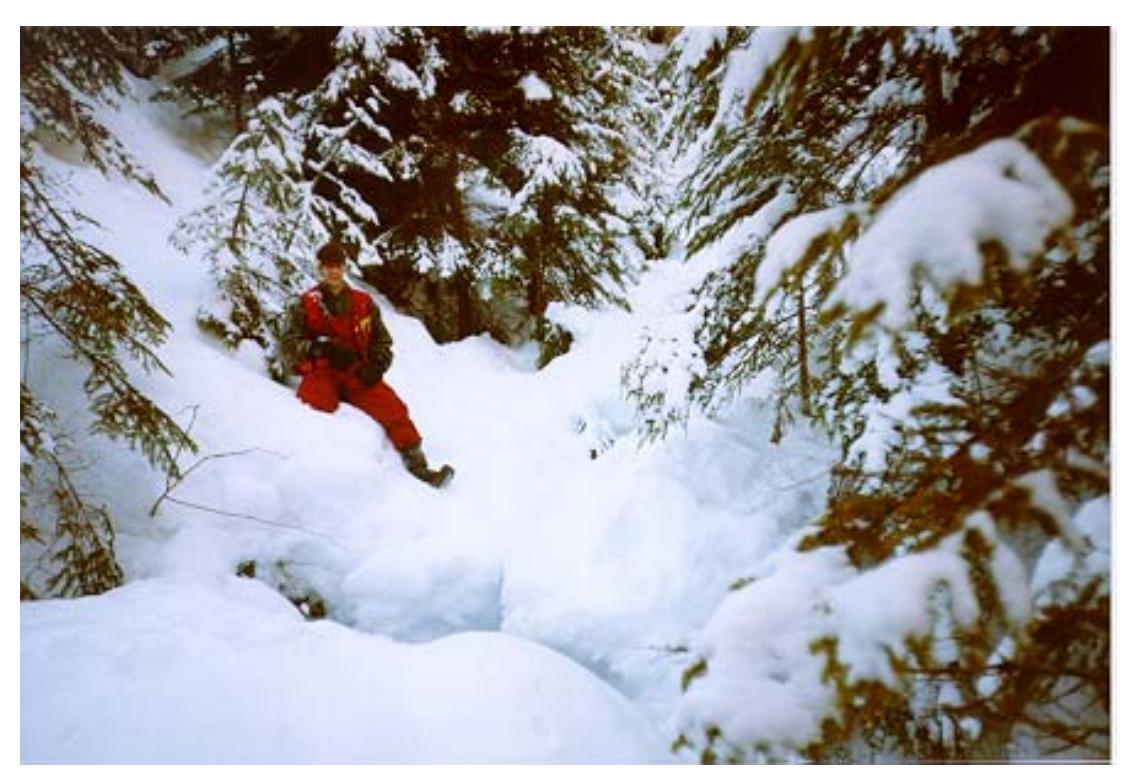
The average channel gradient was approximately 14% and the bankfull width was approximately 2 m. There was adequate LWD and the substrate consisted of cobbles with boulder cover. At 200 m above the mouth there was a 4 m high bedrock falls that was likely a barrier at all flow conditions to fish migration upstream. This stream contained good fish habitat that was in good condition. The headwaters of this stream were shown on the TRIM map (103I037) as a small pond. The field crew found this pond drained to the northeast into what we have called Tributary 710G, which was not recorded on the map.

Photo 26. Looking upstream in Trib 710F.
