***EXCHAMSIKS BACKCHANNEL
REHABILITATION
2008***

June 2009

Fisheries and Oceans Canada
Sandra Devcic – Restoration Eng. Tech.
Don Hjorth – Restoration Engineer
Lana Miller – Restoration Biologist
North Coast Area

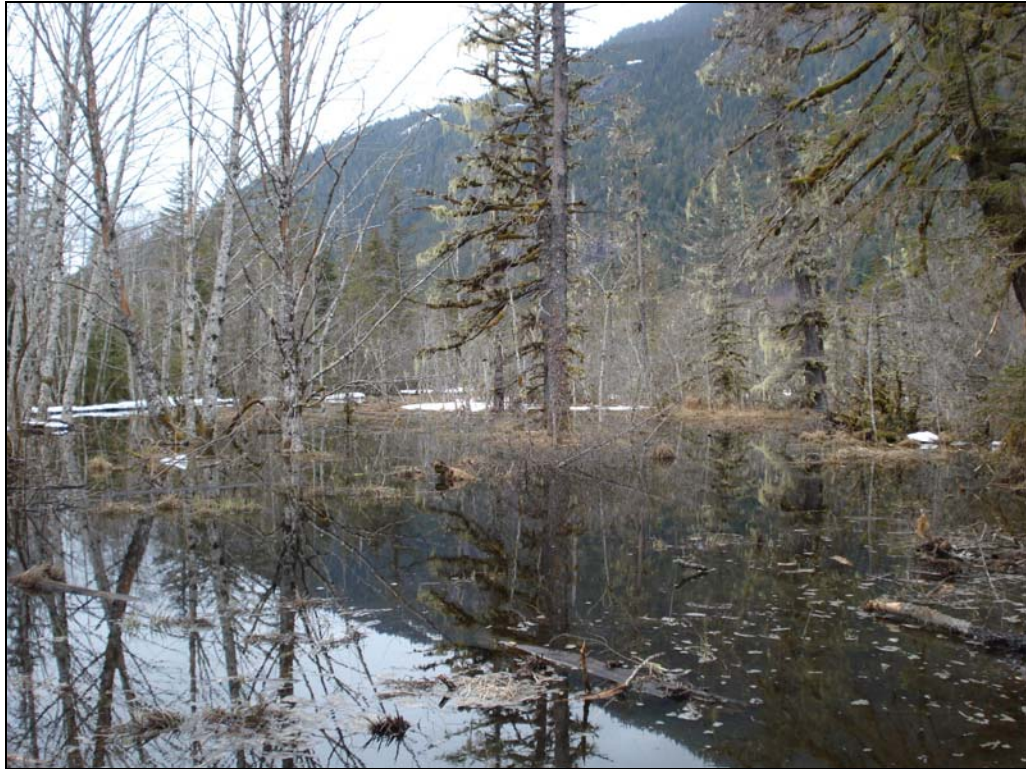
Figure 7: April 3, 2008 – Water within the sidechannel area at late winter low-flow conditions, a time of year when other creeks and rivers are low.

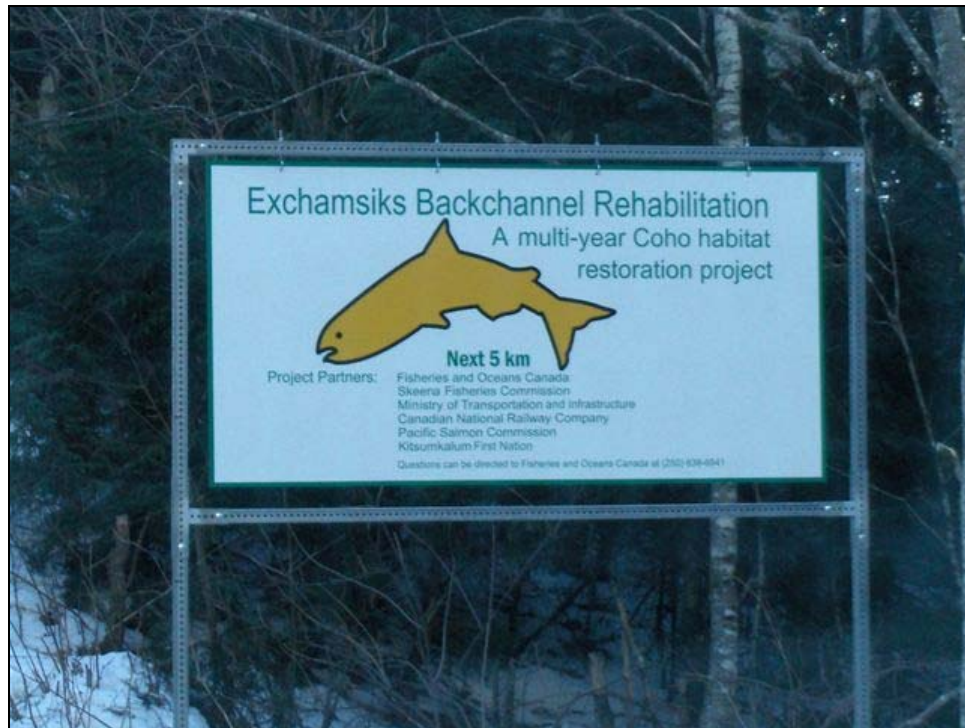
Two large signs were installed in the summer of 2008 explaining the project and acknowledging credit (Figure 13).

Figure 13 – Project information sign.

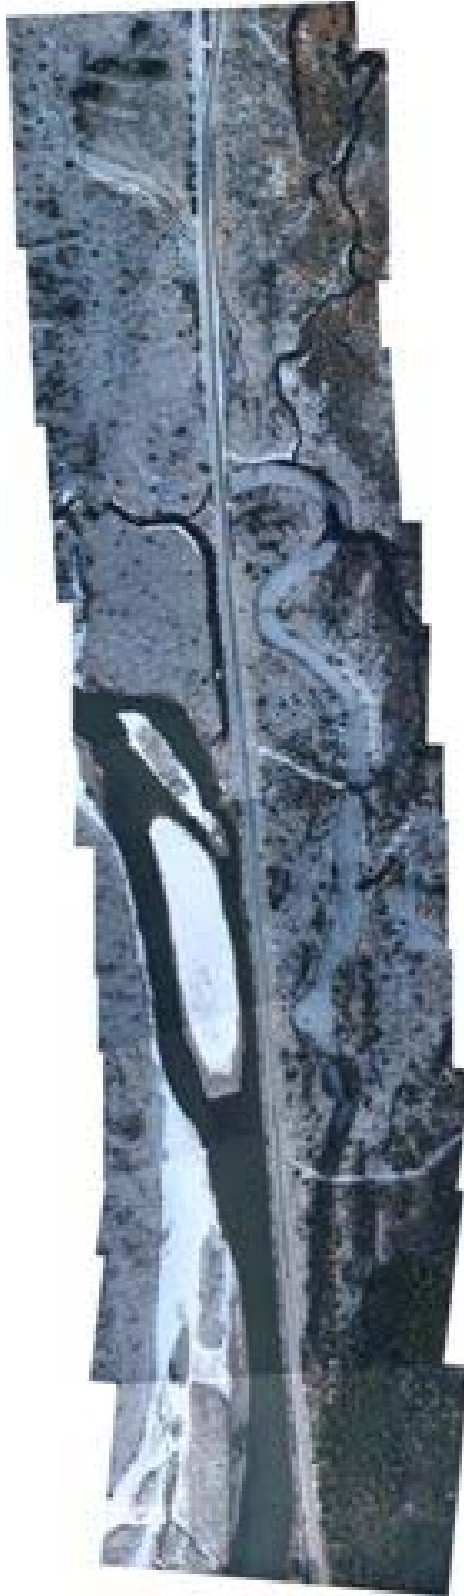
The east half of the project. North is on the right of the page.

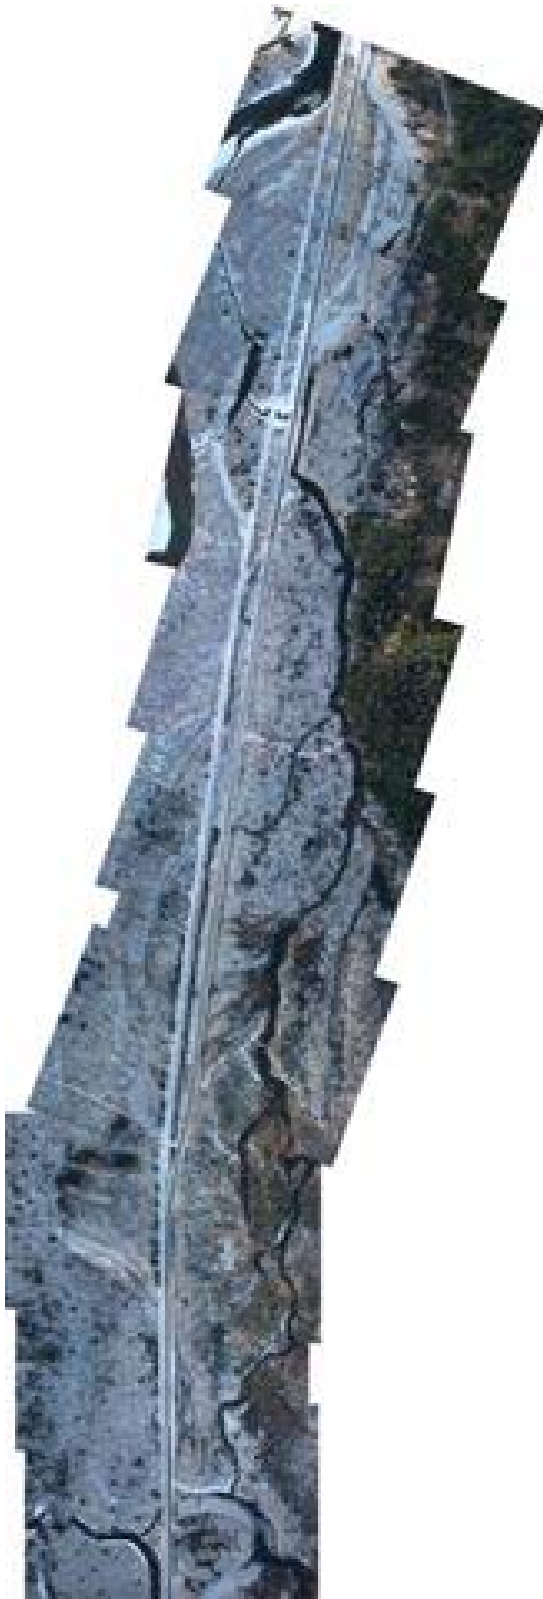
The west half of the project. North is on the right of the page.
