Copper River WRP

2000-2001 Instream Works Summary Report

TRITON
ENVIRONMENTAL CONSULTANTS LTD.

January 2001

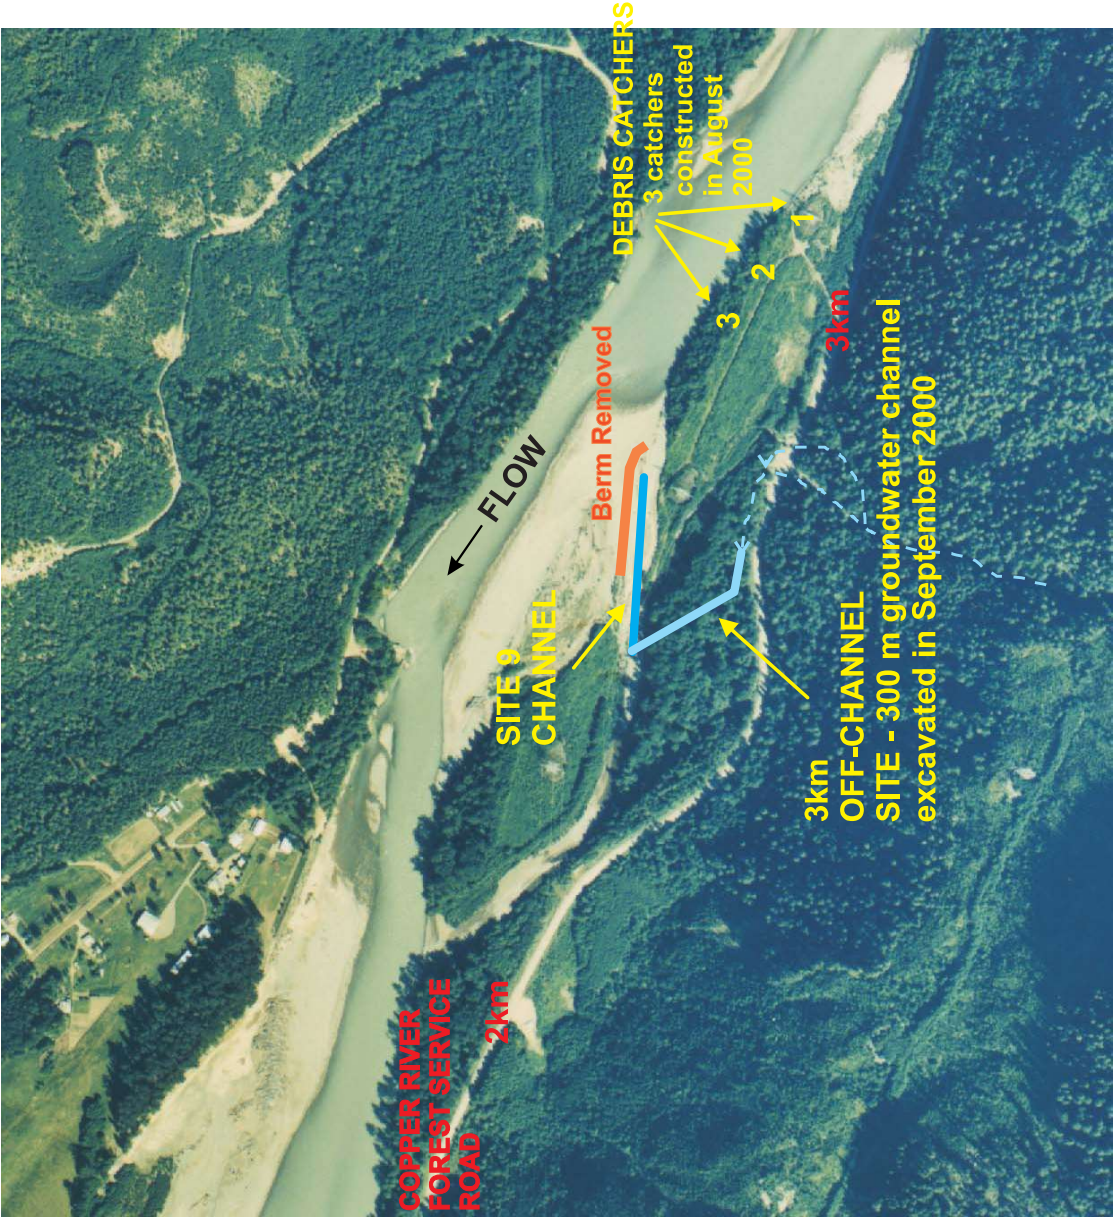
Figure 2. Lower Copper (Zymoetz) River Aerial Photo: Construction Sites

3149.01 - Copper River	Map # 31490001	Scale: 1:10000	Created By: Shawn Giesbrecht 1/01 Revised By: 2000 Overflight Source: Dec. 2000 Overflight
Figure 2: Locations of Instream Restoration Projects

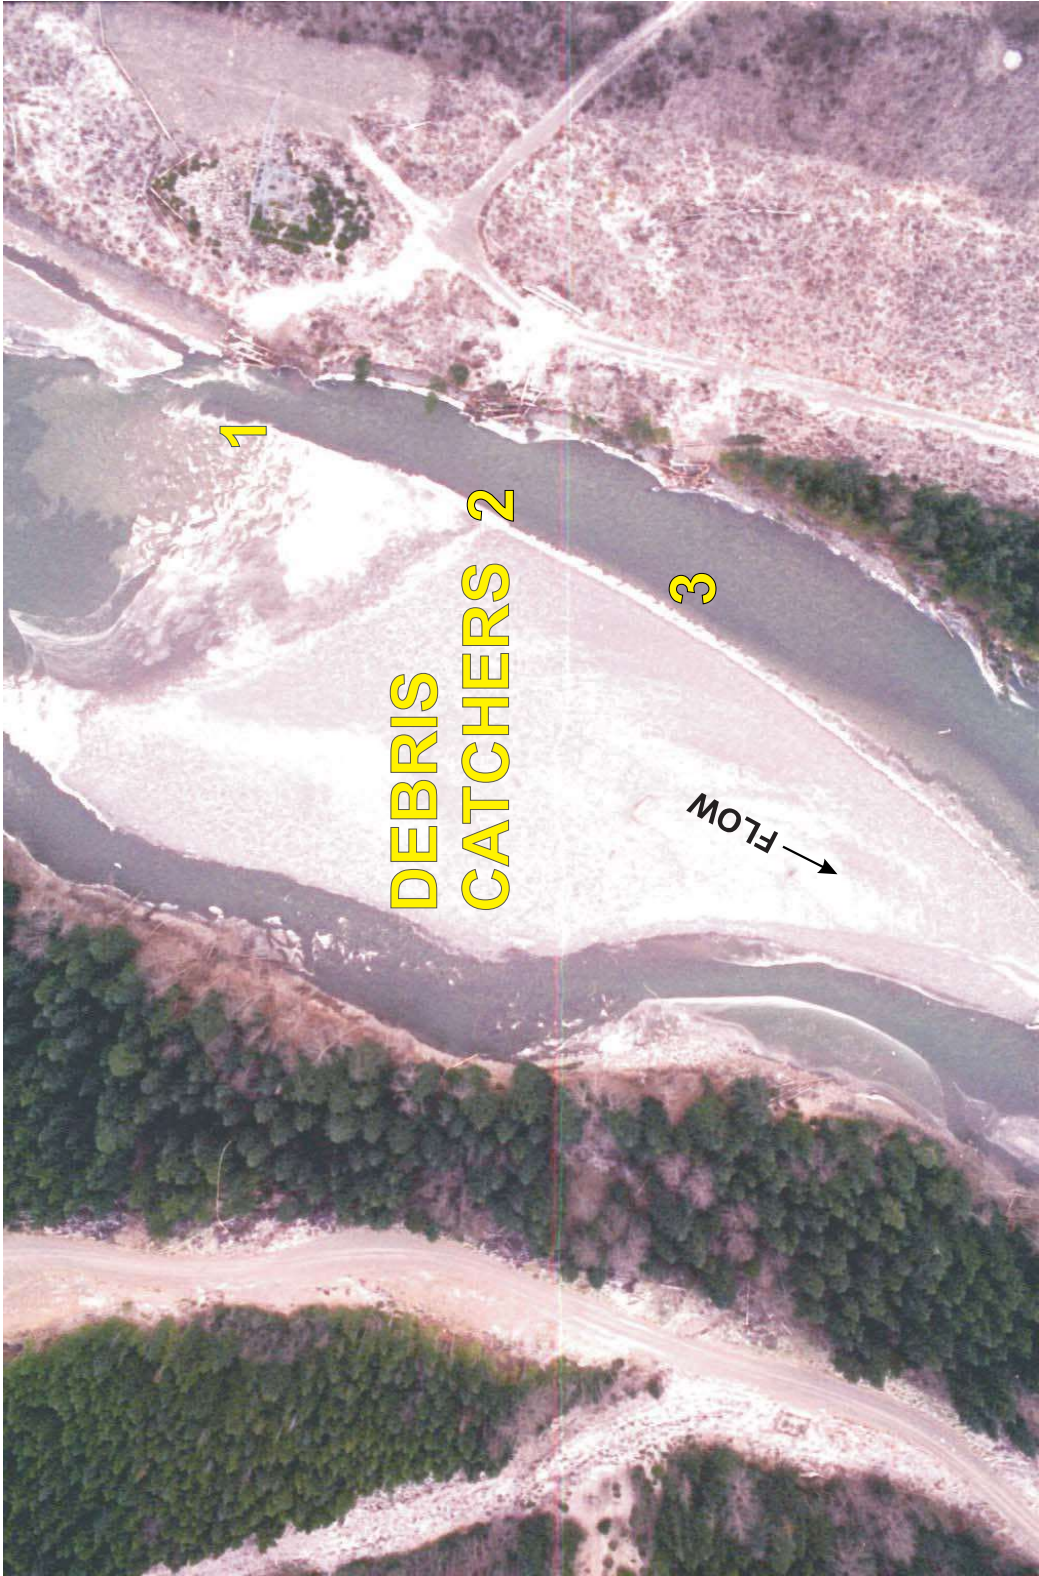
Figure 7. December 2000 overflight of debris catchers.

Monitoring of the structures through fall and winter 2000 found no significant shifts in orientation or location of wood or boulders and little additional debris accumulation on the ramps. Between DC1 and DC2, approximately 1 to 2 m of bank sloughed into the channel and contributed some woody debris to DC2. A helicopter overflight in December 2000 (Figure 7) and October 2000 (Appendix 7) can be used in future to monitor channel changes and rates of channel migration towards the spur road and Hydro tower. A moderate to large flood will provide a significant test of the durability and effectiveness of the structures.

- Monitoring of fish use and habitat changes adjacent to the structures,
- Monitoring of rates of erosion of bank by measurements from known points (spur road or tower) and documentation prior to and after flooding.
- Monitoring of debris accumulation on the ramp logs through photo documentation and possible addition if natural accumulation is too slow,
- Addition of shrub and conifer seedlings along banks for future stability.
- Completion of overflight for air photos in 3 to 5 years to document large scale channel changes.
- Installation of a fourth catcher adjacent to the natural wood jam approximately 100 m downstream of DC 3 since sufficient logs (5) and boulders (10) are onsite and unused.

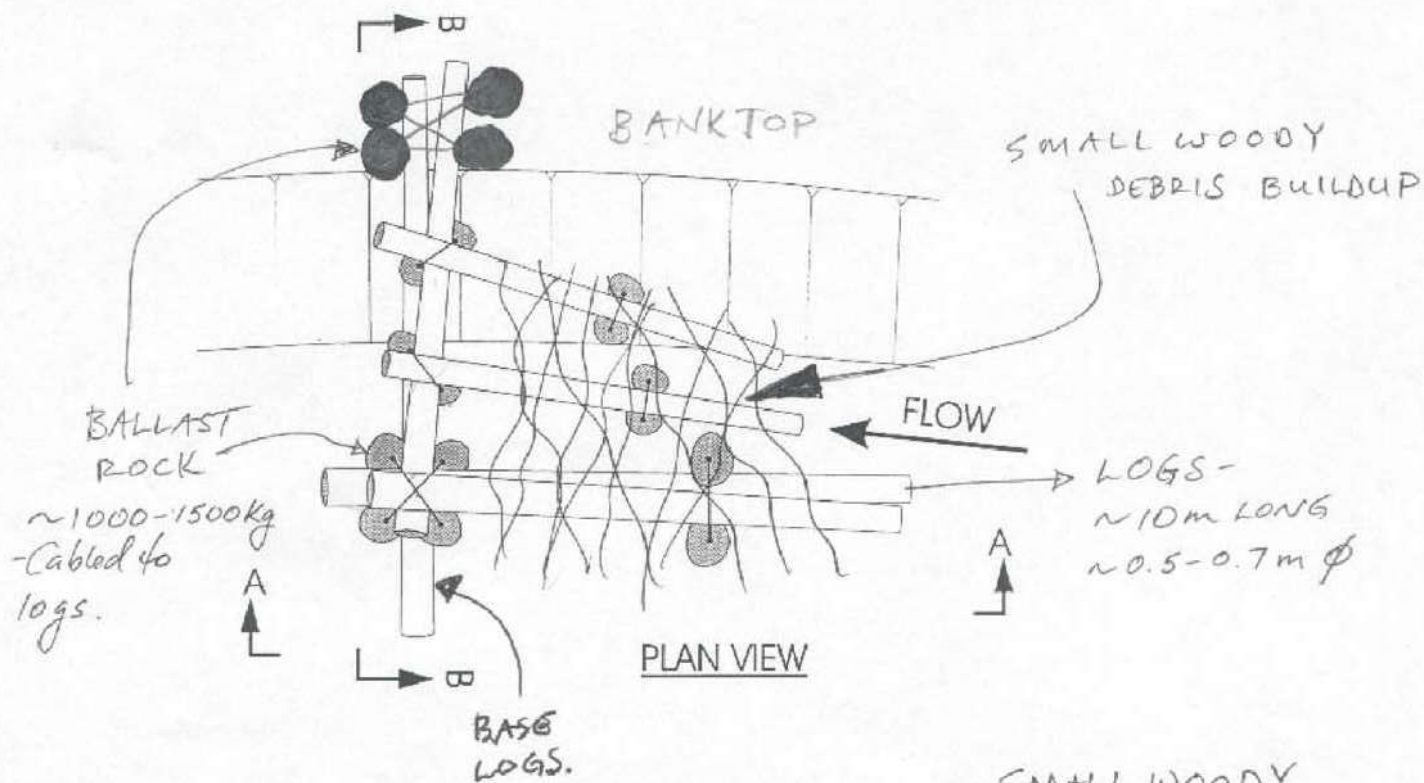
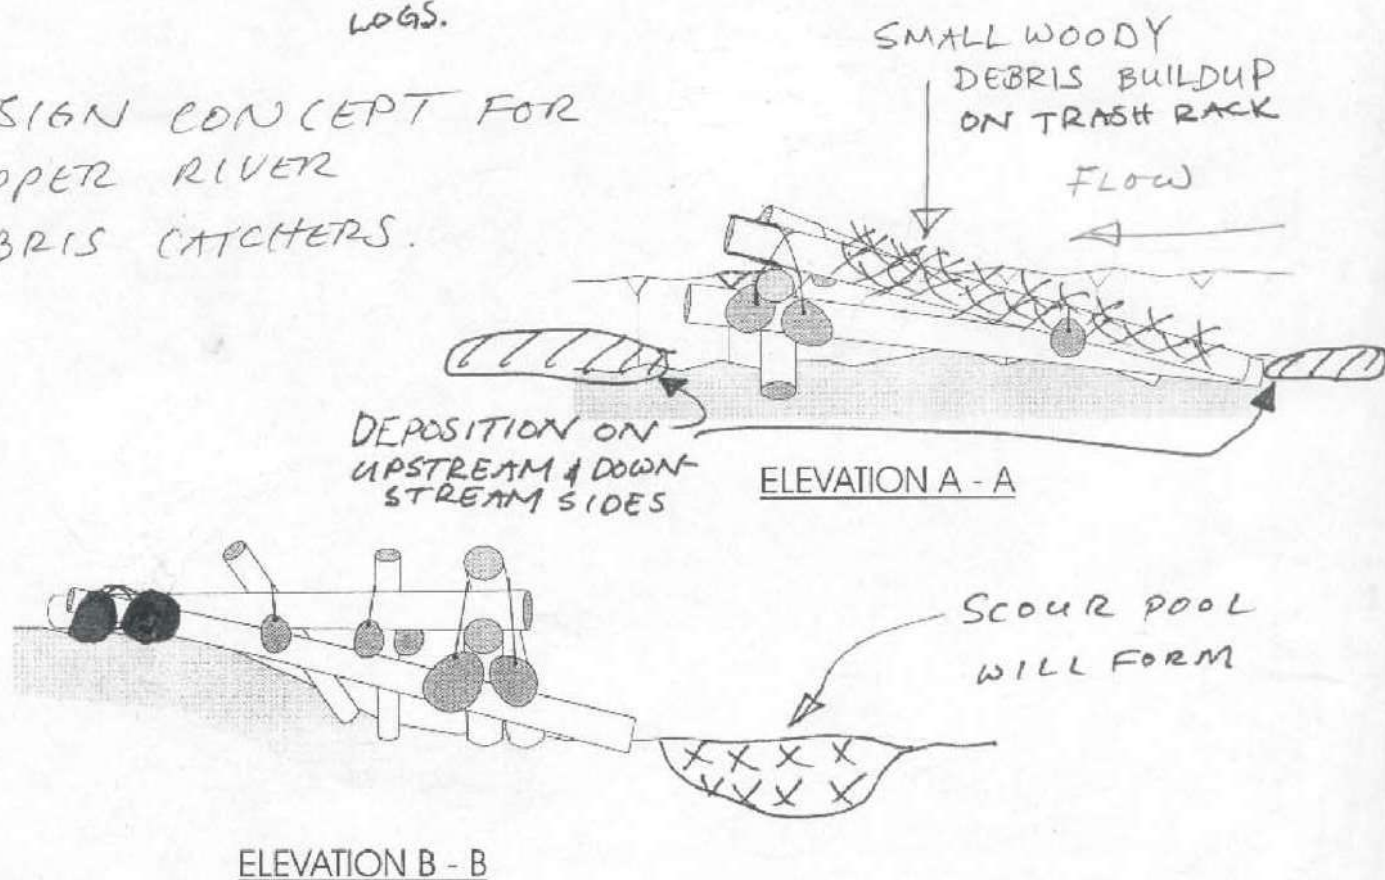
Figure 8. Concept Drawing of Debris Catchers (R. Finnigan).

The debris catching structures act as a trash rack which accumulates small woody debris on the upstream face, slows the water velocity and enables substrate deposition in back eddies immediately upstream and downstream of the structure. A key factor for structural integrity of these structures is to overballast or increase, typically by a factor of two or three times, the minimum weight of rock attached to the logs to ensure that the structures do not become buoyant and shift. Figure 8 shows the basic design of the debris catchers with several base logs installed perpendicular to the bank on which upstream facing logs are installed to act as a 'trash rack' and catch floating debris (source: R. Finnigan). As a result, less erosion of the bank will occur since
