**1996 MAXAN WATERSHED STREAM
HABITAT RESTORATION AND
ENHANCEMENT DESIGN REPORT**

Dz'ilh K'Az Kwa Development Corporation
Burns Lake, British Columbia

AGRA Earth & Environmental Limited
Prince George, British Columbia
Calgary, Alberta

March 1997

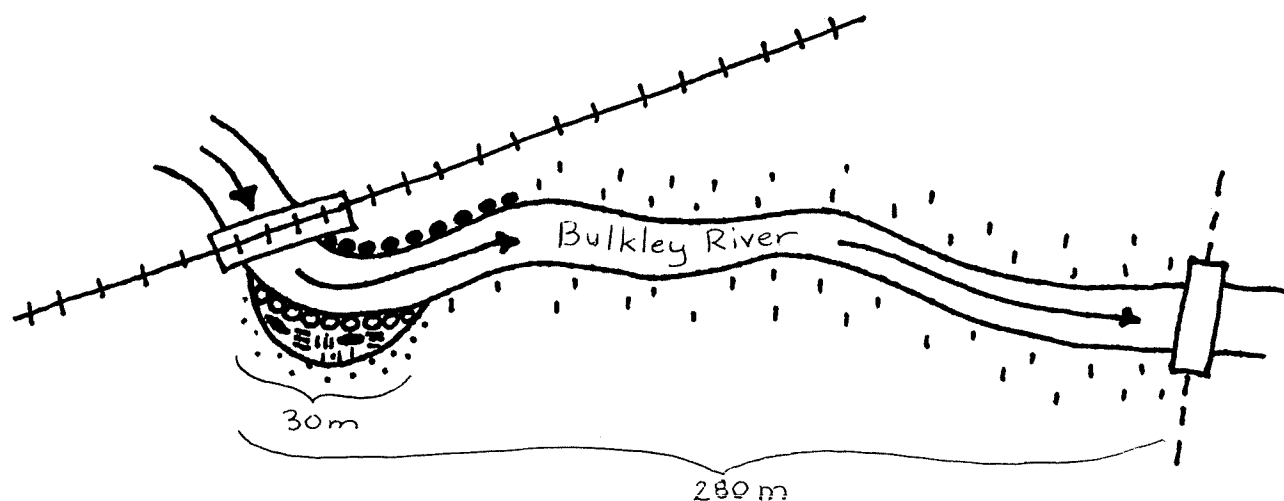
Site 1 (BR-S1) is located about 500 m downstream of the Bulkley Lake outlet (based on thalweg distance). It is 280 m long and is situated between a Canadian National Railway (CNR) crossing and an active bridge. Channel constriction at the crossing has resulted in increased flow velocities and erosion of a 30 m section along the right bank (looking downstream). Resultant mass wasting processes threaten to undermine the Rose Lake Cutoff Road (Photo 10). Excluding a 70 m section of riprap along the CNR tracks, banks at this site are partially reposed to vertical (eroding), comprised of fines and have little shrub and tree cover (Photo 11).

A schematic overview of recommended enhancement works at BR-S1 is provided in Figure 2. Equipment, manpower and cost requirements necessary to complete activities at this site are provided in Table 4.

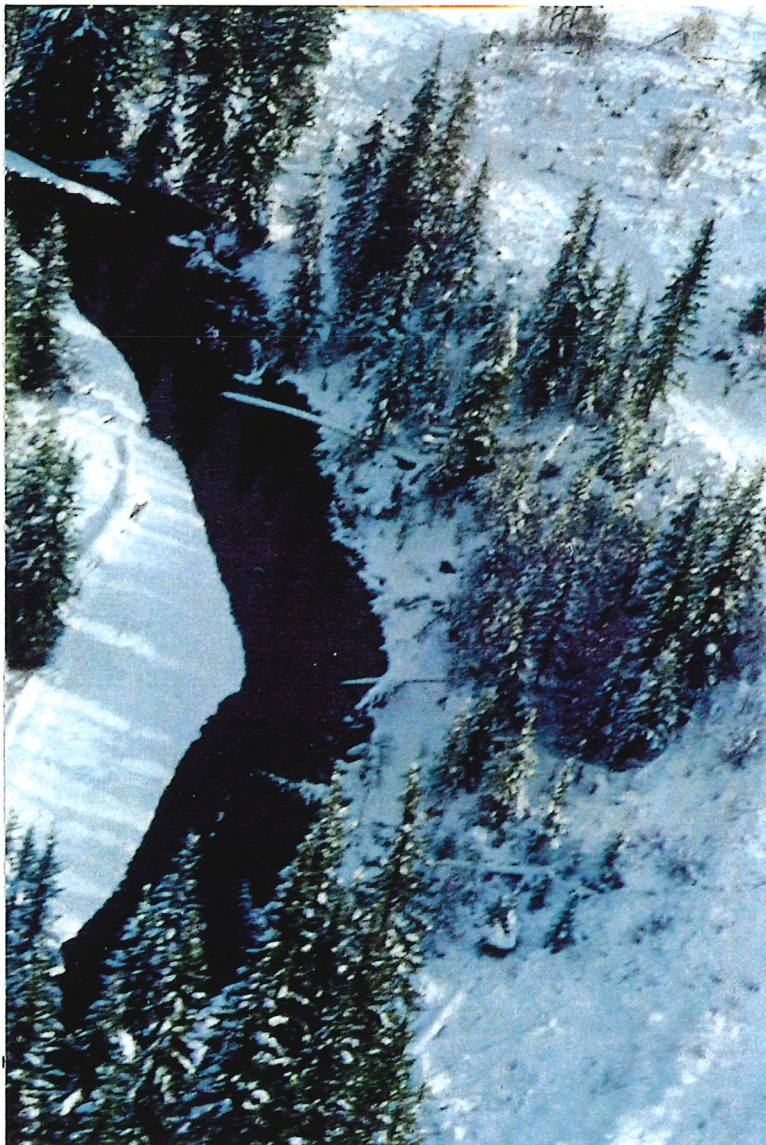
Photo 2
Typical Habitat Along Reach 1
of Lower Maxan Creek

Reach 1 of Lower Maxan Creek meanders through flat bottomland for 8 km (Photo 2). It is a highly sinuous, irregular meander which is occasionally confined. The banks are low and generally well vegetated with herbaceous vegetation, dense shrub thickets and mixed timber stands. Banks are comprised primarily of fines. The substrate is dominated by clean gravels/cobbles and is ideal for spawning. Abundant Large Woody Debris (LWD) provides overhead and instream cover. Frequent, deep scour pools have been created off the tips of this debris. Minor beaver activity was noted in the reach. According to Department of Fisheries and Oceans (DFO) files, chinook salmon and rainbow trout spawn within the reach. Dolly Varden may also spawn in Reach 1.

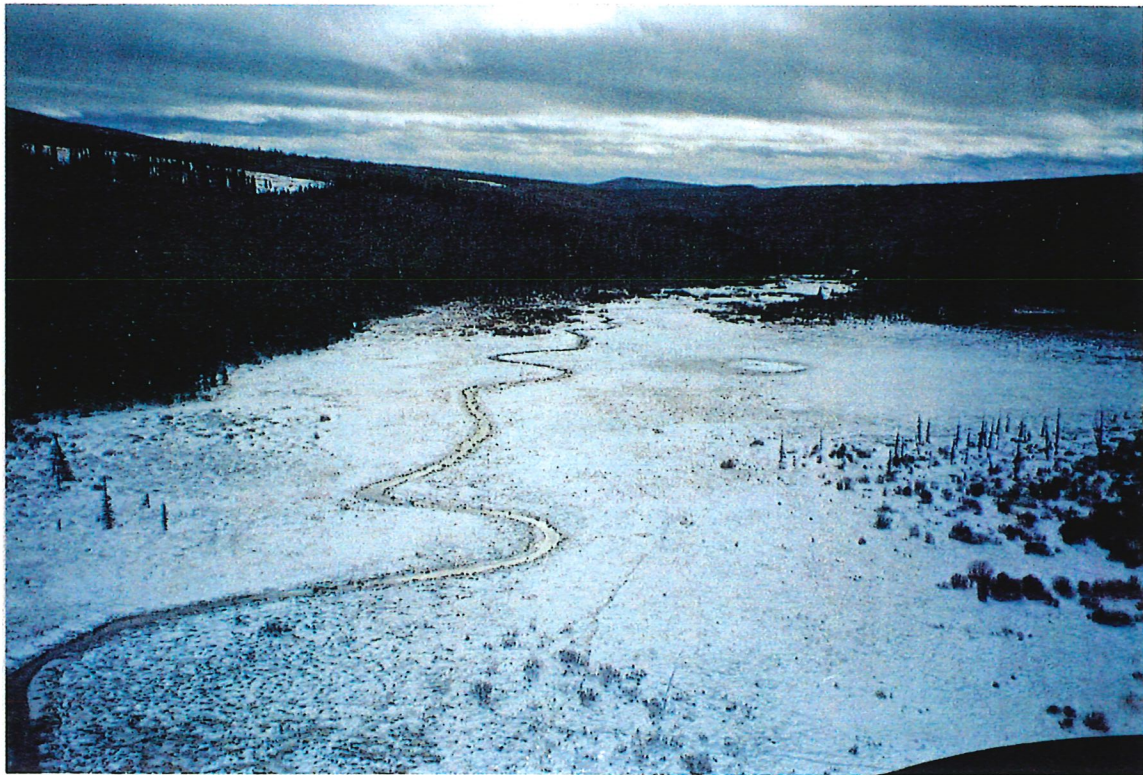
Photo 4
Typical Habitat Along Reach 1 of Upper Maxan Creek

In this reach, the stream is an unconfined, irregular meander which wanders through flat, marshy bottomland (Photo 4). The channel is confined between low, stable, heavily vegetated banks. The substrate is generally compacted. Occasional sand/gravel long bars and side channels are present. Pool and run complexes are dominant in this reach. A few harvested openings have been cleared near the mainstem. Coho salmon were observed in 1970 by DFO staff.

Narrow, deep, well-vegetated streambanks indicate that Reach 1 has not been significantly impacted by hydrologic increases. No enhancement or restoration works were designed for this reach due to overall good habitat conditions and poor access.

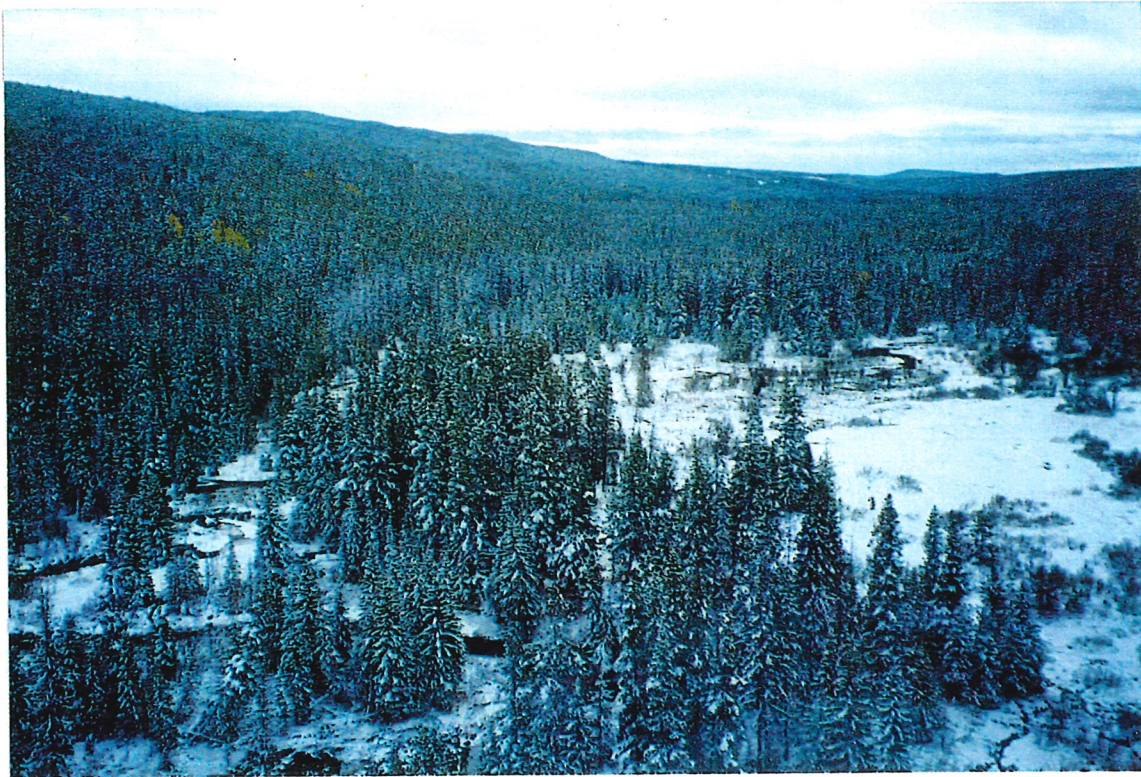
Photo 5
Typical Habitat Along Reach 2 of Upper Maxan Creek

Reach 2 is an unconfined, irregular meander which runs through marsh and meadow land (Photo 5). Characteristic low banks are well vegetated with herbaceous vegetation and shrub thickets. Occasional timber stands occur where suitable conditions exist. There is some beaver activity within the reach. Meander pools and long glides typify the habitat. Two harvested openings have been cleared in the lower portion of the reach. A logging road east of the reach crosses six tributaries as well as the mainstem near the headwaters and "Bernadette" Creek near the mouth. Fish species composition, distribution and use are unknown, but it is likely that coho salmon inhabit the reach given their presence in Reach 1 and the lack of obvious barriers to upstream fish movement.

No enhancement activities are recommended for Reach 2 due to good habitat conditions and poor site access.

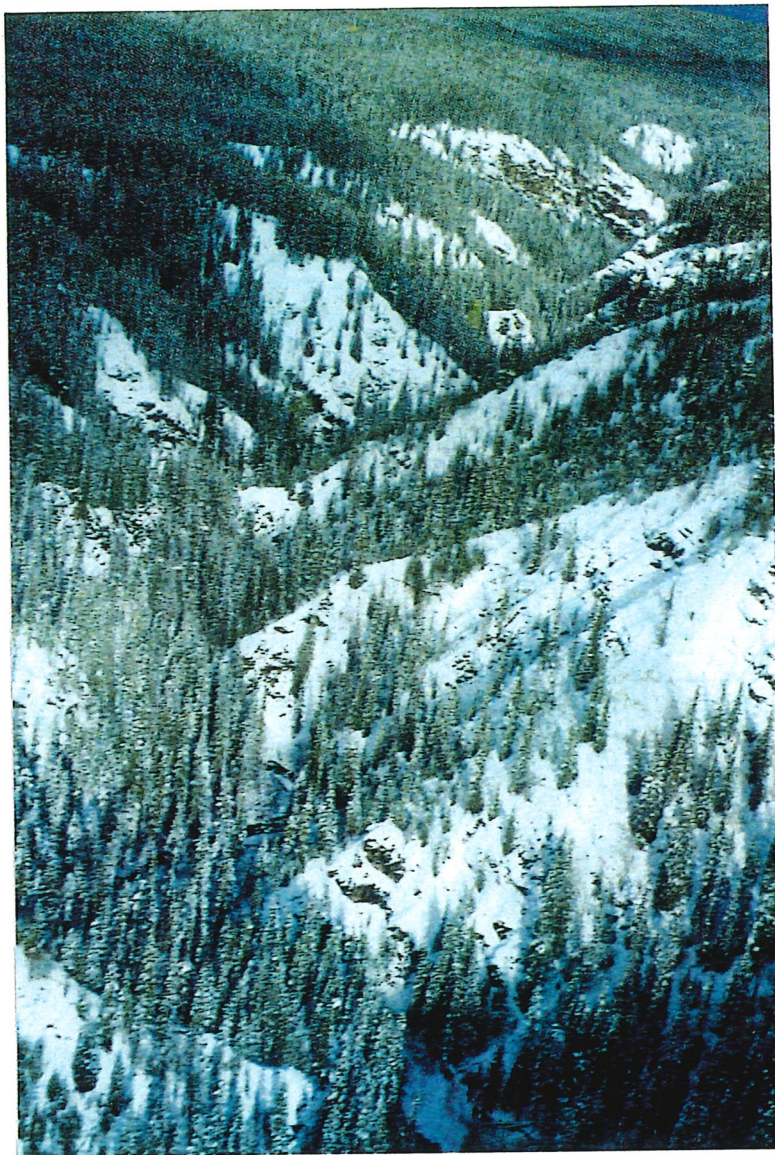
Photo 7
Typical Habitat Along Reach 2
of Foxy Creek

Foxy Creek is entrenched and confined within a deep canyon in Reach 2 (Photo 7). Mature pine and spruce stands provide limited canopy cover over the stream. Banks are protected by bedrock ledges as well as cobble and boulder materials. Small bank slumps are common throughout the reach. Two extensive bank slides and accumulated debris across the creek are major point sources for sediment input into the stream. A large slope failure has also occurred downslope of a clearcut (Opening #45). Two large log jams partially dam the creek and may be barriers to fish movement during low flow events. Abundant LWD obstructions form the pool-glide sequences which typify the habitat. Spawning gravels are limited in the cobble-bedrock dominated substrate. Reach 2 supports the same eight fish species as Reach 1. However, use of this reach by individual life history stages is not known. Bustard & Associates (1989) confirmed that rainbow trout spawn and rear within the reach.

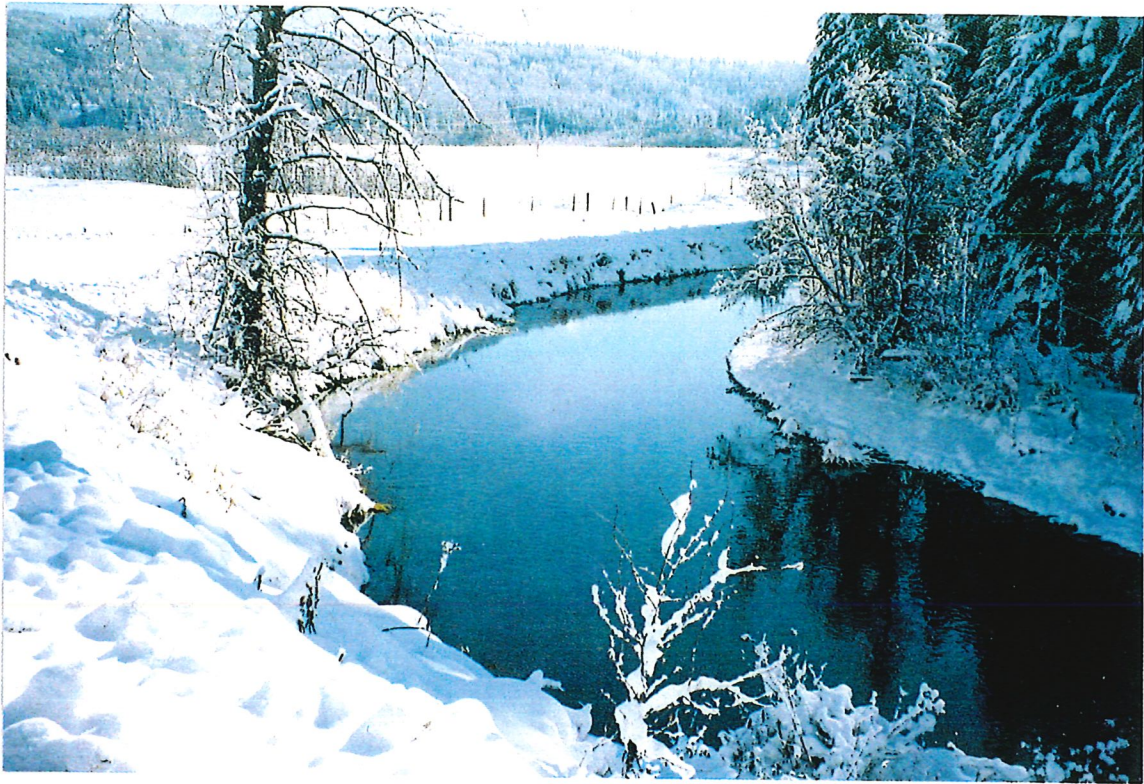
Photo 17
Stream Habitat at BR-S5

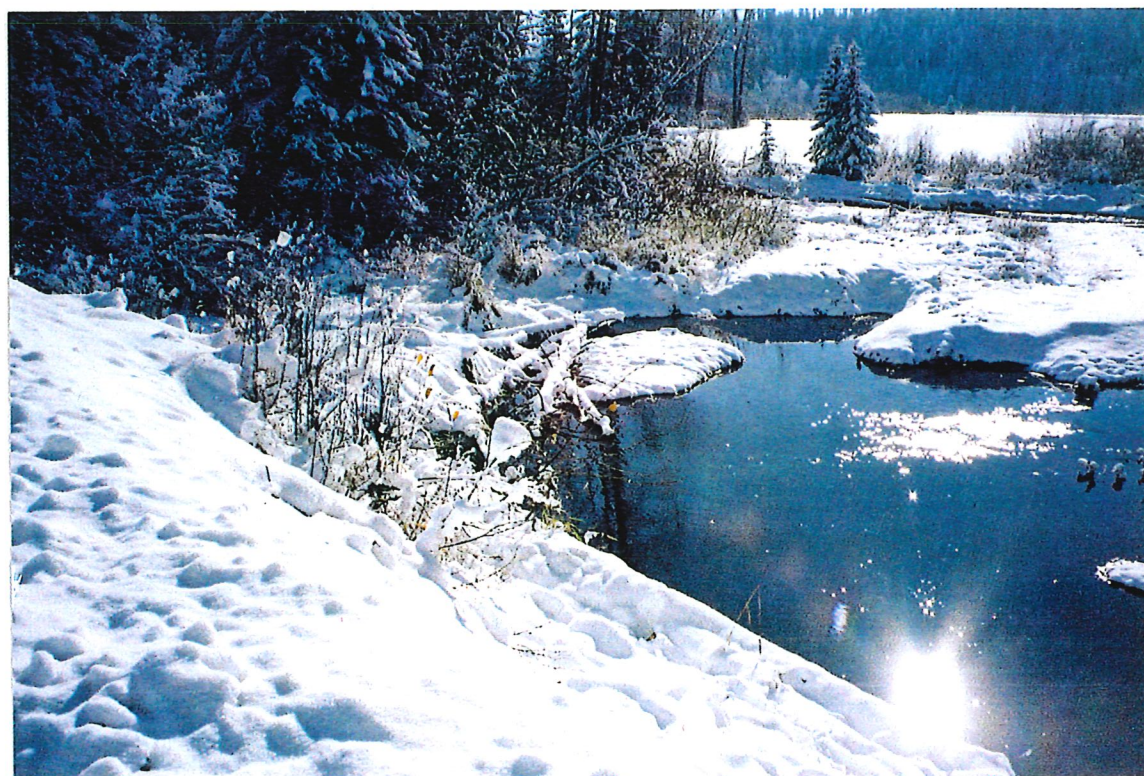
Photo 20
Site Characteristics
at the Upstream
end of BR-S6

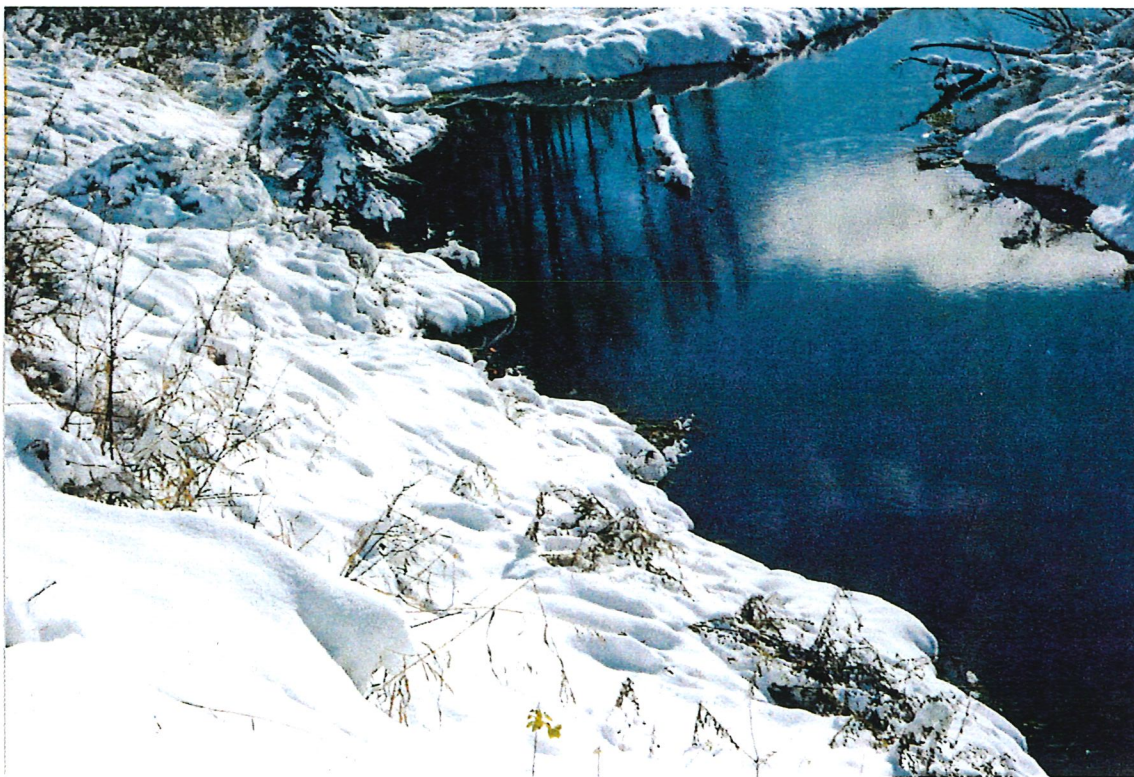
Site 8 (BR-S8) parallels the Rose Creek Cutoff Road and is located 160 m from the downstream end of Site 7 (Photo 24). The right bank is 140 m long, 7-10 m high, comprised of fines and generally stable. Grasses and overhanging banks provide limited fringe habitat. No woody vegetation has established along the roadbank. A long, deep pool runs along the entire length of the meanderbend.

Photo 24
Stream Habitat Characteristics at BR-S8

A schematic overview of recommended enhancement works at BR-S8 is provided in Figure 9. Equipment, manpower and cost requirements necessary to complete activities at this site are provided in Table 11.

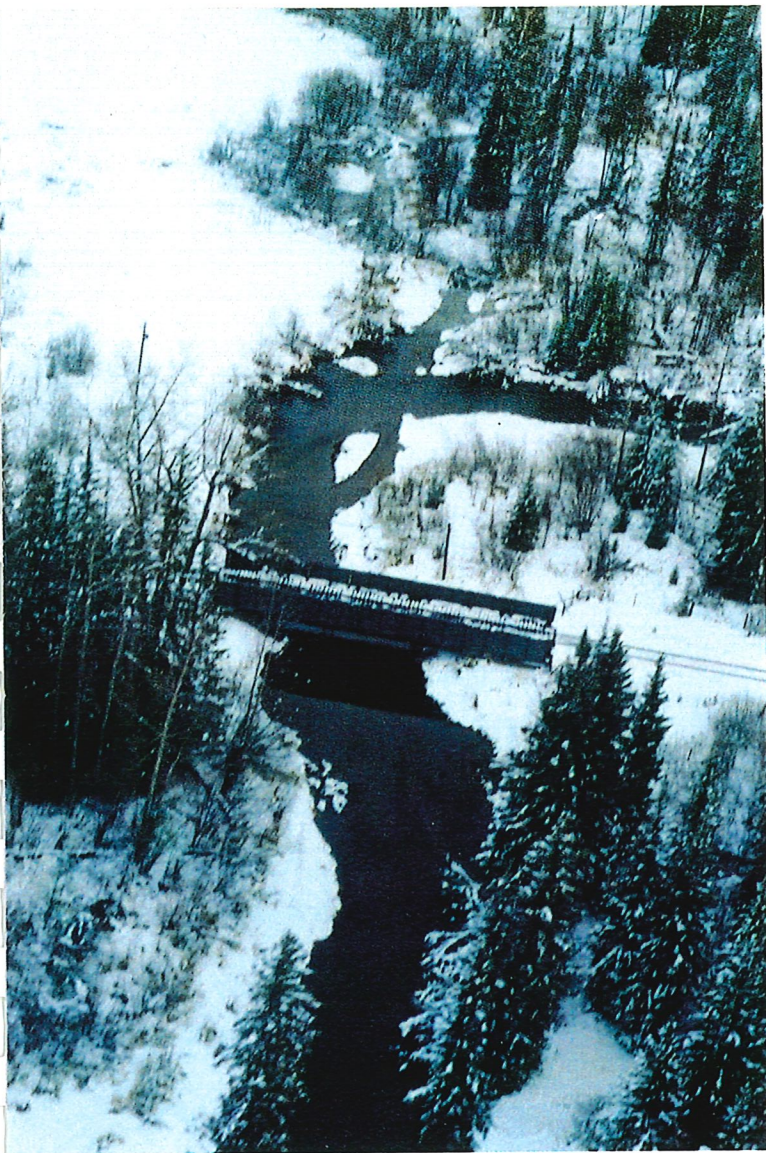
Site 9 (BR-S9) is located upstream of a railway crossing and is approximately 750 m downstream of Site 8 (Photo 25). Variable habitat at the site is provided by a 50 m long pool-riffle-run complex. Clean gravels and cobbles have deposited on the inside of the meanderbend. The right streambank is eroding (near vertical to vertical) and is composed of fines (Photo 26). Deep-rooted vegetation along the right bank is limited and overhanging vegetation provides abundant fish cover opportunities. Riprap protecting the base of the right crib has pulled away from the bank and is scattered on the channelbed.

Photo 25
Site Overview of BR-S9

A shrub/tree revetment will be positioned along the right bank to control erosion and provide overhead fish cover. Shrub revetments will be constructed from individual shrub clumps (bushes) which will be cut near the base and bound with heavy biodegradable twine and #9 galvanized wire. Trees and shrub bundles will be transported to the site by quad. If possible, revetment tips will be anchored near the base of the bank using T-posts. Tips will not be anchored if the posts cannot be pounded flush into the base of the bank. A floating revetment has the ability to move laterally, as well as up and down as streamflow rates increase and decrease. It is expected that continued build-up of material behind the structure will create a relatively stable overhanging bank while also enhancing fish habitat.

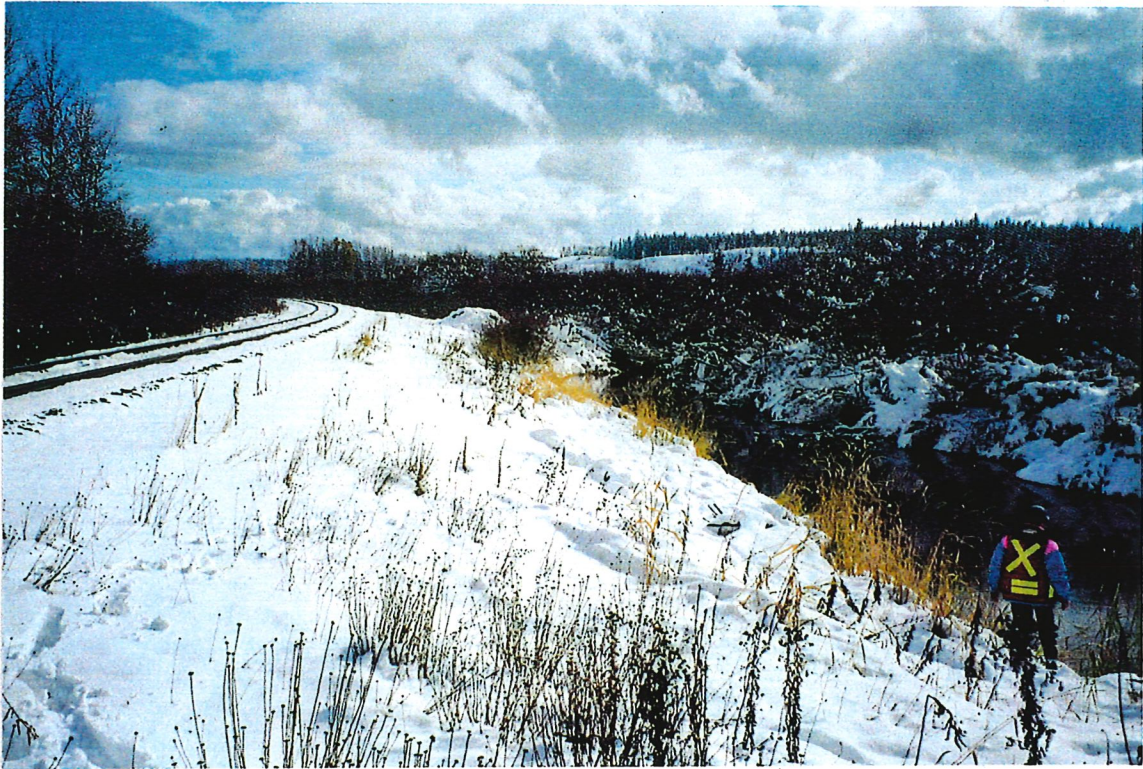
Site 12 (BR-S12) is located parallel to the CNR tracks 1550 m downstream of Site 11. It is 90 m long, partially armoured with riprap and stable. Herbaceous vegetation overhangs the banks but no shrubs are present (Photo 33).

Photo 33
Streambank Characteristics at BR-S12

In order to improve overhanging vegetation along the bank, the site will be intensively staked with quick-suckering shrubs.

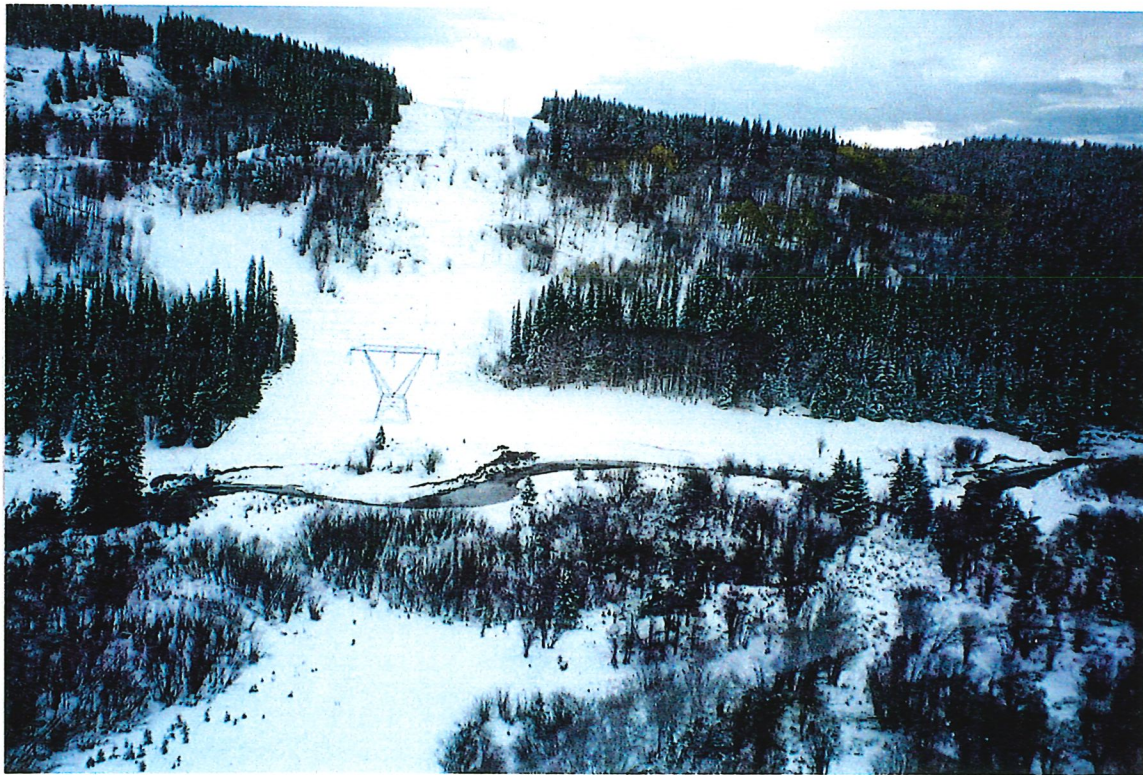
Site 13 (BR-S13) is located near a hydroline which crosses the Bulkley River 5.7 km downstream of Site 12 (Photo 34). Over 350 m of bank (left and right) is undergoing extensive erosion. Banks are 2 - 6 m high and are comprised of fine materials (Photo 35). The right bank has been clearcut upstream and downstream of the hydroline. Deep binding roots are absent and cover is marginal. Channel bed cobbles and gravels are veneered with silt. Bank stability and vegetation have been impacted by unrestricted livestock access - wide, flat channel morphology with low banks are indicative of prolonged livestock use (Photo 36).

Photo 34
Aerial Overview of BR-S13

Livestock access to this site (and along all watercourses and waterbodies in the watershed) should be restricted to protect downstream water quality and aquatic resources. This will involve large scale participation of landowners in the area. Ranchers, for example, should be educated about livestock impacts and learn the different methods available to mitigate these impacts.

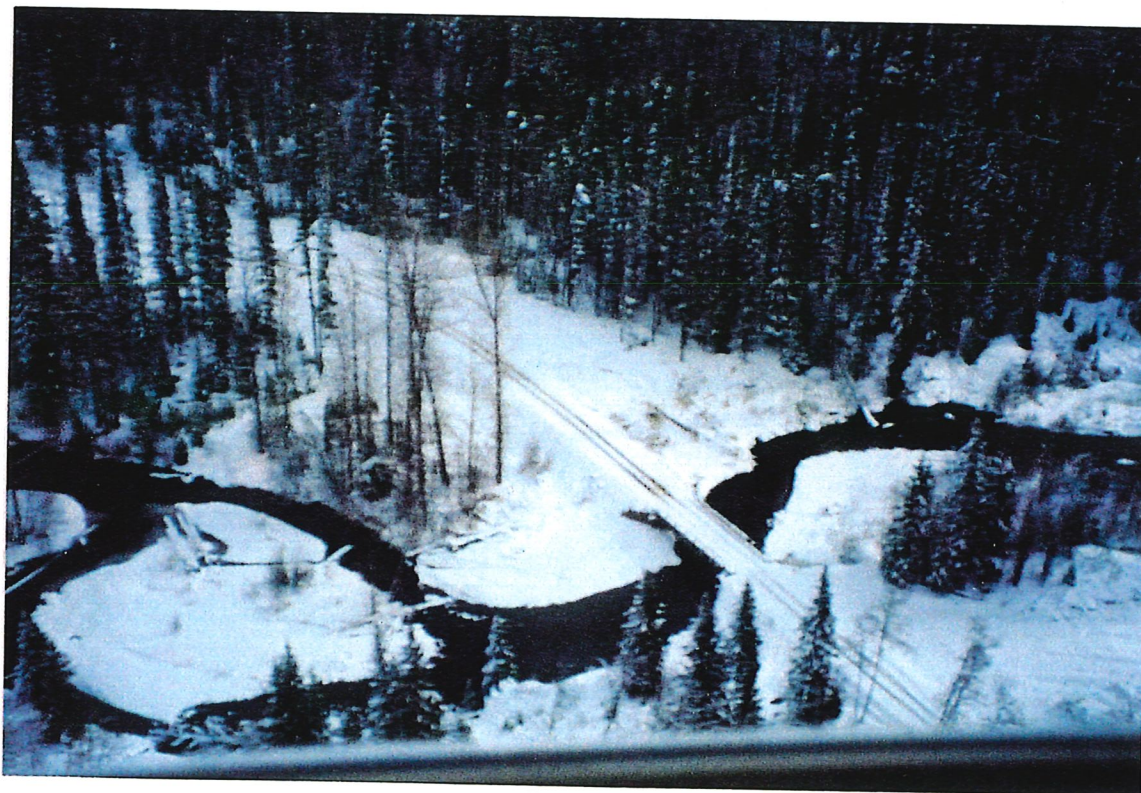
Site 1 (LMC-S1) is located at the Thompson Road bridge about 1.8 km downstream of the Maxan Lake outlet (Photo 44). Banks are reposed to steep and consist of fines to cobbles. Instream habitat is characterized by a shallow riffle-run at the upstream end and a long, deep pool downstream. Direct flow attack from the run complex has scoured a pronounced "nick point" in the right bank 16 m upstream of the crossing. Resultant downstream back-eddies are gradually eroding the downstream bank and will eventually cut behind the right bridge crib (Photo 45). Channel constriction, hardened artificial banks (wooden bridge cribs) and turbulent back-eddies have accelerated erosion along a 28 m long and 1.5 m high bank immediately downstream of the crossing (Photo 46). The left bridge approach is eroding through an underground piping system which has developed behind the crib (Photo 47). The absence of deep, well-rooted vegetation along the banks has decreased bank integrity, increased sedimentation rates and limited streamside fish cover. Instream habitat, excepting that provided by the deep pool, is limited.

Photo 44
Aerial Overview of LMC-S1

A schematic overview of recommended enhancement works at LMC-S1 is provided in Figure 17. Equipment, manpower and cost requirements necessary to complete activities at this site are provided in Table 19.
