MAXAN WATERSHED STREAM HABITAT RESTORATION WORKS

1998/99

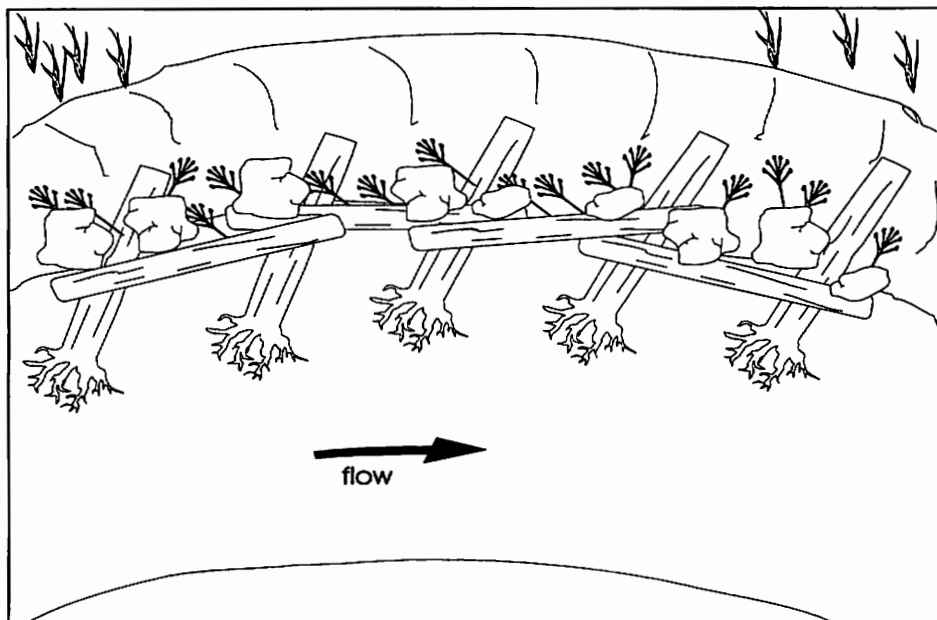
Figure 3: Typical LWD Revetment

The basic method used to stabilize banks was the large woody debris revetment for moderate energy sites (page 6-20, WRP Technical Circular No. 9). Typical installation is shown in Figure 3 and involved the following steps:

Variations of this method were used depending on site conditions and materials available. Variations included; placing an additional row of root wads over top of the header log, placing root wads with no footer log, placing root wads with no header or footer log, using branched spruce trees as the header logs, incorporating live willow clumps into the structure, and anchoring root wads with driveable anchors.
