Gitsegukla Band Council 1998 Submission to

**Annual compendium of WRP
Aquatic Rehabilitation Projects**

Kitsequecla River WRP 1998 Site Works

Kitwanga River WRP 1998 Site Works

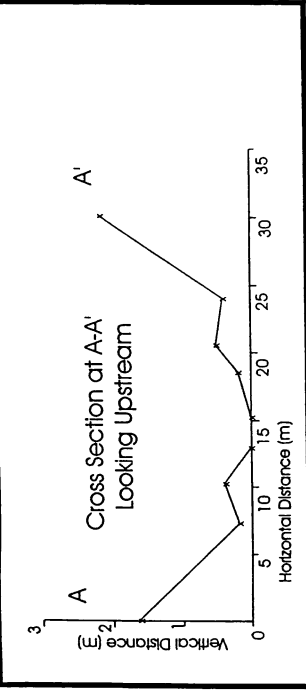
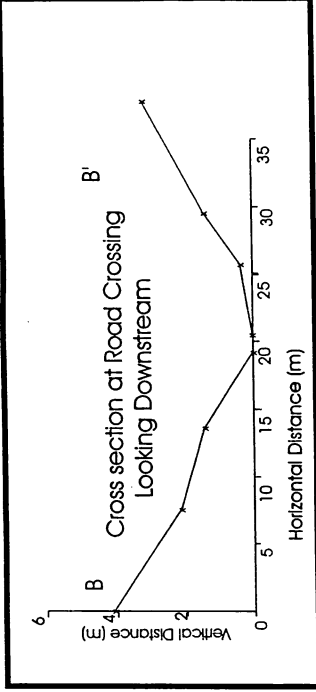
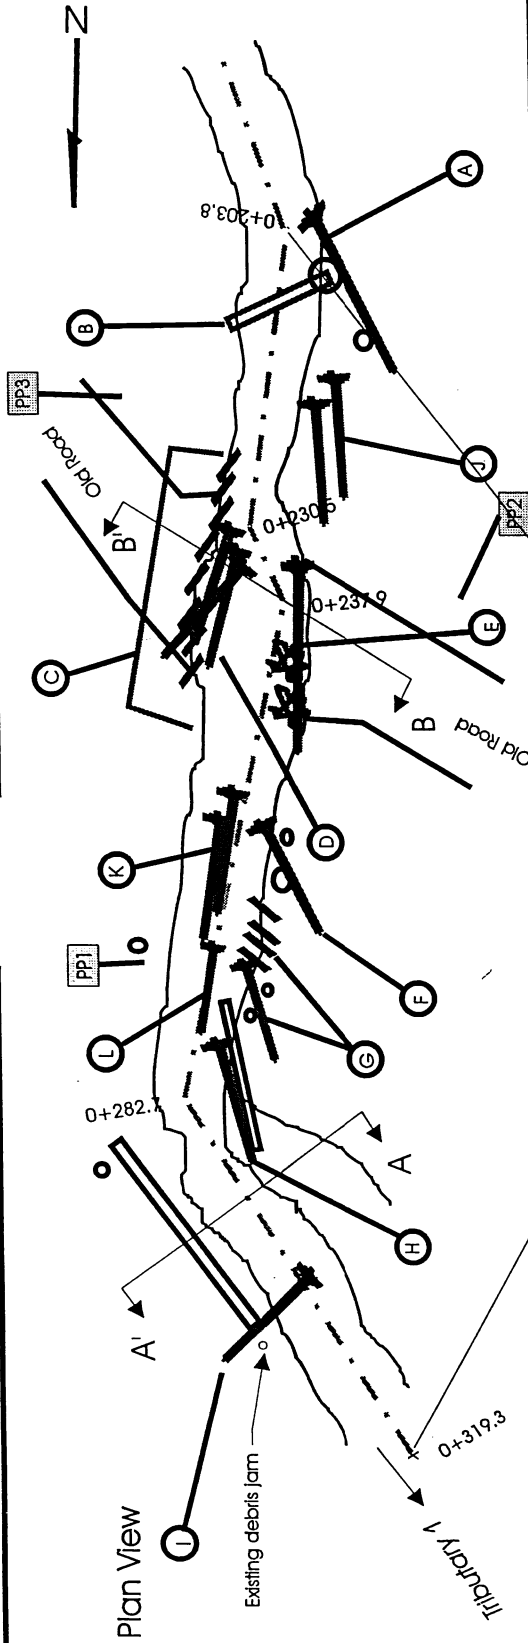
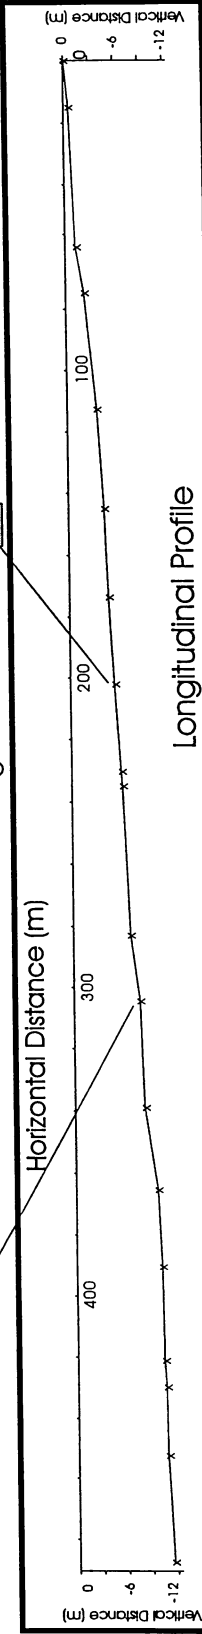
Prescription Site 3
Construction Drawing

Total Materials Required
 14 complete trees (>40 cm diam. x >8 m long)
 1 log (>40 cm diam. x >6 m long)
 12 debris catchers (~0.2 m diam. x >2 m long)
 2 root wads

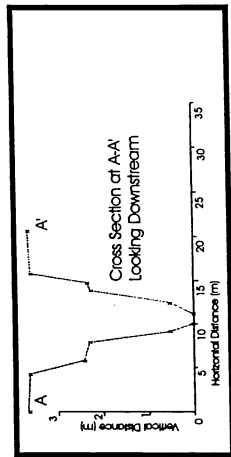
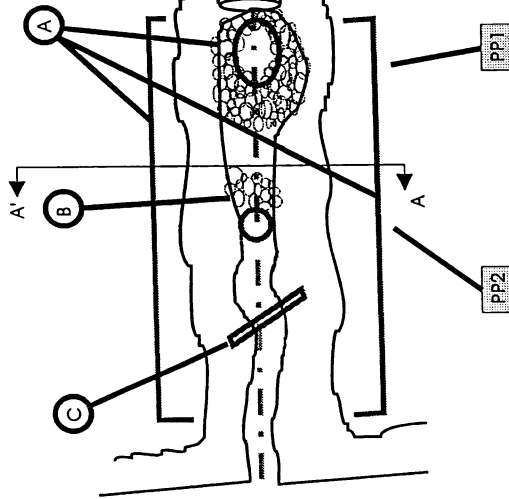
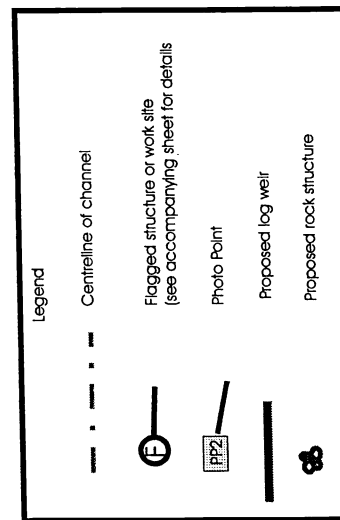
Prescription Site 14
Construction Drawing

Perched Culvert
