The purpose of this report is to present background information and results from effectiveness evaluations conducted on instream structures, riparian, road deactivation, and stream crossing works that were installed between four and eight years ago by watershed restoration programs. In 2006, Gitksan Watershed Authorities was retained by the Pacific Salmon Commission to conduct a effectiveness monitoring in three Mid Skeena sub-basins: the Kispiox, Kitseguecla, and the Suskwa.

This watershed restoration effectiveness monitoring assessment is part of a larger regional effort to ensure treatment designs and their applications are effective, and if not, provide technical feedback to refine designs. As well, the evaluations will rate the extent of watershed recovery achieved and help to ensure funds are spent on the most cost-effective treatments.

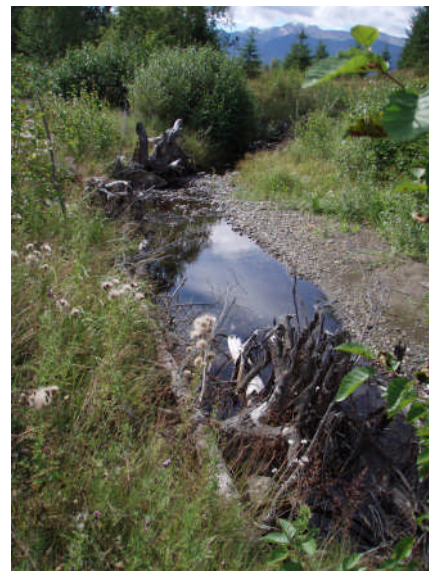
Figure 7. View downstream at P8-1.

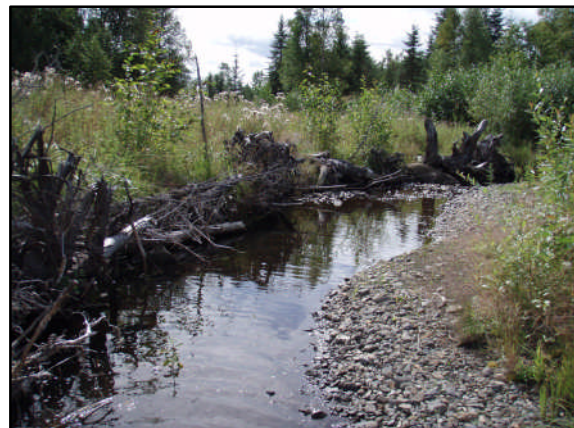
Figure 9. View downstream at P8-1.

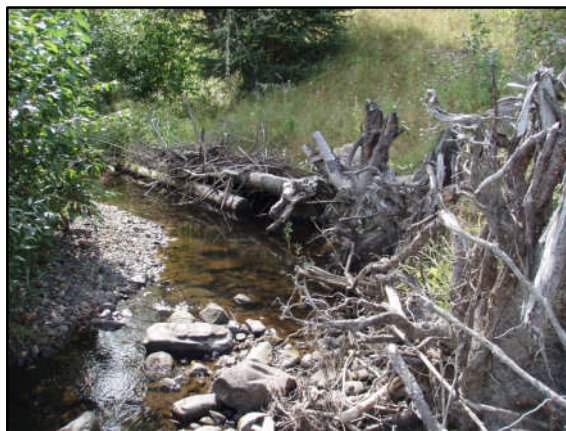
Figure 11. View downstream at P8-2.

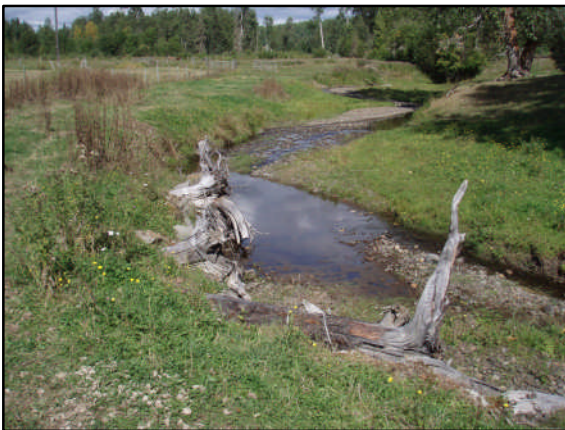
The Site P-2 restoration installation is achieving its objectives of reducing bank erosion, creating instream habitat, and reducing water velocity. All structural components are integral with no sign of instability. There is minor bank erosion upstream of the installation as seen in Figure 31. It is recommended that angular rock could be hand-placed at this point for 4-5 m upstream to reduce any erosion in high flow events.

**Figure 25. View upstream of P-2 and channel.**

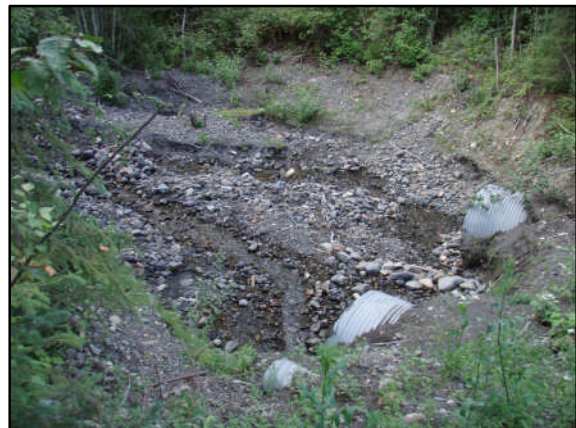
Figure 28. View upstream from culvert inlets.

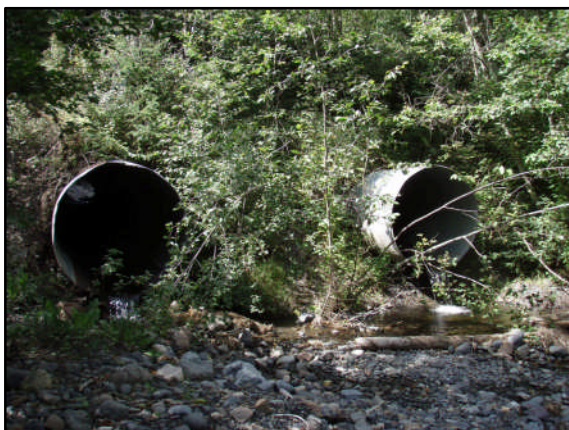
Figure 29. View upstream to culverts outlet.

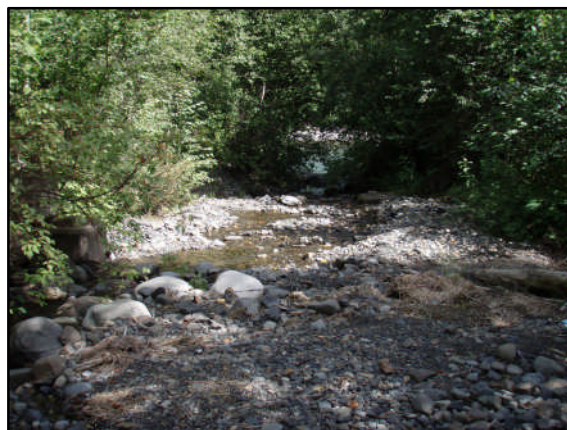
Figure 30. View downstream from culvert outlet.

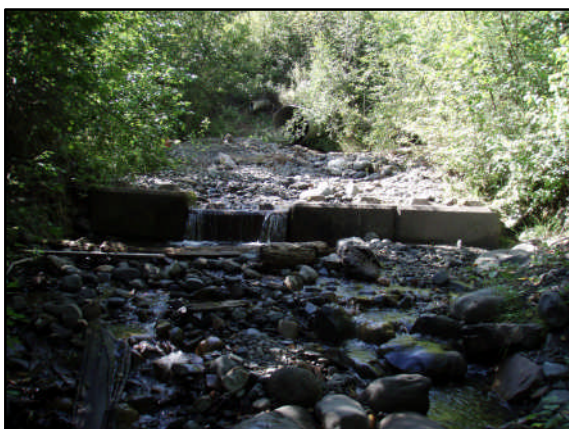
Figure 31. View upstream first lock block step.

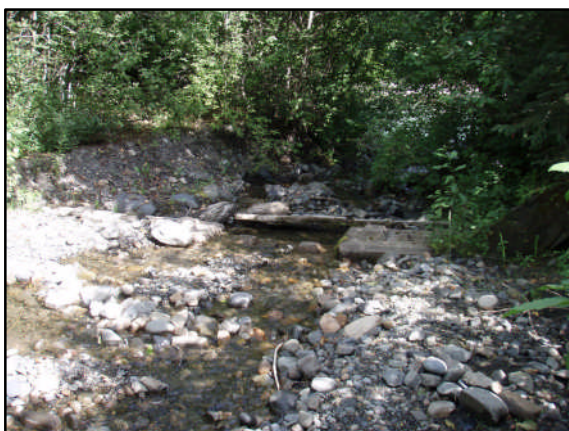
Figure 33. View downstream to 2<sup>nd</sup> lock block set.

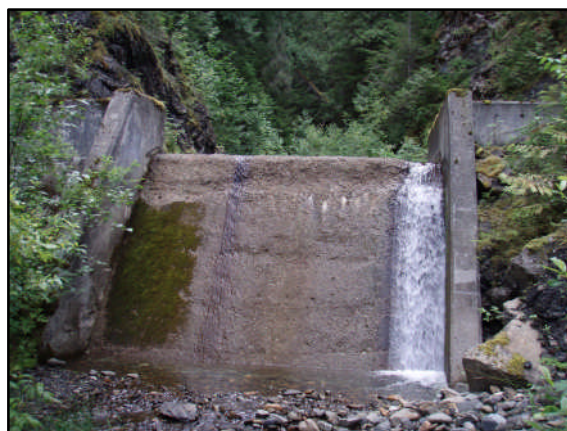
Figure 34. Dam spillway 630 m upstream.

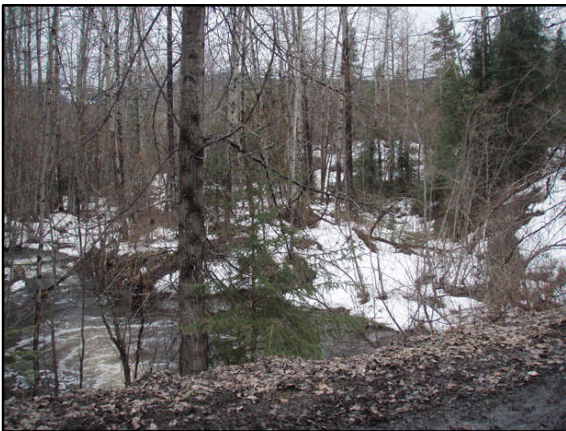
Figure 38. Original channel shows to the right.

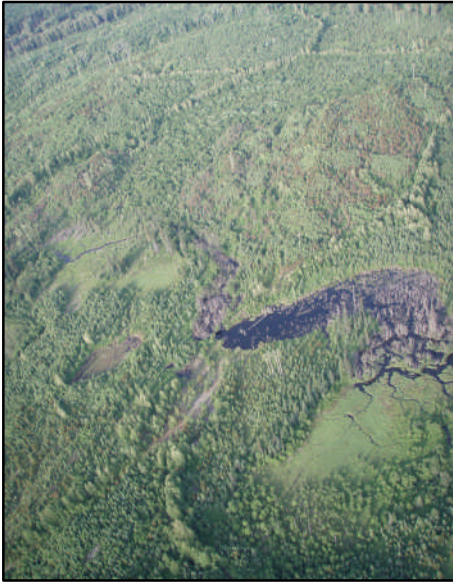
This evaluation could not locate any of the instream structures and it is suspected that highwater flows carried the structures downstream.

**Figure 56. Photo shows lower reach of Beaverlodge Creek.**

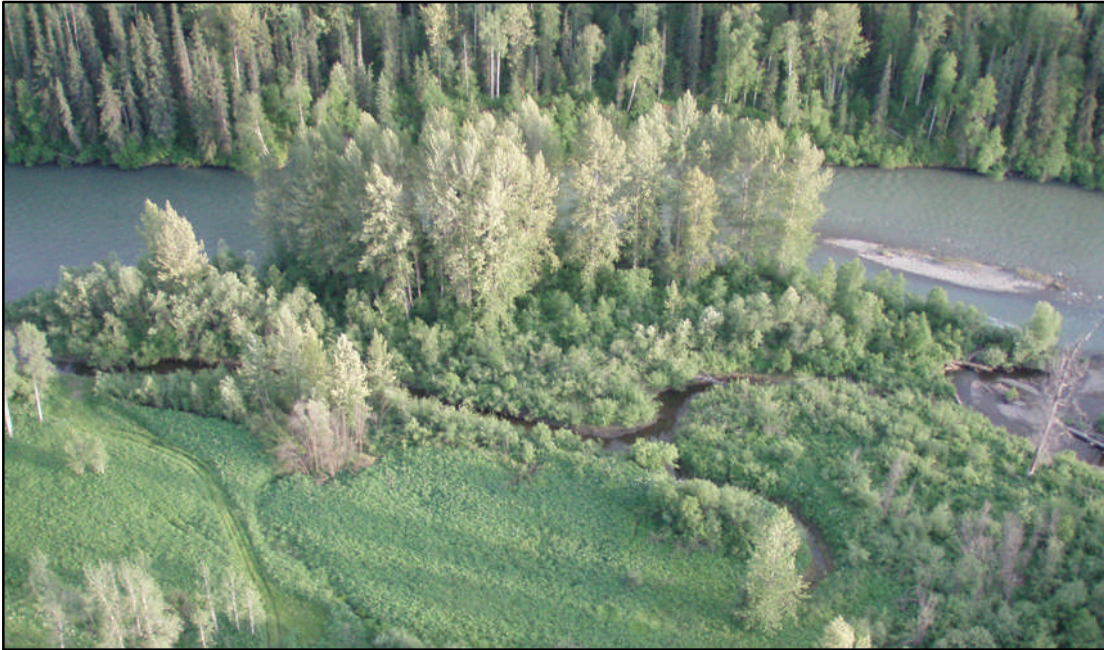
In 1997, a channel was excavated on the south side of Kispiox Trail close to the Cullon Creek/Kispiox River confluence. The objective of the channel was to provide rearing opportunities for juvenile fish. The 189 m in length excavated channel follows a high water channel located in the lower level of the Kispiox River floodplain and a 55 m channel forks off to the northwest 130 m from the Kispiox River. The initial 33 m from the Kispiox River was dry when surveyed in mid-August. The excavated channel depth was apparently 1.75–2.0 m with the excavated material piled adjacent to the channel. The bank slopes were hydro-seeded, but erosion is still occurring. The channel substrate is covered with silt and mud. Bank stabilization, planting

**Figure 61. Excavated channel with Cullon Creek to the right and Kispiox River at the top.**

During the course of summer 2006, observations indicated that water levels fluctuated, often day by day. Typical water depth recorded August 22 ranged from 0 to 0.79 m. Due to low water levels; fry trapped in shallow pools were being preyed on by birds. DO levels ranged from 5.1 to 2.9 mg/L, while water temperatures ranged from 11.9 to 13.2 C°. DO levels measured by McElhanney (1999) in 1998 were all below 4.8 mg/L.

Overall, the conceptual design and site suitability for this project are rated poor. Critical physical characteristics needed such as appropriate DO levels and in-flowing water reflect poor planning. It is recommended that the site be abandoned.

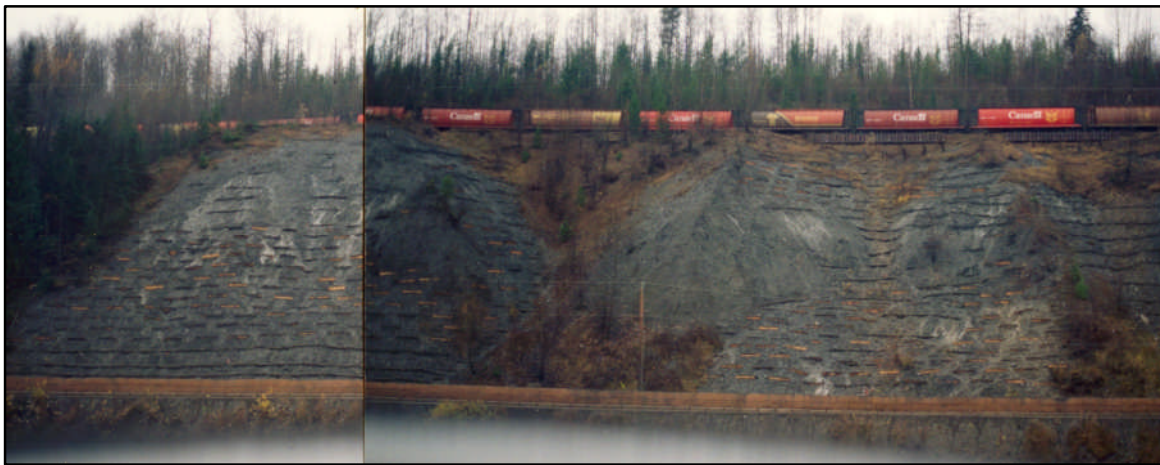
**Figure 70. CN Rail tracks at the top, hillslope stabilization structures completed in 1997, and brown drainage berm at the toe of the slope.**

Structures installed included 248 modified brush layers, 383 m of wattle fence, 48 m of live pole drain, 54 gully breaks, 320 live willow stakes, and grass seeding spread over four face units and three gullies. In 1998, structures that failed following spring snowmelt were repaired. Periodic maintenance has occurred since that time, which has mostly consisted of removing sediment from the drainage berm at the toe. This evaluation found 78% of the bioengineering structures intact and functioning. Seepage from high on the slope was not channeled appropriately and continues to provide surficial slides as shown in Figure 71. These surface slides primarily affected the modified brush layers by either burying or removing them. Approximately 52% of the bioengineering structures installed failed to sprout or sprouted and then died. However, the physical structures have maintained hillslope stability.

Evaluation results indicate that the seepage zones located high on the hillslope need to be drained by mechanical or bioengineering methods if full restoration is to occur. It is recommended that a rock filled drainage ditch that directs water to the side of the slide and into the gullies with rock blankets installed over the seepage zones and applied from the CN Rail grade would likely be successful in stabilizing the slope. Future bioengineering projects could benefit from the addition of fertilizers or manure.

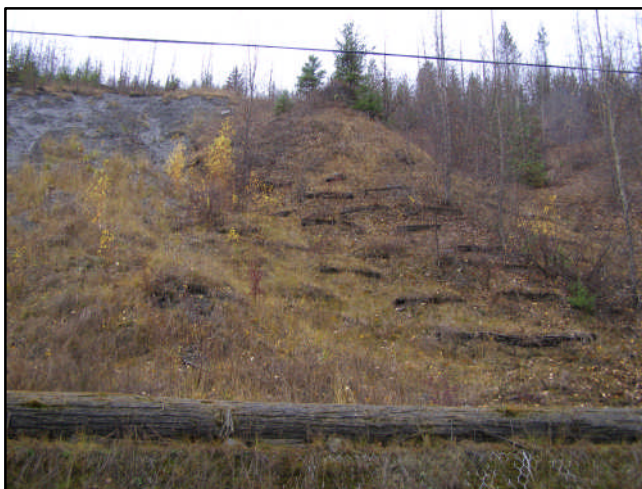
**Figure 73. Photo shows drainage berm at the bottom and stabilized brush layer area.**

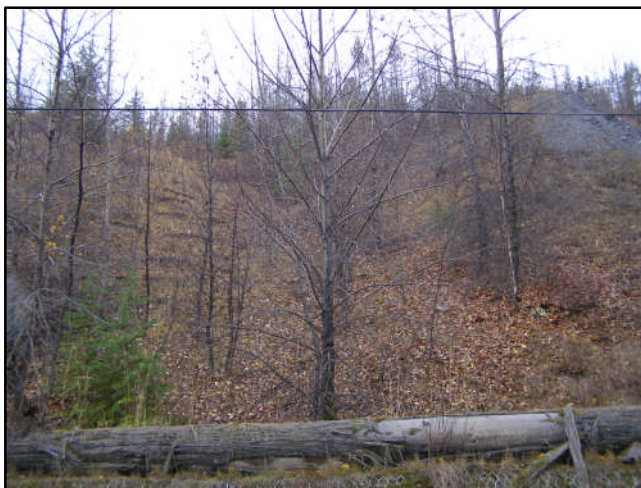
**Figure 74. Photo shows stabilized Gully #1.**

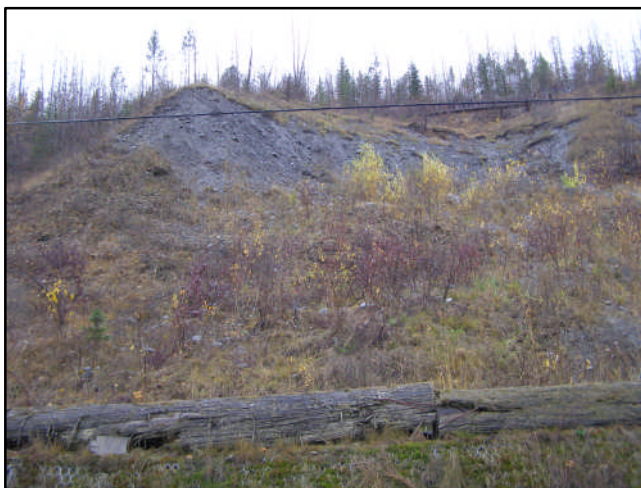
**Figure 75. Photo shows drainage berm at the bottom, stabilized brush layer area, and seepage zone above.**

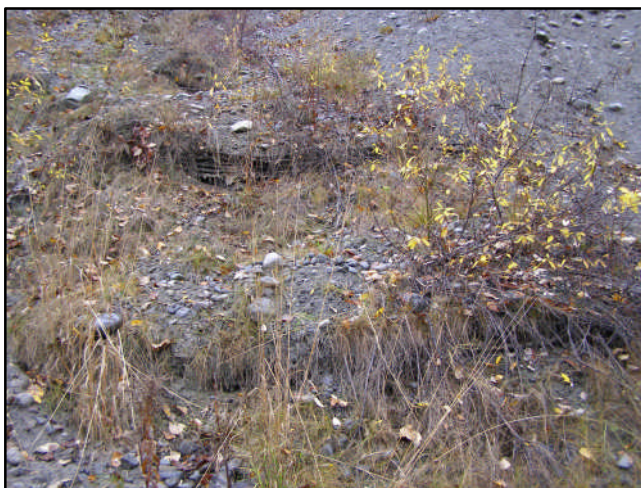
**Figure 76. Photo shows a close-up of functioning gully breaks in Gully #2.**

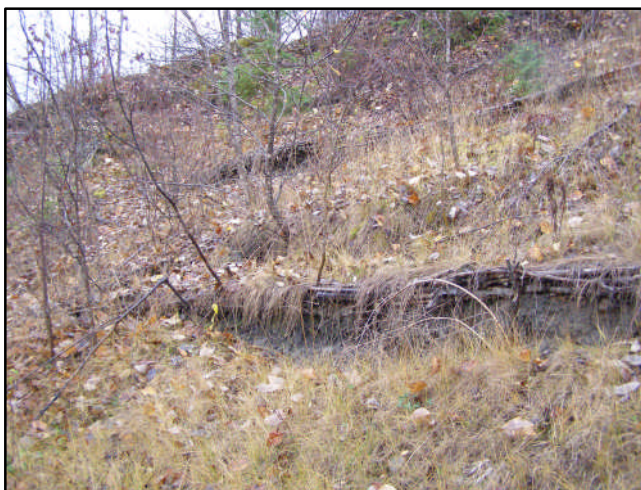
**Figure 78. Photo shows functioning wattle fences in Area #4.**

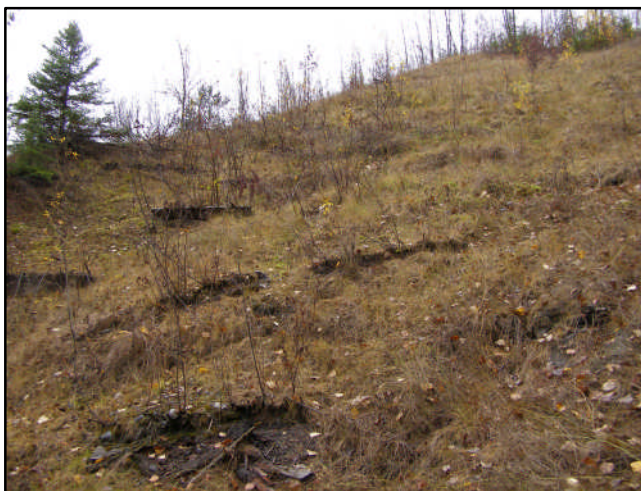
**Figure 79. Photo shows modified brush layers with willows established.**

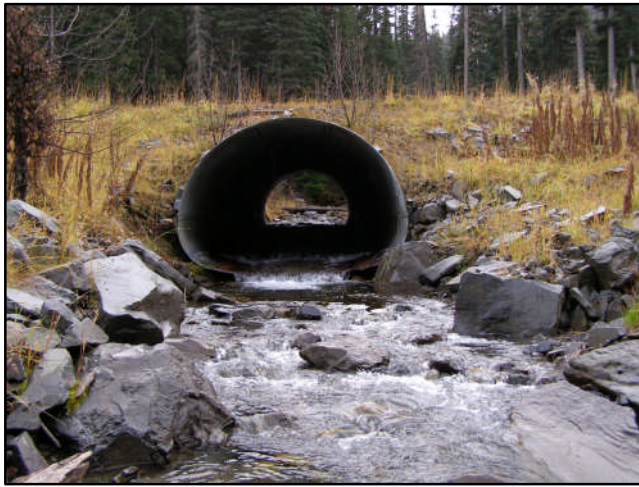
This effectiveness evaluation found high elevation, low quality habitat with 1.3 m falls and shallow, swift flows upstream and downstream of the culvert. The stream gradient upstream for approximately two km averages 14%. Currently Dolly Varden and bull trout are negotiating the 1.3 m falls framing the crossing site. Currently the culvert outfall drop is 15 to 20 cm depending on water levels. Velocities range from 0.85 to 2.13, again depending on flow levels. The outlet pools have been scoured out by high flows and don't function as step pools presently. Our recommendation is to install an open bottom structure, be it a culvert or bridge.

Figure 93. View is upstream to culvert outlet.

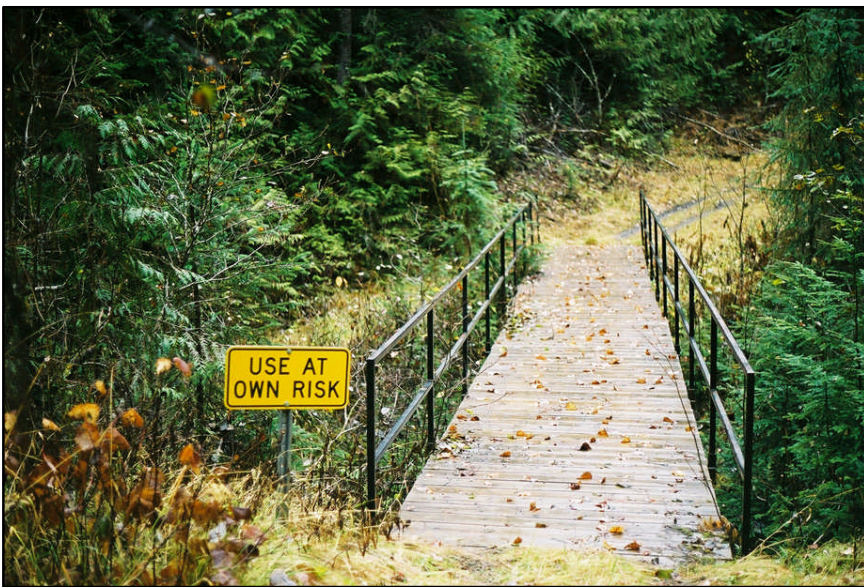
At some point in the near future, the old crossings will sink into the channel and exacerbate the bank failures that have occurred in the past. The ATV bridge instalment indicates poor planning and conceptual development. It is recommended that the ATV bridge be pulled, the old crossing structures be pulled out of the channel and the ATV bridge be repositioned. The streambank failures need to be assessed by a geomorphologist in regard to drainage and stabilization.

Figure 97. View eastward across Fifteen Mile Creek ATV bridge.

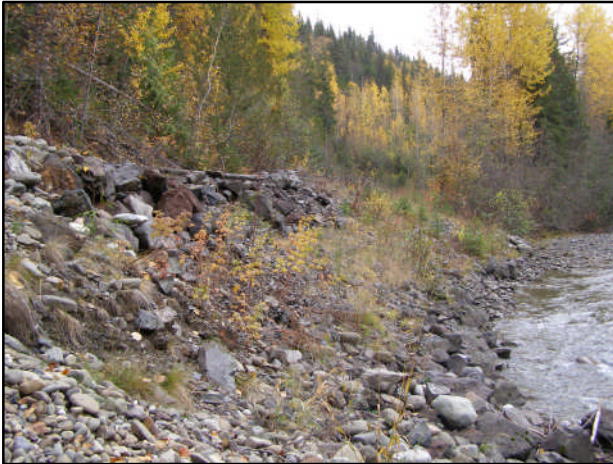
**Figure 100. View upstream with Kitsequecla River on the right and berm at base of slides on the left.**

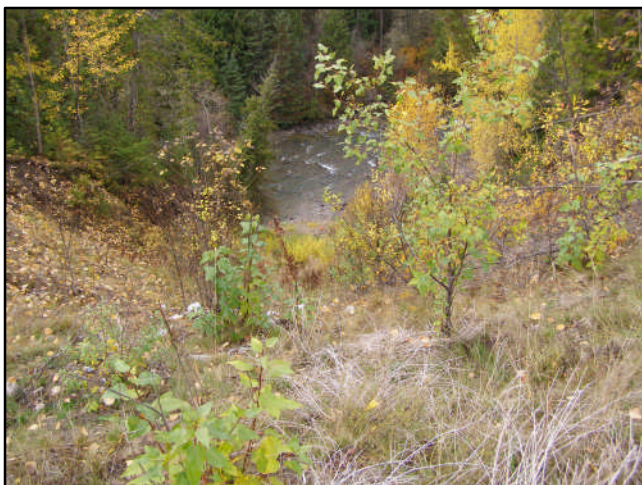
**Figure 103. View down Slide 1 from the roadside.**

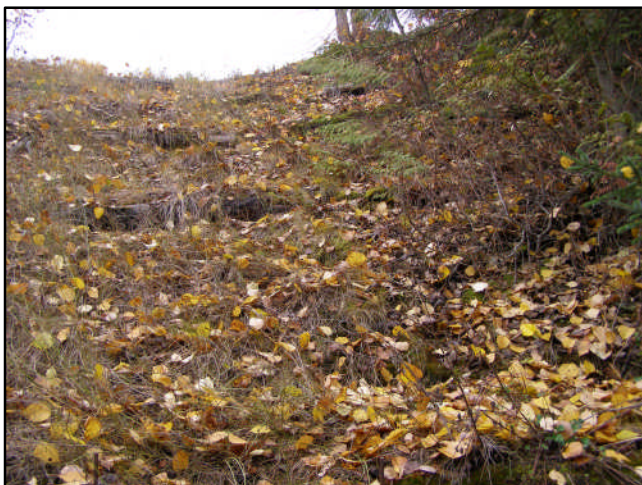
**Figure 104. View of the upper, northern portion of Slide 2.**

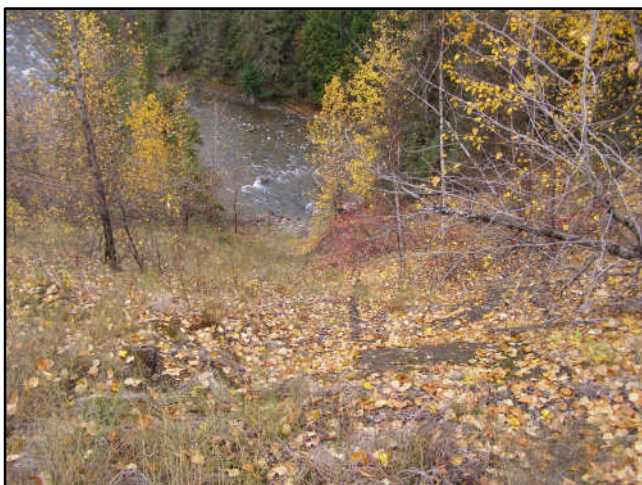
**Figure 105. View down southern side of Slide 2.**

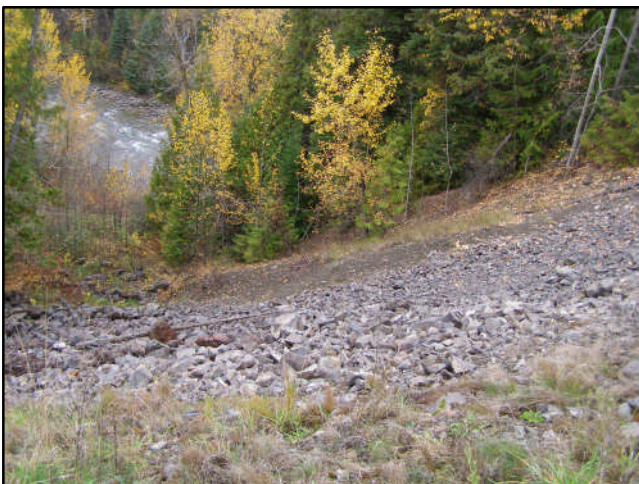
**Figure 107. View across the lower portion of Slide 3 that received a rock blanket.**

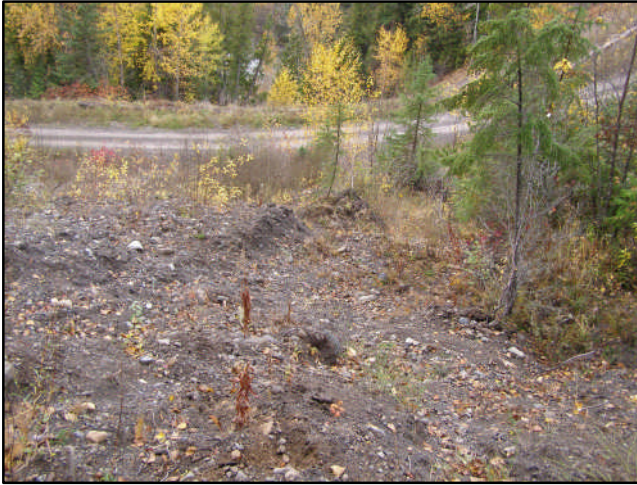
being ravelling. On Slide 3, the upper, northern portion has experienced light slumping. The southern portion of Slide 4 and Slide 5 are experiencing active wasting and the live pole drains are no longer functional. These sections need to be reconstructed and then maintained. We recommend a hydrologist visit the site and make recommendations on potential drainage solutions that may be an opportunity upslope of Slides 4 and 5. If drainage solutions aren't apparent, we recommend installing a rock blanket the lower portion of Slide 5 and the southern lower section of Slide 4. Overall, this effectiveness evaluation rates the site as fair to good.

**Figure 109.** View down northern side of Slide 4 to the road.

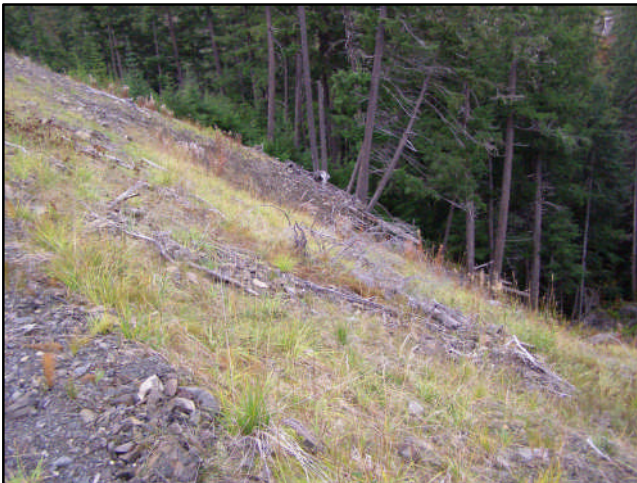
**Figure 112.** View across slope located at Slim Jim 0+467. The slope has been rock blanketed.

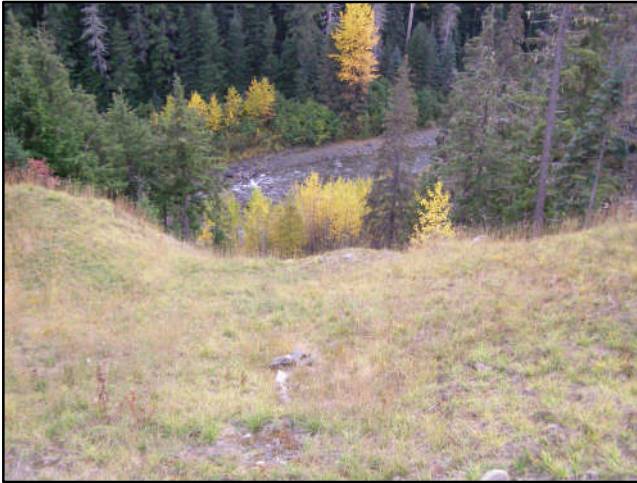
**Figure 113.** View southward downslope and across West Kitsuns Creek 500 m downstream of the bridge. The slope has been pulled back to a certain degree.

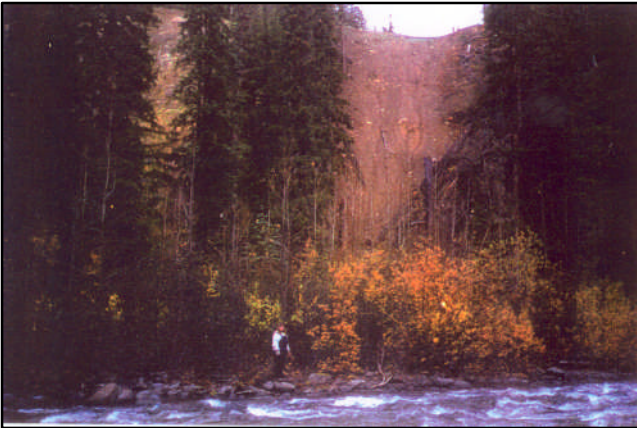
**Figure 114.** View northward across West Kitsuns Creek to slide area shown in Figure 113 above.

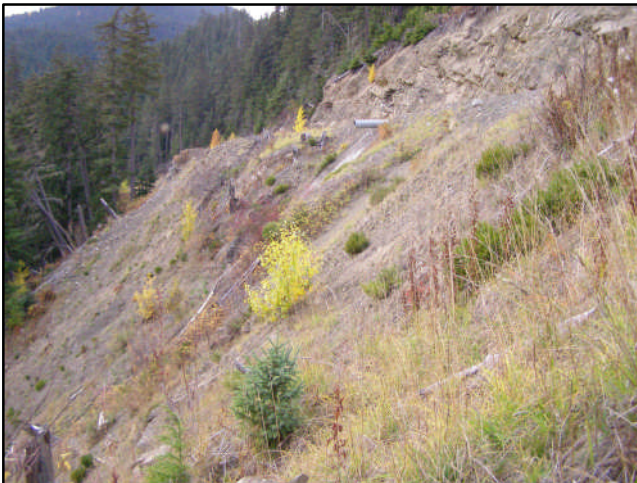
**Figure 115.** View westward across slide located 340 m downstream of the bridge crossing West Kitsuns Creek. Note over-extended perched culvert delivering drainage to unstable slope.

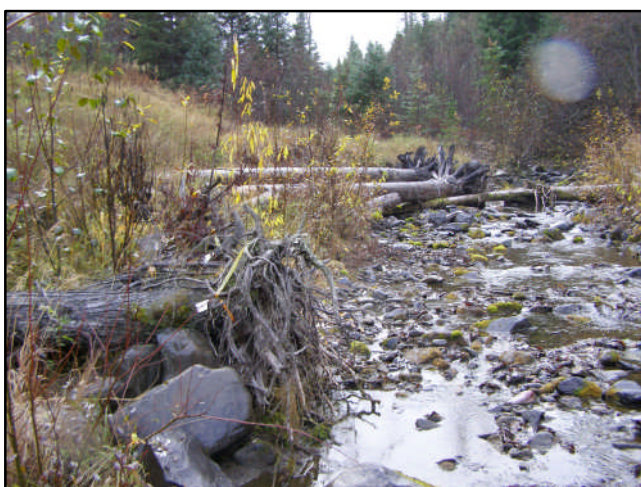
**Figure 119. View upstream from Tree #10.**

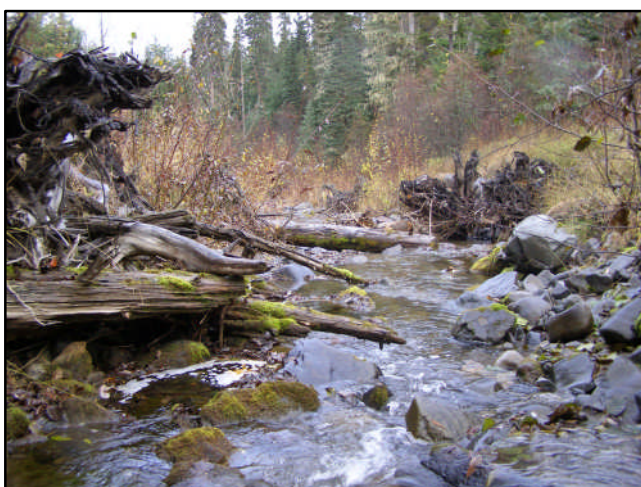
**Figure 122. View downstream from upstream end of installed structures.**
