Riparian and Channel Photos

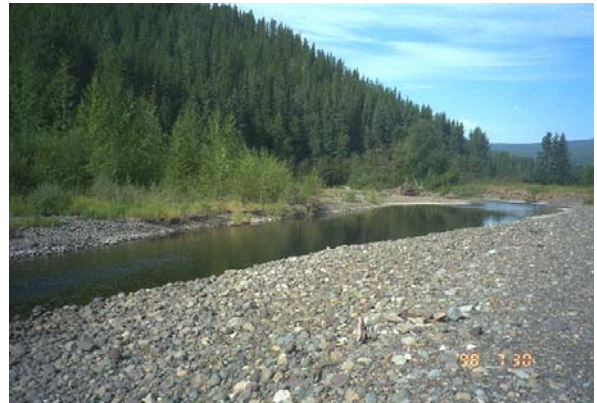
Plate # 5: Typical riparian forest community in predicted site series 08 (\$58) polygons.

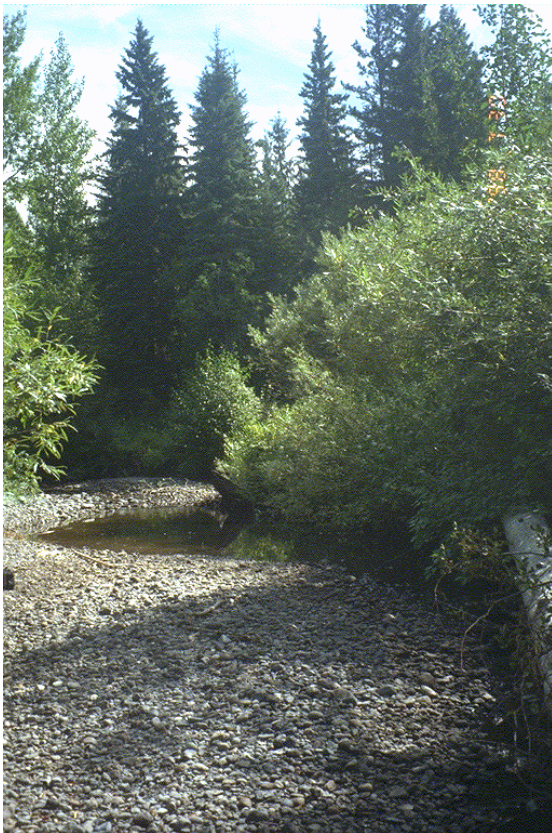
Plate # 6: More complex section of channel due to LWD input. Typical riparian forest community in predicted site series 08 (\$58) polygons.

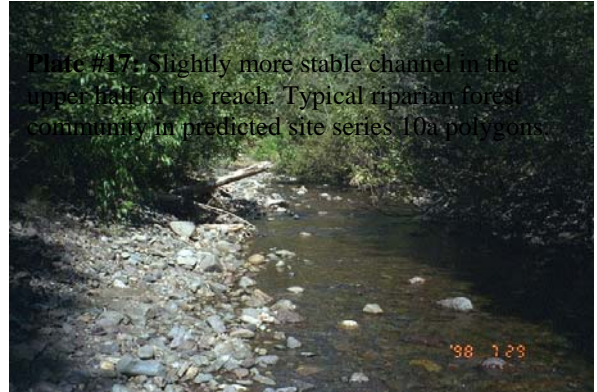
Plate #17: Slightly more stable channel in the upper half of the reach. Typical riparian forest community in predicted site series 10a polygons.

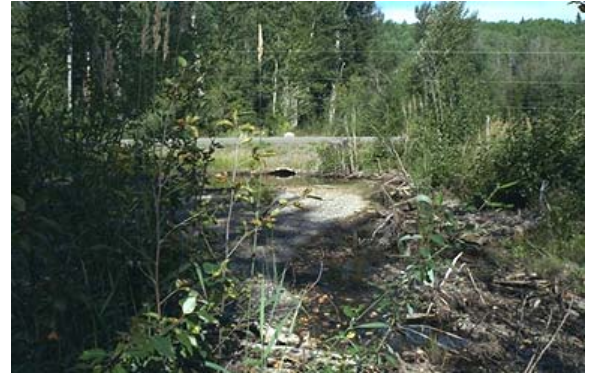
Plate #_: Typical riparian forest community in predicted site series_ polygons.

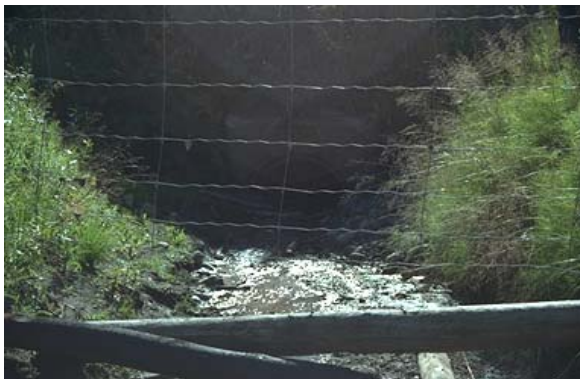
Plate_: Downstream view of railway culvert 28 metres upstream of the Barren/Bulkley confluence. The remainder of the reach runs through private ranch lands.

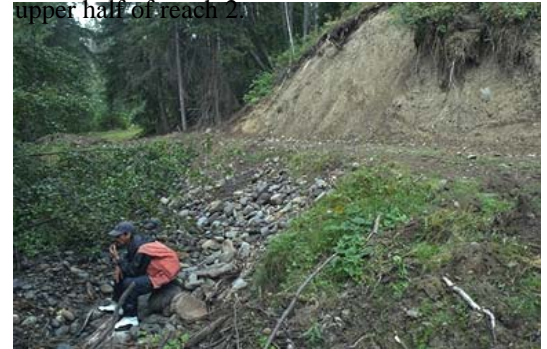
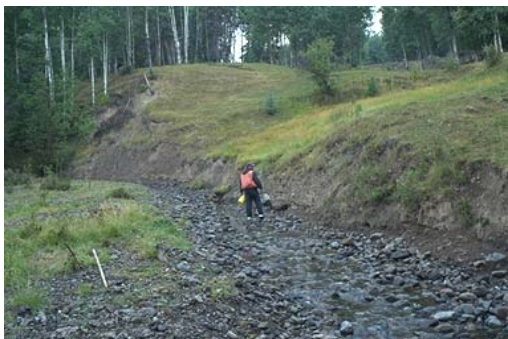
Plate_: Cattle tracks and eroding banks contributing sediment to the reach, downstream of the powerline crossing.

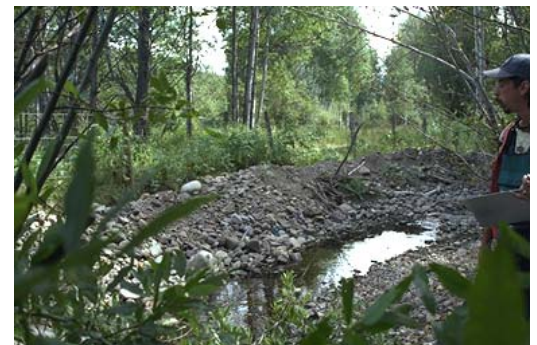
Plate_: Dyking put in place by neighbouring land owners, to protect fence line during high flow period.

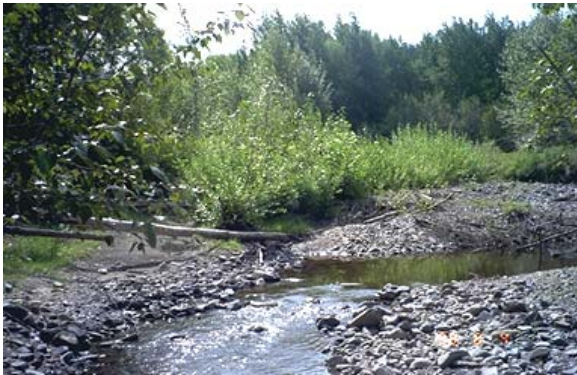
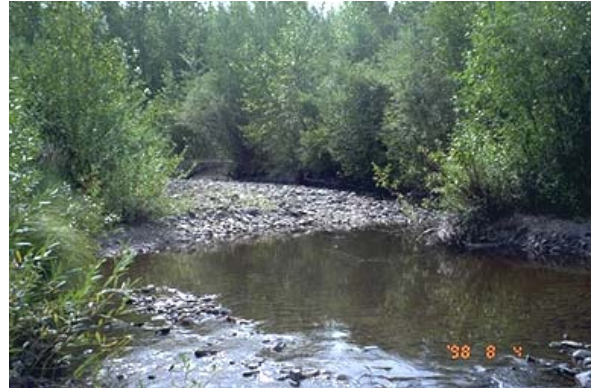
Plate #_ : Typical channel and riparian at transition zone, 500m upstream of reach break, where creek becomes more complex.

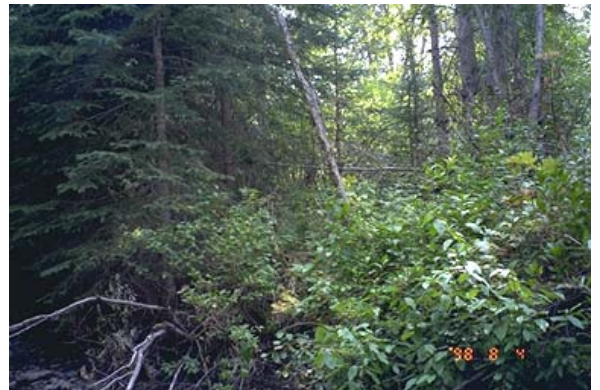
Plate #_ : Typical riparian forest community in predicted site series_ polygons.

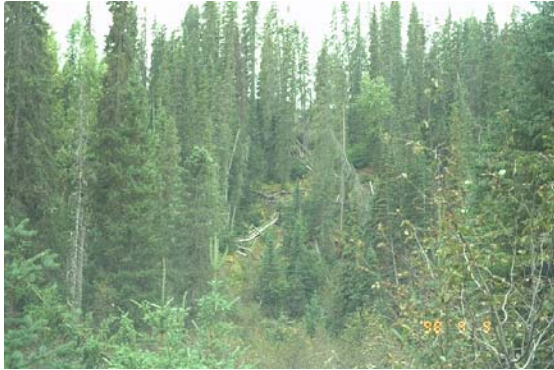
Plate # 42: Typical riparian forest community in predicted site series 05 polygons.

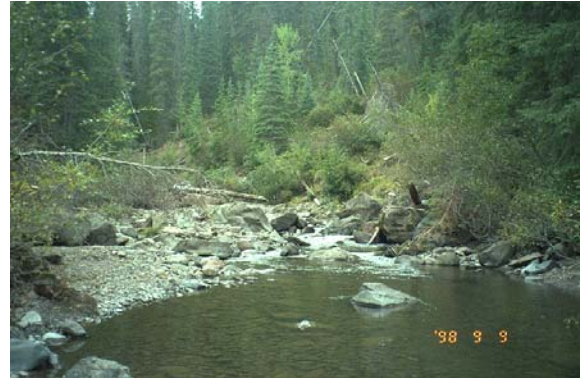
Plate # 43: Slightly aggraded section of channel. Typical riparian forest community in predicted site series 06 polygons.

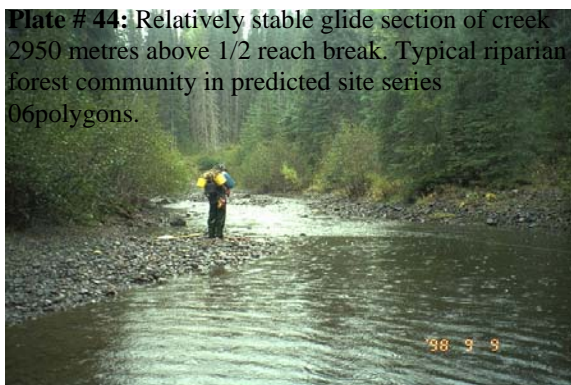
Plate # 44: Relatively stable glide section of creek 2950 metres above 1/2 reach break. Typical riparian forest community in predicted site series 06 polygons.

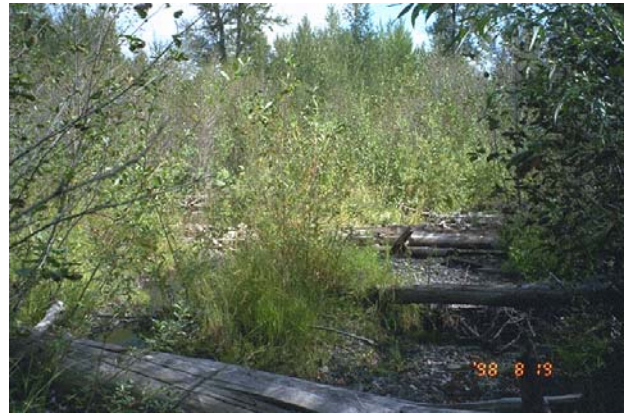
Plate #47: Main channel braid in recolonizing gravel bar area. Typical riparian forest community in predicted site series 08 polygons.

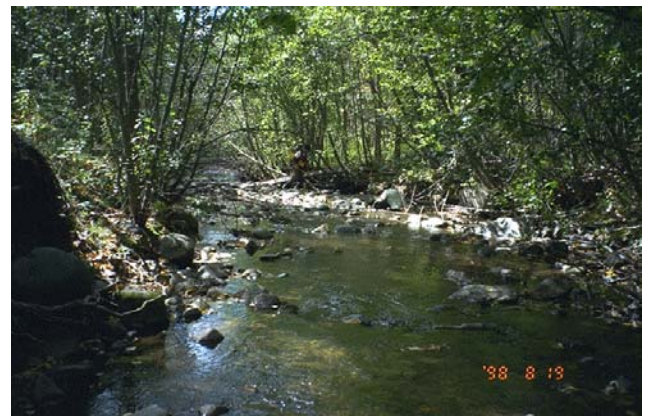
Plate #49: 250 metres upstream of Dungate/Buck confluence where channel becomes more stable. Typical riparian forest community in predicted site series 08 (\$58) polygons.

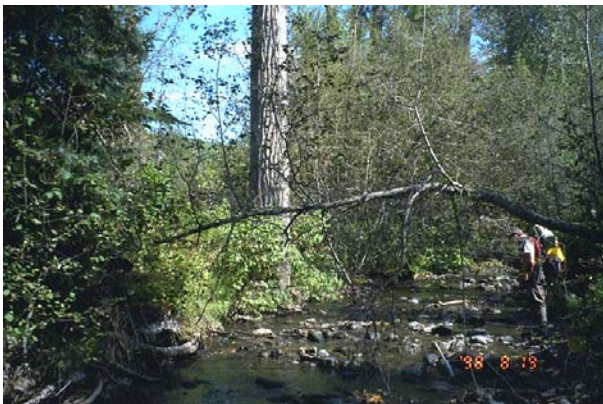
Plate #50: Typical riparian forest community in predicted site series 08 (\$58) polygons.

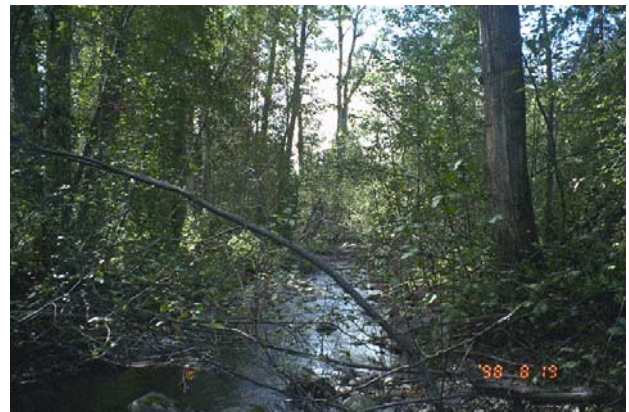
Plate #51: Typical riparian forest community in predicted site series 08 (\$58) polygons.

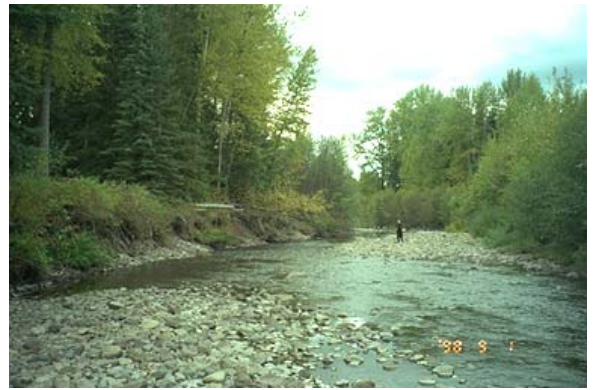
Plate #59: Representative channel and riparian forest community in predicted site series 08 (\$59) polygons, typically seen in the upper half of the reach.

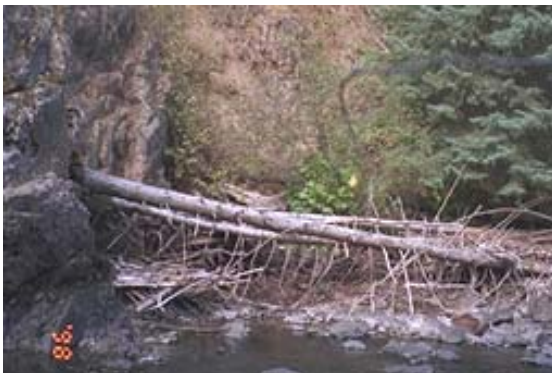
Plate #_: Canyon section located in the bottom half of the reach.

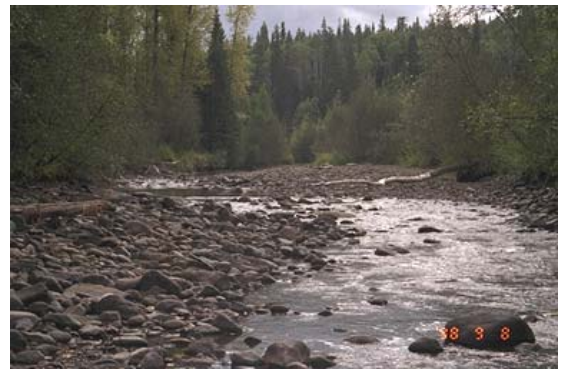
Plate #_: Very aggraded section (A2) above 1170metres, with a lack of overstory on the right bank. Typical riparian forest community in predicted site series 08 (\$59) polygons.

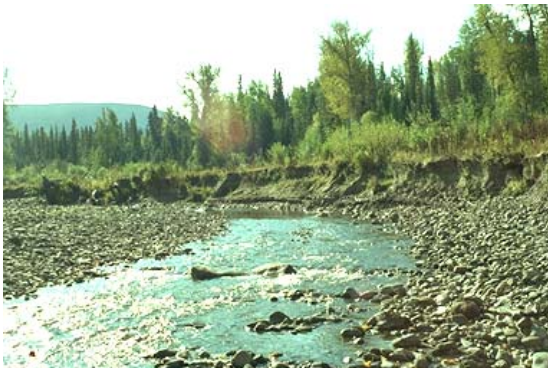
Plate #_: Extensive lateral channel movement and bank erosion common in the upper mid-reach in areas of intense land clearing.

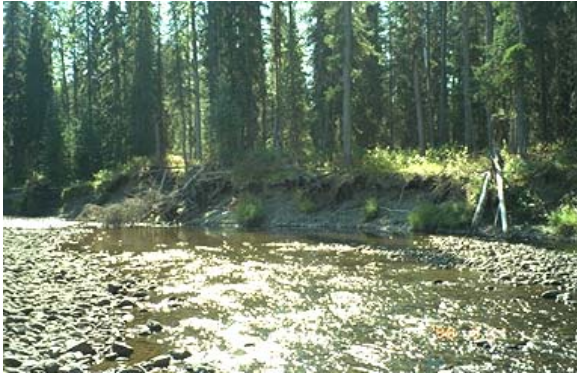
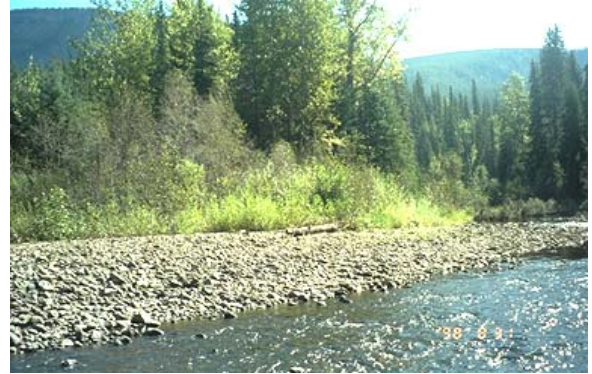
Plate #66: Typical riparian forest community in predicted site series 06 polygons located at bottom end of reach.

Plate #67: Typical riparian forest community in predicted site series 07a polygons located at bottom end of reach.

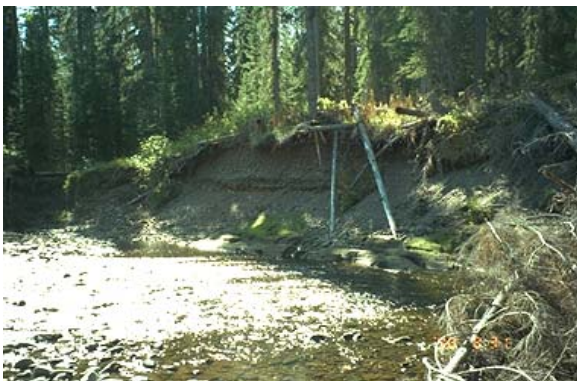
Plate #68: Eroding bank located at bottom end of reach, the result of unstable flow regimes.

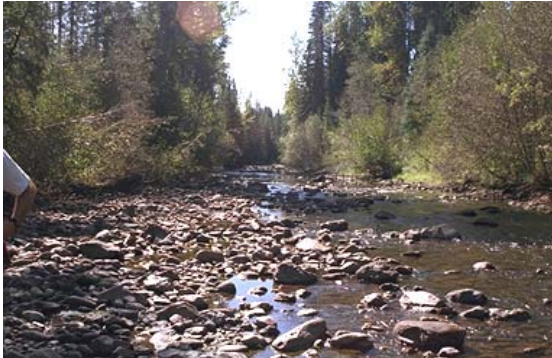
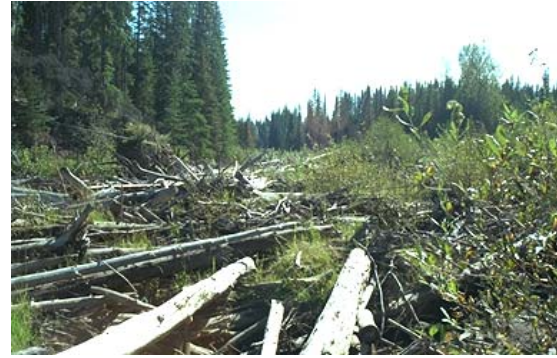
Plate #75: Area of high volume LWD jams and lateral channel movement approximately 1 km upstream of the 4/5 reach break.

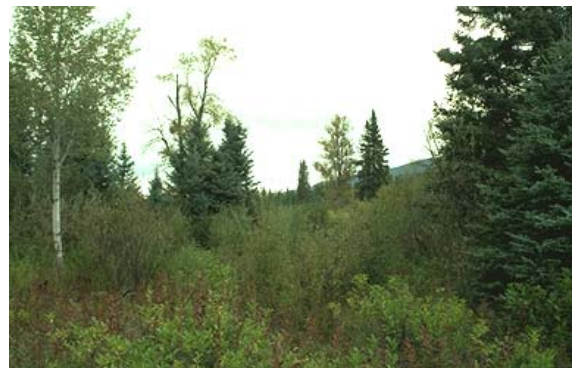
Plate #85: Typical riparian forest community in predicted site series 06 (\$55) polygons in a selectively logged area of the Swiss Fire, located 3700 metres upstream of the 5/6 reach break.

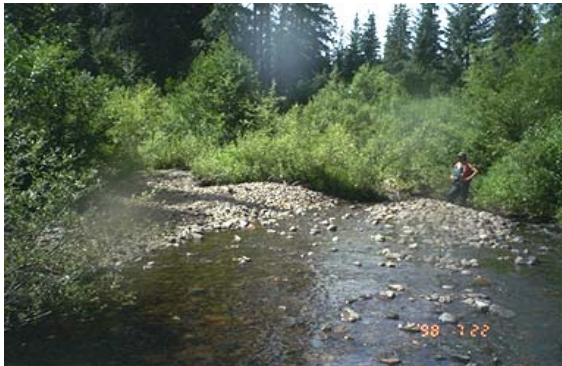
Plate #89: Large aggraded area 800 metres above the a/b section break. Note willow and alder recolonization on gravel bar deposits. Typical riparian forest community in predicted site series 07b polygons.

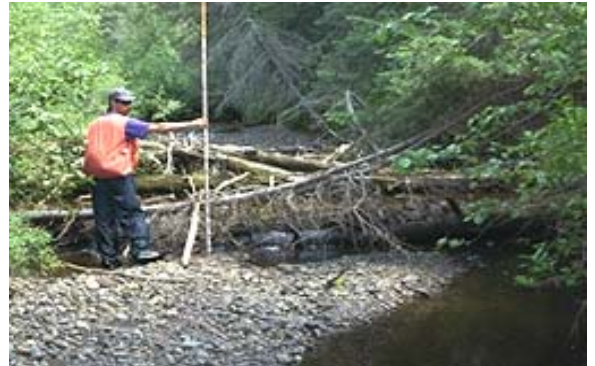
Plate #90: Log jam 900 metres above the a/b section break.

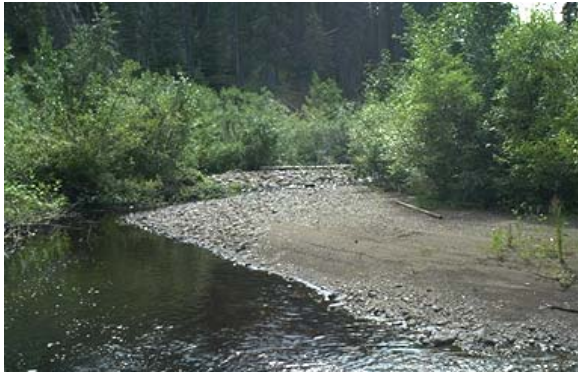
Plate #91: Large point bars in are of moderate-high lateral channel movement.

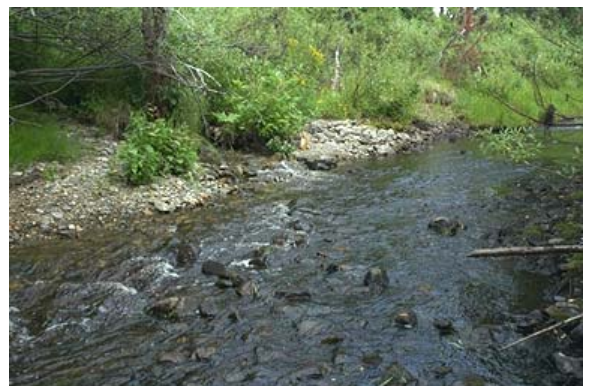
Plate #92: Riffle section in the upper half of the reach.

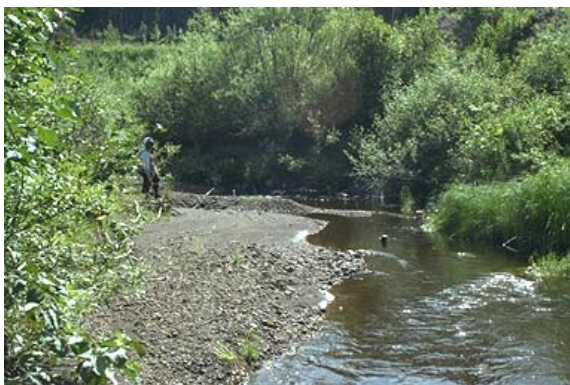
Plate #93: Aggraded section of creek with slumping grass banks. Note close proximity of road in upper left corner background.

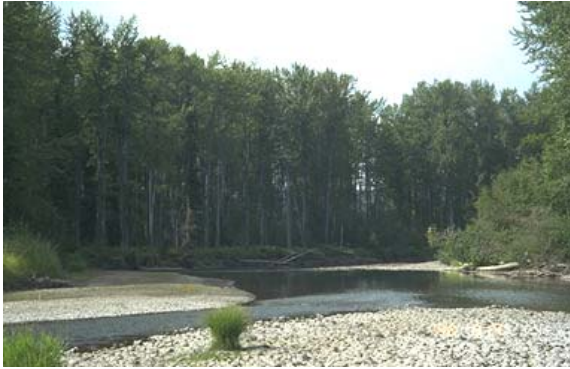
Plate #95: Mature cottonwood dominated riparian polygon, vital for supplying the largest functional LWD in the reach. Located at the bottom end of the reach in predicted site series 08 (\$59) polygons.

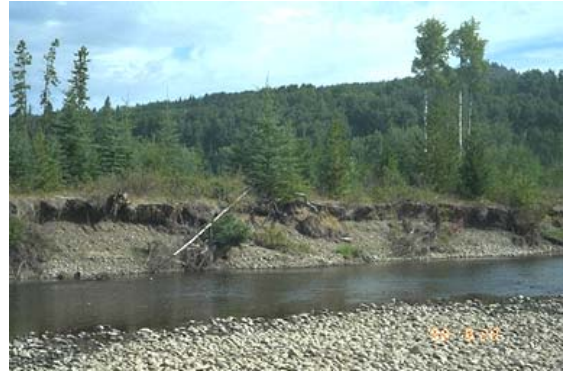
Plate #96: Outside bank erosion seen below area of historically cleared land in the lower end of the reach.

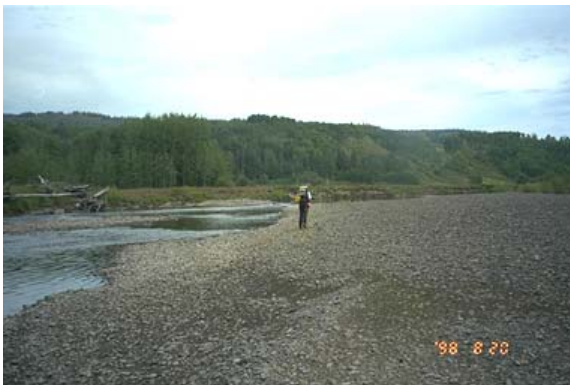
Plate #97: Typical riparian forest community in predicted site series 07a (\$57) polygons seen at 1800 metres above Bulkley/Morice River confluence on the hill in the background.

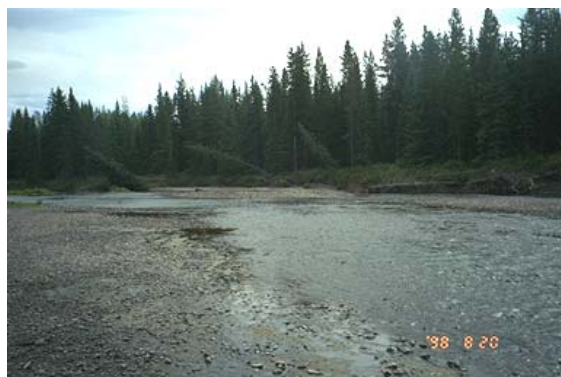
Plate #99: Long riffle section of channel between 1200 - 1300 metres.

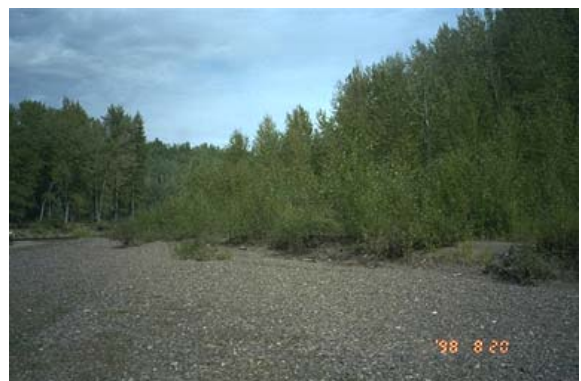
Plate #100: Typical riparian forest community and gravel bar recolonization at 8800 metres above Bulkley/Morice River confluence.

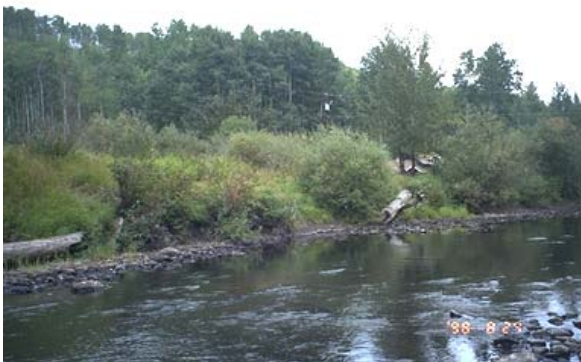
Plate #104: Typical riparian forest community in predicted site series 08 (\$59) polygons with shrub-herb seral stage in foreground.

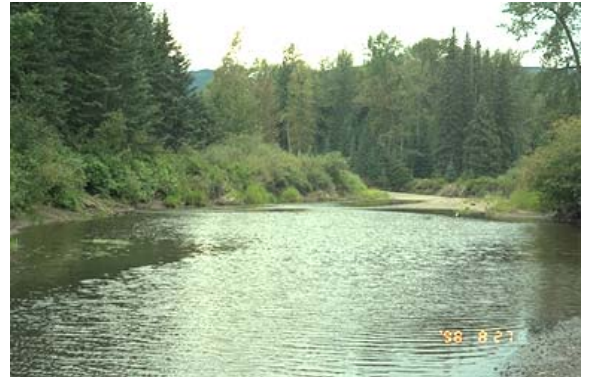
Plate #107: Typical riparian forest community in predicted site series 07a polygons at toe of hillside in foreground.

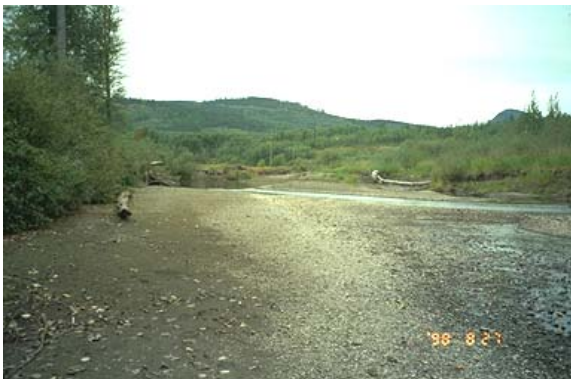
Plate #108: Aggraded channel, extensive bank erosion and minimal riparian forest seen above the Knockholt Bridge.

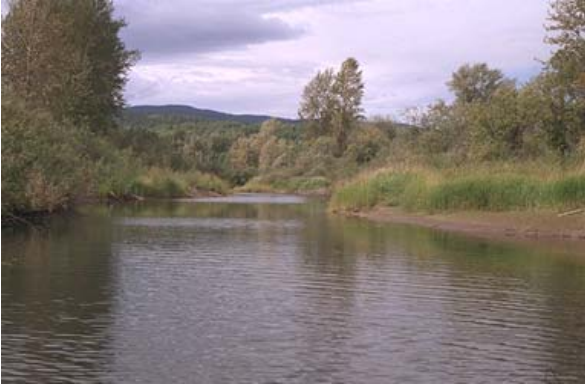
Plate #110: Deep, low gradient depositional section of channel characterized by long glides and pools and typical riparian forest community. Located 18000 metres above the 1/2 reach break.

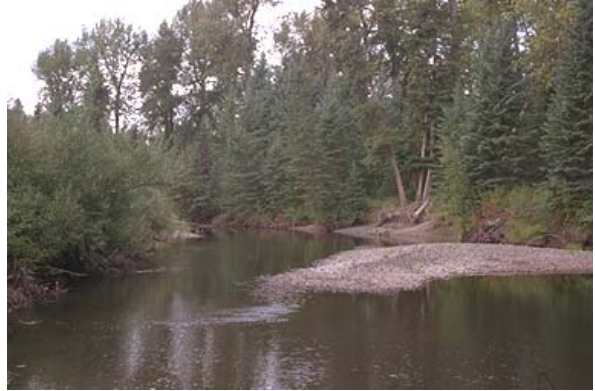
Plate #111: Typical hillside riparian forest community in predicted site series 07a polygons.

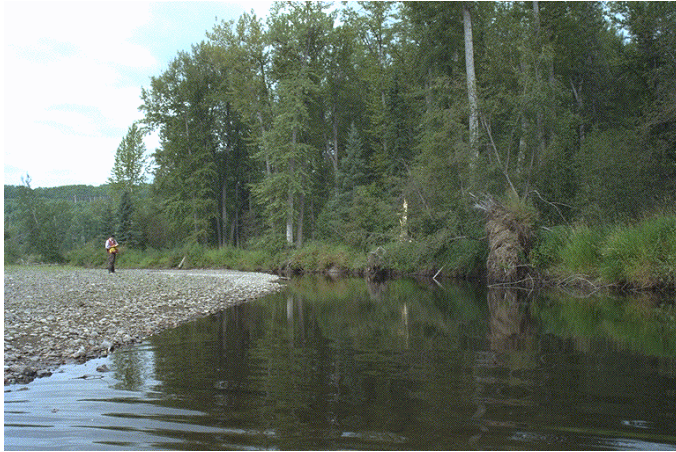
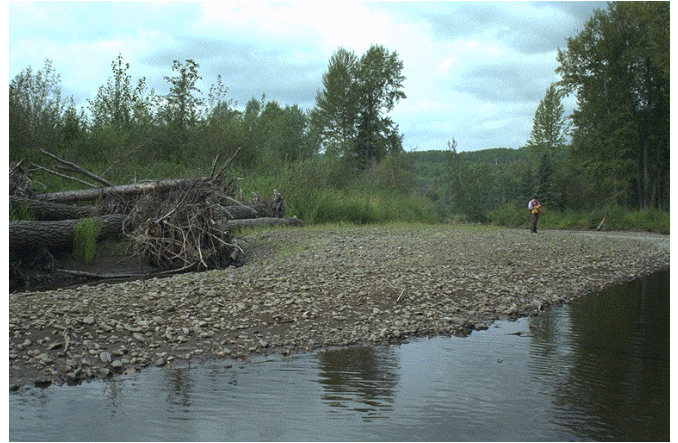
Plate # 120: Degrading, well incised channel upstream of the McQuarry Creek confluence. Typical riparian forest community in predicted site series 08 (\$59) polygons.
