KM 34 STREAM CROSSING

STREAM RESTORATION CULVERT OUTLET

**(W.C. 46 - 700 - 30-130)
SUSKWA FOREST SERVICE ROAD**

March 31, 1999

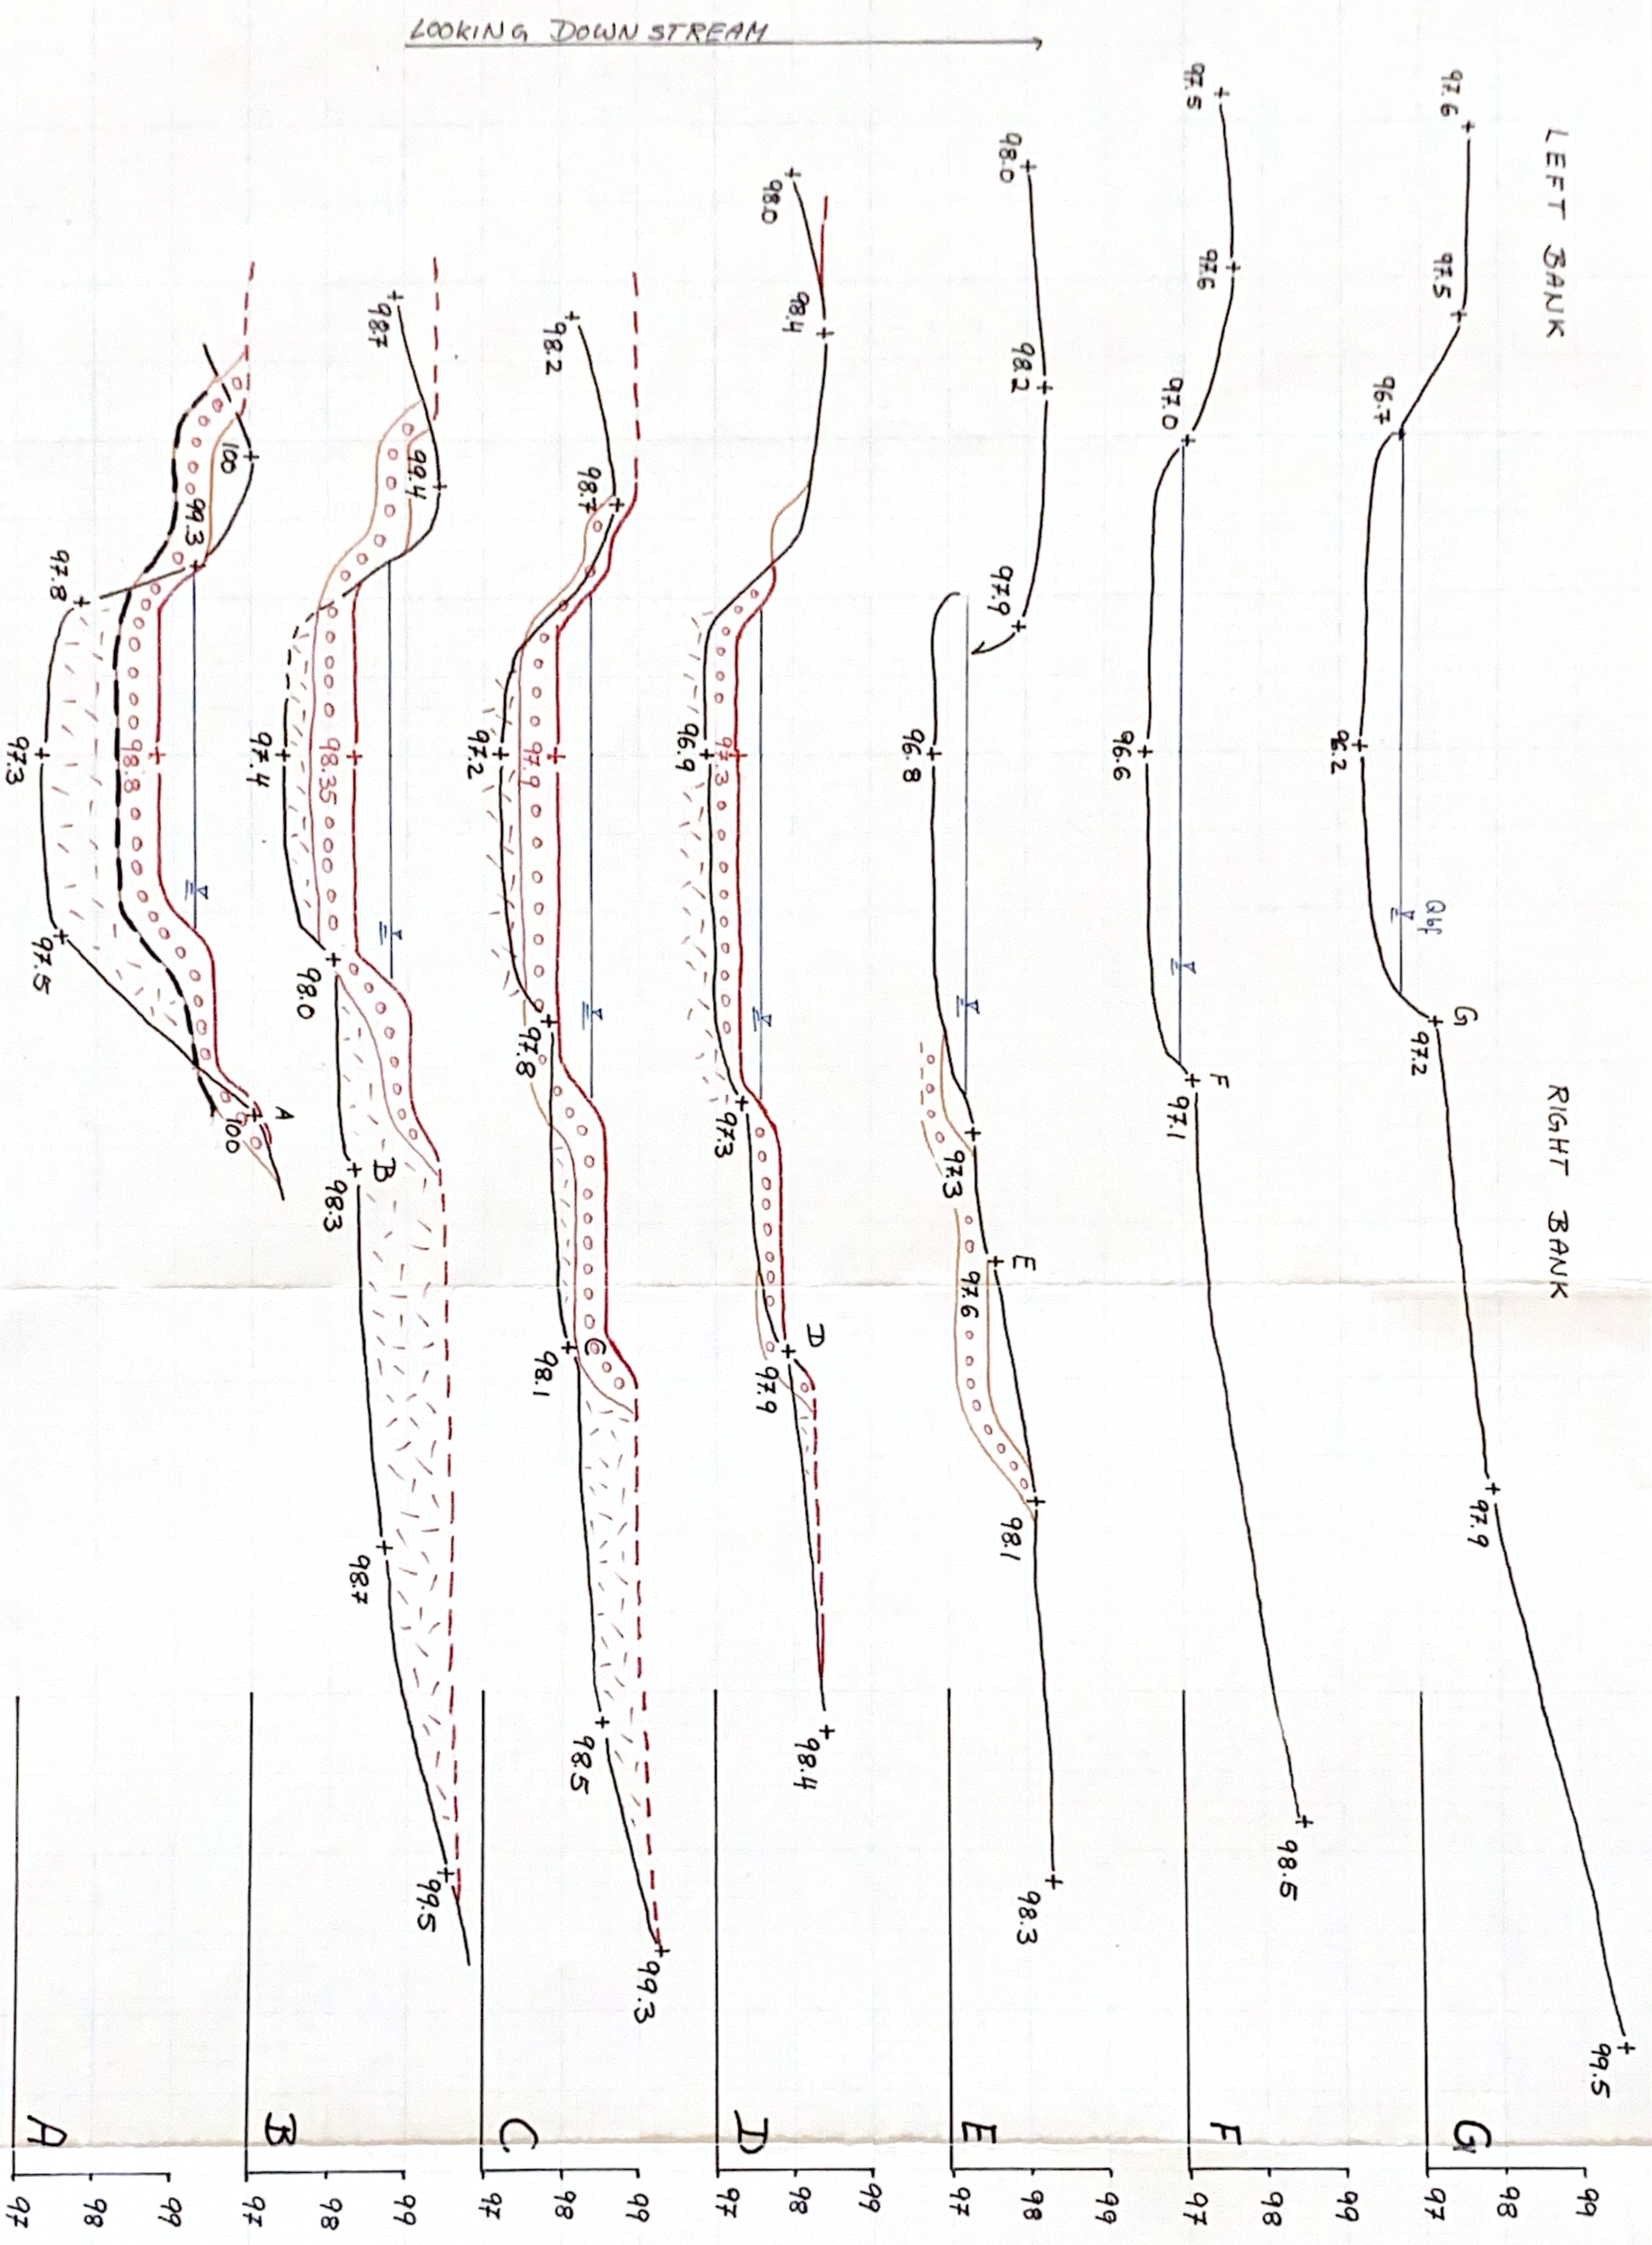
CROSS SECTIONS

Cross-sectional measurements: a bank height (D) of 0.5 m and a width (W) of 6 m was found upstream of the road and adopted as a suitable bank height and channel width; near the culvert outlet (proximal section), the width was reduced to 4 m to tie into the narrow culvert width of 3.69 m. Depth was increased to 0.75 m.

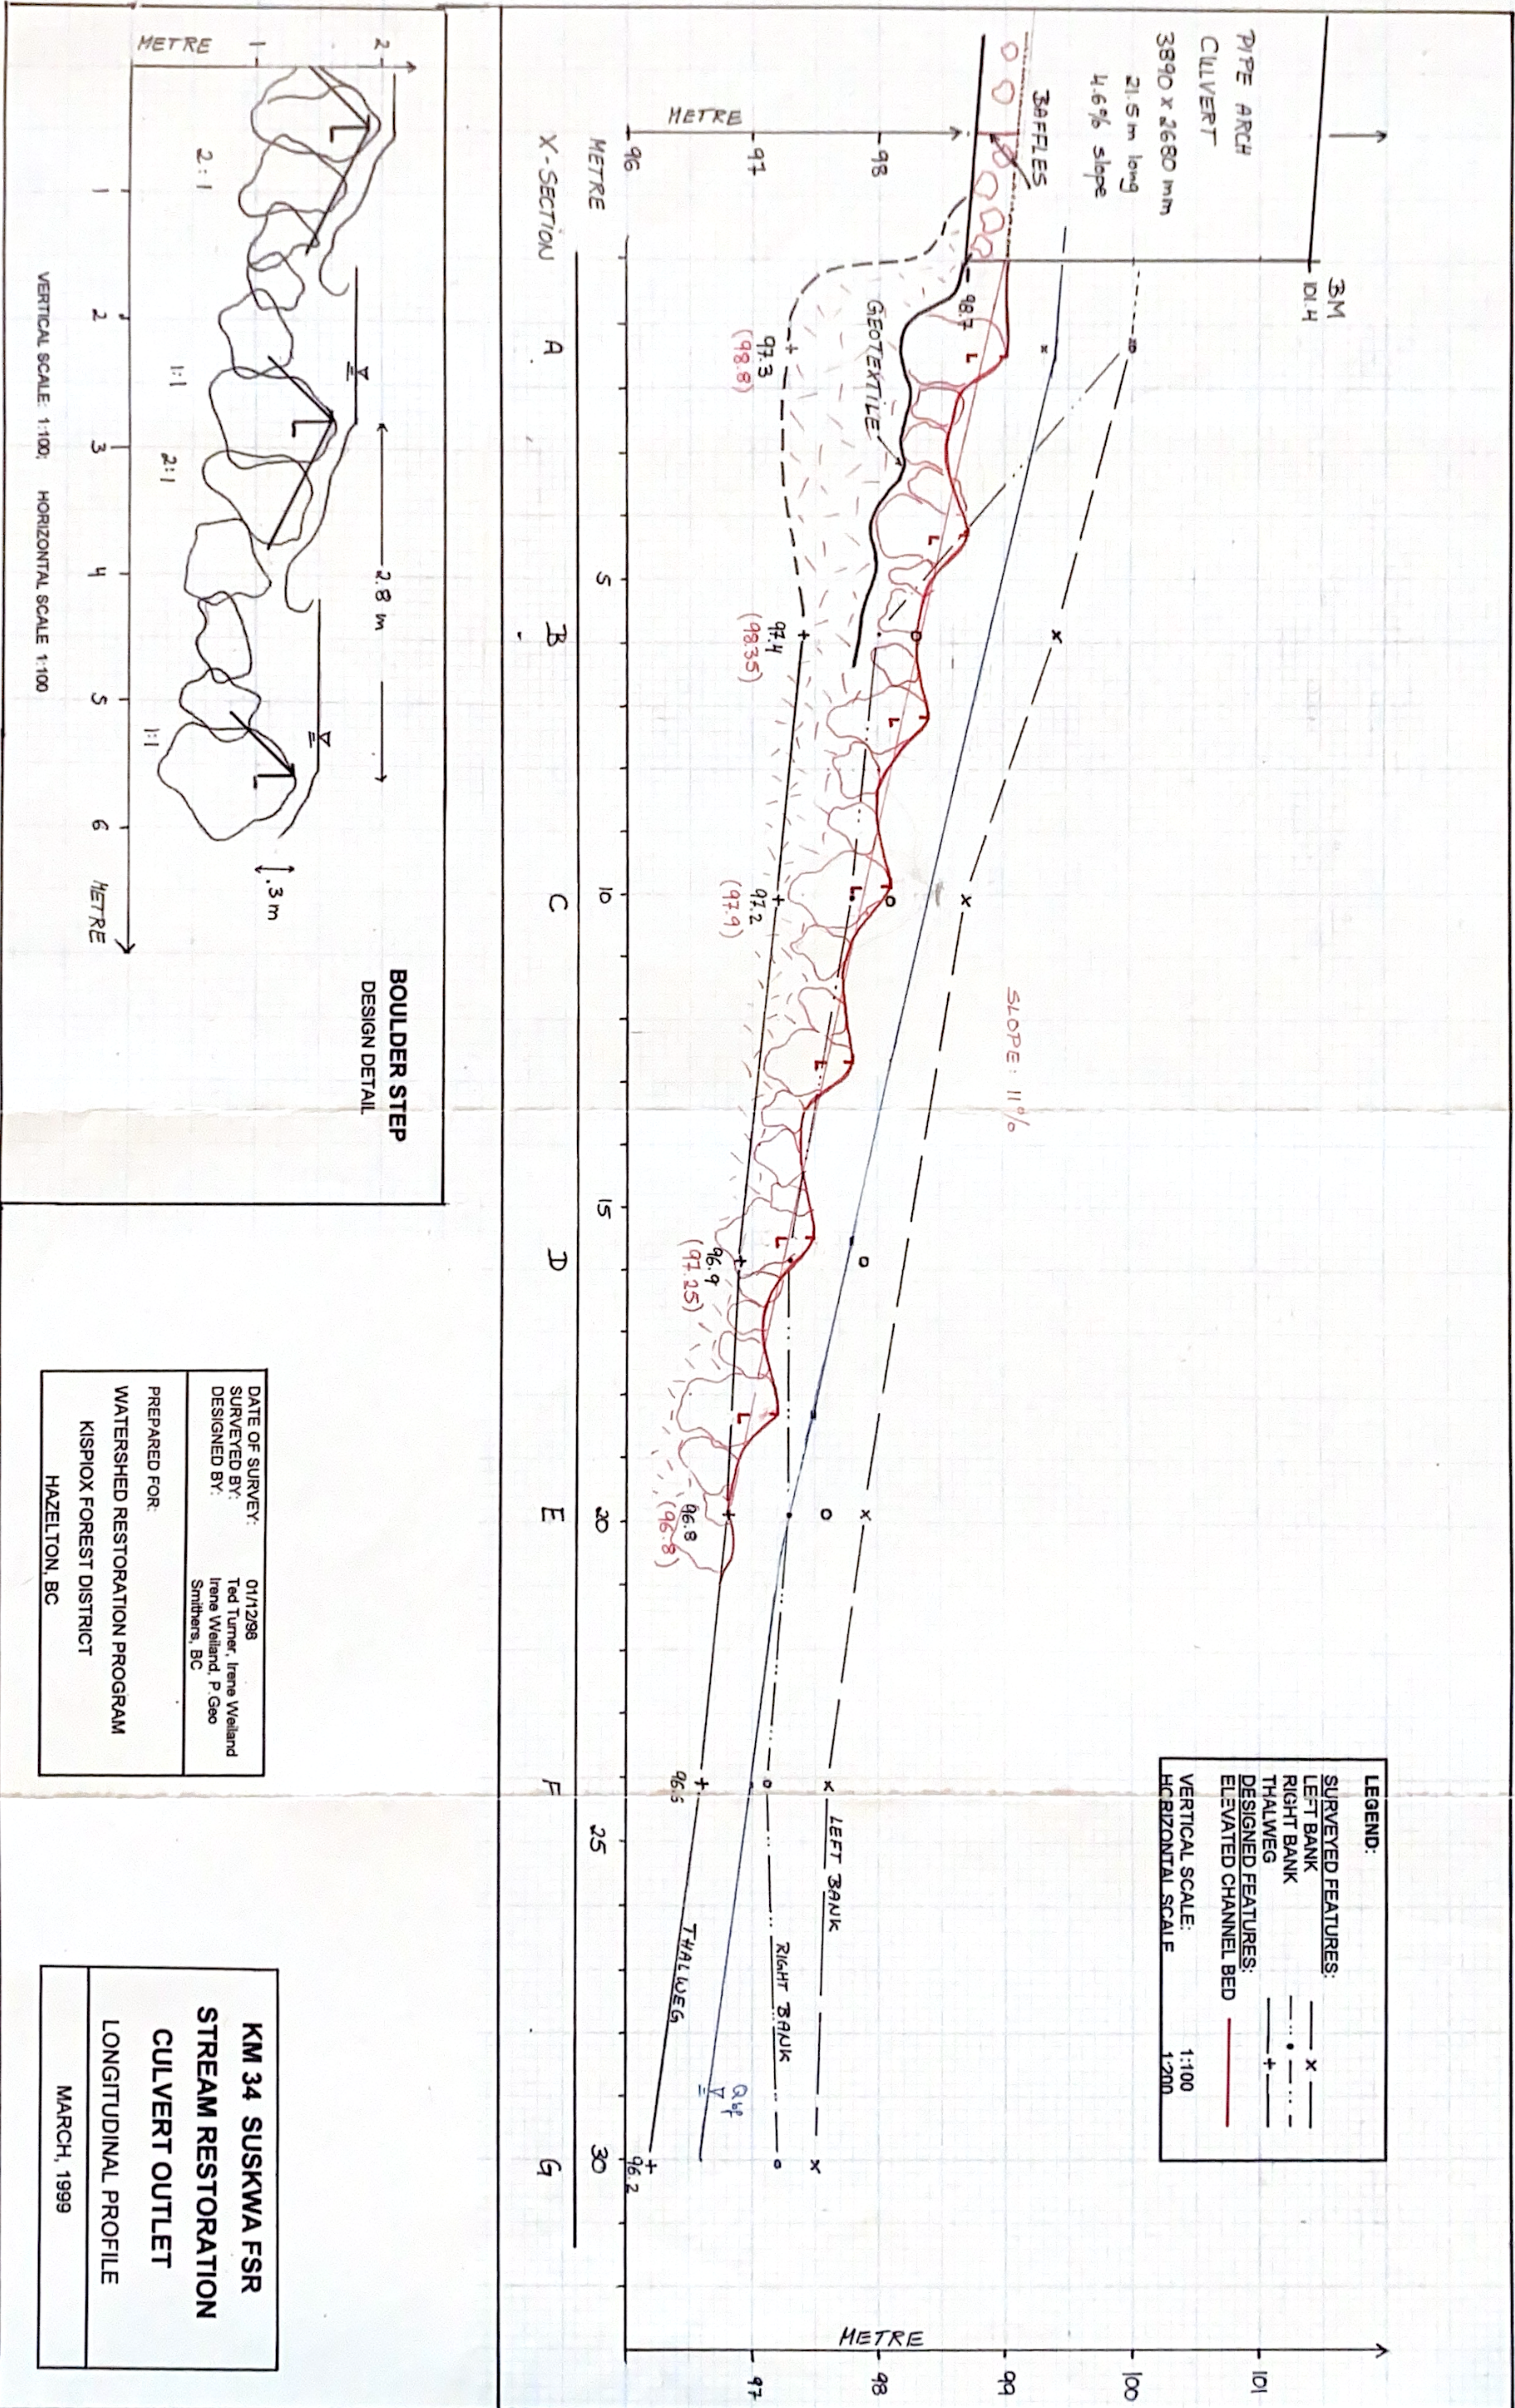
In the 3,890 x 2,690 mm multi plate arch culvert, the natural channel width is reduced to less than 4 m. Flow is accelerated, causing erosion and scour at the outlet of the culvert. Presently, the culvert outlet is .85 m perched above an 0.8 m deep scour pool. Continuing erosion at the outlet slowly enlarges the scour pool, and has caused 0.9 m wide undercutting under the culvert invert. Bedload is mobilized from the 1.5 m high channel banks just below the culvert and is deposited in the gentler channel section in the forest downstream. Two logs were placed perpendicular to the stream flow, 4.5 m downstream of the culvert, spanning the entire channel width. The logs may have been partly embedded in a 5 % channel bed when the culvert outlet was built in 1988. They are now undermined and have approximately 0.7 m clearance above

Photo 1: Culvert outlet; looking upstream; 17/05/98
