**Summary of Monitoring and Evaluation of In-Stream Works at Sites 14
and 15 in the Kitwanga River South Sub-Basin to March, 1999**

Prepared for the
Gitsegukla Band Council

by
Alan Gilchrist, Ph.D.
Hydroglyphic Terrain Analysts
and
Glenn Grieve, R.P. Bio.
BioLith Scientific Consultants Inc.

March 31, 1999

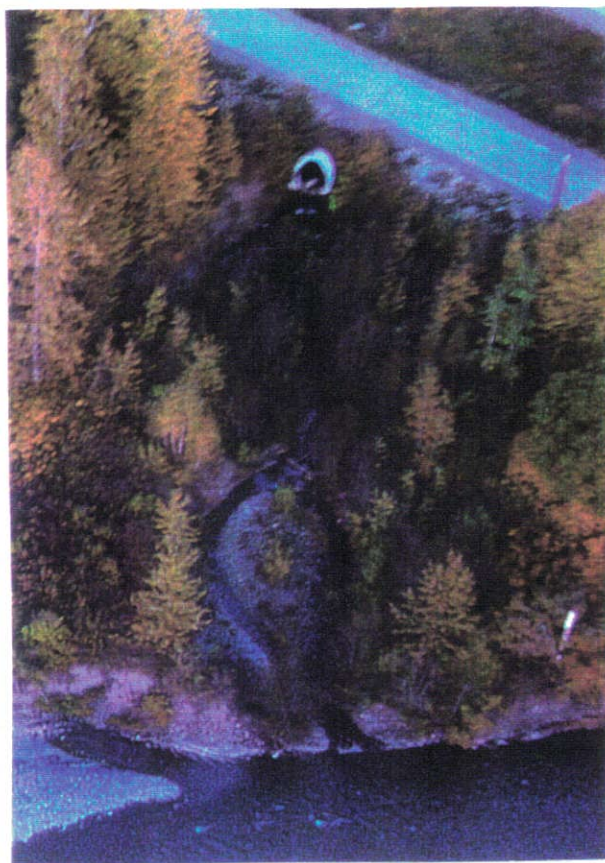
With respect to Site 15, they suggested that, although the LWD was of high quality, branches and tops should be left attached. They further suggested that the LWD be anchored. Concerns were expressed over the stability of the debris catchers, possible end scouring around a channel spanning piece of LWD, riparian area degradation by machine use and the channel excavation.

Photo 3. An aerial view of Site 15.

It is recommended that the LWD installed at Site 15 should be anchored to imported boulders >65 cm in their b axis, using steel cable >1.5 cm in diameter epoxied into 15 cm deep holes drilled into the rock using the Hilti Epoxy system. Such boulders may be available along the west Kitwancool Lake FSR.

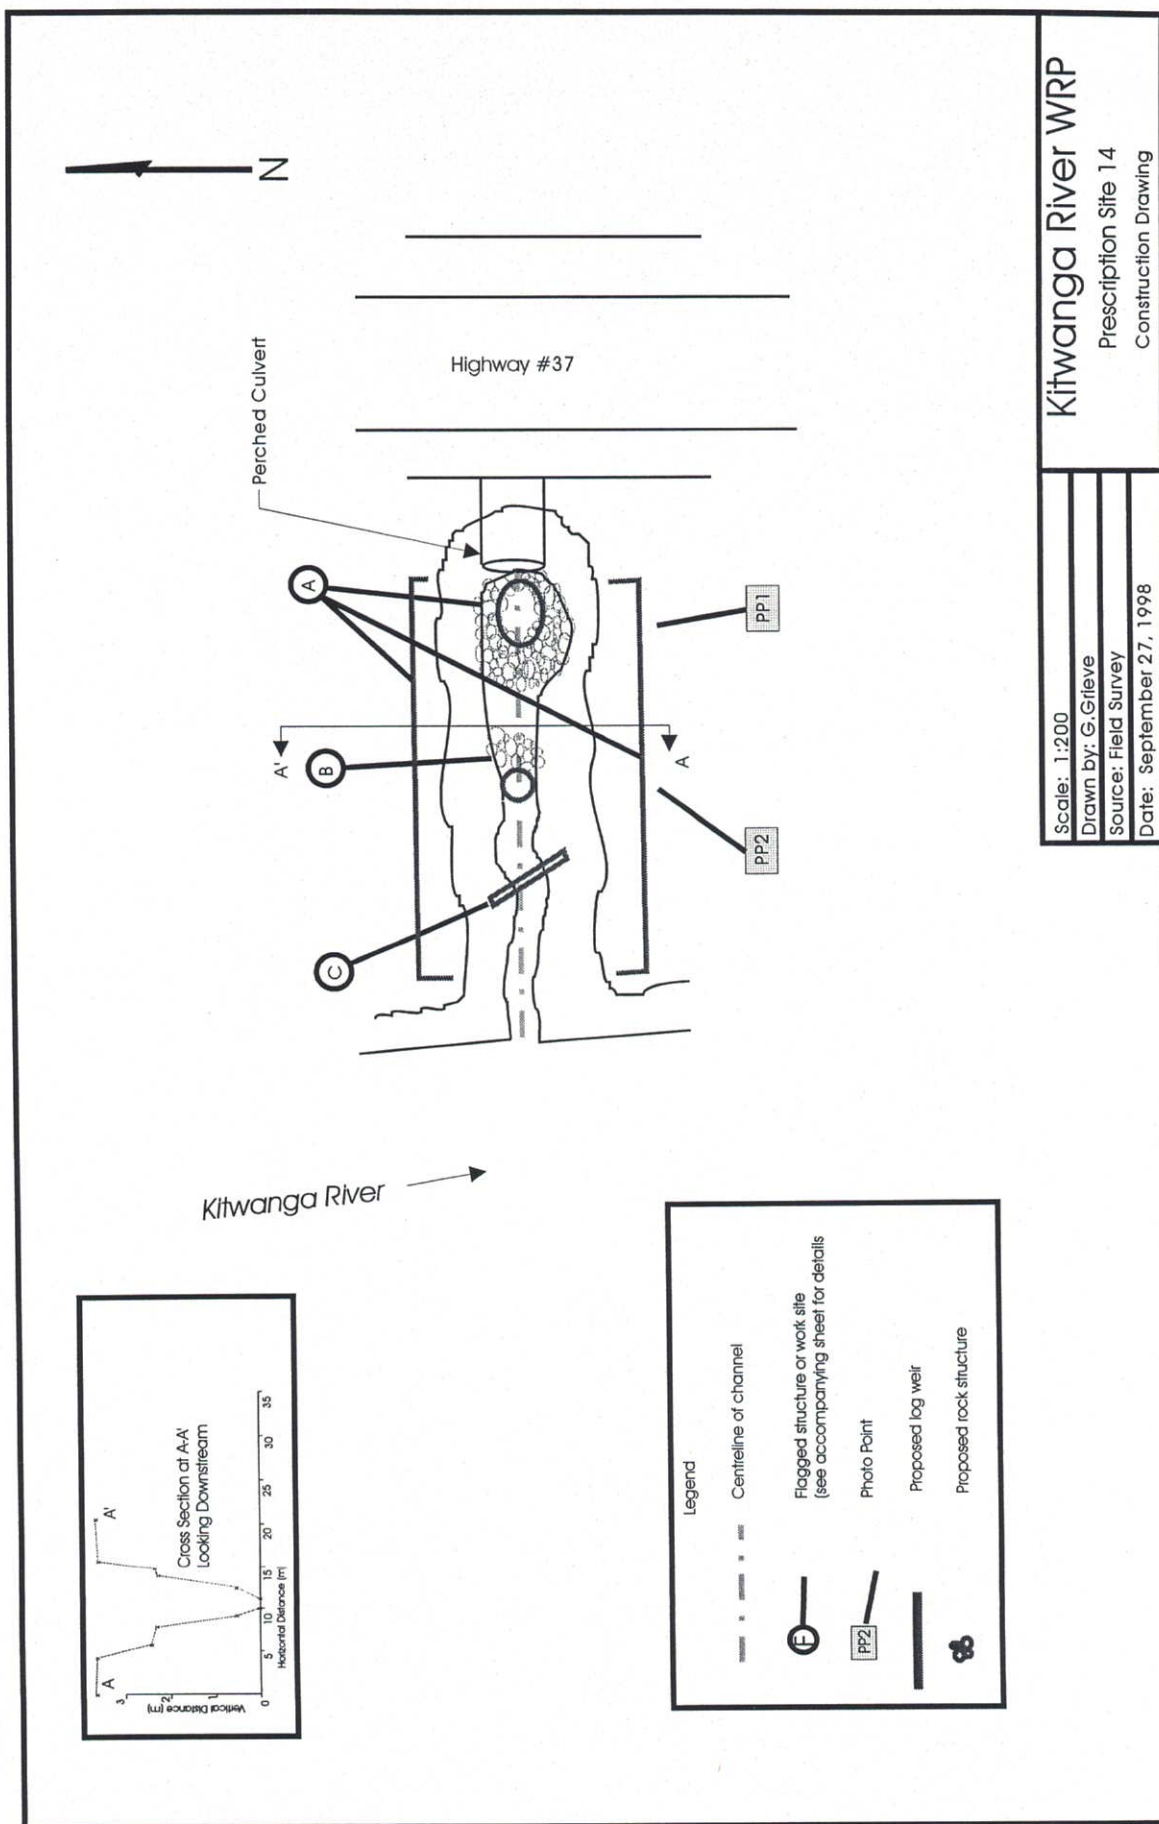
Figure 2. Construction drawing for Site 14, Kitwanga River.

Site 14 Pre-Construction Survey Data					
This site is ~ 19 m long from the culvert lip to the mainstem Kitwanga					
The thalweg has <1 m sinuosity.					
The channel is incised ~ 2 m below an old road grade in fine material.					
The channel is ~ 2 m at Wb					
X-Section @ 5 m below culvert, starting from s side					
0	3.6				
5	3.5				
7	2.4				
8	2.2				
9	0.4				
10	0				
12	0				
13	0.4				
14	2.2				
15	2.4				
16	3.5				
21	3.6

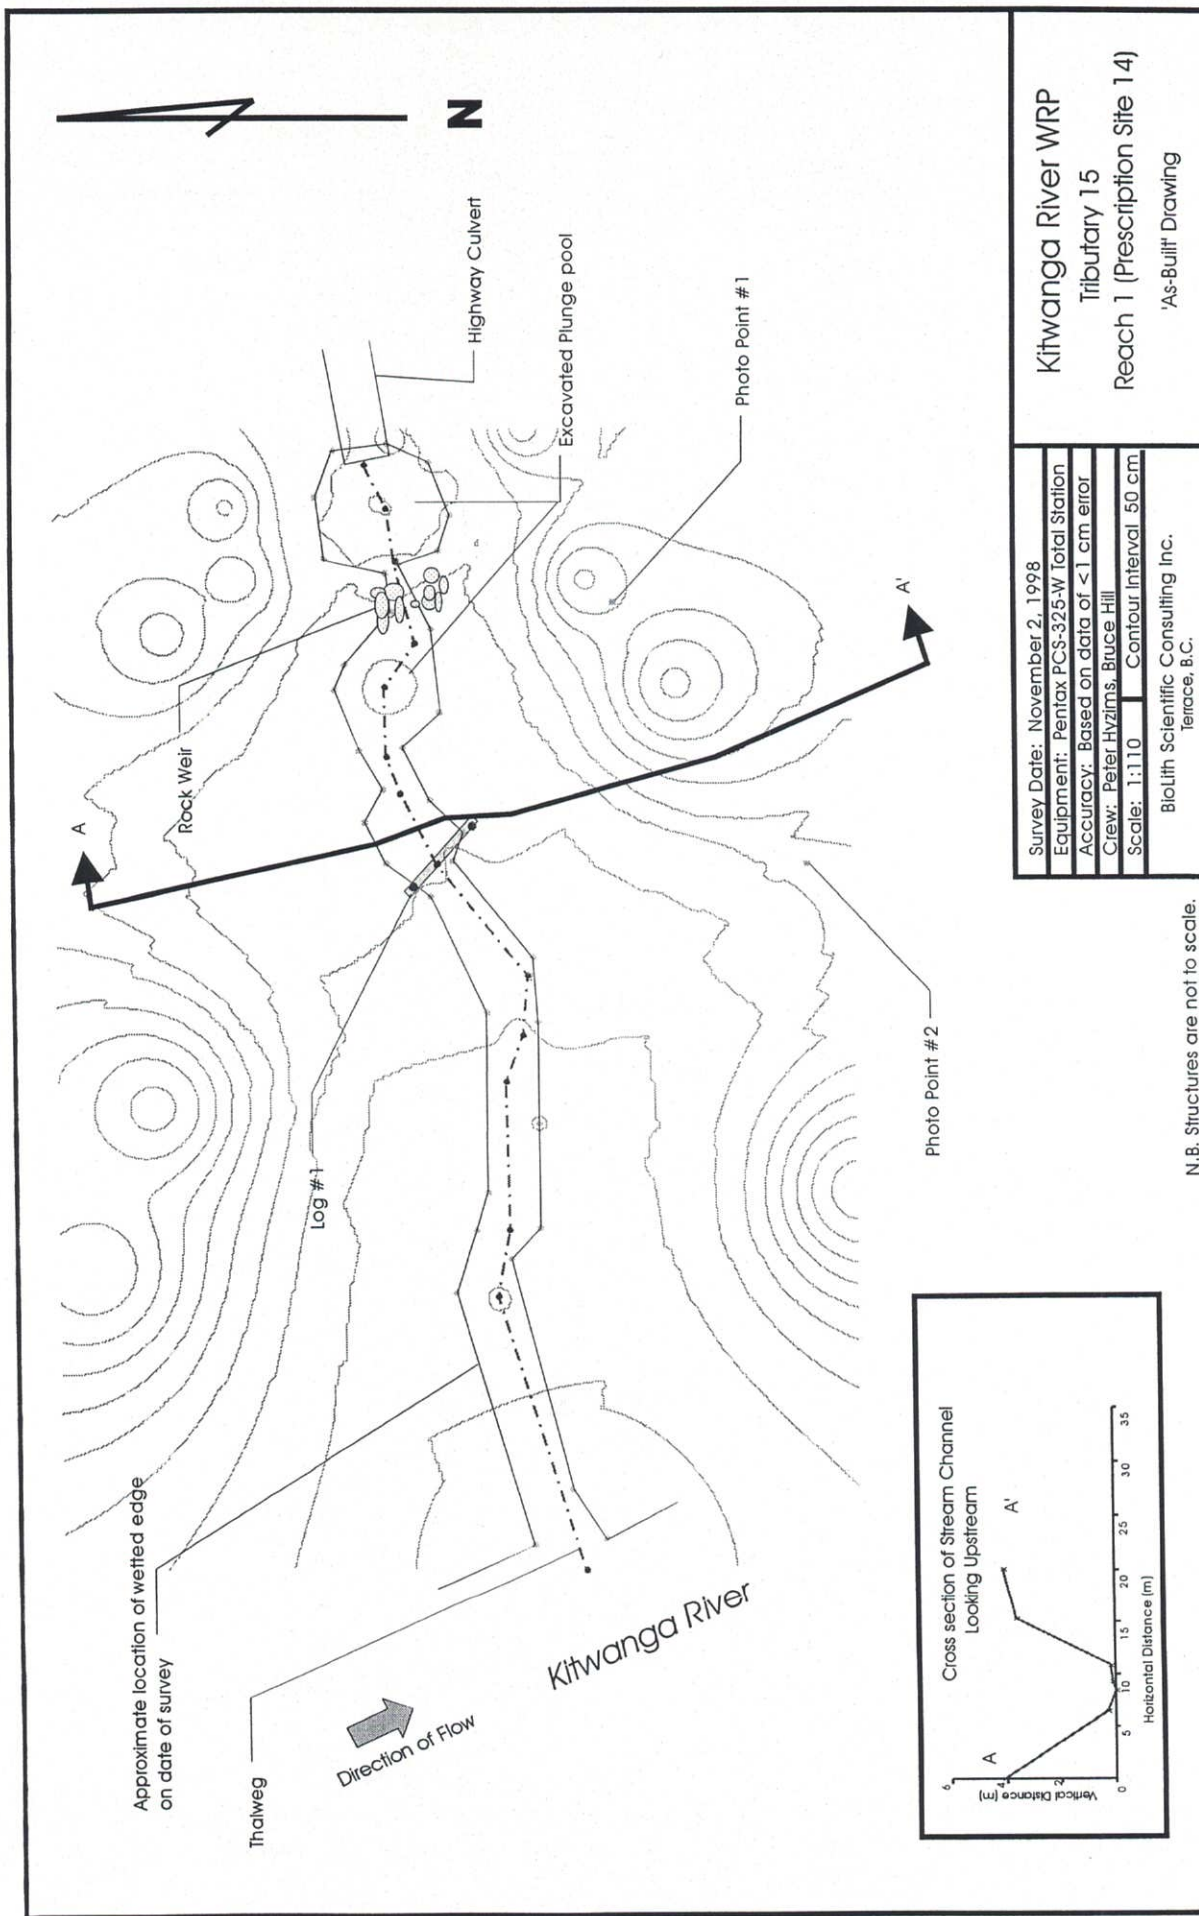
Figure 3. As-Built drawing of the construction at Site 14 on Tributary 15 in the Kitwanga River South Sub-Basin.

In this letter they expressed concern regarding Site 14 with respect to the pull back of banks, inadequate seeding with grass, loss of low shrub and herb cover, inadequate step pool construction using insufficiently sized and improperly oriented materials and inadequate regulatory agency approvals.
