**Summary of Stream Restoration Activities at Sites 14 and 15 in the
Kitwanga River South Sub-Basin to March, 1999**

Prepared for the
Gitsegukla Band Council

by
Glenn Grieve, R.P. Bio.
BioLith Scientific Consultants Inc.
Terrace, B.C.

March 31, 1999

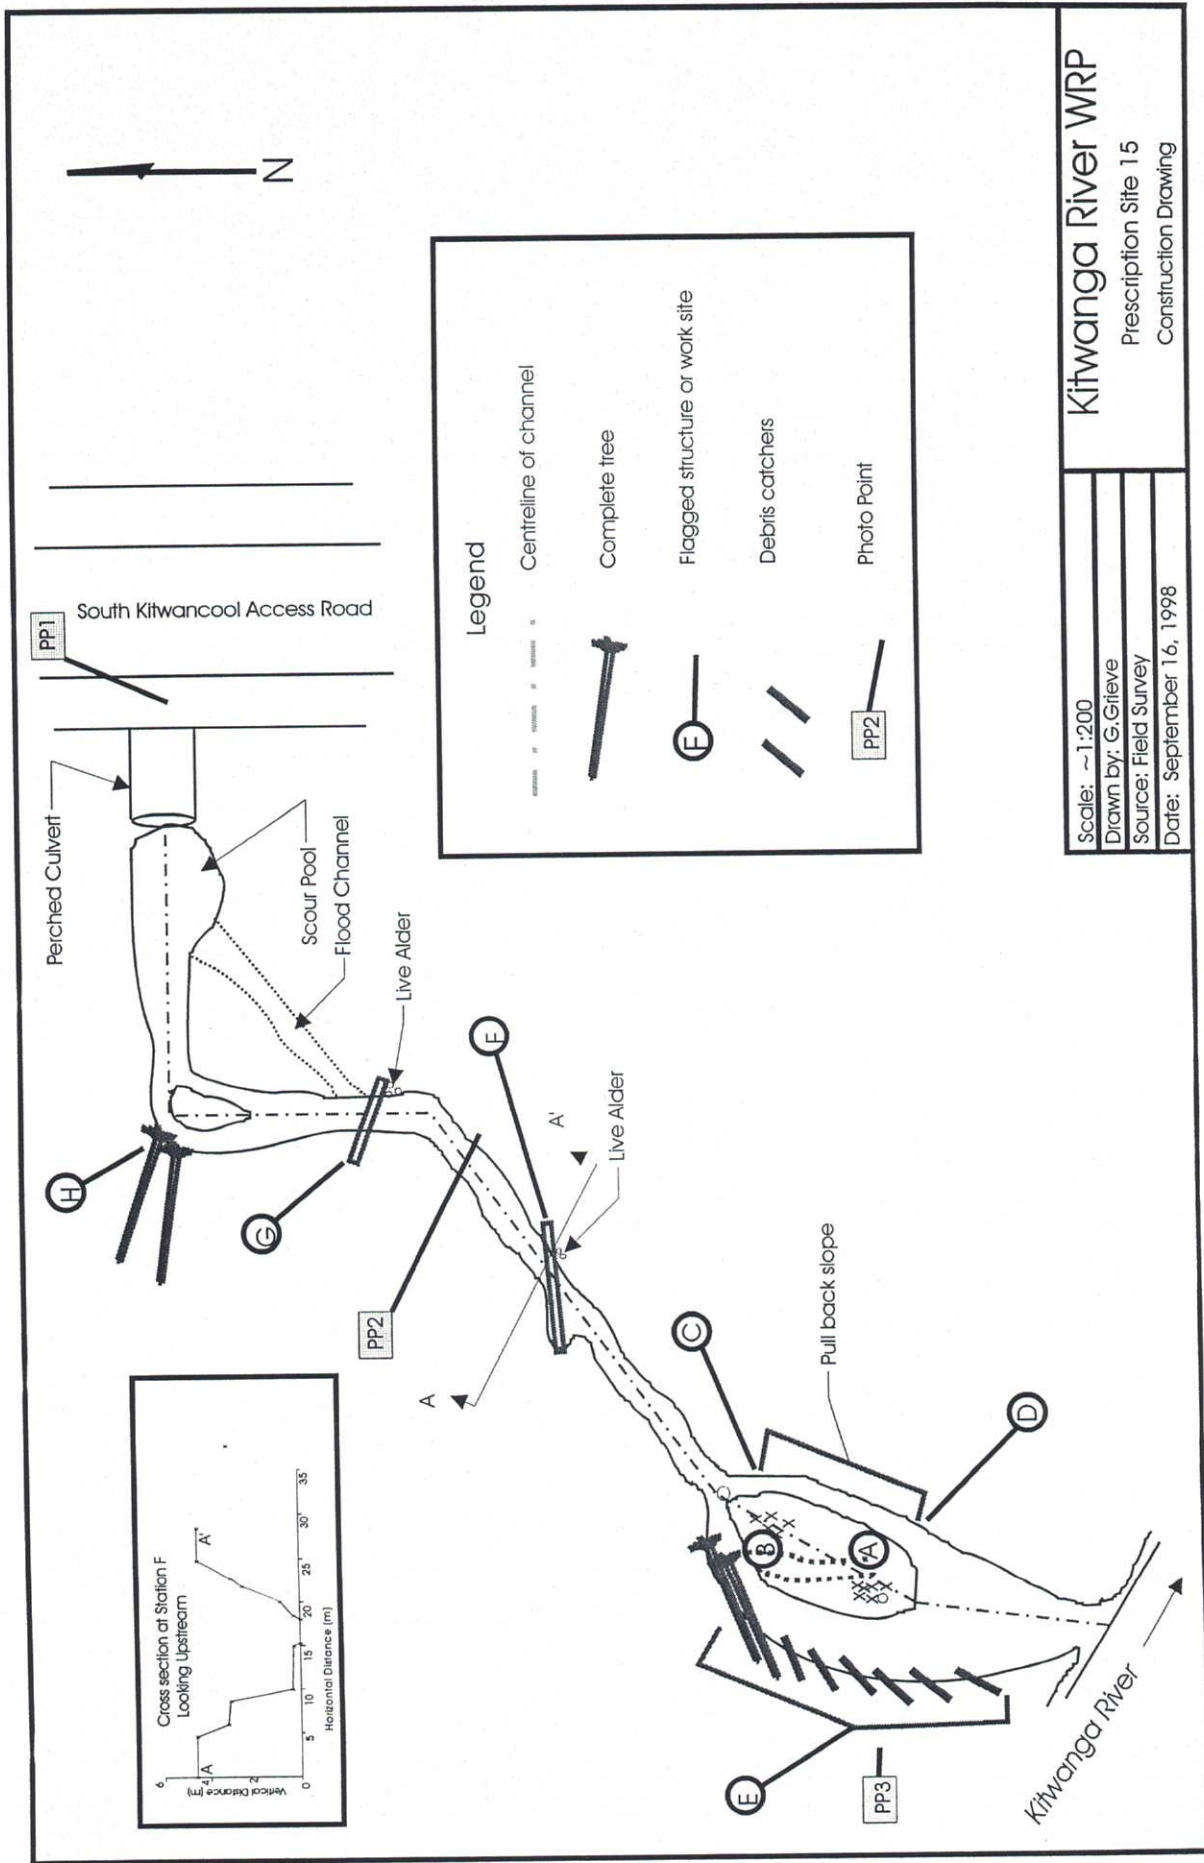
This site was less than 50 m in length and was considered a Type I project. This site was visited by two biologists from BioLith and the Project Manager. The site was surveyed using a tape measure, clinometer and compass (see Appendix B) and labeled flagging was hung where restorative measures were prescribed. This information was used to produce a construction plan and drawing (see Figure 4). The plan prescribed

- placement of two channel spanning log weirs set into the stream bed,
- placement of complete trees with root wads and branches intact at two locations, and the redirection of the stream from its position near the northern eroding bank near the mouth to a position further south by a small trench hand dug into the raised mid-channel bar.
