Annual Compendium Of Aquatic Rehabilitation Projects For The Watershed Restoration Program 1998 - 1999

Watershed Restoration Project Report No. 13
1999

Deep Creek Side Channel and Bank Stabilization

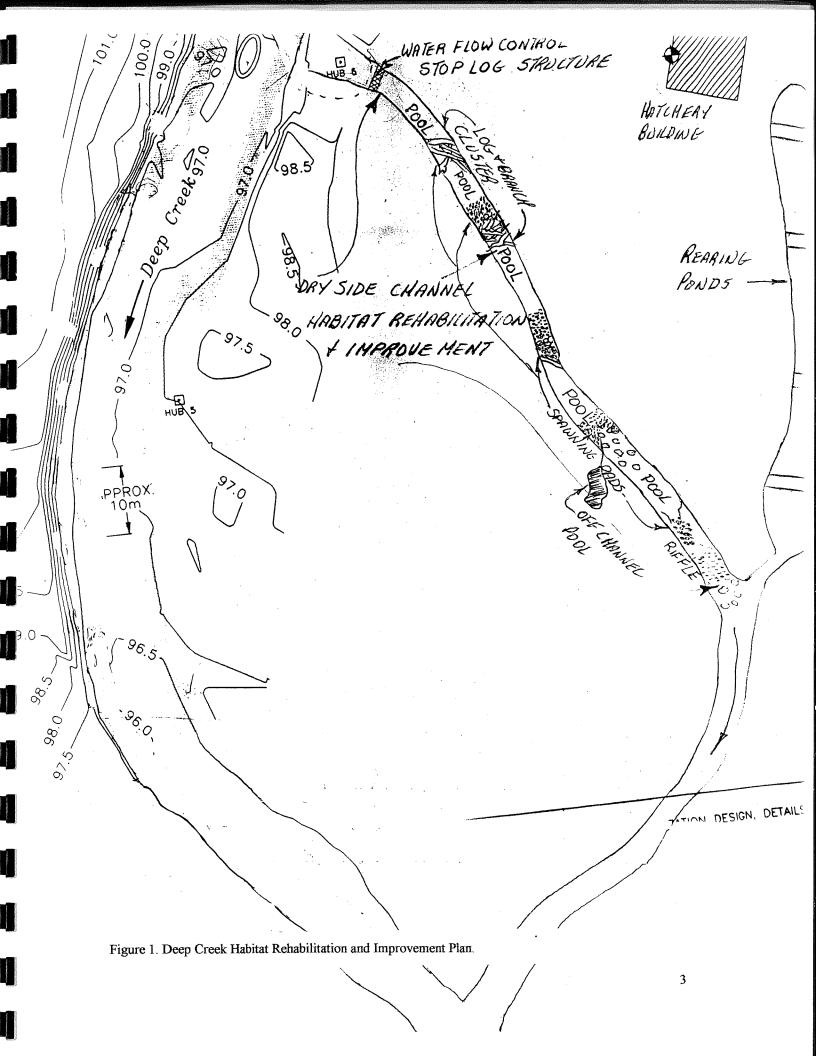
Figure 6-16. Deep Creek side channel water levels during low flows.

Drought conditions during July 1998 caused very low water conditions in Deep Creek resulting in the channel inflow to be dramatically reduced. This threatened the ability of the channel to maintain suitable water conditions for fish to rear in. To alleviate the low flows into the channel during drought periods, a 20'x 12" culvert was placed under the berm at the top of Deep Creek side channel in August 1998 (Fig. 6-15). To accomplish this, a trench was excavated with a mini excavator and covered over by the restoration crew who also completed the bank cleanup and rock placement. The end result of this additional intake was the establishment of suitable flows that will support spawning, incubation and rearing of salmonids during low flows (Fig. 6-16).

The culvert installed in August 1998 is working very well, providing a flow of water to the channel that should be sufficient during the lowest Deep Creek water conditions.
