## **Exchamsiks Fish Ladder Repairs Construction Summary Report**

## Exchamsiks Fishway Repair Prescription

EXCHAMSIKS FISHWAY  
REPAIR  
PLAN, PROFILE, AND NOTES

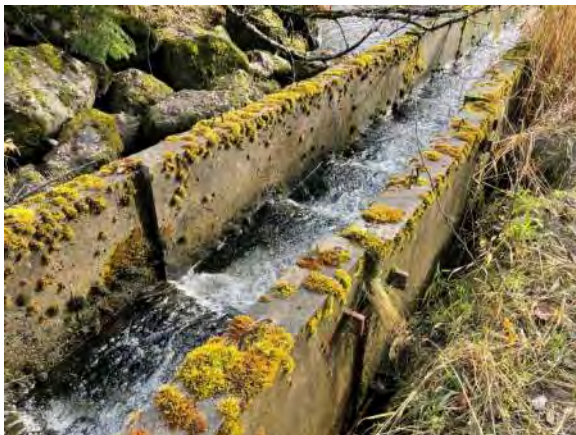
After review of the fish ladder, it appears that the individual boxes have shifted positions, causing gaps to form between the boxes (see photo 3, 8 & 11). The overall location of the ladder does not appear to have changed. Large amounts of material around the boxes have been eroding away causing large gaps between the concrete boxes and the adjacent ground (see photo 3 & 4). The material under the culvert into the ladder has been completely eroded away causing the pipe to be suspended between the road fill material and the concrete boxes. It is recommended to disconnect the boxes from each other (see photo 12 for bolt connection) and lift the individual boxes out of the way in order to re-establish the base materials. Since the overall elevation of the boxes doesn't appear to have changed much it is assumed the support rails under the boxes are still in good condition and have not moved. Therefore, only the base material will only require repair, but a review of the rails and base should be inspected to confirm this upon removal of the boxes. Upon re-installing the boxes, Con Seal CS-102 Butyl Rubber (product information is attached) sealant (or approved fish friendly equivalent) should be placed on all joints prior re-bolting the boxes securely together. After the boxes have been put back into place, they should be backfilled with an approved granular material to match the existing ground with a minimum 2% grade away from the boxes to reduce the potential for additional erosion. Care should be taken when backfilling around the culvert to ensure that compacted material is established underneath the pipe. Within the locations that the backfill is within the water, Class 50 kg riprap should be used to prevent erosion specifically in the location of the left side of section B on the drawings between the boxes and the railway grade, as depicted in photo 10 where water continues to flow during low flow periods.

*Photo 3 - Ladder View Depicting the Displacement*

- DISCONNECT AND LIFT OUT EXISTING FISHWAY CONCRETE BOXES
- REPAIR BASE AND FILL DIRECTLY ADJACENT HOLES WITH 25mm MINUS MATERIAL. COMPACT TO 98% STANDARD PROCTOR DENSITY, SLOPE AND ELEVATION OF BASE TO MATCH EXISTING
- RE-INSTALL FISHWAY CONCRETE BOXES, APPLYING PASTE TO SEAL WALL JOINTS AND THEN RE-BOLTING THE BOXES SECURELY TOGETHER
- BACK FILL AROUND BOXES

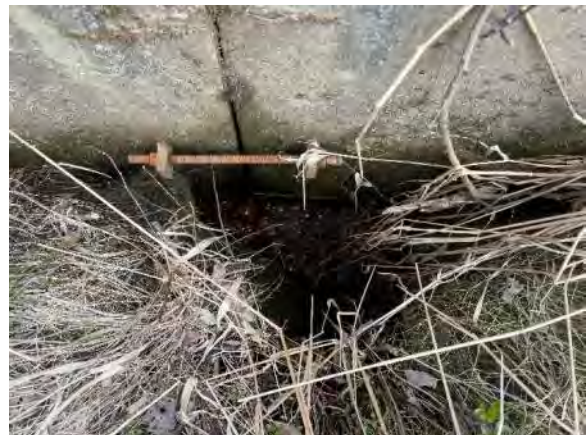
*Photo 4 - Eroded Fill Adjacent to Boxes*

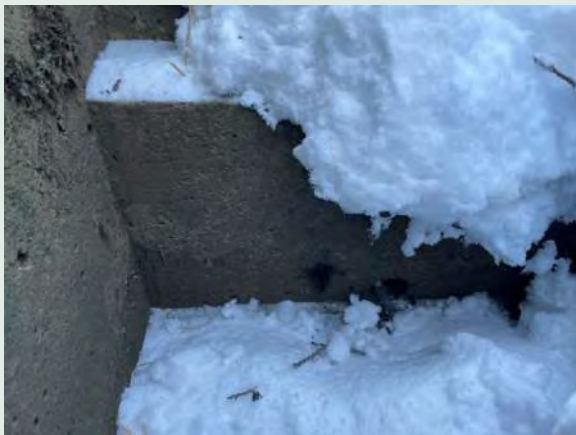
*Photo 9 - Box Drain Hole*

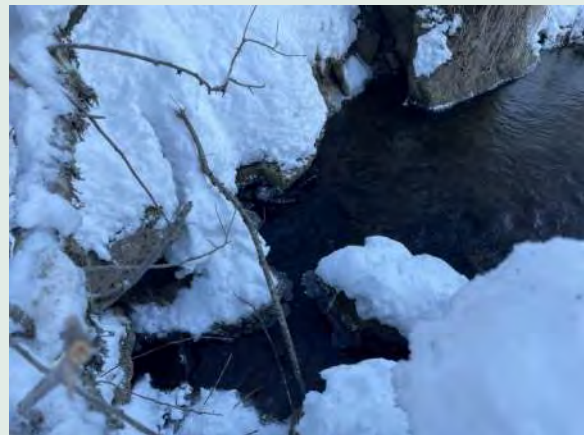
*Photo 10 - Flow through the Riprap in Low Water*

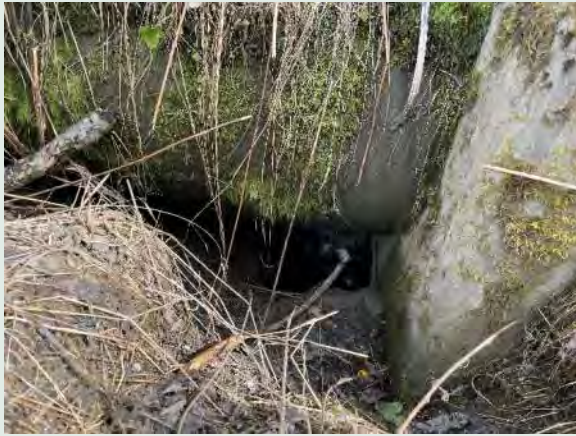
*Photo 13 - Erosion under the pipe*

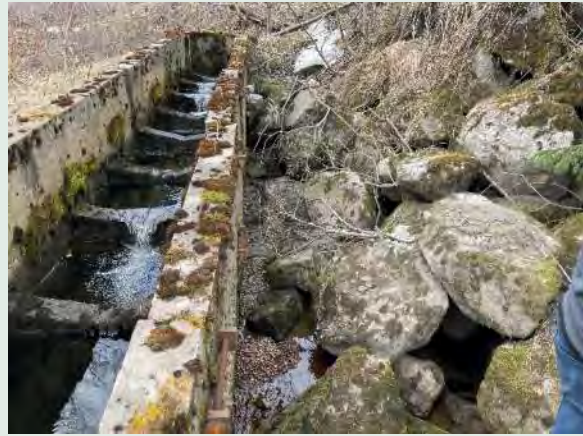
*Photo 4 - Erosion between rail riprap and fishway*

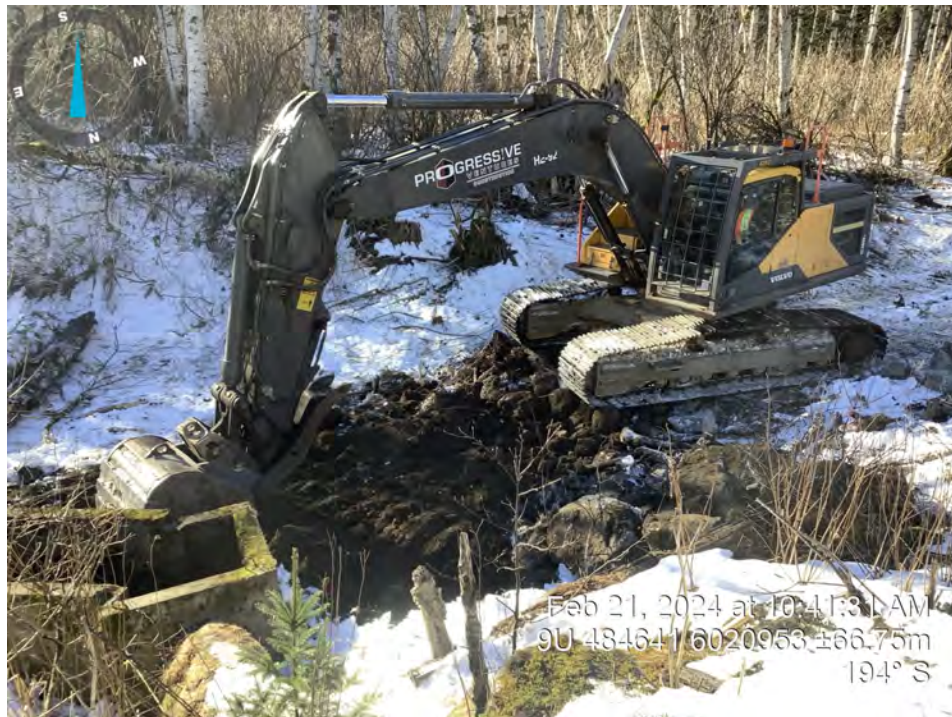
5 Excavator removing rip rap from west side of fishway

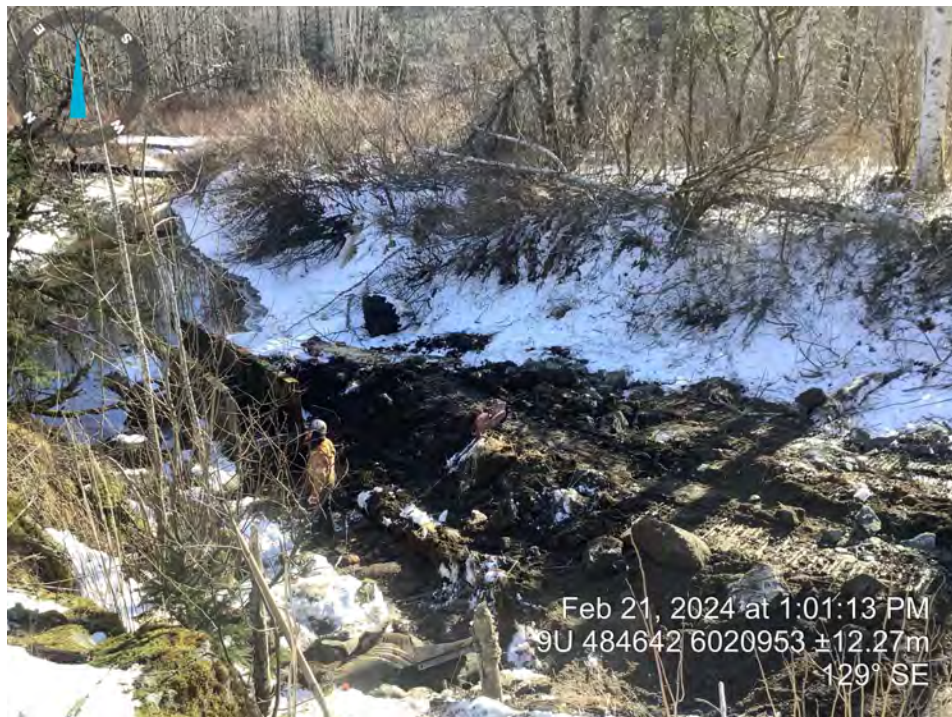
6 Partial removal of fishway

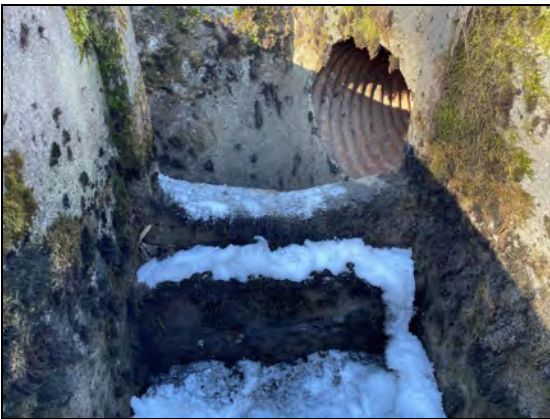
Photo 9 – corner box at the top of the fishway. Weir should be backwatering the culvert to the inlet

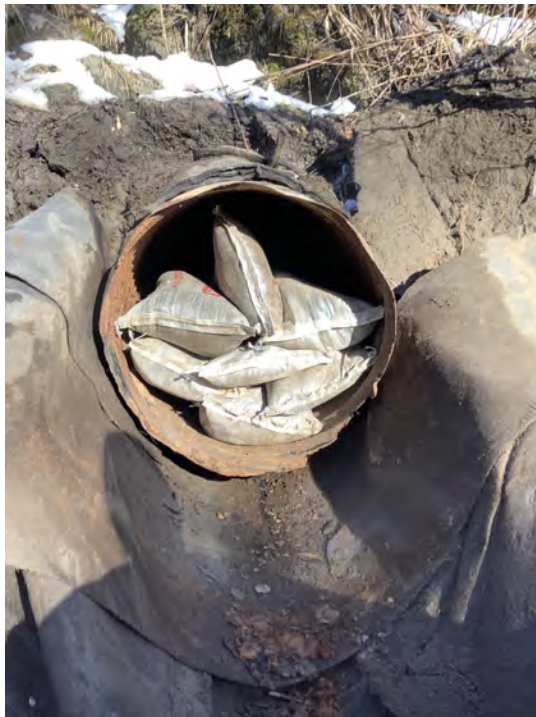
6 Sandbags in culvert to block potential flow

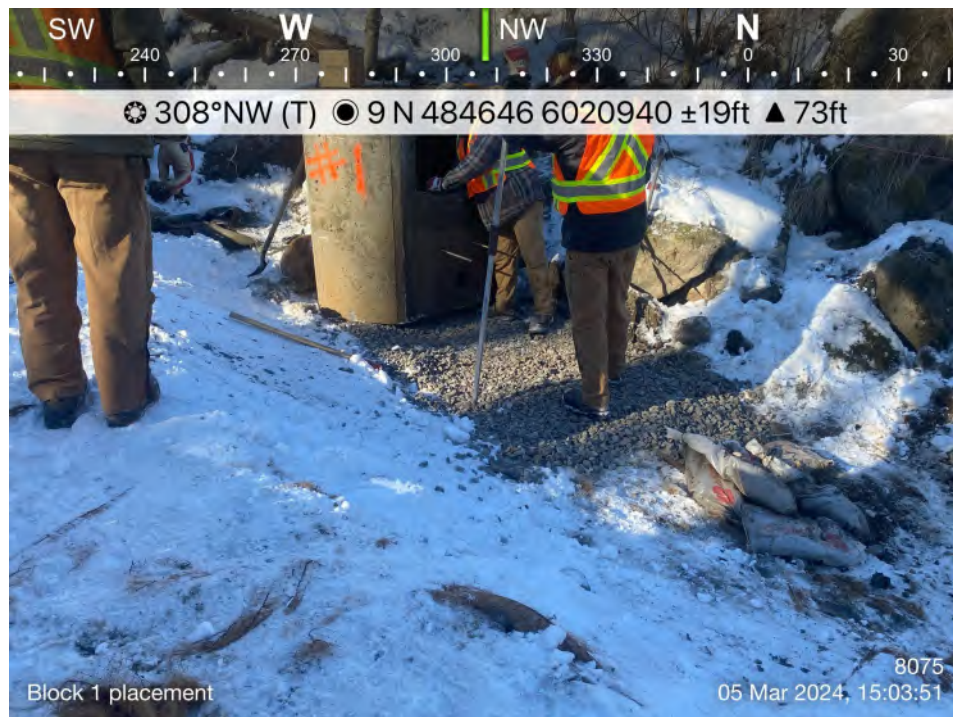
2 Adding drain rock under block 1

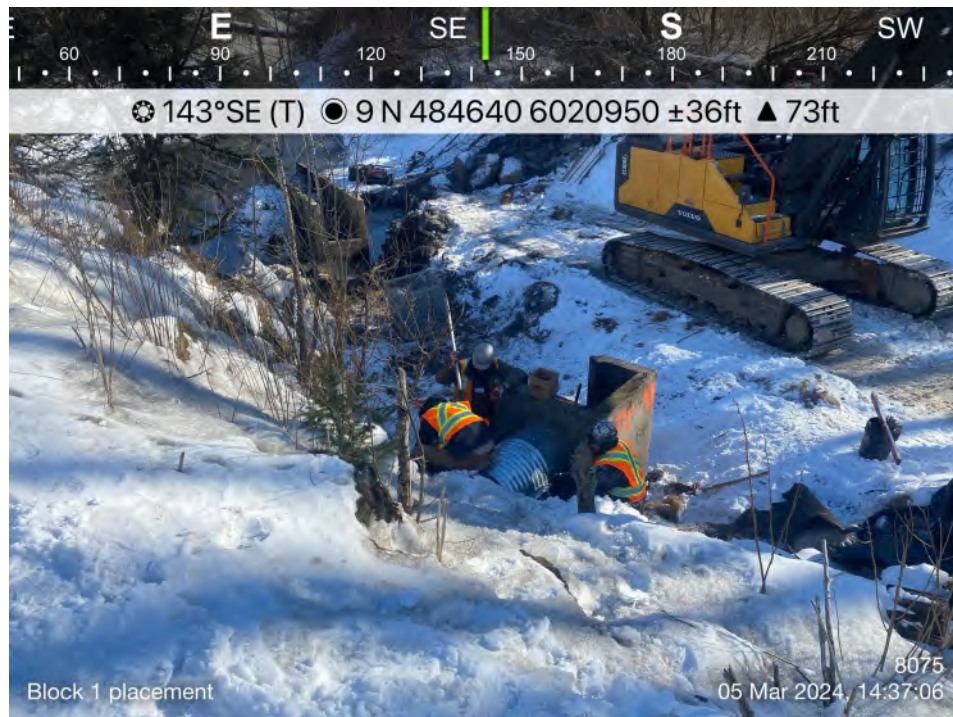
3 Installing culvert junction

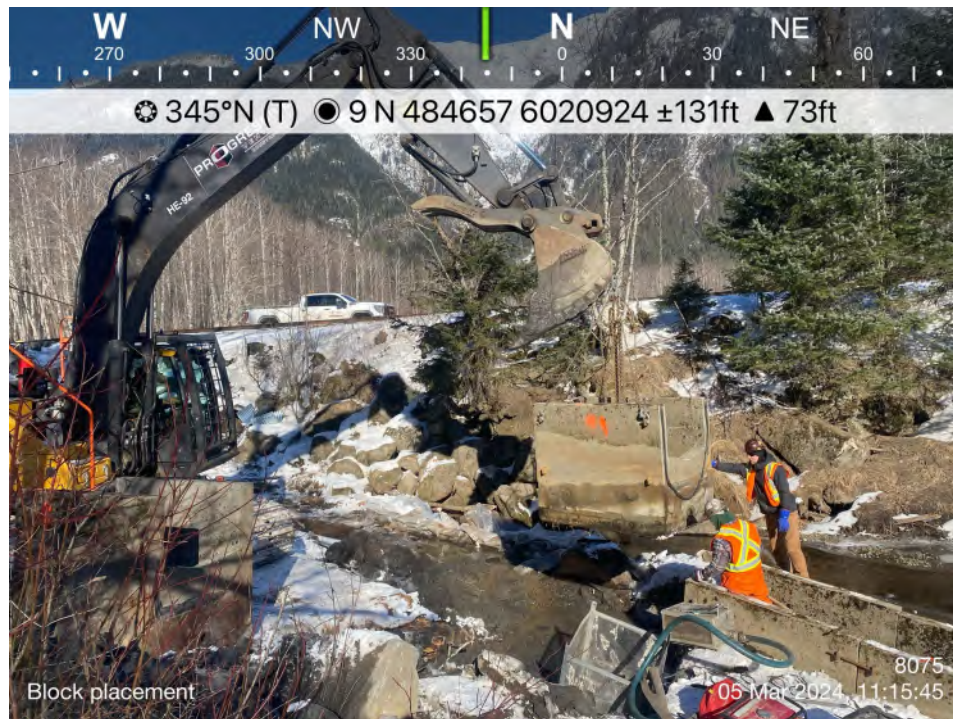
7 Block 9 placement including view of con sealant

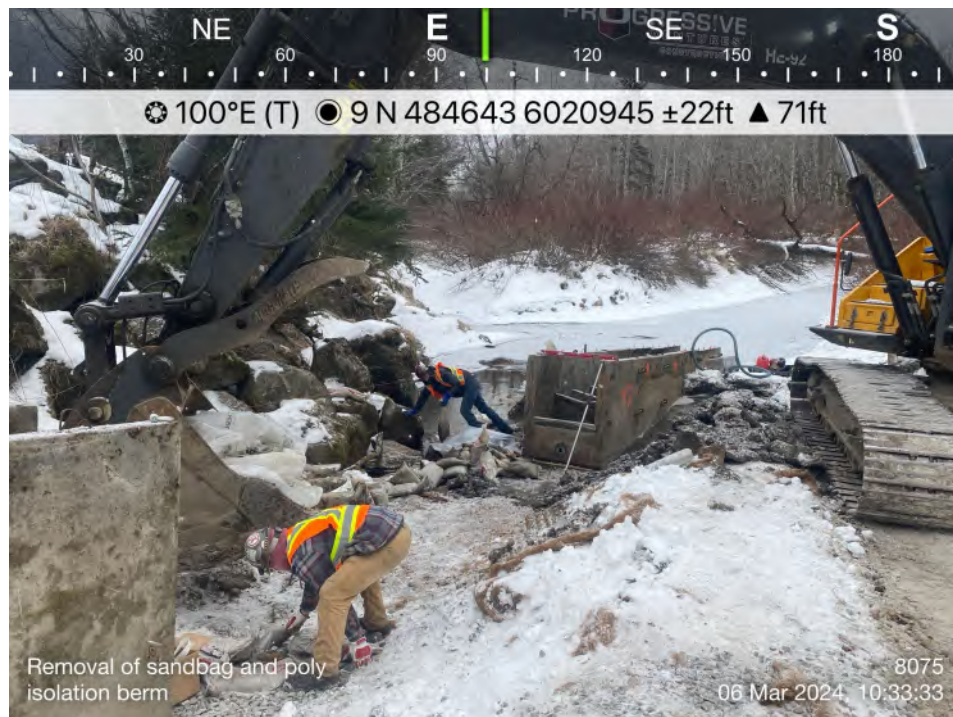
6 Removal of isolation berm.

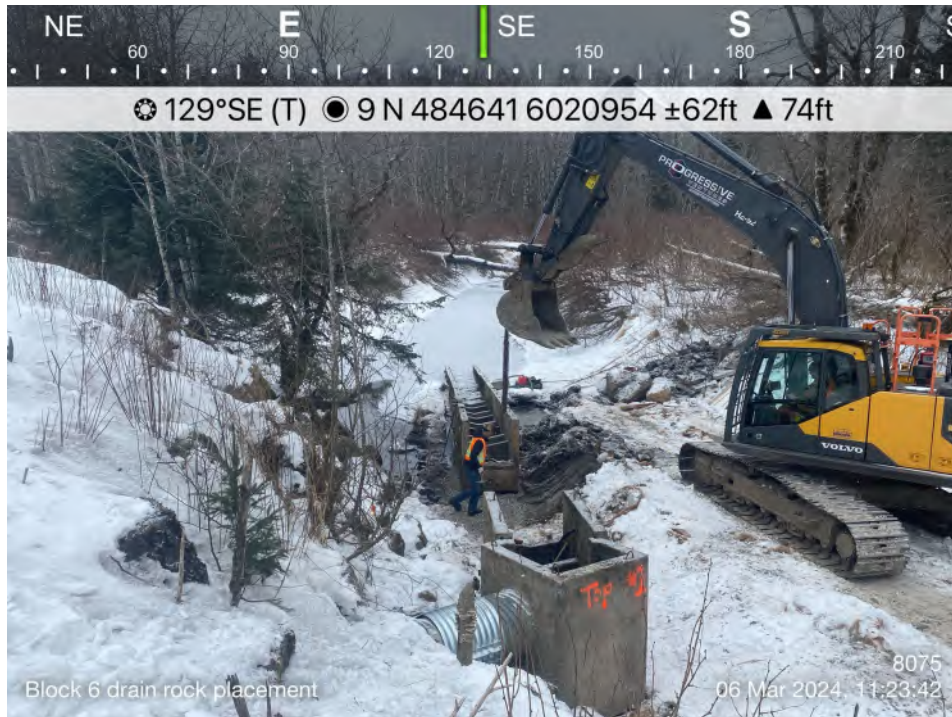
7 Placing drain rock for block 6.

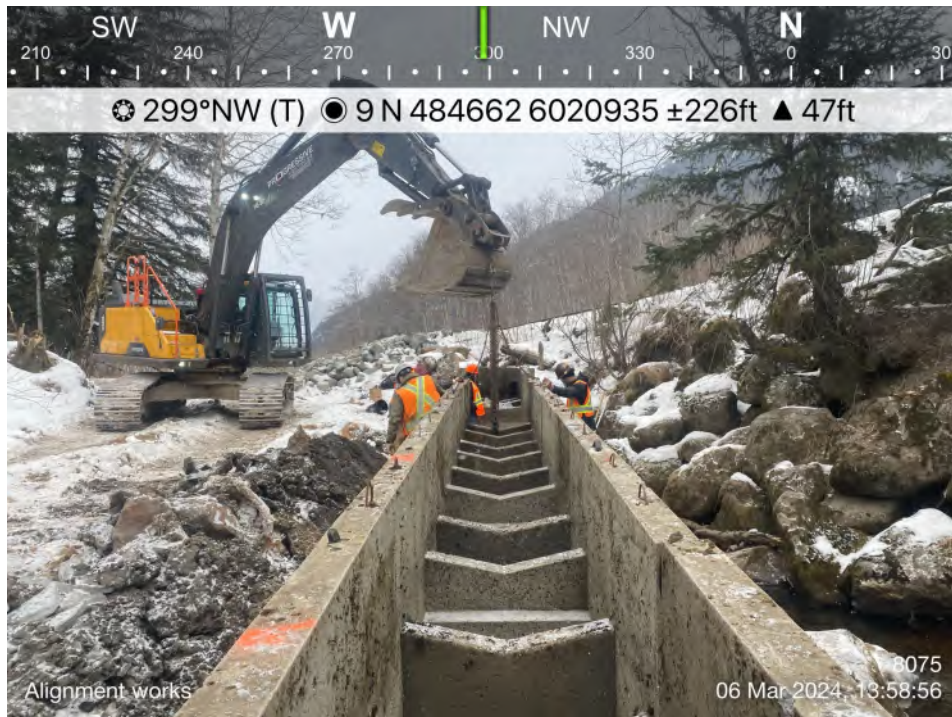
8 Alignment works in progress. All blocks placed.

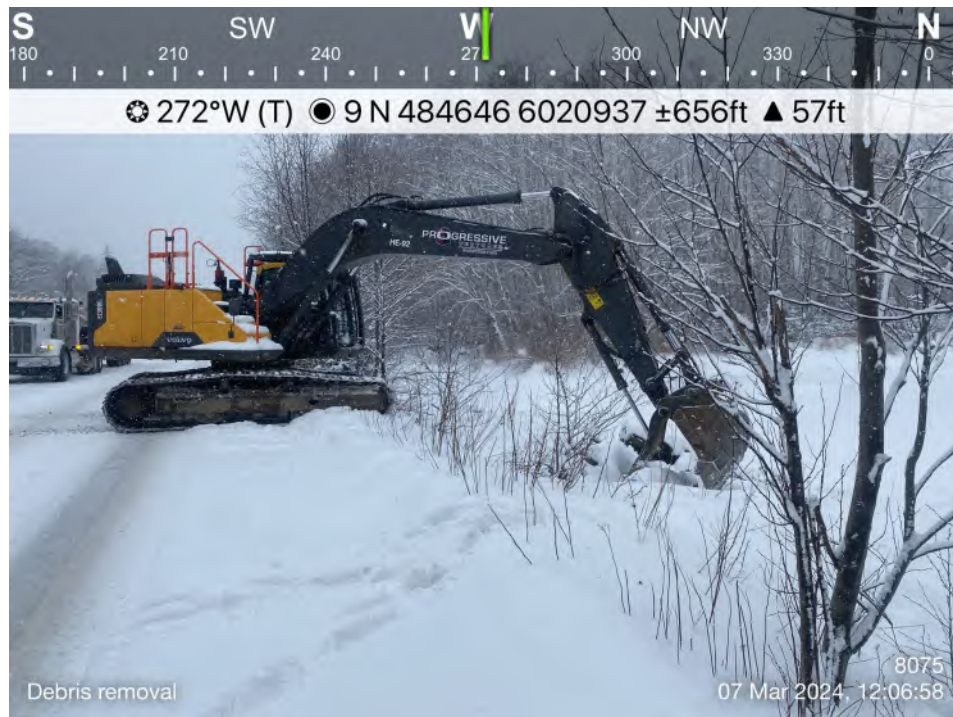
3 Excavator clearing woody debris from upstream side of culvert.
