Fish Passage Assessment of Kispiox Forestry Road Stream Crossings

Ken Rabnett & Tim Wilson
Gitksan Watershed Authorities
January 2007

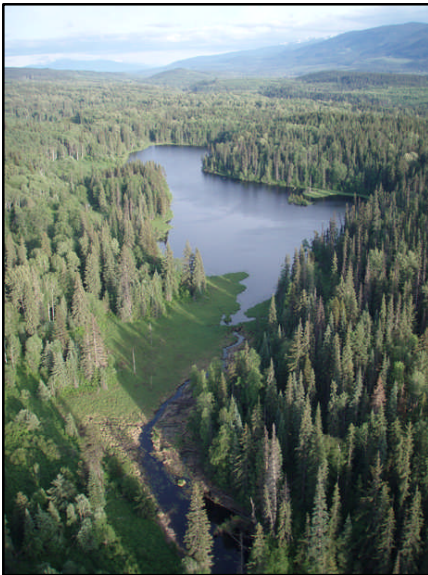
Skunsnat Creek Site 12

Figure 16. Skunsnat Lake and outlet from the northwest

The Kispiox Trail crosses Skunsnat Creek at approximately 70.3 km. Since the early 1960s when the culvert was installed there have been recurring fish passage problems and implementation of short-term solutions. Baffles were first installed in 1965 to assist fish in low and high flows; as well, it was recommended that the culvert be replaced by a bridge (DFO 1966, Hancock *et al.* 1983). The fish ladder below the road crossing washed out in the October 1978 flood; a jump pool was constructed in 1979 by Department of Highways; and baffles needed to be replaced in 1981 (Hancock *et al.* 1983). The drainage has been heavily harvested except for the mid-portion which is a burn area. Overall logging related impacts are rated moderate to high and primarily consist of road, channel, and riparian disturbance.
