**Detailed Fish Habitat, Riparian and
Channel Assessment
for
Select Central Bulkley River Tributaries**

Greg Tamblyn
Resource Management Consultant
Smithers, BC.

Matthew Jessop
British Columbia Conservation Foundation
Smithers, BC.

February 29, 2000

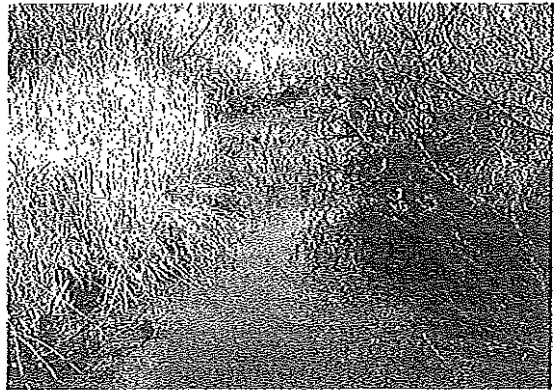
D: Upstream view of glide near reach 1 and 2 break.

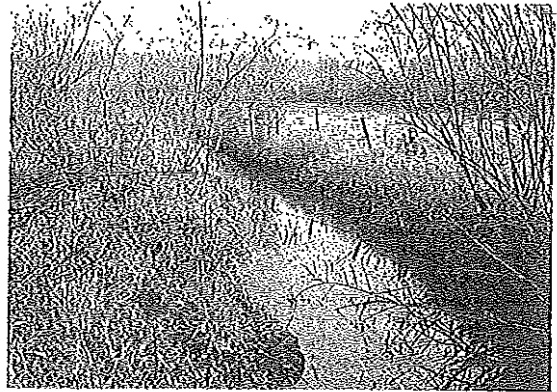
B: Downstream view of ditched channel. Note the lack of riparian shrubs and trees.

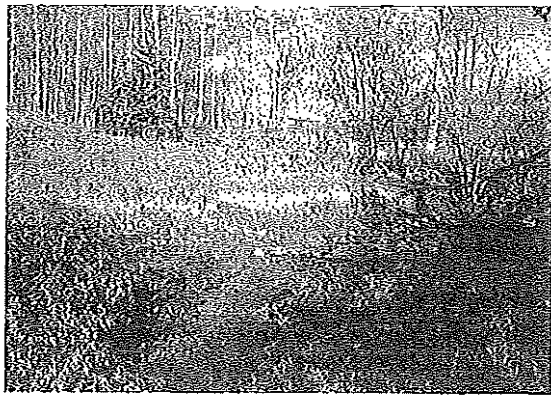
C: View of typical impacted channel and riparian habitat at 0+510 m. Note the bank shear and sediment input.

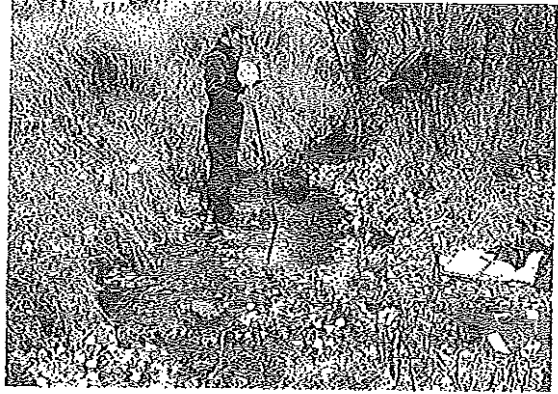
B: View of bank erosion and large substrate particle size at 0+280 m.

Approximately 60% of the channel in section 2A is moderately disturbed. The lower 140 m is moderately aggraded as evidenced by mid-channel bars, multiple channels, eroding banks, minimal pools and minimal LWD. Localised areas of aggradation occur behind LWD and intertwined willow branches crossing the creek. About half of the rest of the reach is moderately degraded as indicated by minimal pool area, extensive riffles and disturbed stone lines. The straightening of the channel upstream of the road is likely the main contributor to the downstream bank erosion and degradation (Fig. 14B).

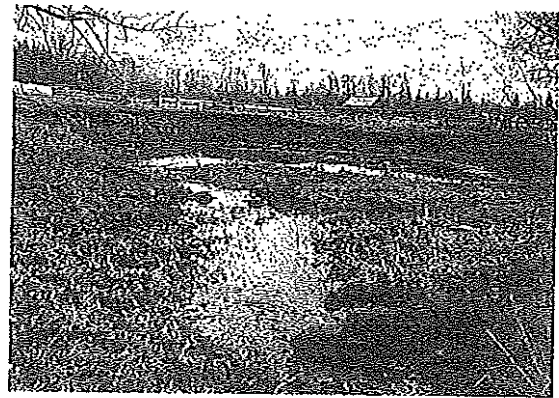
D: View of artificial pond in section 1B at 0+720 m.

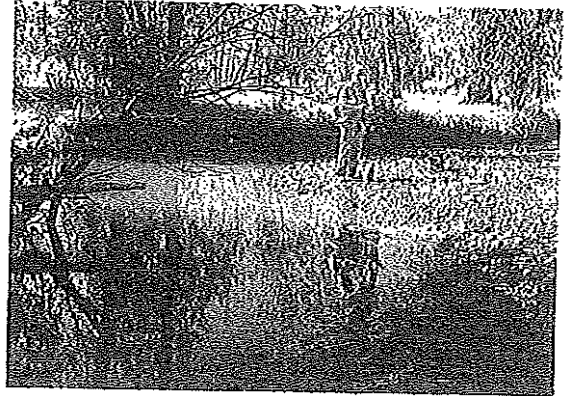
B: View of typical channel and riparian habitat at 1+945 m. Note the large point bar.

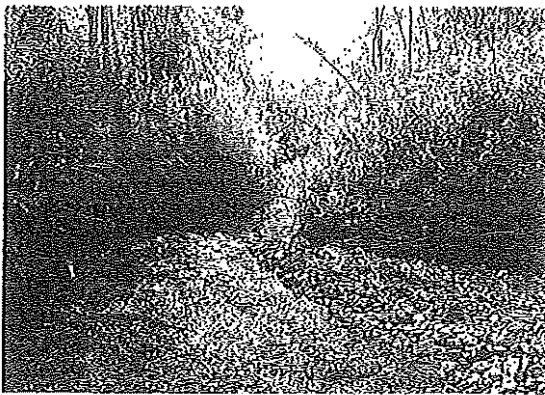
C: Downstream view of the top of the avulsion at 3+620 m. Note the incised banks and exposed roots in the new channel.

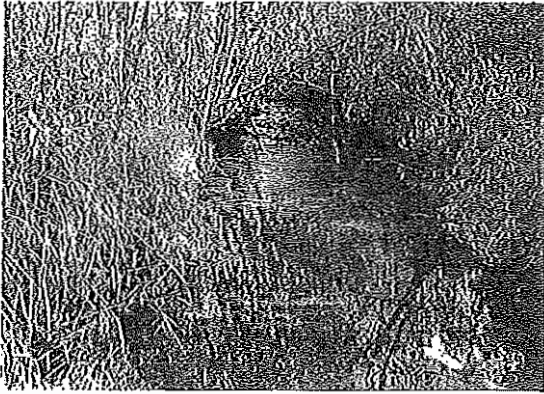
A: Upstream view of typical channel and riparian conditions in section 1A at 0+147 m.

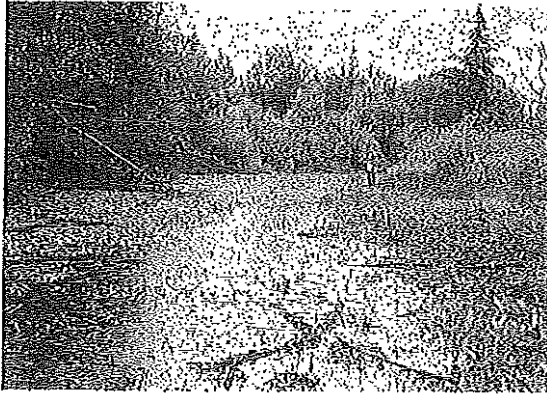
A: Upstream view of reach 1, a side- or flood-channel of the Bulkley River.

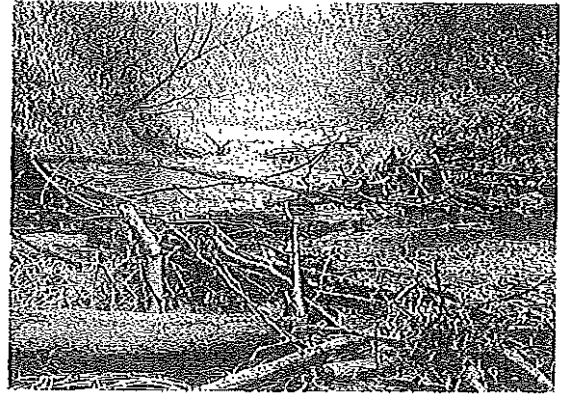
B: Downstream view of the mouth of reach 1. The Bulkley River is in the background.

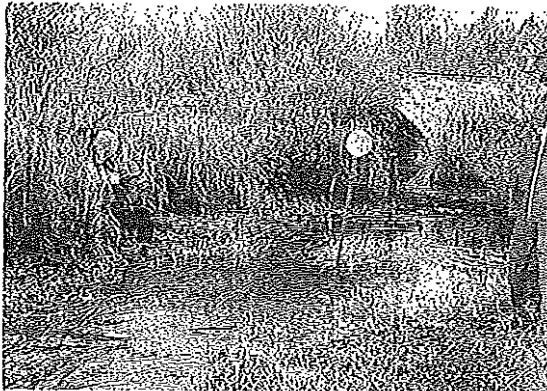
C: Upstream view of typical channel and riparian habitat at 0+030 of reach 2. The CN tracks and culvert are in the background.

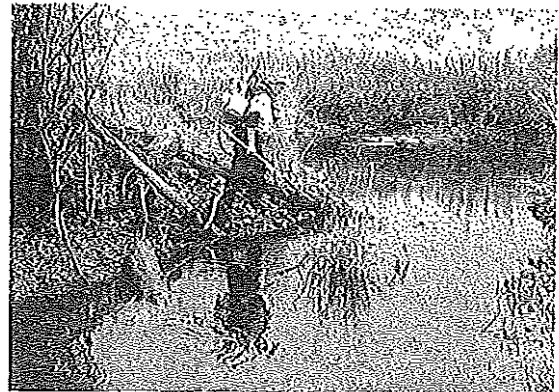
Reach 2 of Helps Creek is a short section of fluvial channel linking the reach 1 back-channel to the large wetland comprising reach 3. Reach 2 is 220 m long and flows under the CN tracks and through an old road embankment (Fig. 29D). The culverts under the tracks were passable to fish and the deactivated road crossing offered one of the only areas of substrate suitable for anadromous salmonid spawning. This reach contains moderate rearing and overwintering habitat in its lower end where the channel is deep and abundant cover is present. Spawning habitat occurs in this reach and is suitable for resident and anadromous salmonid species. We captured coho (0+, 1+), chinook (0+), rainbow trout (0+), cutthroat trout (2+) and mountain whitefish (1+) in the glide and pool we sampled. Functional LWD was relatively scarce (0.23 functional pieces per bankfull width). However, 33% of the functional wood had a diameter of 50 cm or greater (Table 31a). Limited LWD is available for recruitment and the riparian vegetation along this reach consisted mainly of willows, red-osier dogwood, alder and grasses.

D: Upstream of deactivated road crossing at 0+161 m in reach 2.

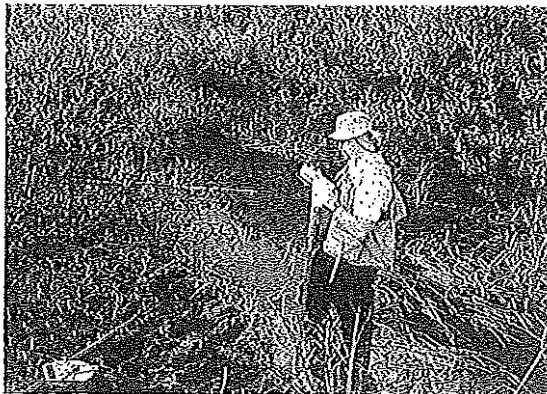
E: View of channel and riparian conditions in reach 3.

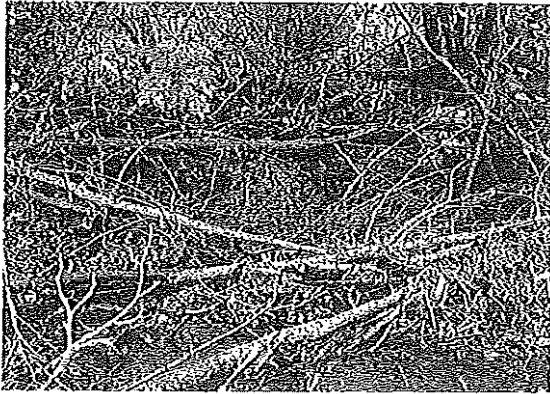
A: Downstream view of channel at 0+107 m. Note the abundant SWD and shrub cover.

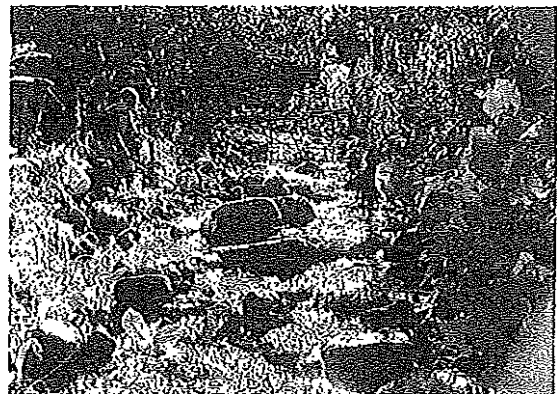
F: Upstream view of reach 3 from the reach break.

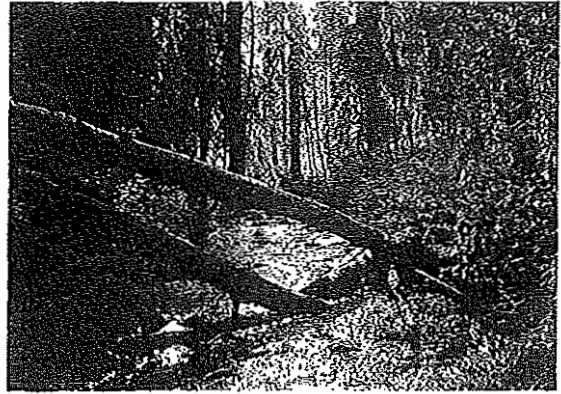
B: Upstream view of typical channel and riparian conditions at 1+597 m. Note the LWD spanning the channel.

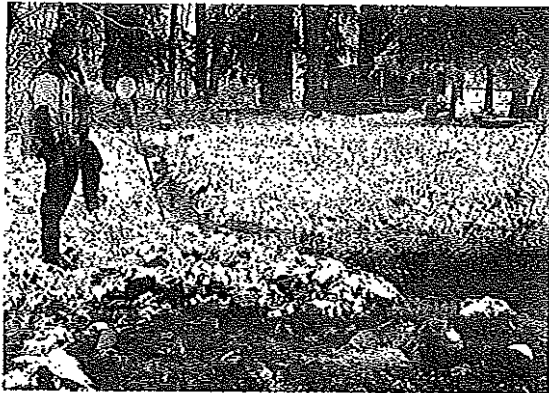
C: View of a small stone weir, 30 cm high, diverting flow to a small channel at 0+235 m in Reach 1. The diversion channel flows into a small pond.

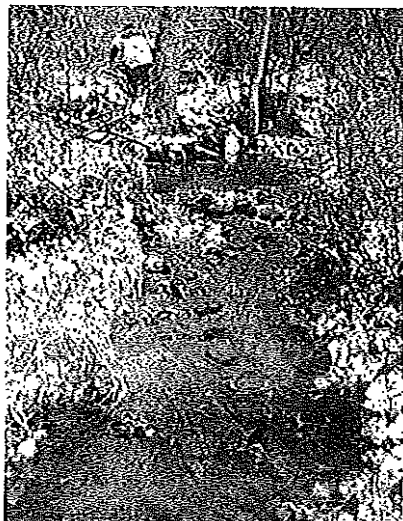
E: Upstream view of reach 2 from the Main St. crossing. The gradient of this site is 7%.

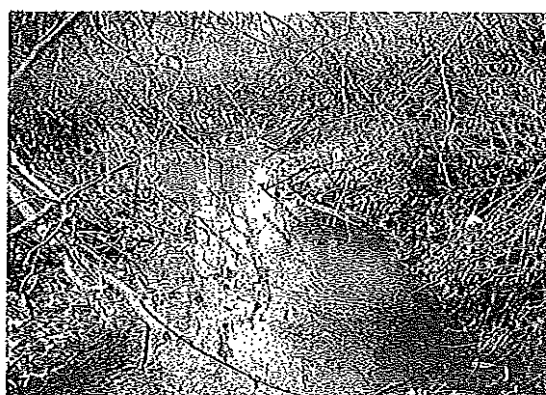
D: View of typical channel and riparian vegetation habitat upstream of Highway 16 at 1+461 m.
