Fish Habitat Assessment and Selected Rehabilitation Prescriptions within the Zymoetz Watershed

Terrace Salmonid Enhancement Society
Terrace, B.C.

Ministry of Environment, Lands and Parks Watershed Restoration Program

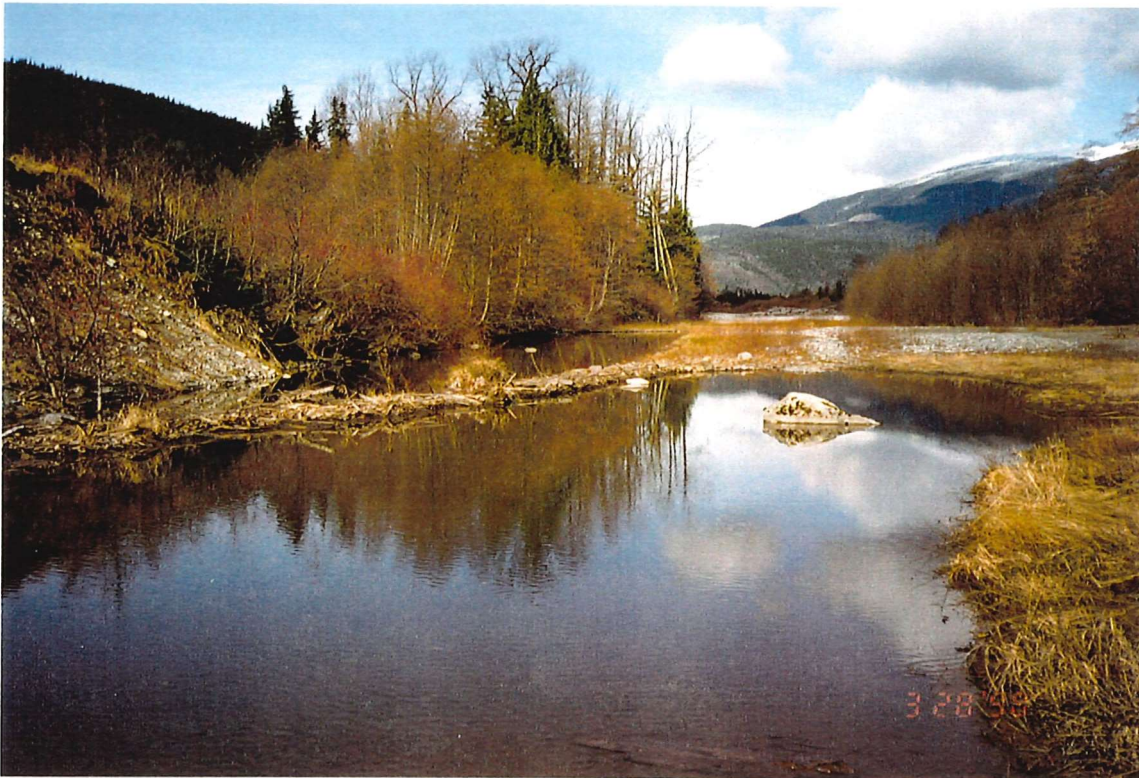
Photo 4: Mid-channel pool at old bridge.

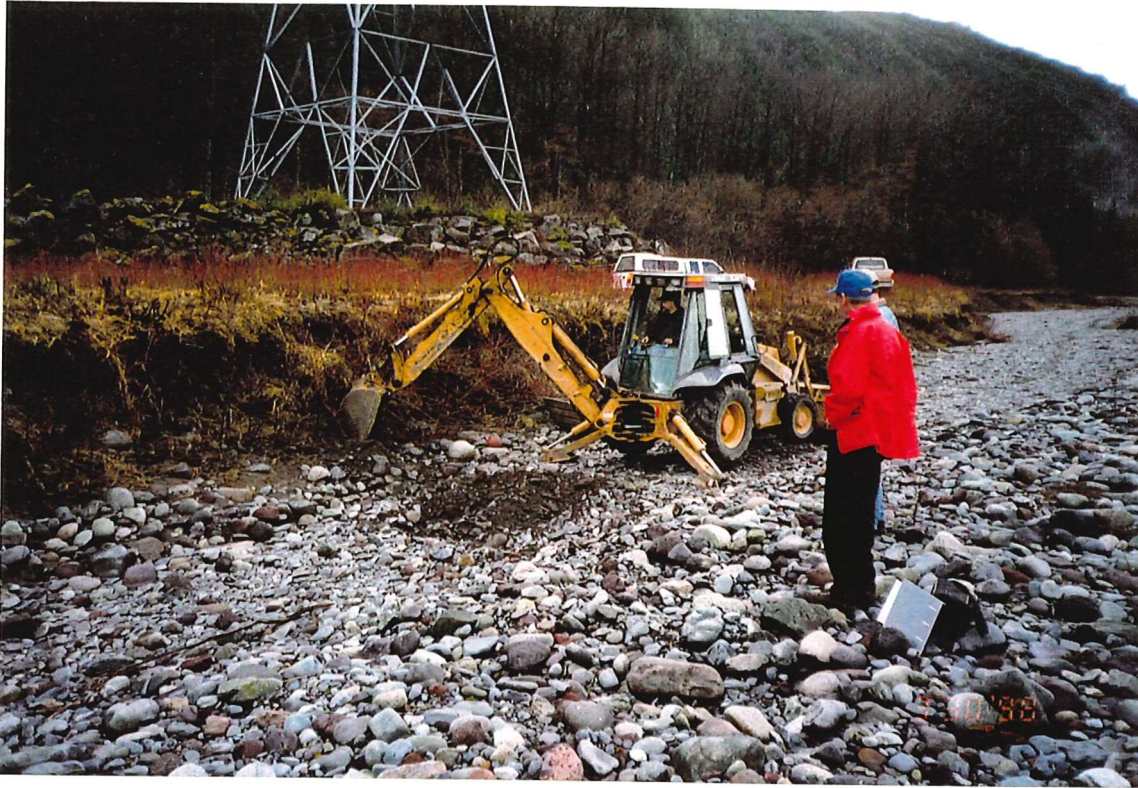
Photo 6: Digging test hole one in the upper channel.

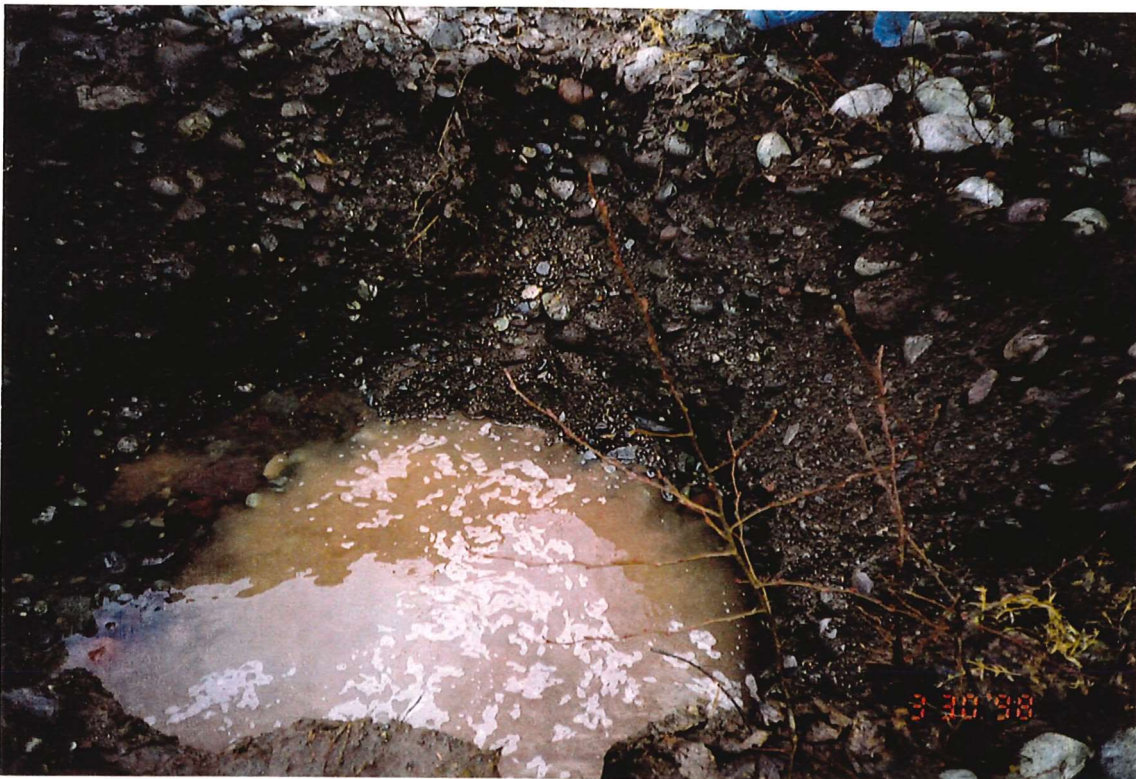
Photo 7: Sub-surface water reached at 1.5 m in test hole one.

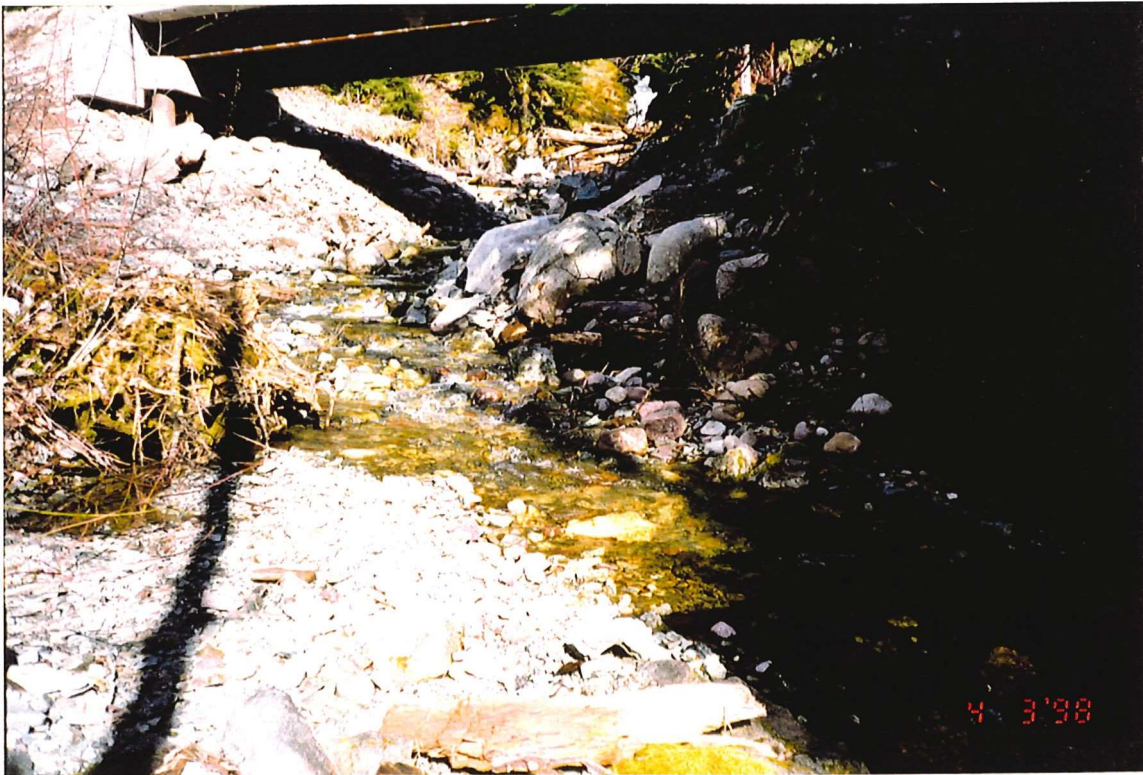
This stream crosses the North Copper FSR with a gradient of approximately 24% above (reach 2) and 6% below (reach 1) the bridge (photo 10 and 11). A few meters above the position of the existing bridge lies the remnants of the old bridge. The mouth of this creek meets with site 24B side channel (photo 12). Prior to the new bridge being constructed, vehicles drove through the creek. The area adjacent to the creek was logged.

Photo 10: Looking upstream to the bridge.

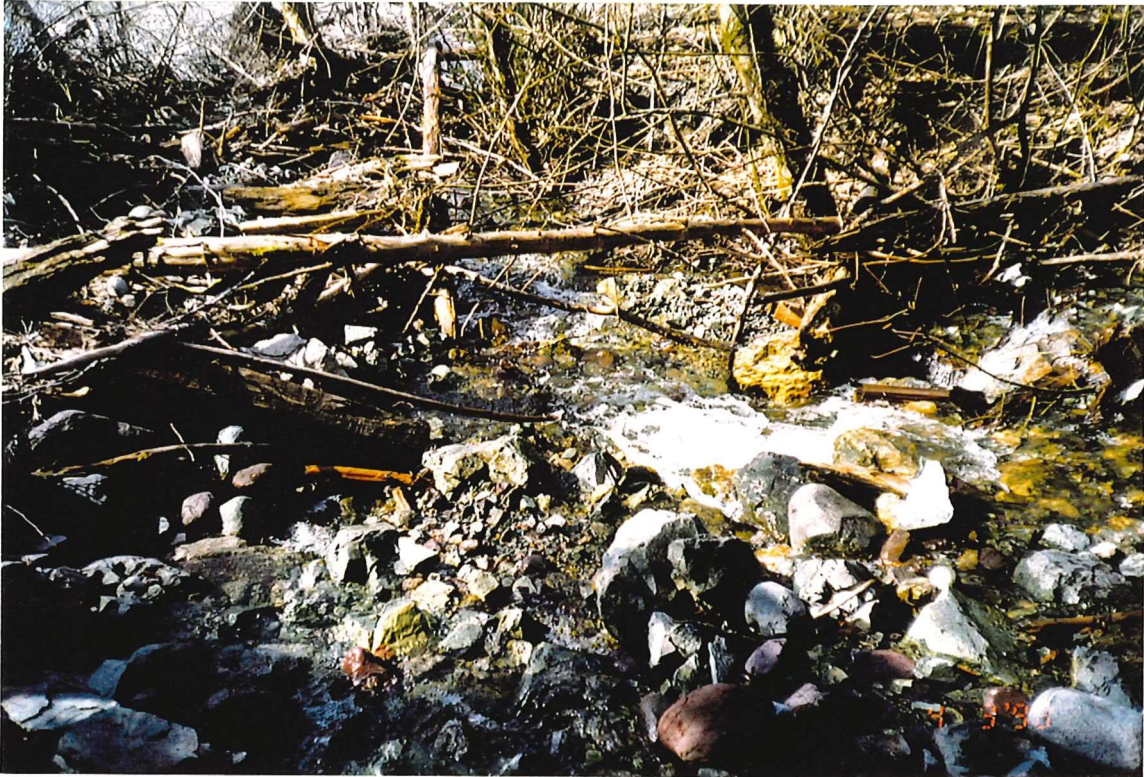
Photo 11: Something Creek between the bridge and the fan.

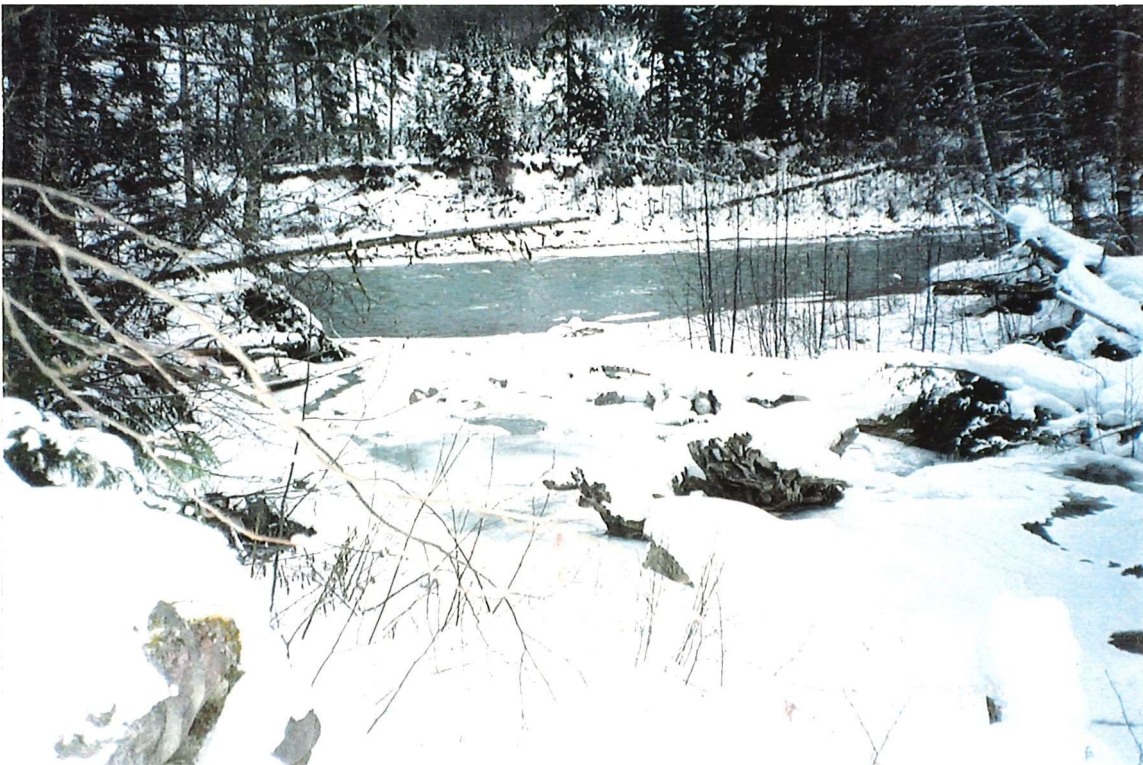
Photo 16: Looking downstream Fiddle Creek from the PNG crossing to the Zymoetz River.

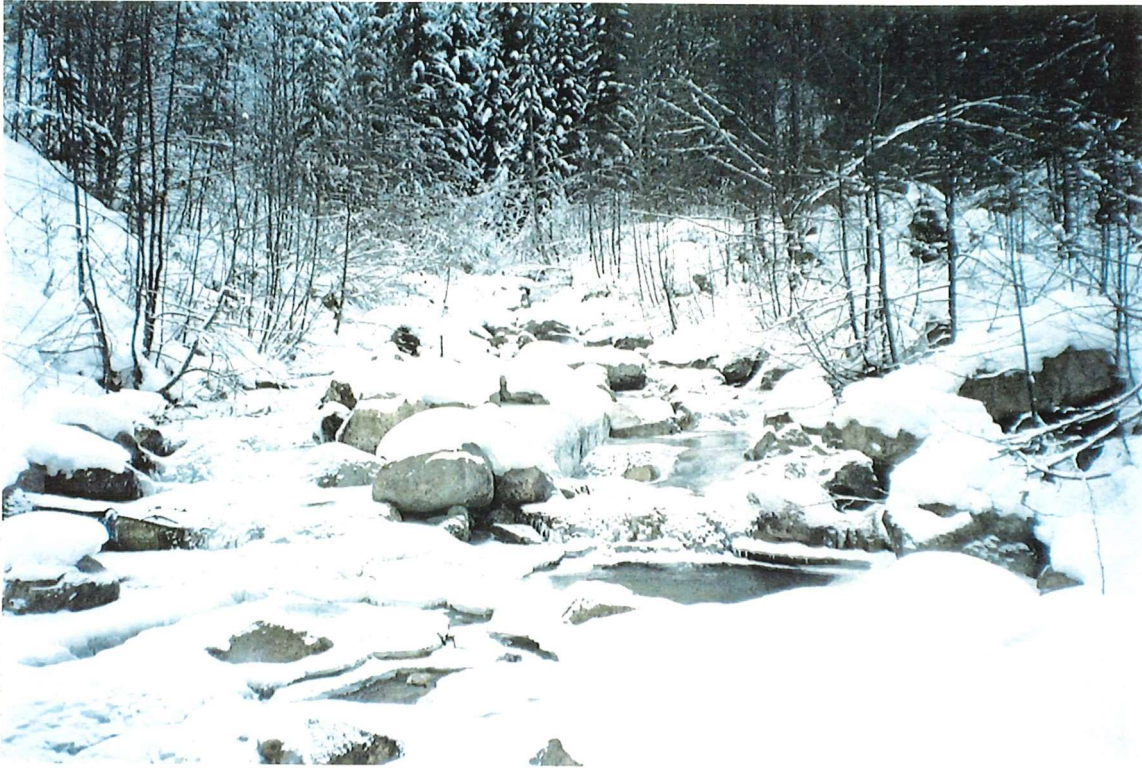
Photo 17: Looking up stream from the PNG crossing. This site consists of poor sized spawning gravel, its make up is medium to large size boulders and LWD for rearing.

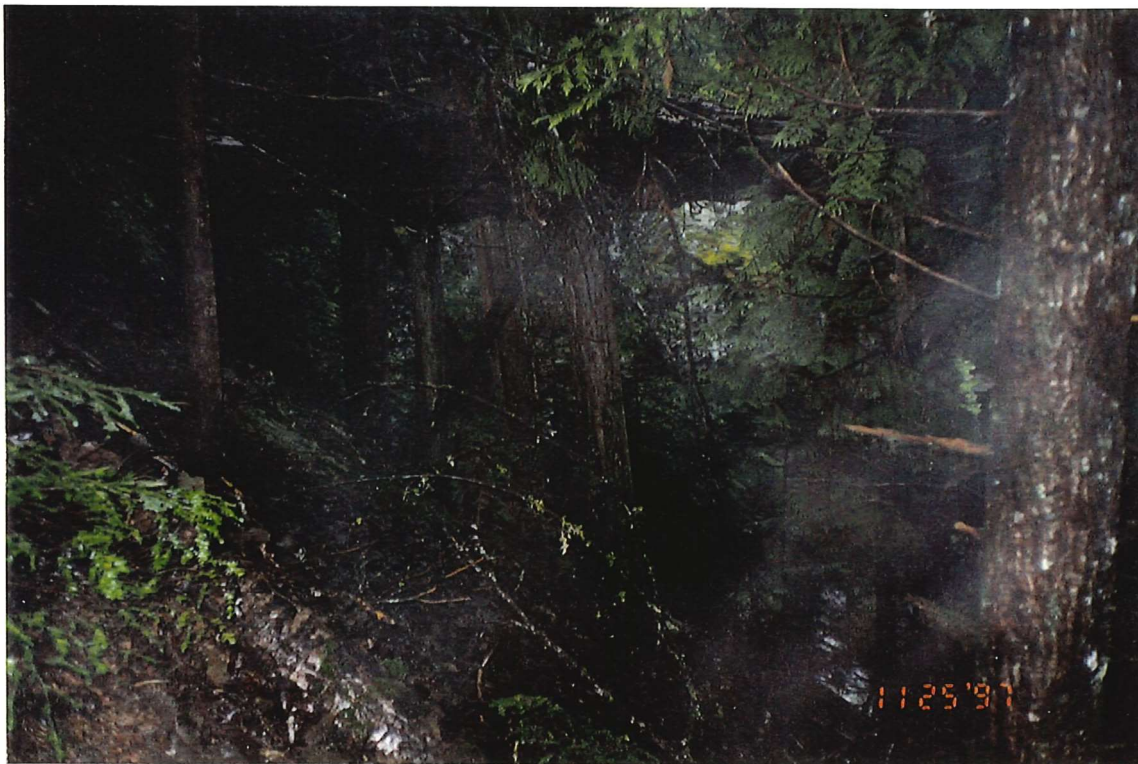
Photo 20: The remnants of an old bridge that risks collapse with little impact upon spawning and rearing habitat.

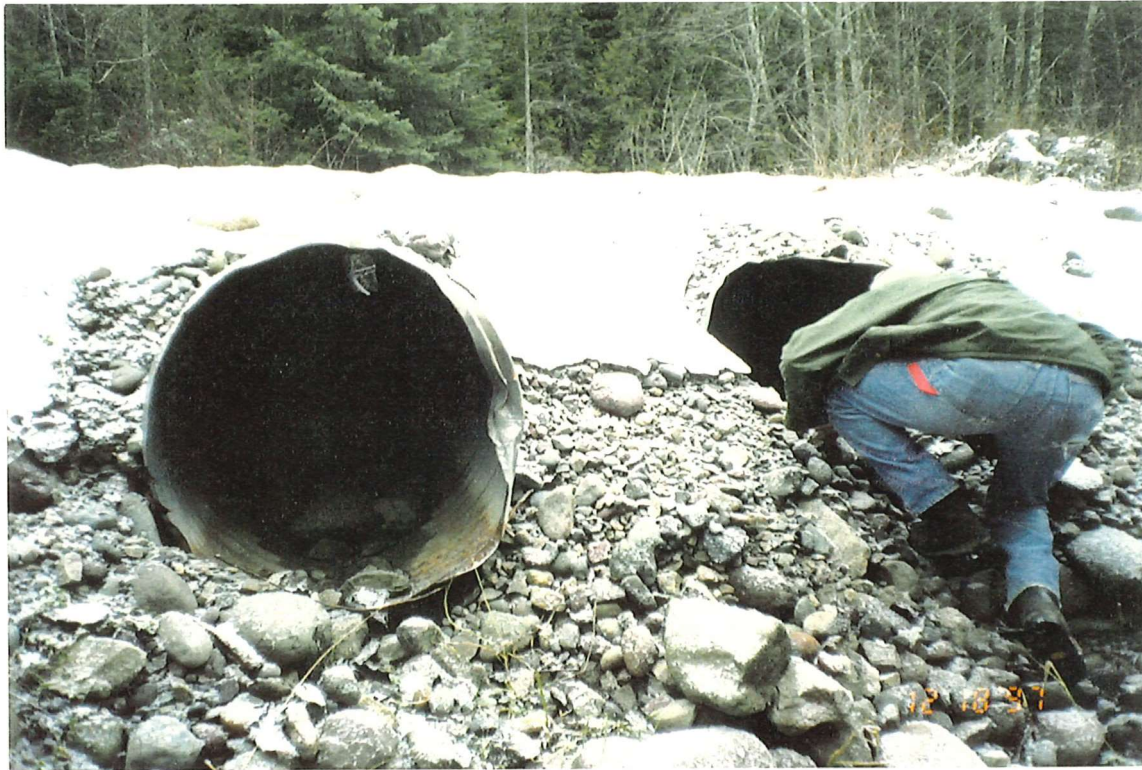
Photo 23: Perched culverts with no flow into the channel.

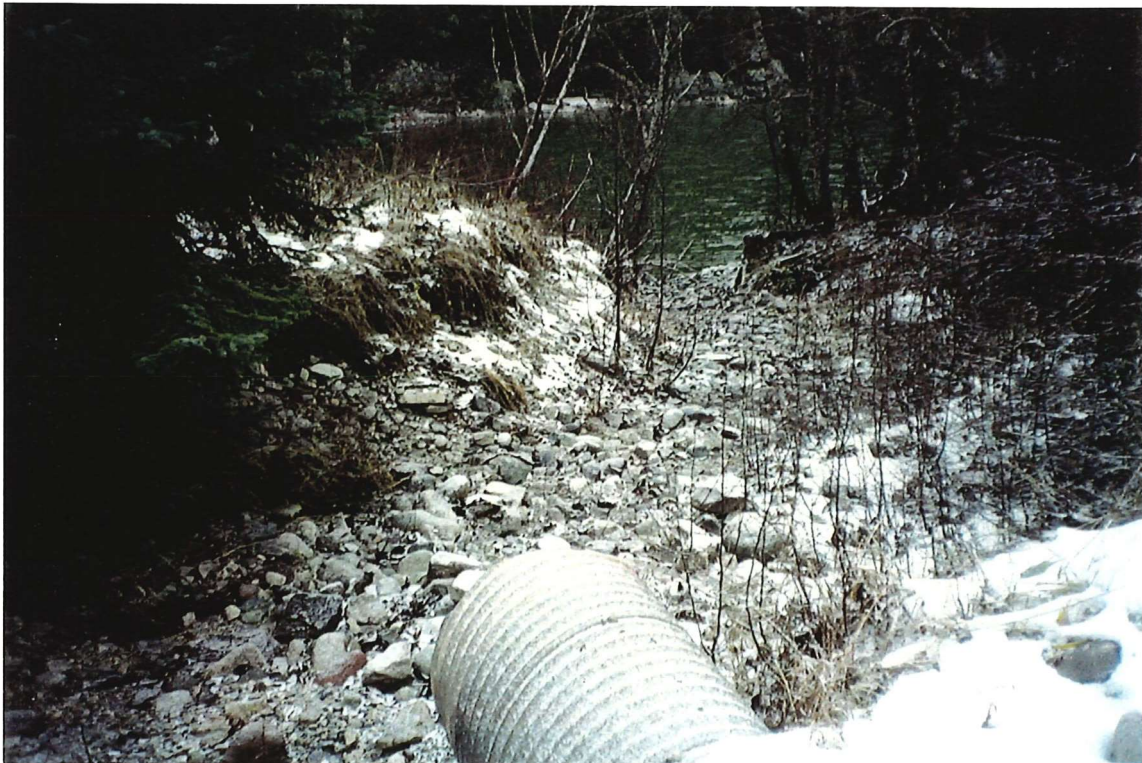
Photo 24: This culvert, just below the Copper FSR, is positioned too high.

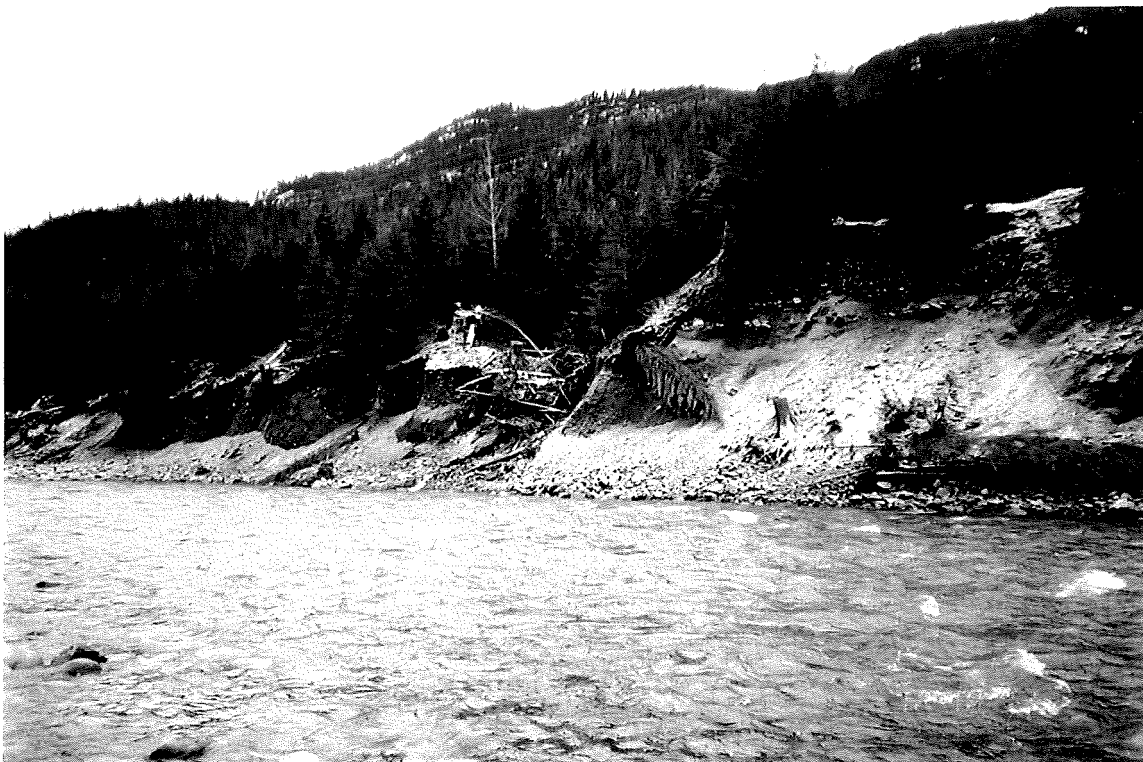
Gravel bank erosion is not serious, but the loss of the riparian zone is.

Photo 25: This eroding bank is causing sediment into the Zymoetz River.

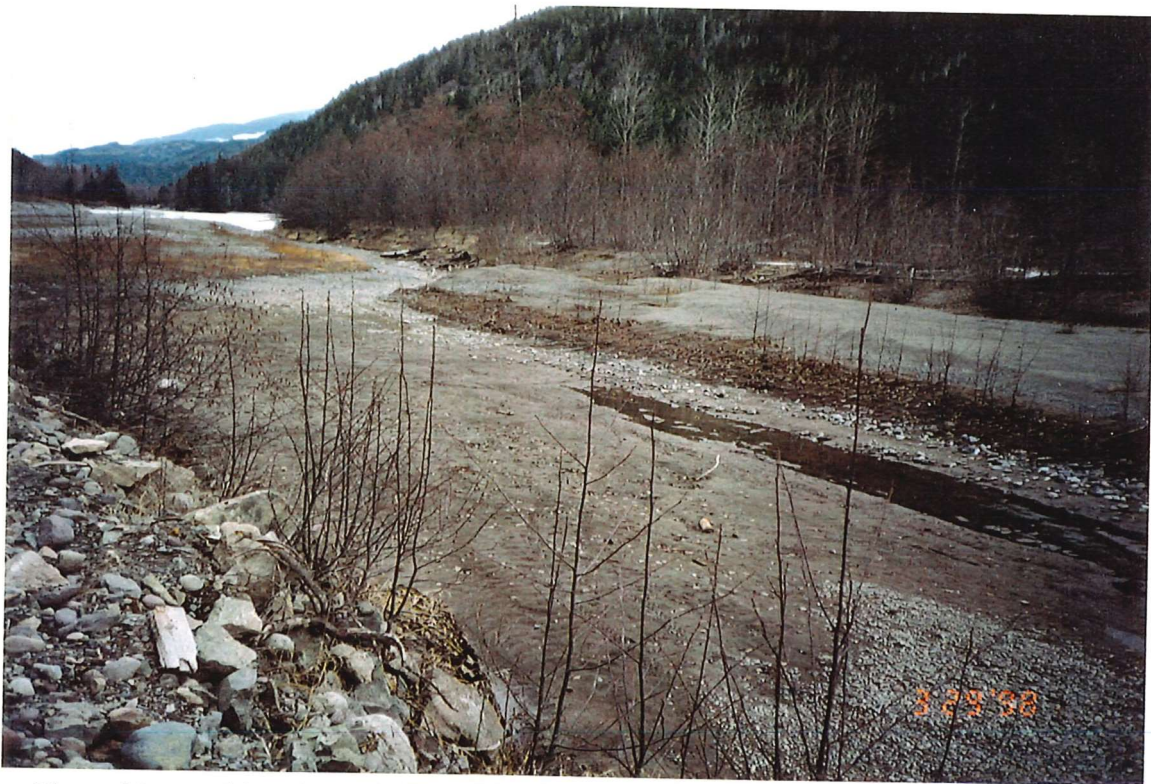
Photo 30: Looking down 16 Km side channel to the Zymoetz River.

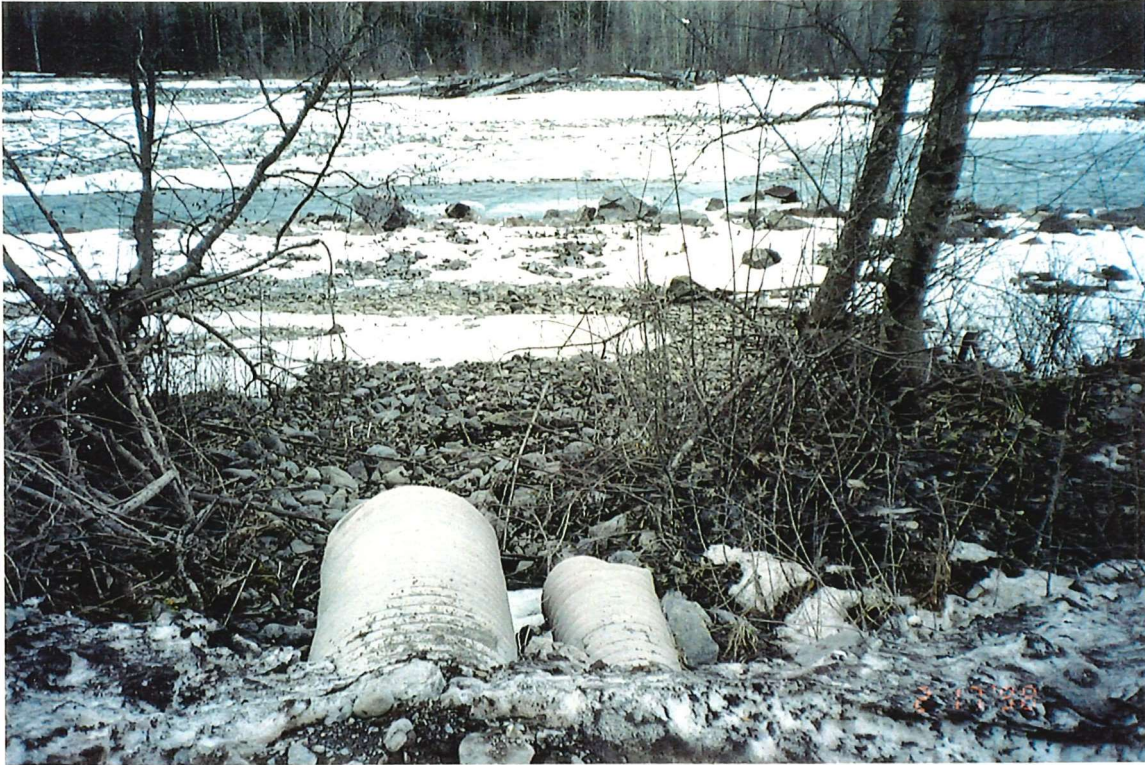
This site is a back channel fed by ground and seepage water that was likely created by the road construction that is drained by a poorly installed culvert that was placed too high (photo 33). This area could provide excellent rearing and over-wintering habitat.

Minnow trapping above the culvert on December 2, 1997, yielded no fish. This could be, in part, due to the cold water temperatures or to the short trapping time of 4 hours. No water was observed flowing through the culvert or under it during a field trip on March 9, 1998 (photo 34).

Photo 34: Water is no longer flowing from this channel (March 1998).

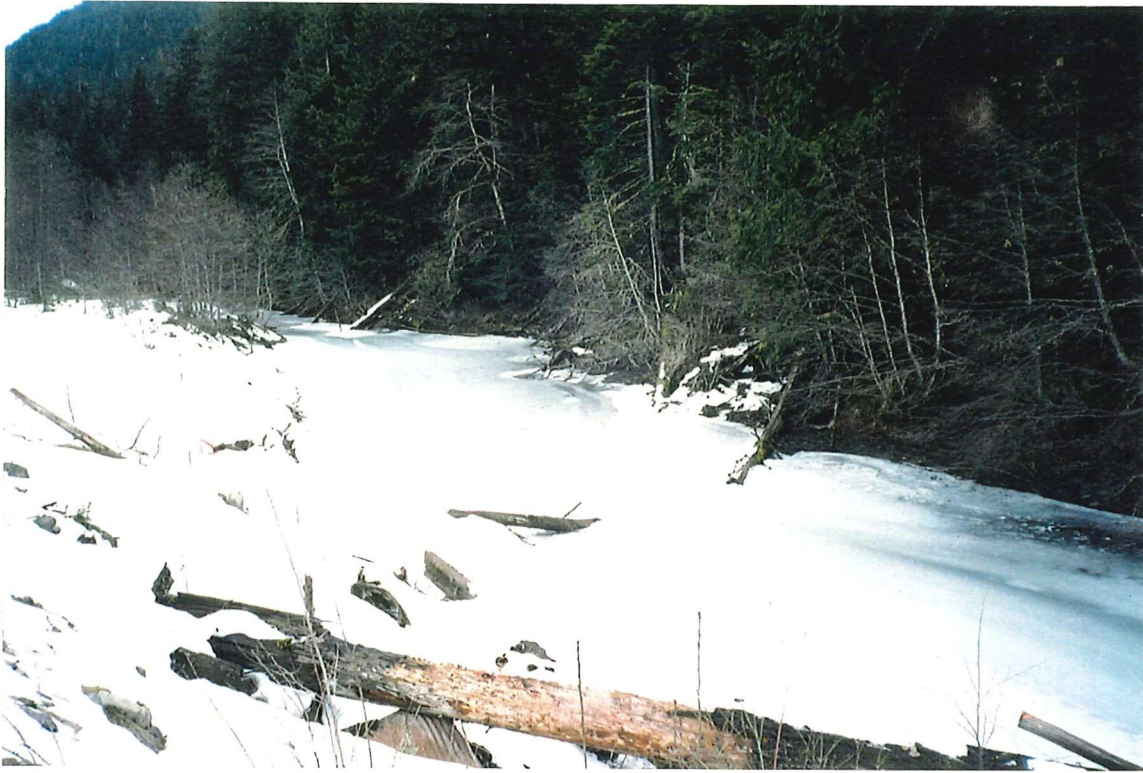
This site was found to have two trickling water sources: a ground water source on its east side and a surface flow on its south end. The culverts on either side of the FSR are plugged preventing water flow from the Zymoetz River (photo 37 and 38). The minnow traps checked on November 14, 1997 revealed a total of 19 coho and 1 char. The water is flowing through the porous shot rock at the end of the channel likely as a result of PNG reconstructing its pipeline. The relative abundance calculated is 0.83. The chart below represents the fork lengths of these fish.

Photo 38: Side channel culvert in foreground provides no access for salmonids.

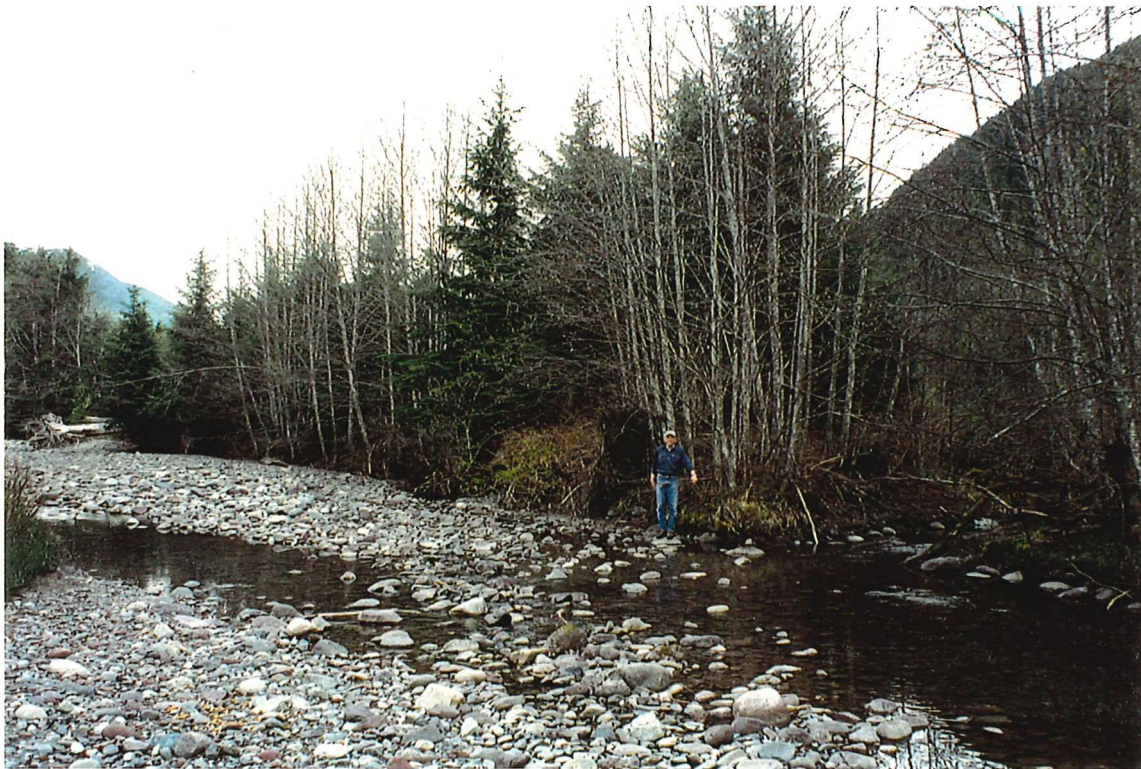
Photo 42: Mid-channel where Swan Creek joins with the side channel.

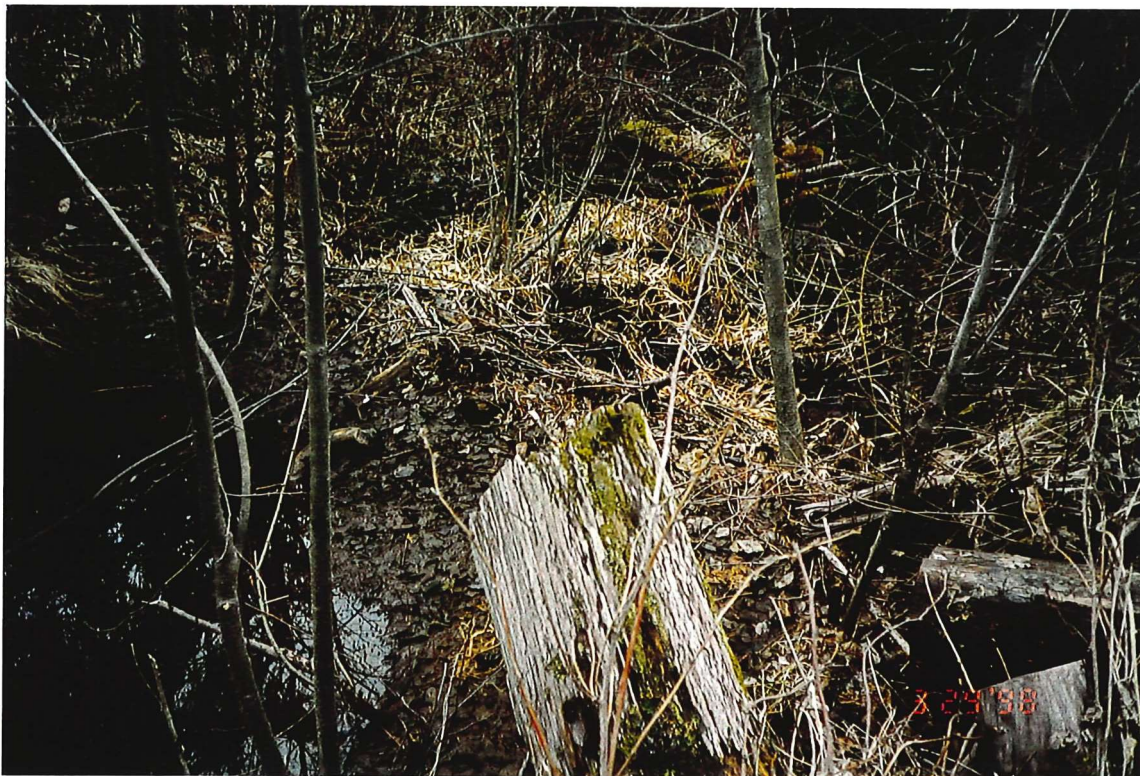
Photo 48: Ditch dry below dam.

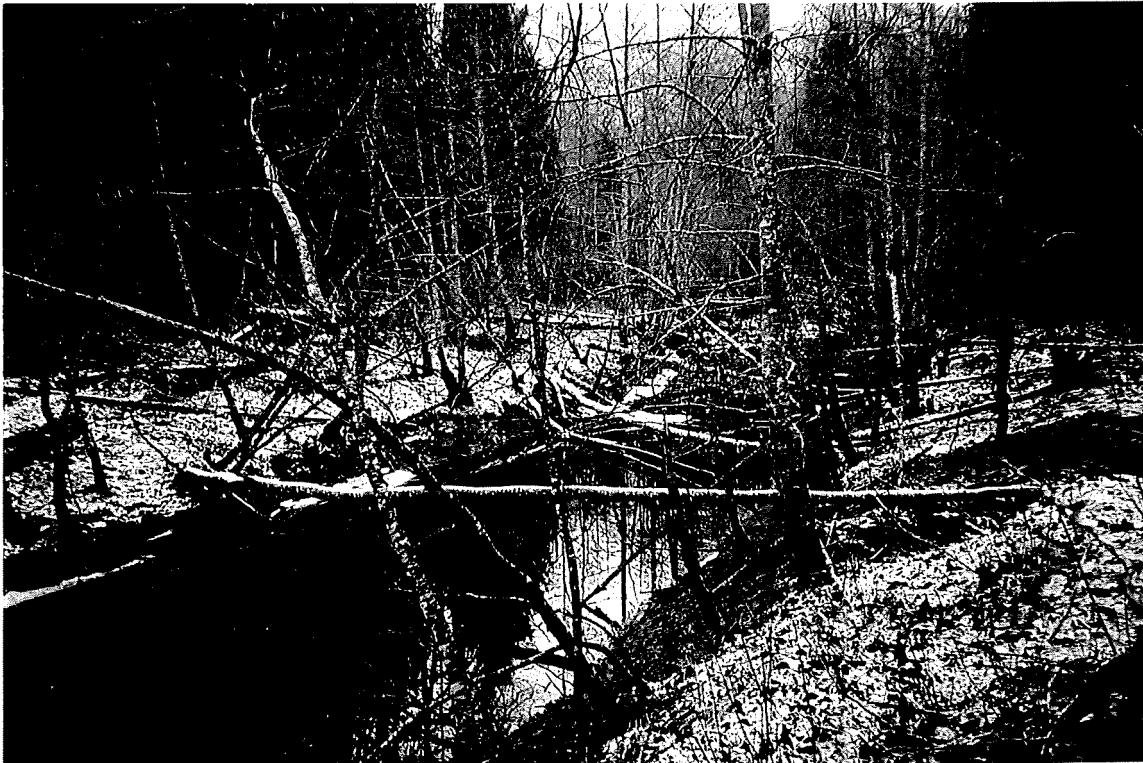
This side channel originates from a break through from an inside bend of the Zymoetz River about 0.75 km from its outlet. There is only seepage flow in the channel that is surrounded by both coniferous deciduous vegetation for shade and shelter (photo 50).

Photo 50: The vegetation surrounding this channel would provide substantial shade and shelter for rearing fish if they had access to the channel.

This report is not putting forward a prescription for development but recommends that this site be analyzed in more detail to determine if habitat rehabilitation or enhancement should be carried out. This should be completed by the TSES at the same time as additional assessment is taking place with other sites, for example, the Clore River Slide.

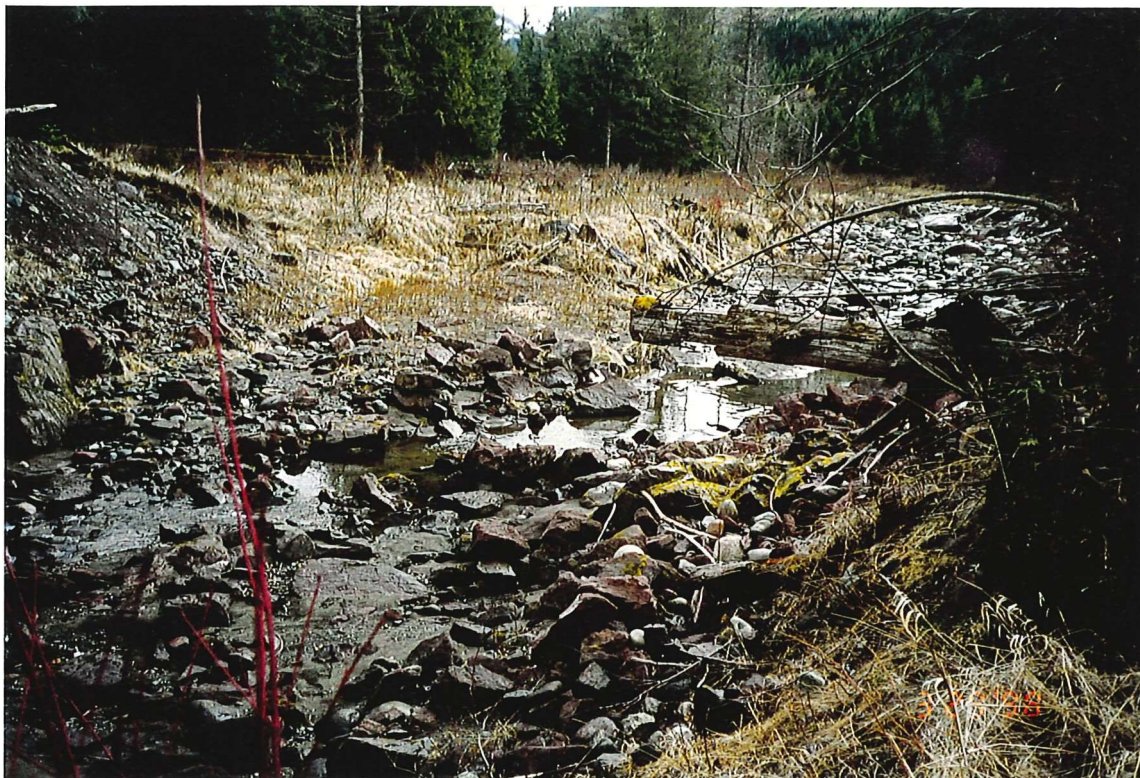
This is a large channel 660 m in length with an average of a 3% gradient. The wetted portion, within reach 1, consists of mainly cobbles and boulders along with occasional pockets of gravel (photo 51 and 52) and the dry portion is in reach 2 (photo 53). The source of flow into the wetted channel is a small stream (Doll Creek) that enters approximately 200 m upstream from the Zymoetz confluence. This entrance appears to be impassable to juvenile and adult fish. As well, Pollard et al. (1996) notes that the entire riparian zone was logged resulting in the non re-vegetation of some sections of the bank. The primary impact was from the 1992 flood that broke through at site 103 altering the habitat throughout the length of the channel, depositing sand and sediment, but also opening the outlet of the channel into the Zymoetz River and providing access for adult and juvenile salmonids.

Photo 51: Looking up the channel from the washed out bridge.

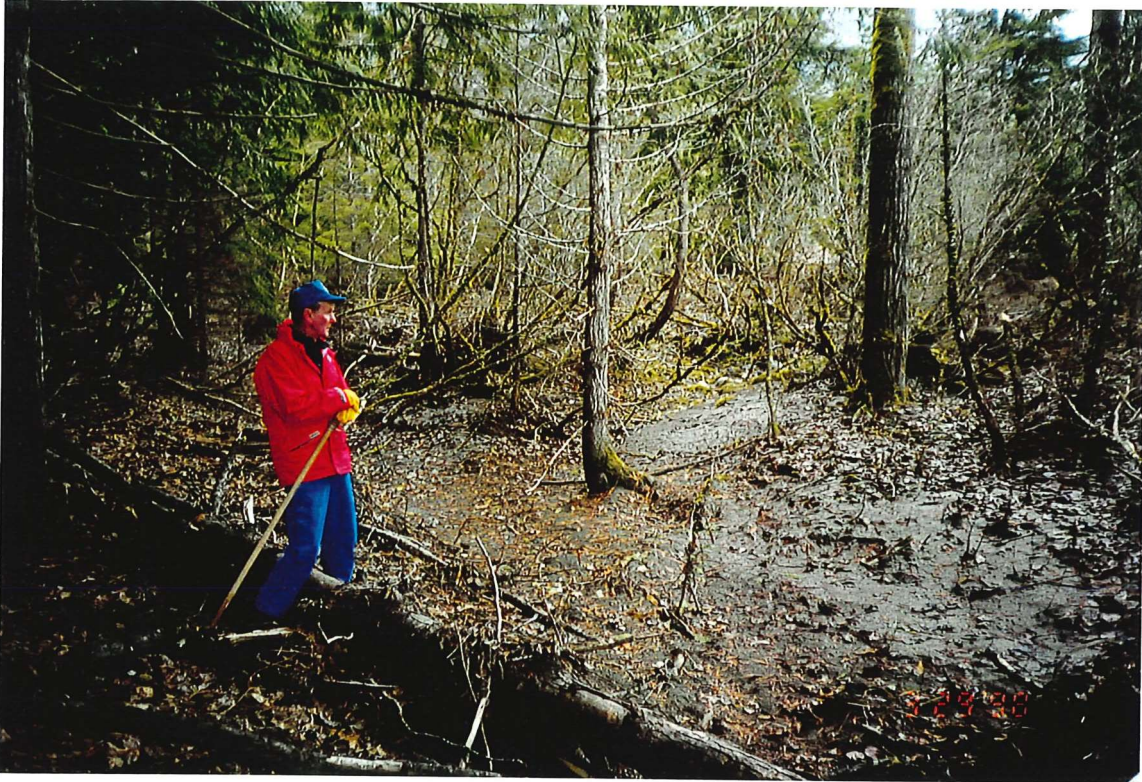
Photo 53: Dry section of side channel (confluence with site 103).

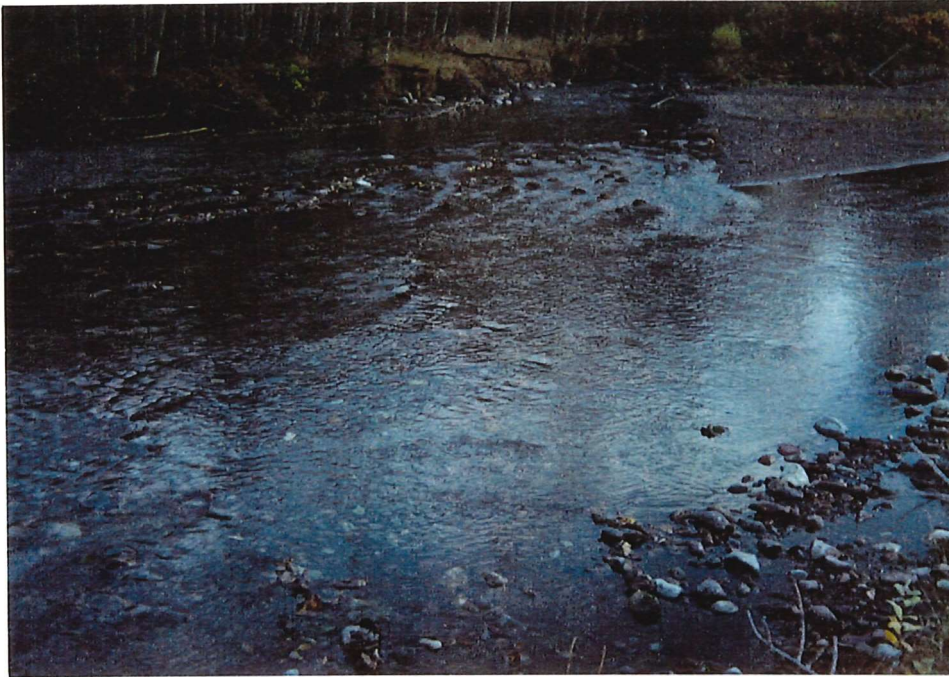
Photo 56: About 1/3 of the way along the channel where the creek flows into the channel.

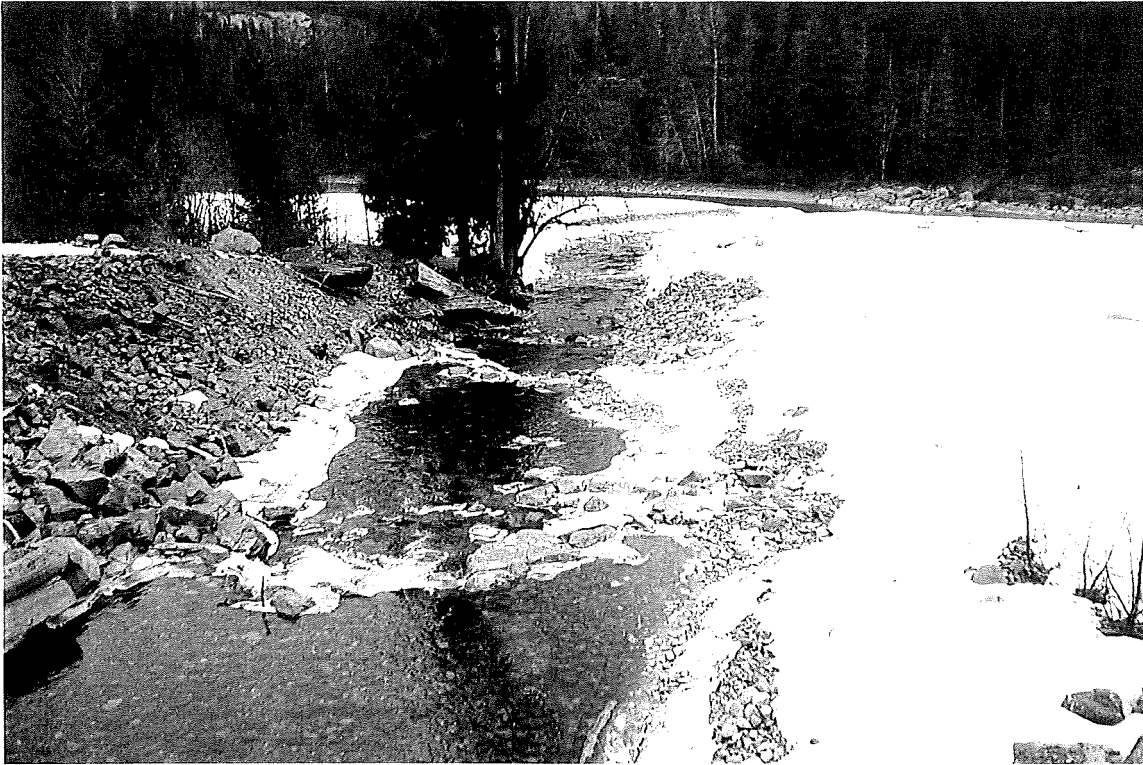
The upstream rock vees placed downstream of the bridge have provided some good spawning gravel for chinook salmon (photo 60). The creek has been monitored since the construction of the vees and while there has not been a major flood, they have stood up well to two high water events and no erosion along the banks has taken place (photo 61).

Photo 60: After the construction of two upstream rock vees (March 1998).

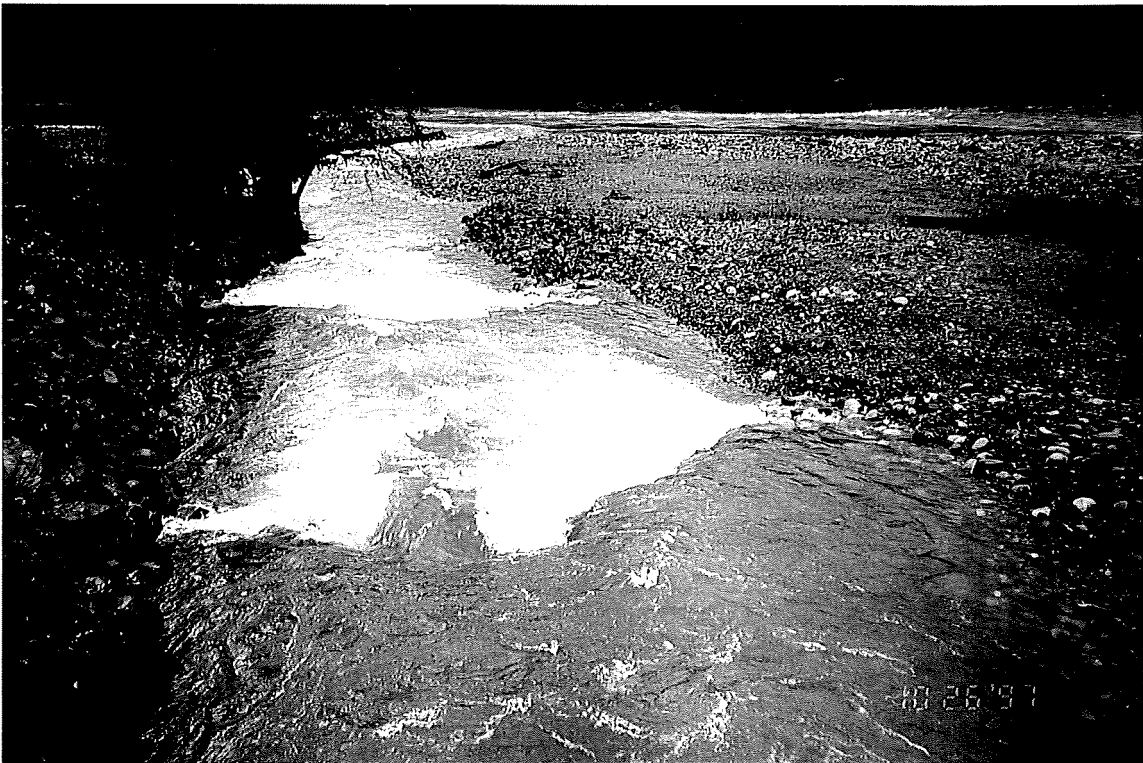
Photo 61: During a mini-flood after construction of two upstream vees (October 1997).

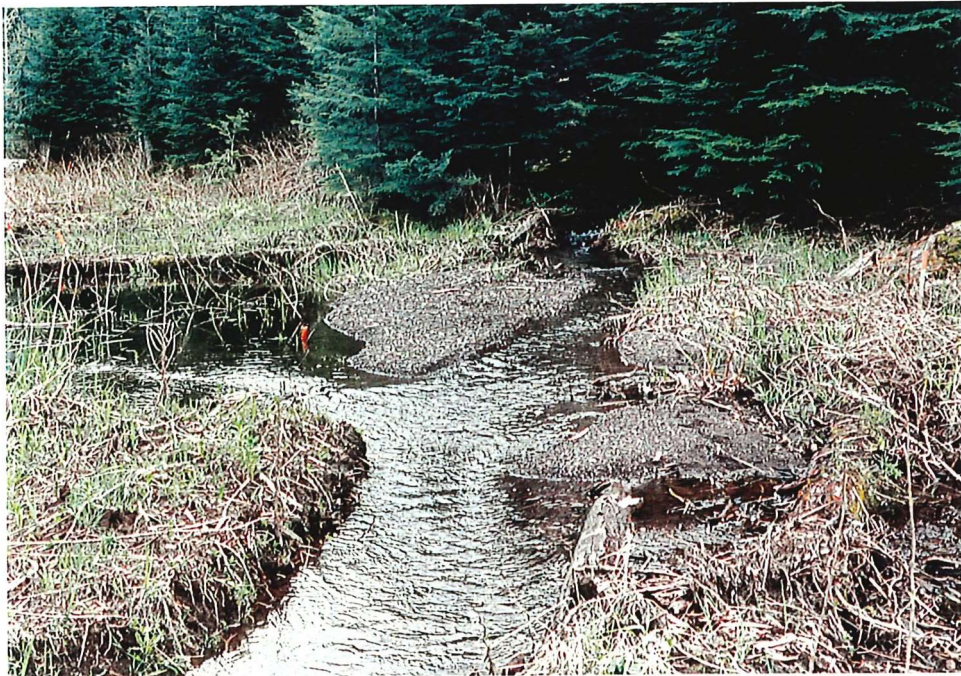
Upon examination, it was discovered that the creek is holding its new position in most places along its upper length (photo 66, 67, and 68). As the creek approaches the Clore River it loses its flow and disappears. A minnow trap set for three hours on November 28, 1997 resulted in no fish caught. There was visual observation and trapping of resident char by J & S Outdoor Ventures at the time of their work in 1995. The creek must be diverted into a new channel (photo 69).

Photo 66: 12 Km Creek at the division where it wants to turn to the right (this is where the creek would be diverted)

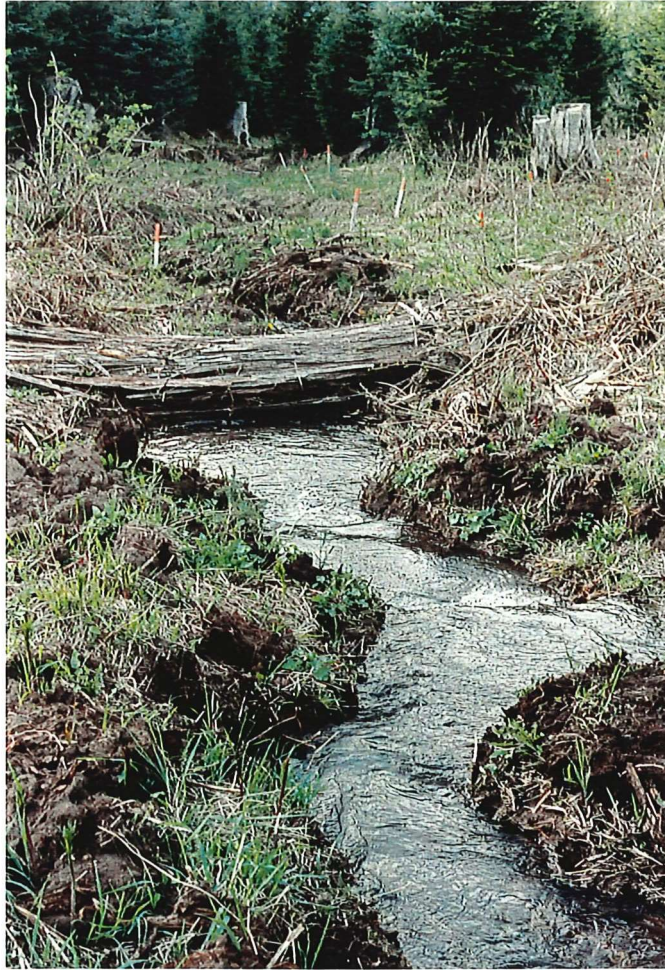
Photo 67: Full flow of 12 Km Creek below division (right channel blocked off at division).

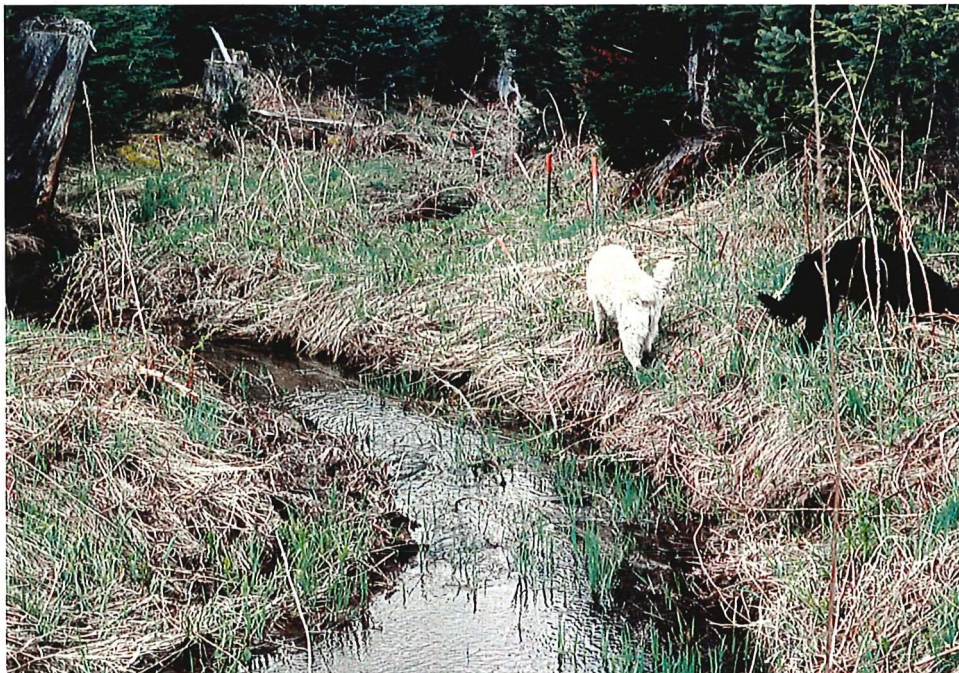
Photo 68: Downstream on creek showing loss of flow even though full flow has passed the division.
