Fish Habitat Assessment and Selected Rehabilitation Prescriptions within the Zymoetz Watershed

Terrace Salmonid Enhancement Society
Terrace, B.C.

Ministry of Environment, Lands and Parks Watershed Restoration Program

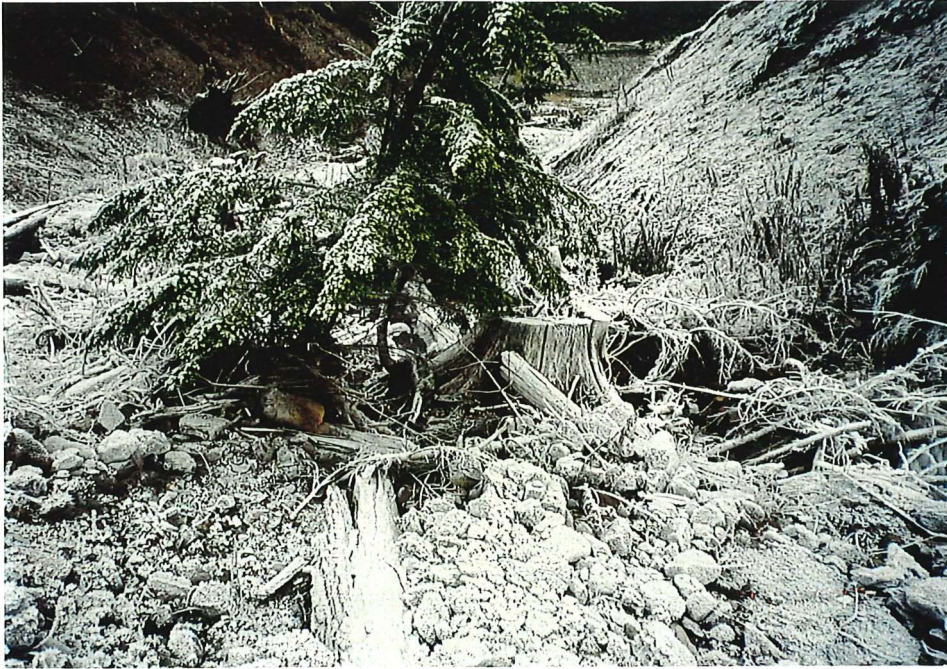
This creek above the Clore mainline bridge (reach 3), flows down a steep gully (photo 70) then reduces its gradient below the bridge to approximately 10% for 145 m where it meets with the old river main channel (reach 2) (photo 71 and 72). It flows along this channel for an additional 592 m before joining with the river. In some places, the old river channel is too wide to accommodate the relatively low volume of water from the creek. The result is an inadequate flow, or fanning effect in some areas making adult fish passage difficult if not impossible at times of low water. An additional problem suggested by Pollard in his Level 1 assessment (1996) is that the banks of the creek are actively eroding and this material is obstructing the old river main channel.

Photo 70: Torrented gully of Elf Creek channel.

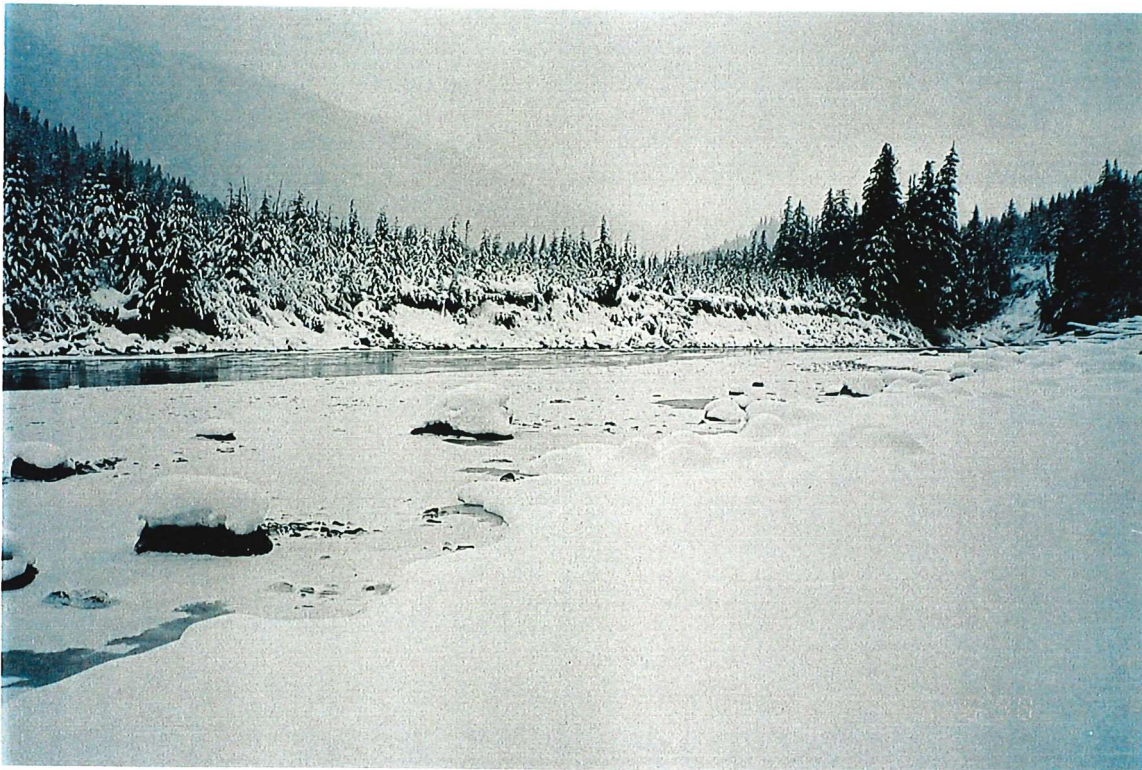
The banks at this site have eroded and the narrow riparian zone has disappeared (photo 76). This is a common impact where a one or two tree width buffer has been left after logging. In this particular situation, a number of trees blew down and the roots pulled loose weakening the bank structure. A series of floods contributed to its collapse. This has resulted in continuing erosion during high water events. Fortunately, the high content of gravel in the bank has resulted in the input of material to the river primarily being gravel and rocks. At the peak time of the impact fines would have entered the river, but not at a continuing rate during run-off from rain and snow. The exception being flood events when the same erosion will take place all over again. The boulder hole adjacent to this bank failure was one of the most popular angling pools in the Clore River before it was lost to the 1992 flood when gravel and rocks from the eroding bank partially contributed to the filling of the pool.

Photo 76: Boulder hole on the Clore River. Note loss of riparian zone and eroded bank.

From a practical and cost effective perspective, little can be done to armour the bank. Most of the damage has been done although a future flood could scour out a clay seam causing more material to end up in the river because of the instability of the bank.

This site could become a test site for actions that can be applied on a wider basis through the participation of a selected team of about three experts: a Hydraulic Engineer, a Geomorphologist, a Fisheries Biologist, the MELP Project Monitor for the Kalum Forest District and the TSES Project Manager to provide some answers on how to rehabilitate an eroded bank where high velocities of water are the cause of the original and continuing impact.
