**Suskwa Watershed
Restoration Program
1996
Fisheries and Riparian
Field Assesments and Prescriptions**

**Prepared by M. Jacobs
for Suskwa Restoration Society**

**Suskwa Watershed Restoration Program 1996
Fisheries and Riparian Impacts
Level II**

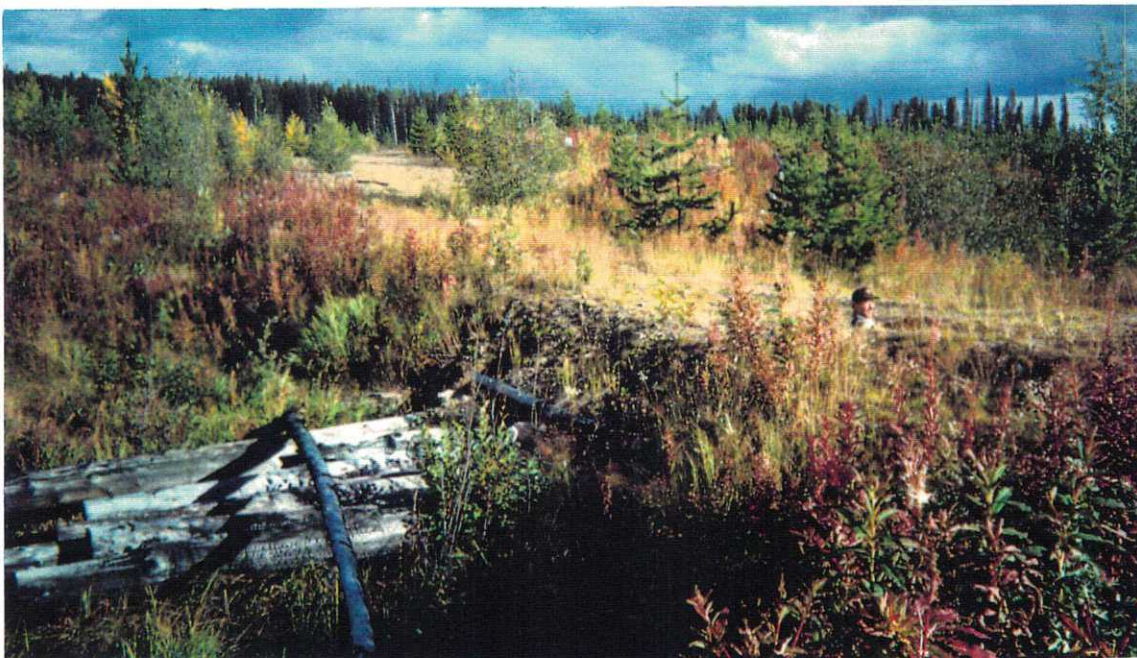
Impact Description: Two corduroy crossings in Blocks 93M017-024 and 93M017-016, have decomposed to this stream (photos 24 and 25). The lower crossing restricts access to viable fish habitat. The upper crossing acts as a dam for local beavers and no fish were discovered here. Recruitment of future LWD is a concern through Block -024. Good initial shrub cover is established (photo 23).

Photos 24 and 25. Trib.
46-700-50-115-010 obstructed by two
coursuroy crossings in blocks
93m017-016 (top) and -24 (bottom).
These roads were prescribed for
deactivation in 1997. (R. Hand G.
"Level 2" prescriptions).
