Final Report #NF-2008-H-9

Bulkley/Kispiox River Agricultural Stream Restoration Seed Funding

SECTION 9 APPLICATION

PRESCRIPTIONS FOR SITES ON: Maxan Creek

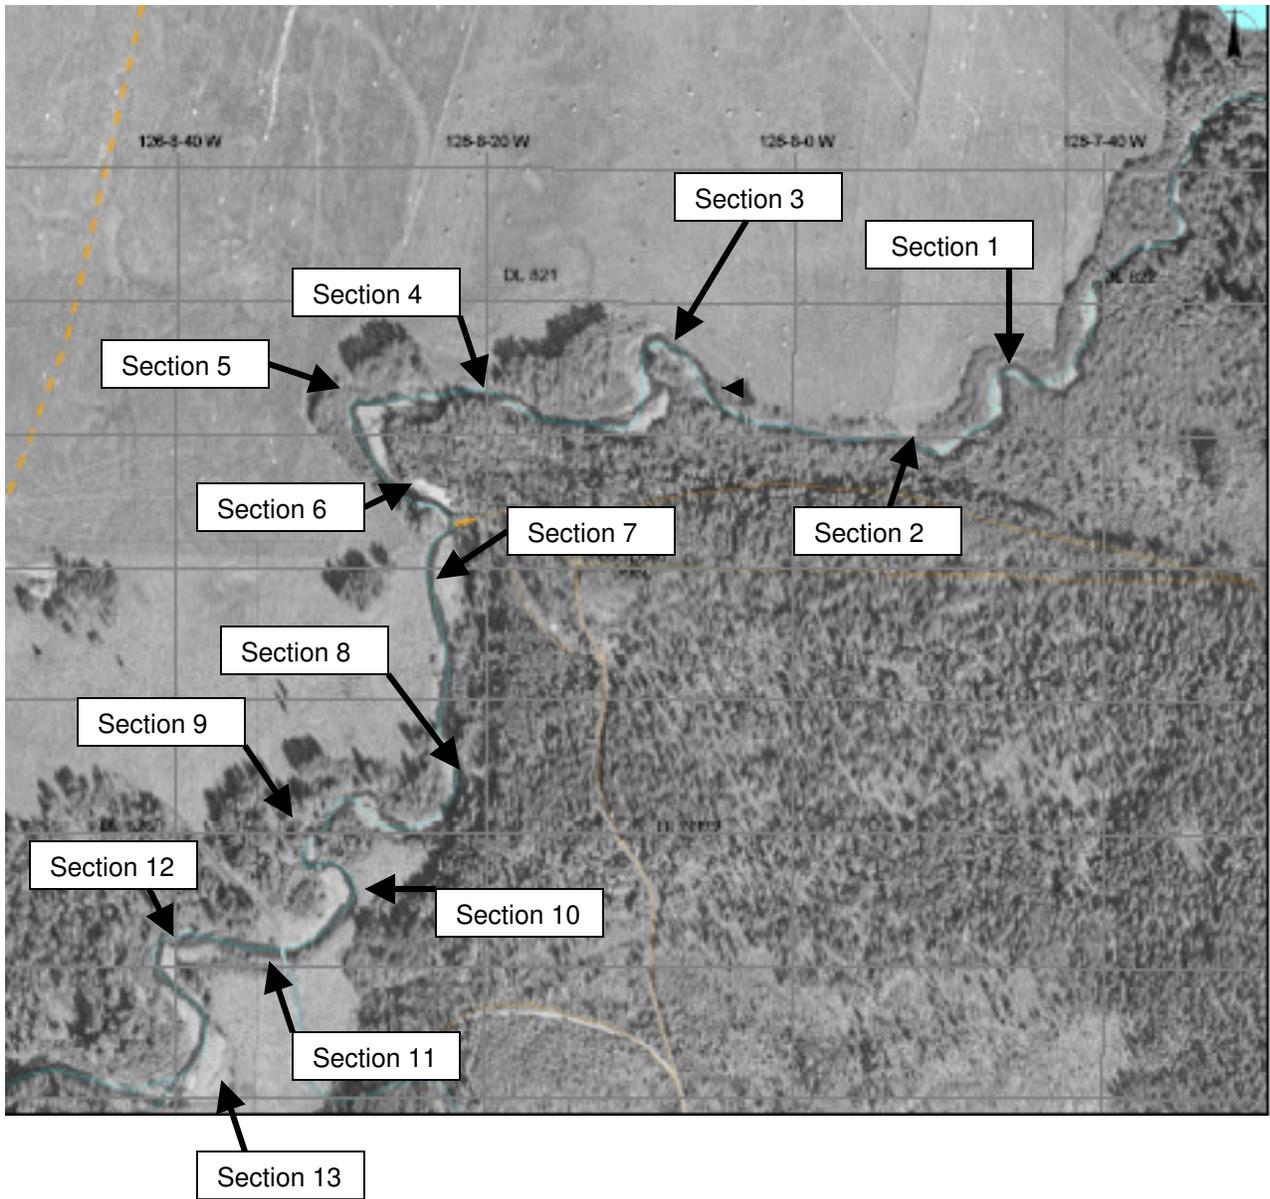
Section 1: Area to be upgraded: 60 meters

Description of over all characteristics:

- Channel morphology: Riffle-Pool
- Disturbance Level: Partially Aggraded to Severely Aggraded
- Limited riparian corridor along migrating creek bank
- Undercutting occurring along 1.2 meter cut bank
- Limited woody debris and over all bank integrity has allowed scouring and potential for further bank migration along 100% of corridor

Recommendation:

- Placement of 3 habitat recruitment structures along exposed cut bank

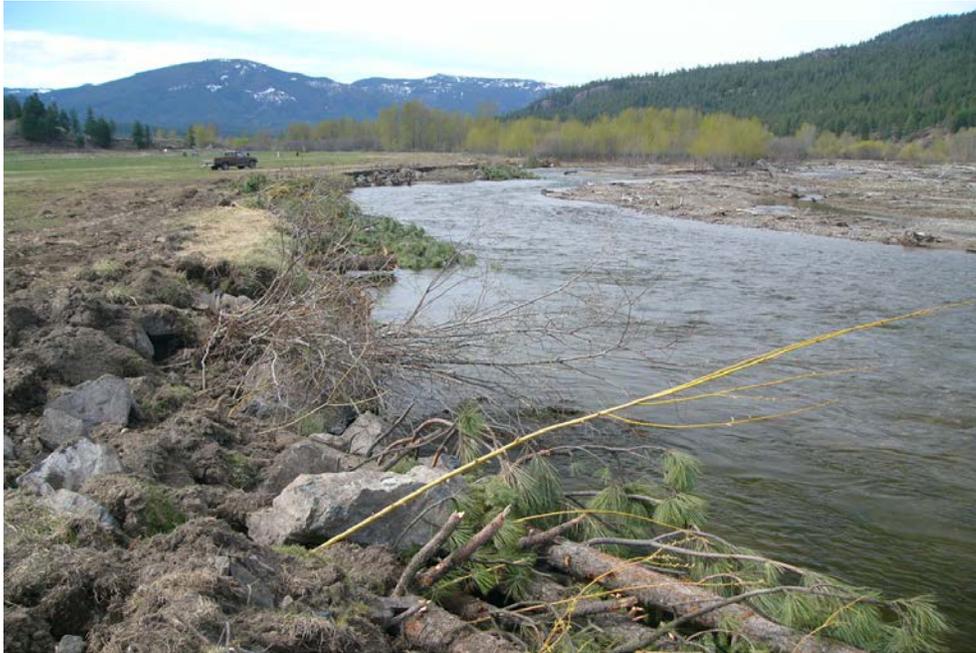
Figure 6: The structures are placed close enough on this outside corner to overlap and appear continuous. Eventually, the soil berm that was left during construction may be eroded, leaving the rock toe with overhanging wood. The live willow, placed with the roots below the high water table, continue to grow through the rock and wood. Cattle are reluctant to walk on the rock and debris to graze the willow overhanging the river.

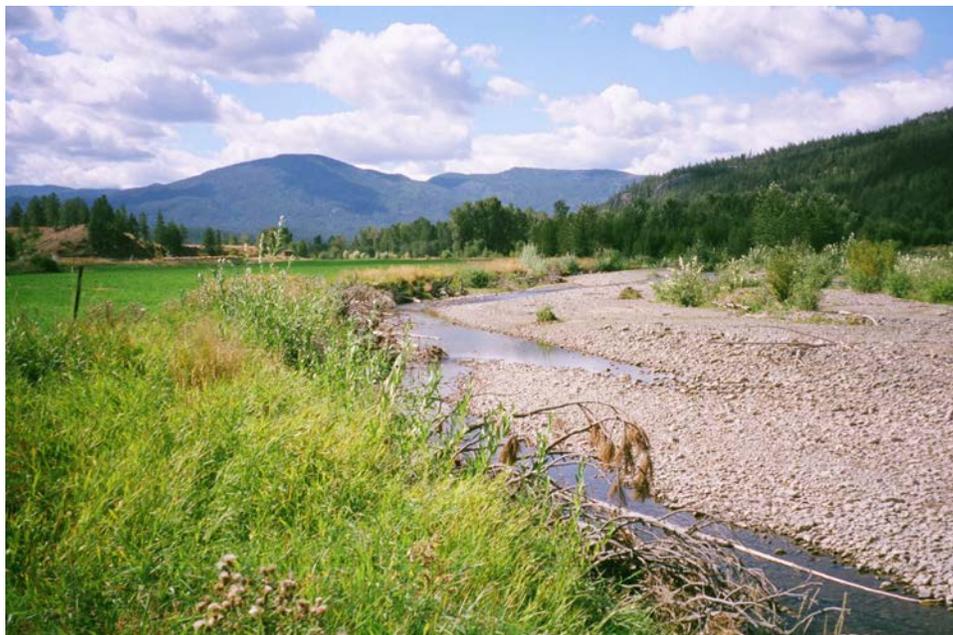
Figure 7: Looking upstream at same location after 2 summers.
