# Reconnaissance Level Fish and Fish Habitat Inventory for the Kispiox Forest District

*Prepared for:*

**Repap Smithers**

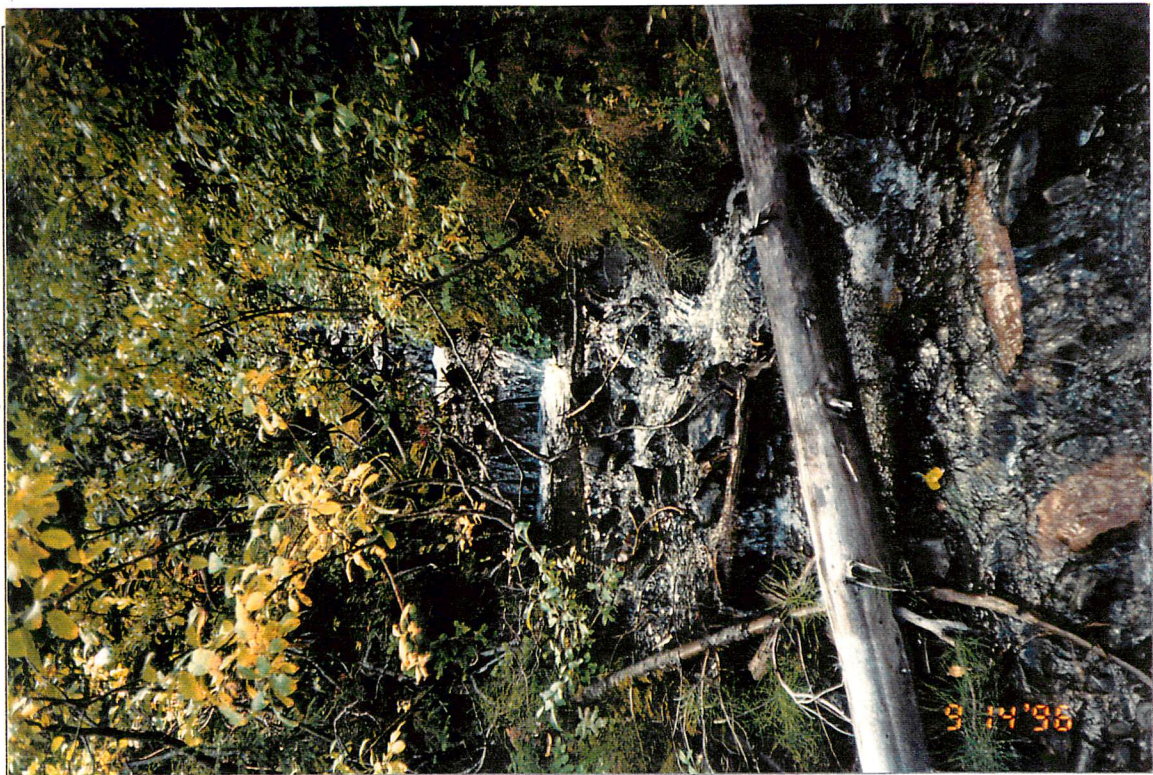
Photo #: A-4-1, 14-Sep-96  
Site #: A24, Cascade in background.

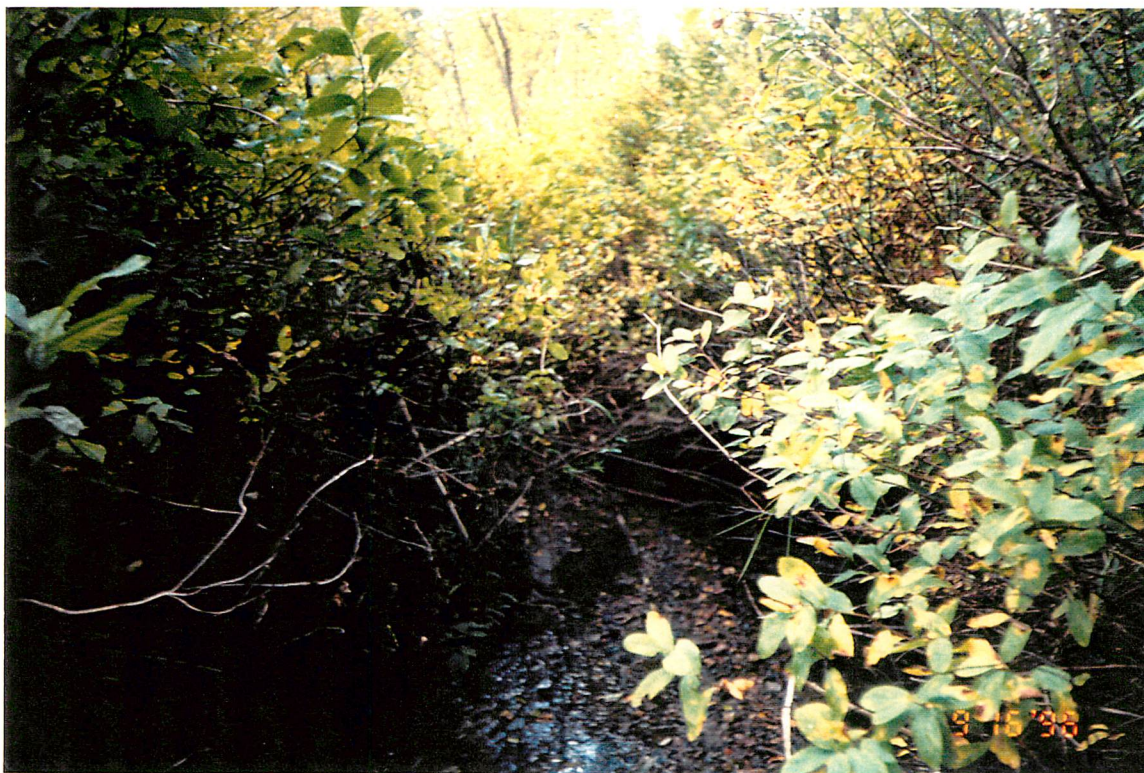
- C1 S3  
C2 LS= 2%, RS = 3%  
C3 A very large fisheries sensitive zone, in the form of a marsh, is connected to this creek.  
C4 The electroshocking effort, using a 12 B POW model, was 661 seconds over 100 meters.  
C5 Lat N 55 47' 36.2", Long W 127 25' 44.2"  
C6 There is a high percentage of unstable banks at this site. The fine material from the banks is collecting in the deep pools.  
C7 DO was not measured.  
C8 Great rearing habitat and some spawning habitat were observed at this site. Cutbanks and pools contribute substantially to the cover.  
C9 The air temperature at this site was 9 degrees celcius.

Photo #: A-5-12, 16-Sep-96  
Site #: A39, Gravel bar in creek.

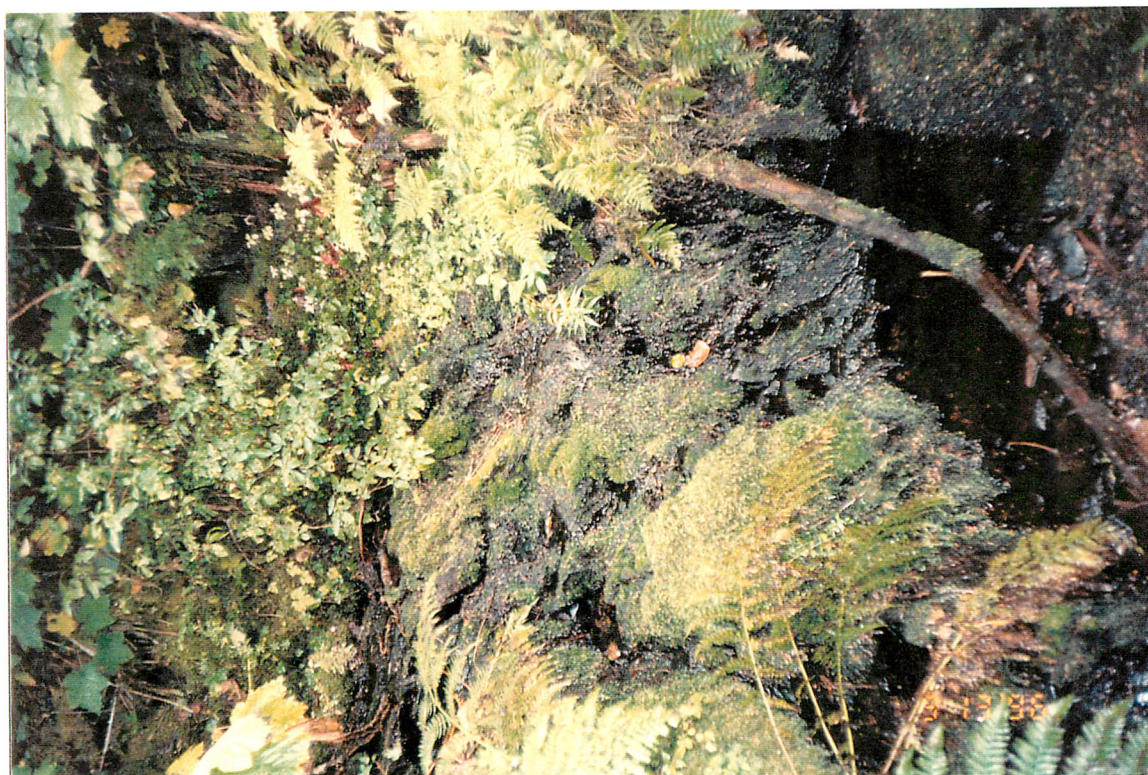
Photo #: B-3-9, 13-Sep-96  
Site #: B18, Water flowing over bedrock.

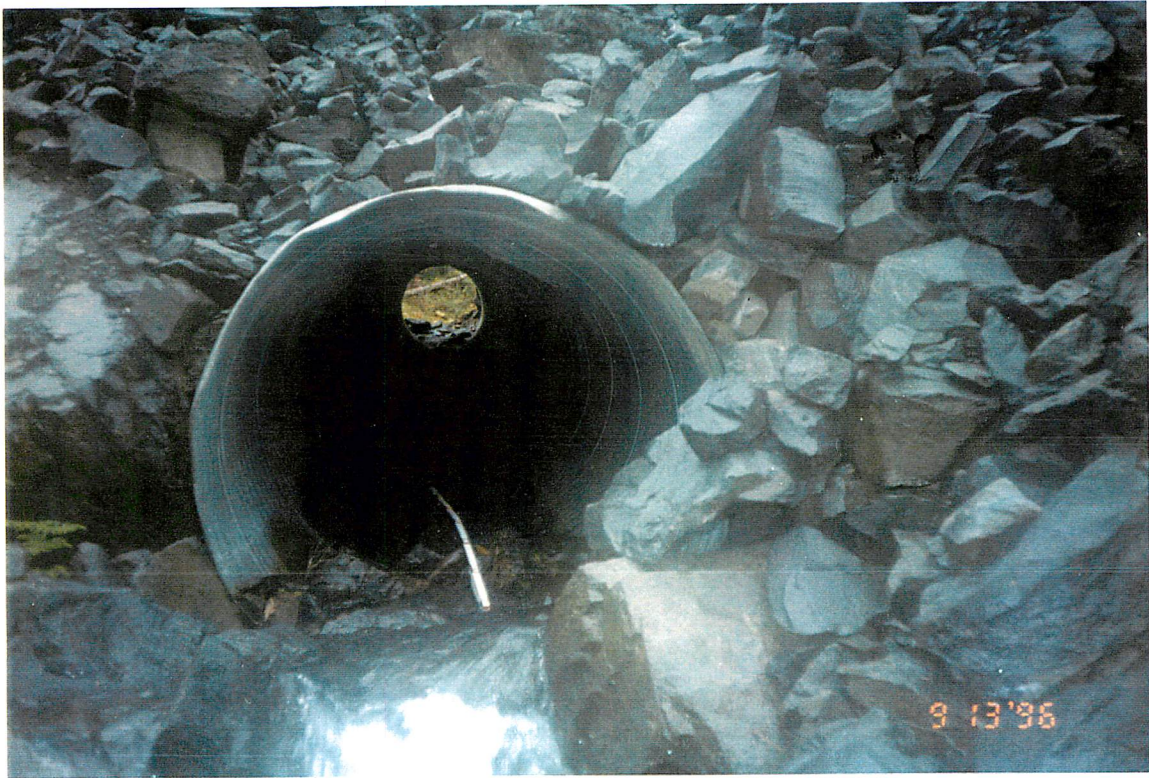
Photo #: A-2-24, 13-Sep-96  
Site #: A15, Culvert parallel to flow.

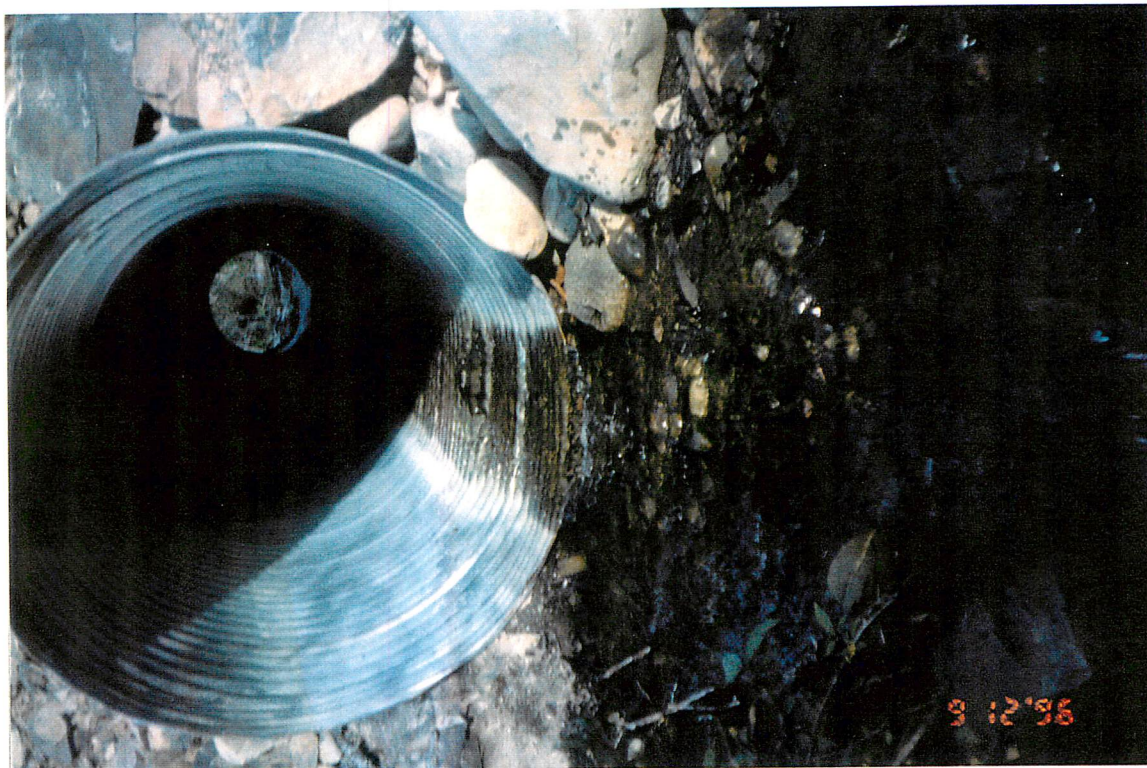
Photo #: A-2-19, 12-Sep-96  
Site #: A14, Upstream view through culvert.

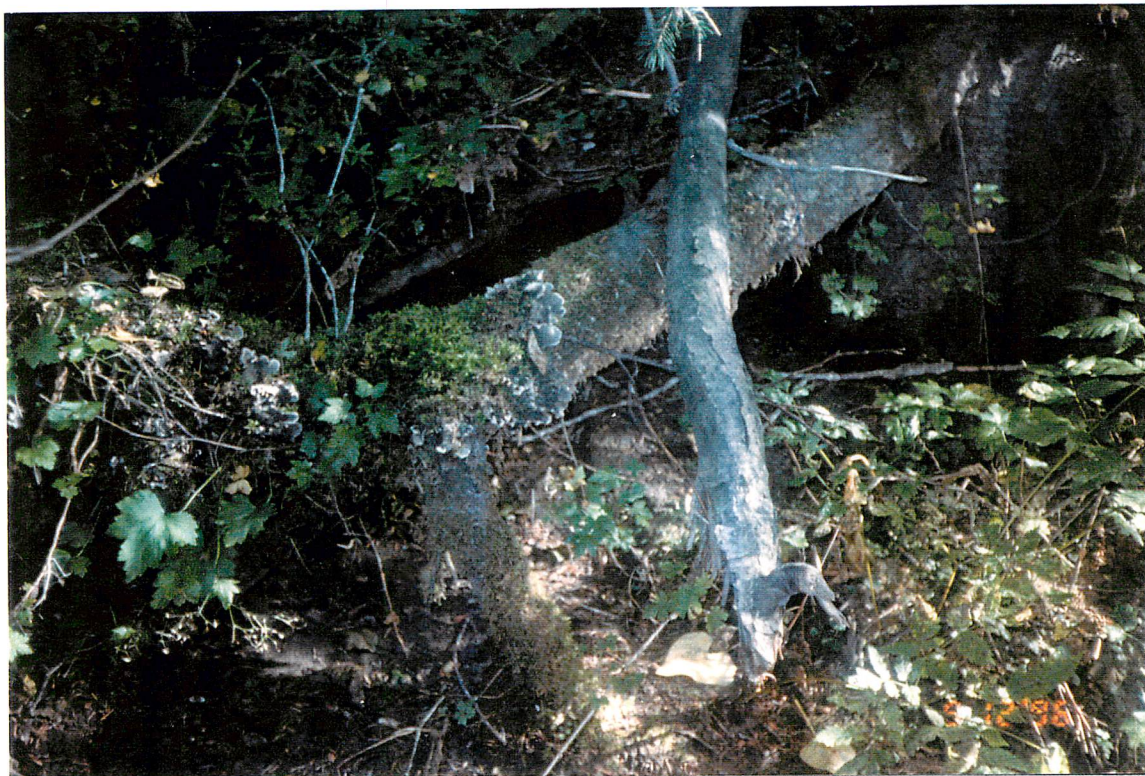
Photo #: A-2-16, 12-Sep-96  
Site #: A13, Tree roots exposed by high flows.

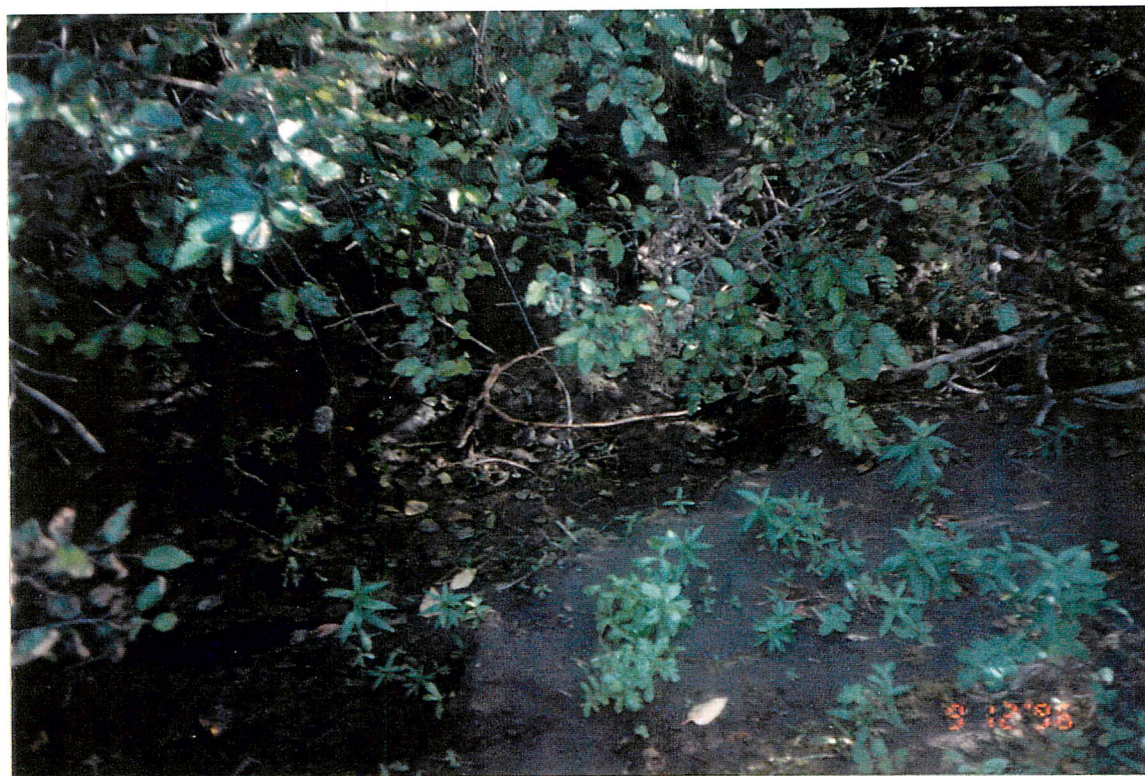
Photo #: A-2-17, 12-Sep-96  
Site #: A13, Dry channel.

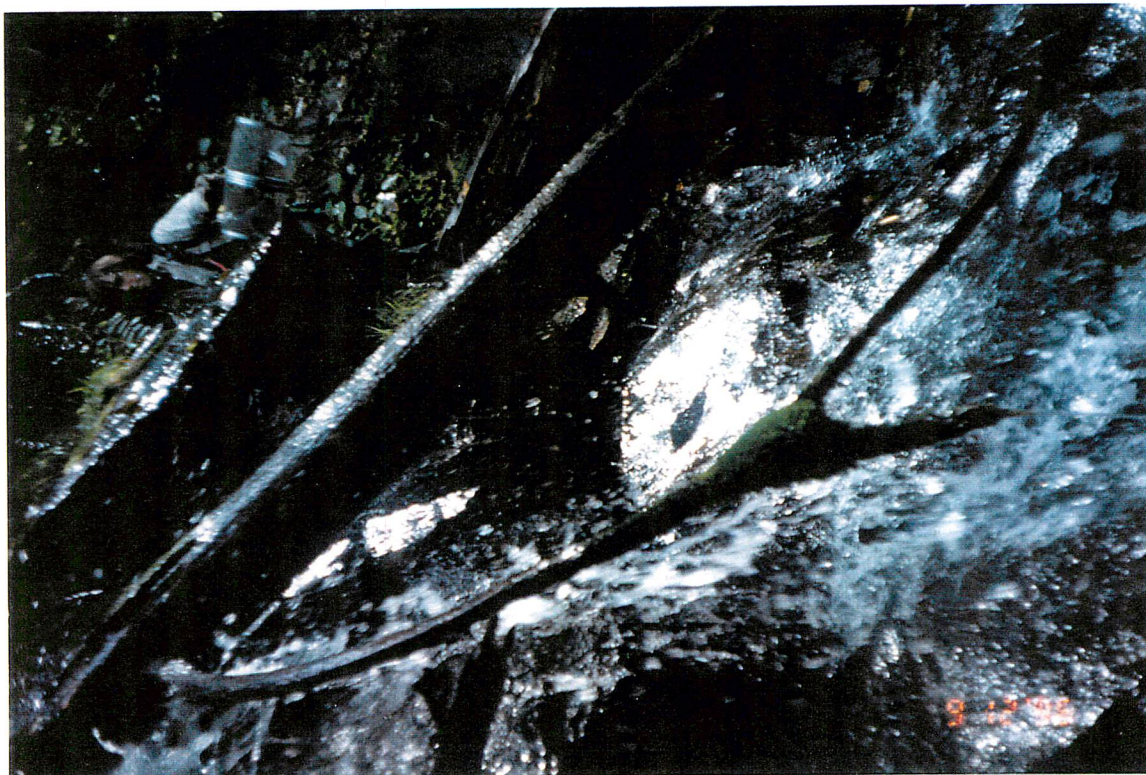
Photo #: A-2-9, 12-Sep-96  
Site #: A11, 3 m falls.
