A BIOPHYSICAL INVENTORY OF
AND
HABITAT ASSESSMENT
FOR
THE INTERTIDAL AND SUBTIDAL FORESHORE
OF THE PROPOSED
NEW MOORING FACILITY
FOR THE
CANADIAN NATIONAL RAILWAY
ALASKA FERRY SLIP
AT PRINCE RUPERT
B.C.

C. N. NORTH AMERICA,
10004 - 104 AVENUE,
EDMONTON,
ALBERTA,
T5J0K2

October 1996

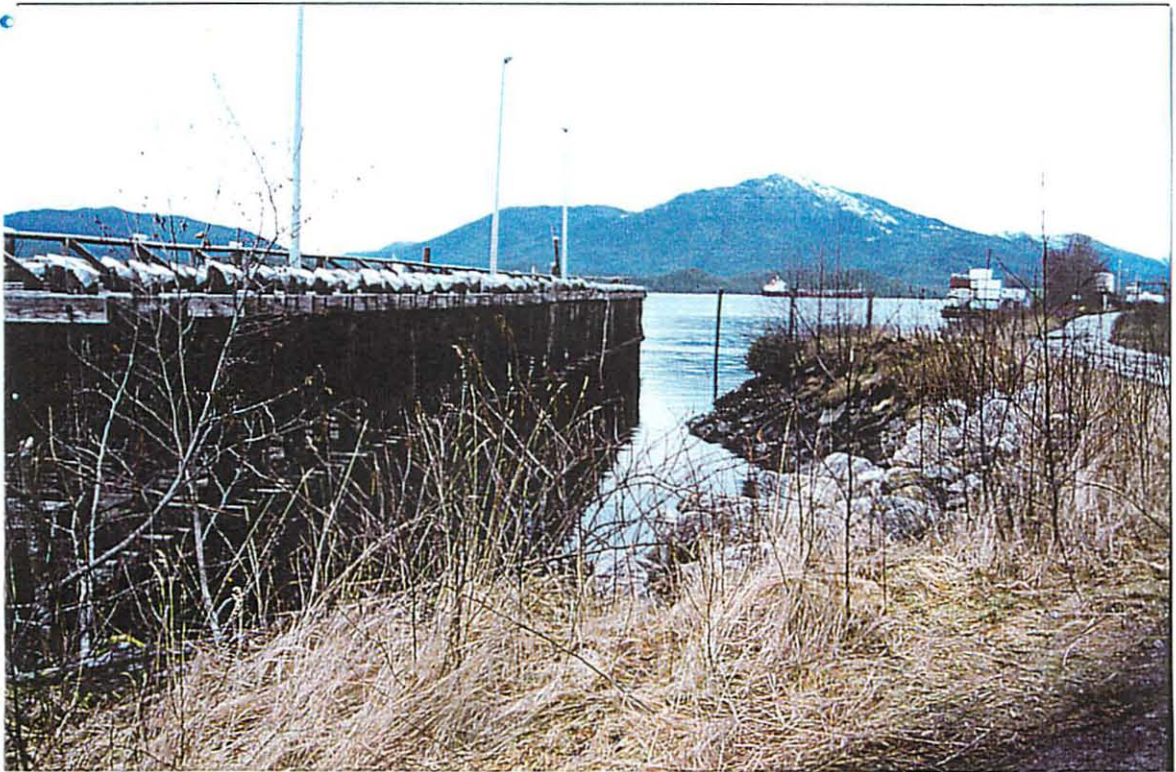
Photo #2: Viewing the back of the mooring wall. Looking North.

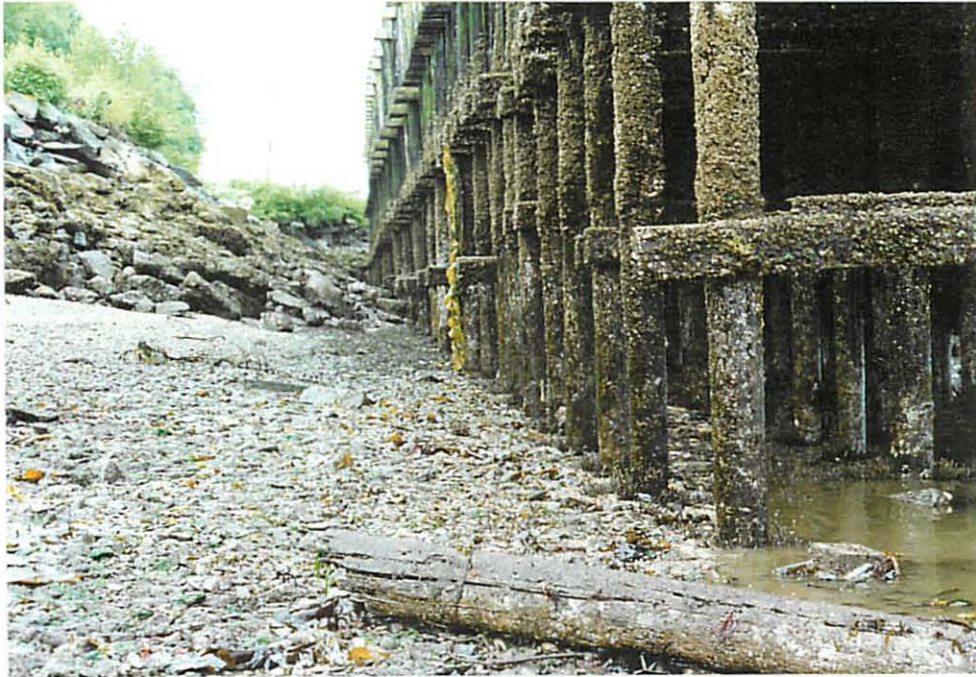
Photo 12:

View of the existing mooring wall from the Northeast on a low tide of .2 meters above hydrographic datum. Foreground shows area of rock and cobble over sandy silt stretching from the toe of the intertidal rock down to the zero tide level through most of the area.

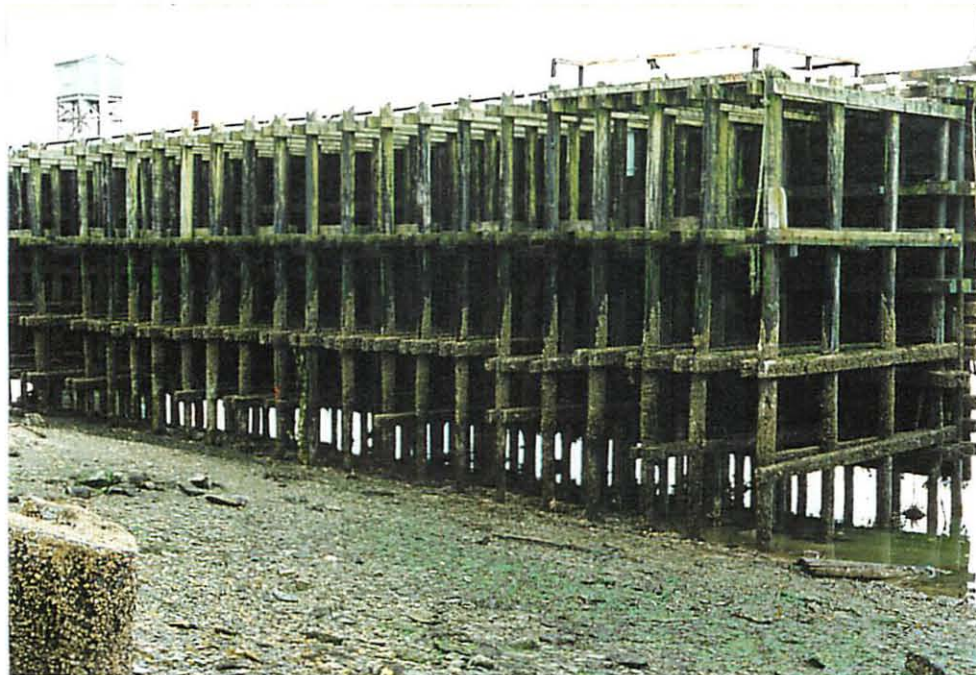
Photo # 3:

View of area between the piles of the existing mooring wall. This photo was taken from Transect # 10 (chainage 96), and shows the water level at the third pile of the mooring wall on a low tide of .2 meters above datum. The photo shows the area between Transect # 10 and transect # 6.

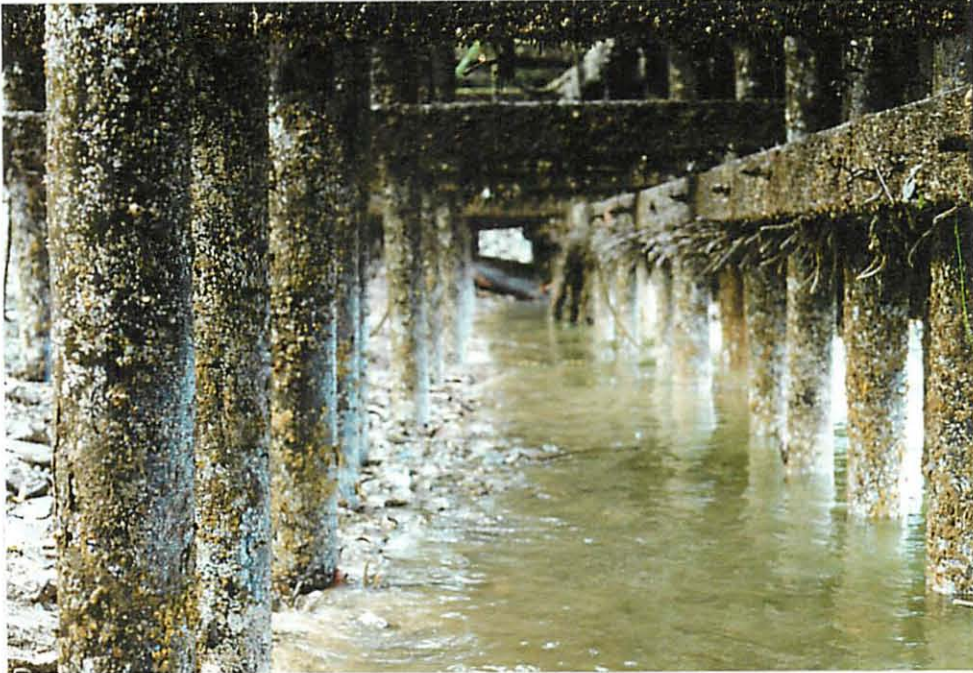
Photo #4:

This photo shows the same area as photo # 3, but looks north from transect # 6 towards transect # 10.

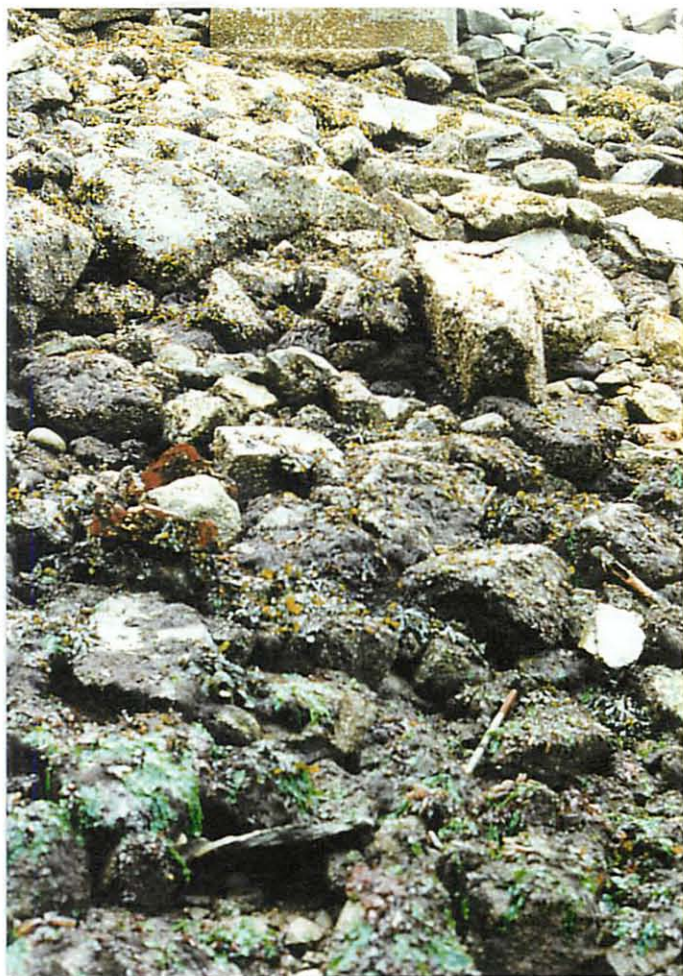
Photographs 17 & 18: Close ups of seaweeds in lower mid intertidal and lower intertidal portions of transect # 0.

(photos # 17 & 18).

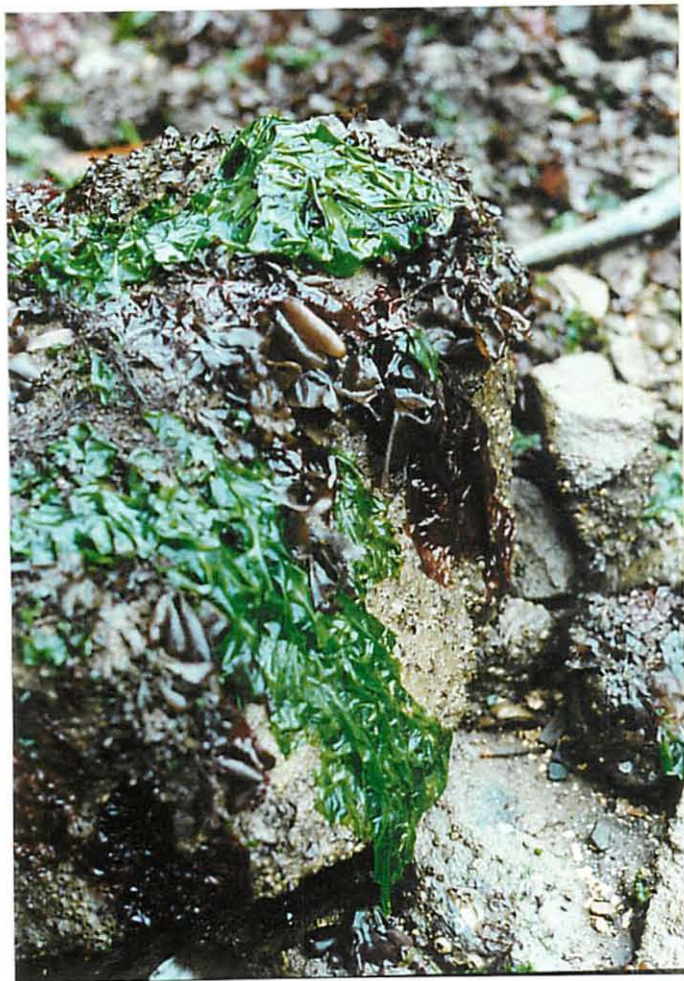
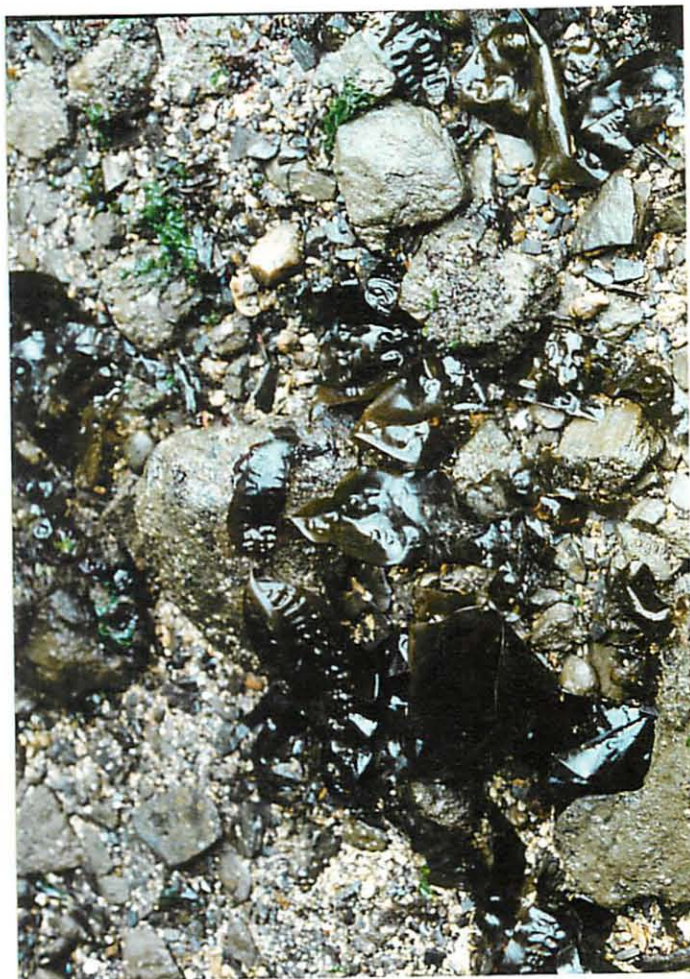
Photograph #19 and 20:

View of the lower intertidal area of transects # 0, 1 and 2 on a low tide of .2 meters above hydrographic datum.

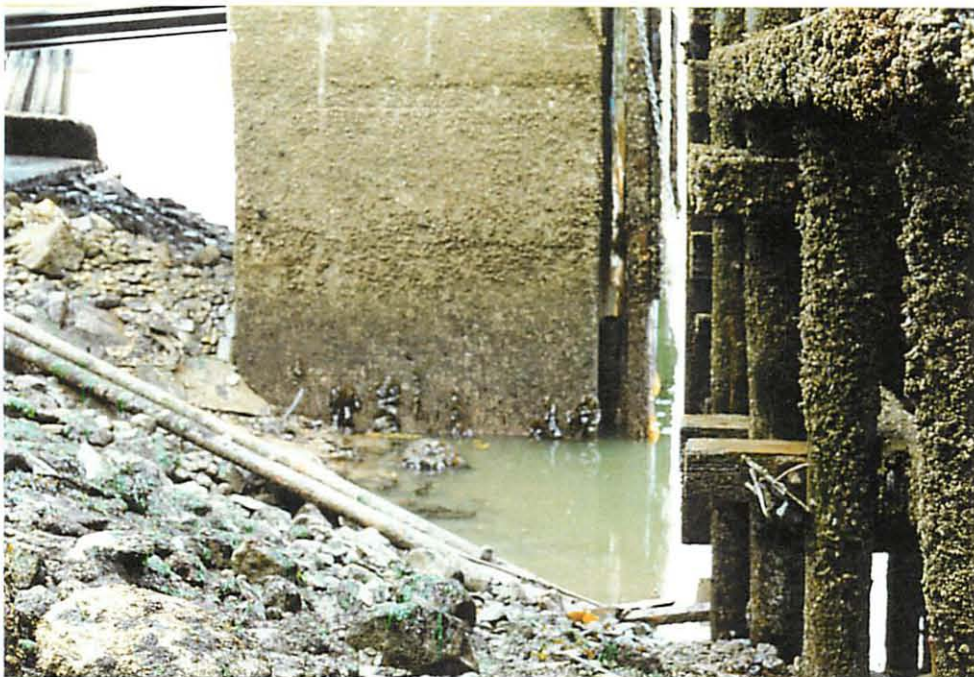
Photo #21: This is a view of
transect # 2 (chainage 32)
showing the upper and
mid intertidal areas.

1.5 to 4:	Extreme upper intertidal area from HHW point. This area consists of large rock (rip rap) boulders. (photograph # 21). The only visible life in this area is unicellular green algae on some areas of the boulders.
4 to 6:	This is a continuation of the large rock boulders (rip rap) in the upper intertidal zone. The 6 meter point marks the beginning of a sparse barnacle zone. (see photograph # 21).
6 to 11:	This is a continuation of the large rock boulders (rip rap) of the existing embankment. The 6 meter point along this transect marks the beginning of the Fucus/barnacle zone. This transect cuts diagonally across this zone. (see photograph # 21 & 22) .
12 to 19 :	This is a continuation of the large rock boulders (rip rap) forming the existing rock embankment. This transect runs diagonally across this area from this point. The area is dominated by filamentous brown algae on the rocks.
19 to 25:	This is an area of smaller rocks and mixed seaweed. It includes Filamentous brown algae, mixed red algae and green algae (Ulva) on the surface of these rocks.

<u>Distance from</u> <u>TOP OF THE EXISTING</u> <u>EMBANKMENT (ABOVE HHW)</u> <u>(in meters)</u>	<u>Description</u>
0 to 1:	Area from top of the existing embankment down to the HHW line. This is an area of mixed vegetation.
1 to 1.8:	Extreme upper intertidal area from HHW point. This area consists of large rock boulders. (photograph # 21). The only visible life in this area is unicellular green algae on some areas of the boulders.

1.8 to 2.4:	This is a continuation of the large rock boulders (rip rap) in the upper intertidal zone. The 1.8 meter point marks the beginning of the barnacle zone. (see photograph # 21).

2.4 to 4.8:	This is a continuation of the large rock boulders (rip rap) in the upper intertidal zone. The 2.4 point marks the beginning of the Fucus/barnacle zone. (see photographs # 21 & # 22)

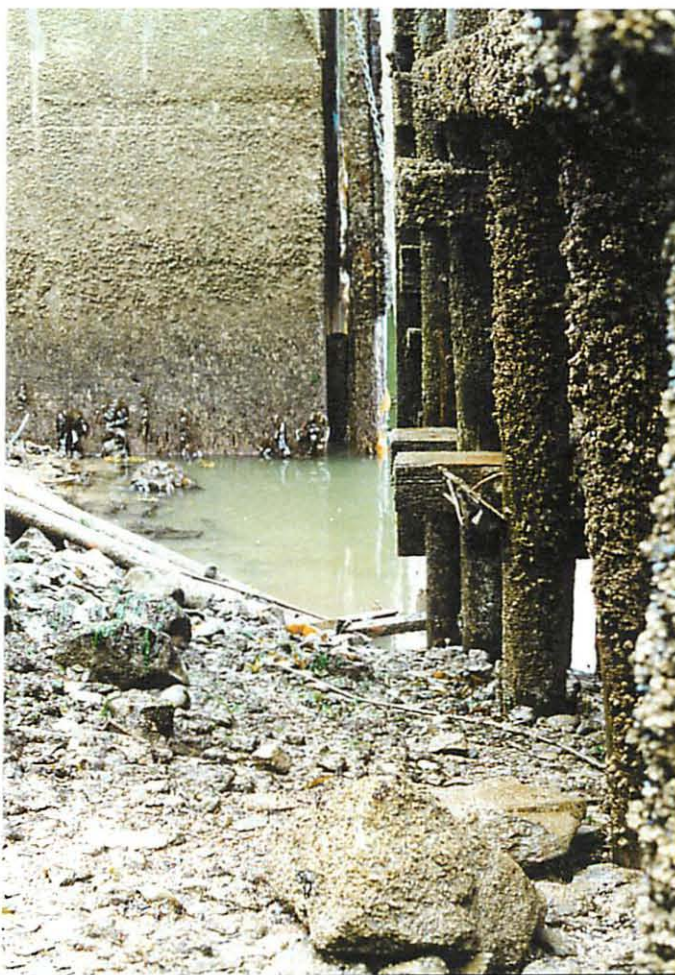
Photograph # 22:
View of Transect # 2
showing the lower mid
intertidal area.
Bulkhead.

4.8 to 6.8:	This is a continuation of the large rock boulders (rip rap) in the upper intertidal zone. The 5 meter point marks the beginning of the barnacle/mussel/Fucus zone (see photograph # 22).

6.8 to 8:	This is a continuation of the large rock boulders (rip rap) in the upper intertidal zone. The 6.8 meter point marks the beginning of the filamentous brown algae zone (see photograph # 22). The toe of the existing rock marks the end of this zone.
8 to 11:	Area of sand/shell over a mud and silt base in the lower intertidal zone. No visible surface macrofauna or macroflora in this area, but benthic digs revealed small clams. (see Results of Benthic Digs, Table 3 and photograph # 50)
11 to 18.4:	This is a region of rocks over a mud/silt base in the lower intertidal area from the 1.2 meter line down to the 0 meter line and below. Benthic digs were carried out randomly but it was difficult to dig in this area. The rocks continued for some depth down through the mud/silt here. No sign of clams was found in this area. Red filamentous algae predominates on surface rocks. Starfish, Polychaete worms and anemones are abundant on the piles.

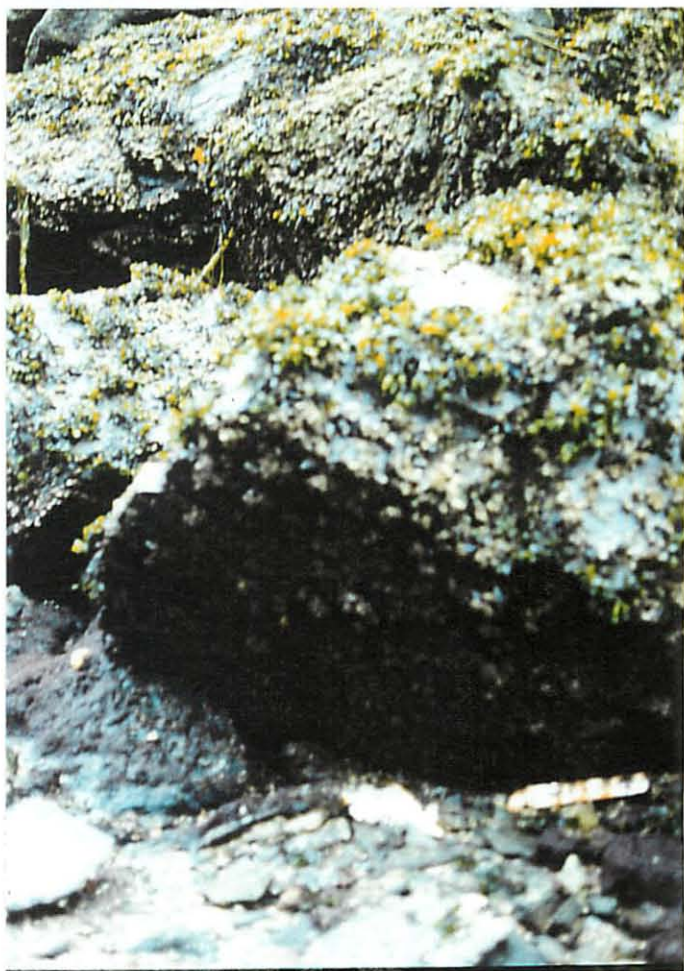
Photograph # 24:
View of the upper
intertidal portion of
Transect # 3 (chainage
40) .

0.8 to 2:	Extreme upper intertidal area from HHW point. This area consists of large rock boulders. (photograph # 24). The only visible life in this area is unicellular green algae on some areas of the boulders.
2 to 2.5:	This is a continuation of the large rock boulders (rip rap) in the upper intertidal zone. The 2 meter point marks the beginning of the barnacle zone. (see photograph # 24).

2.5 to 5:	This is a continuation of the large rock boulders (rip rap) in the upper intertidal zone. The 2.5 meter point marks the beginning of the Fucus/barnacle zone (see photograph # 24).
5 to : 6.5	This is a continuation of the large rock boulders (rip rap) in the upper intertidal zone. The 5 meter point marks the beginning of the barnacle/mussel/Fucus zone (see photograph # 24).

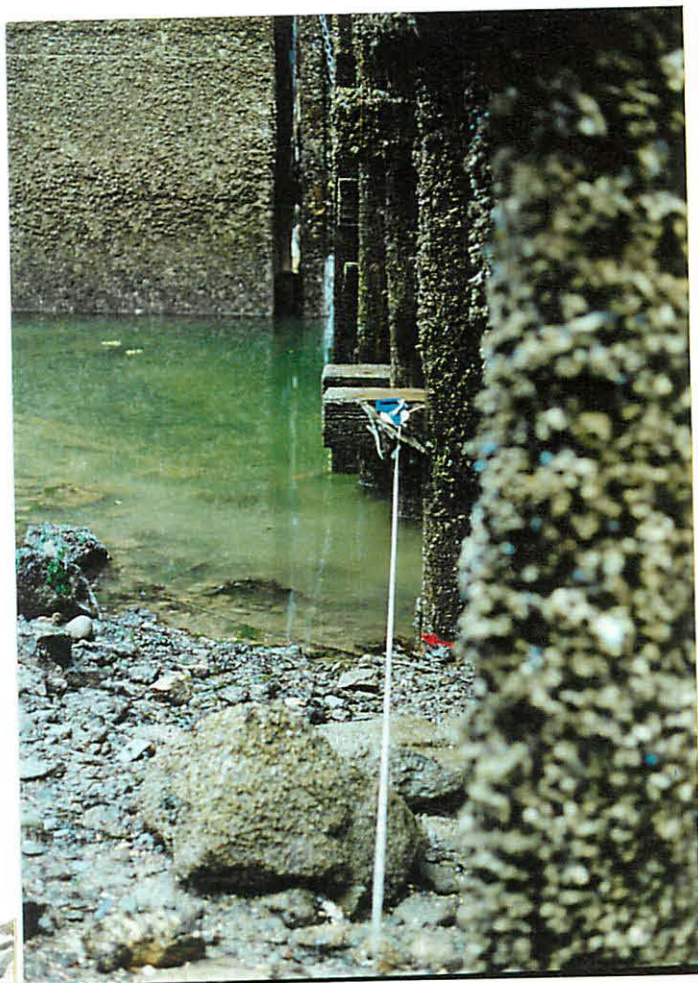
Photographs #25:
View of the lower
intertidal portion
of transect #3 on a
low tide of 1.2 meters.

6.5 to 10.4:	This is a region of fine sand and broken shells with occasional rocks on the surface in the lower intertidal area from the toe of the rock down to the first pile for the mooring wall. Digs in the sand were carried out randomly and clams and marine worms were found in all digs. Substrate in digs is a silty mud. (photographs # 25 & # 50)

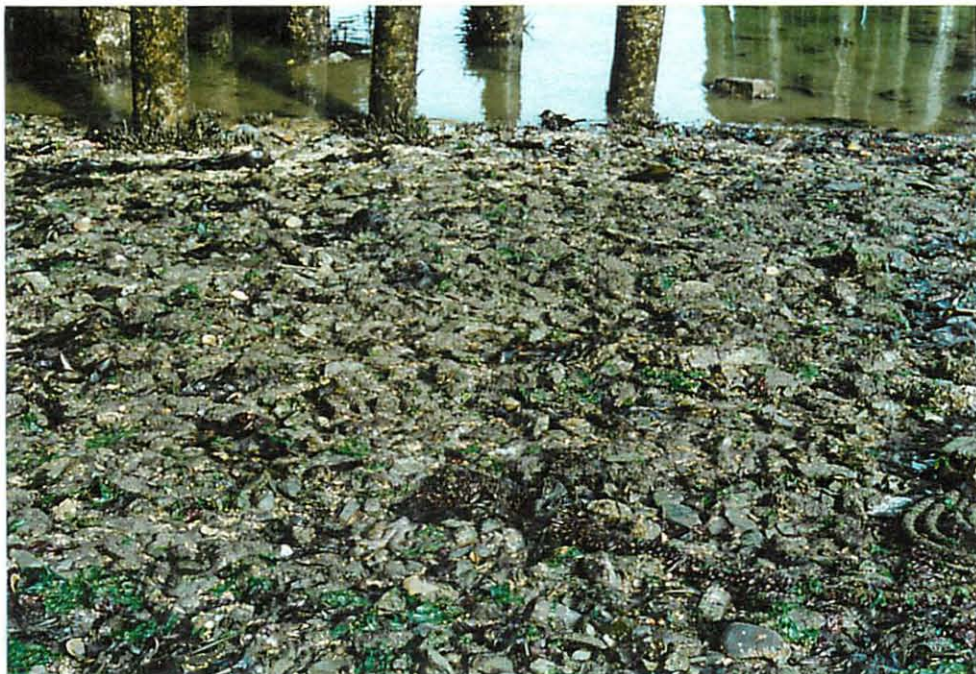
Photograph # 47:

Close up of rocky surface substrate and red and green seaweeds in the lower intertidal portion of transect # 12.

15.5 to 26:	This is a continuation of the gently sloping area below the existing rocky embankment. This is the lower intertidal portion of this area, from approximately 1.5 meter above datum to the mooring wall piles. The surface substrate is a gravel and small rocks. Mixed small seaweeds including Red (Porphyra) and green algae (Ulva) can be seen on surface rocks. Under rocks there are small crabs and worms. Clams were found in Benthic digs. See Results of Benthic Digs and Photographs # 11 & 46.
26 to 26.8:	This is a continuation of the previous zone in the shaded area between the mooring wall piles. The piles support starfish, plume worms, sponges and anemones. Almost all surface rocks near the zero meter tide line had jingle shells and anemones as well as dog welks on their lower surface. Clams and worms were found in Benthic digs. Filamentous Red Algae dominates on the surface of the small rocks. (photograph # 46, # 47, # 48)

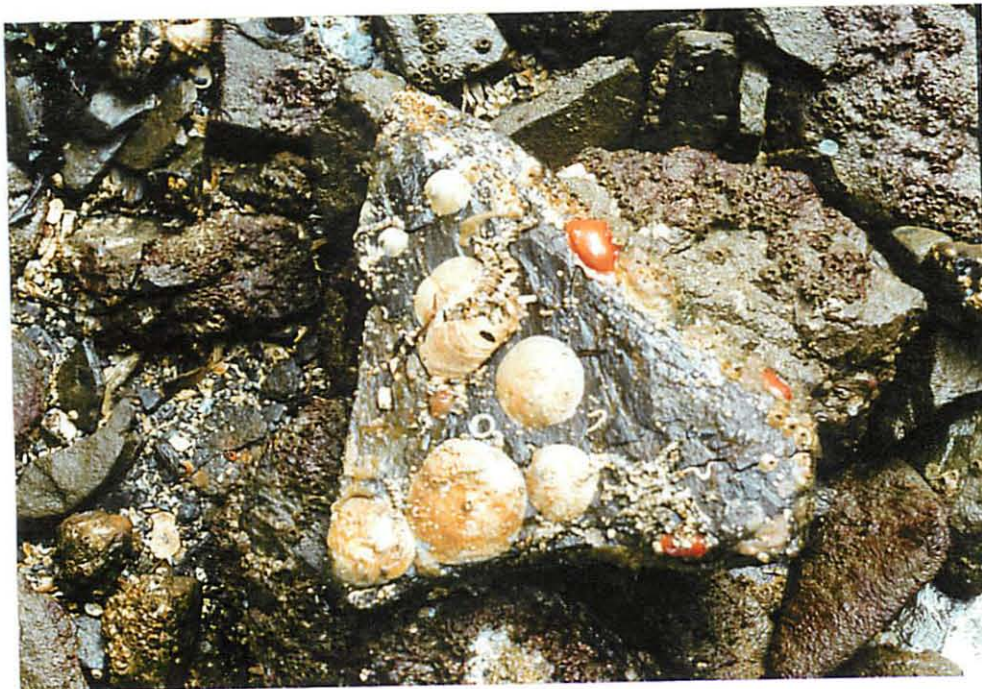
Photograph # 48:

View of the under surface of a typical small rock from the lower intertidal area between the piles supporting the mooring wall.

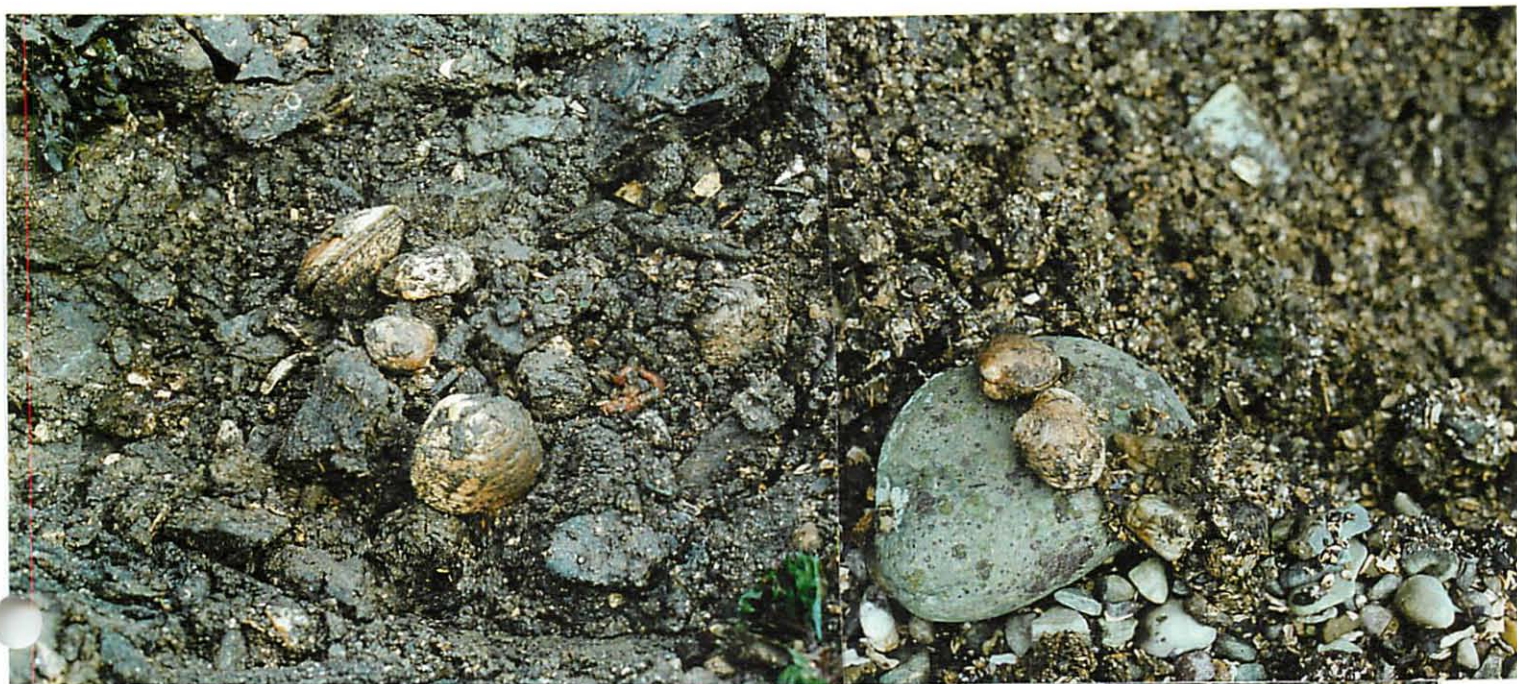
Photograph # 49:

Typical substrate and organisms (clams and worms) from
'typical' Benthic digs.

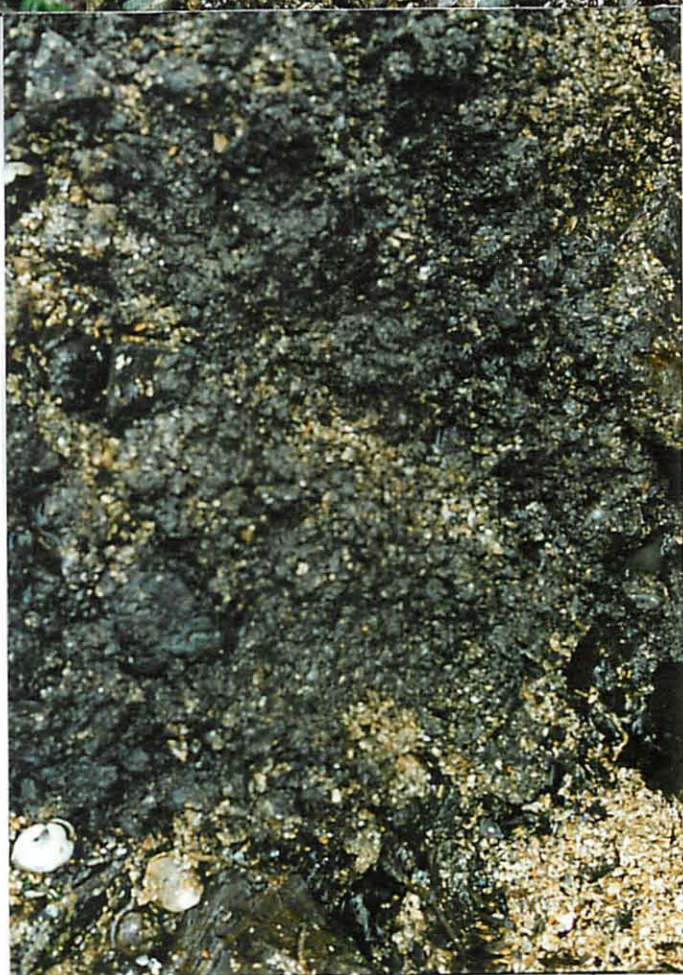
Photograph # 50:

Close up of silty mud
typically found in
the benthic digs.

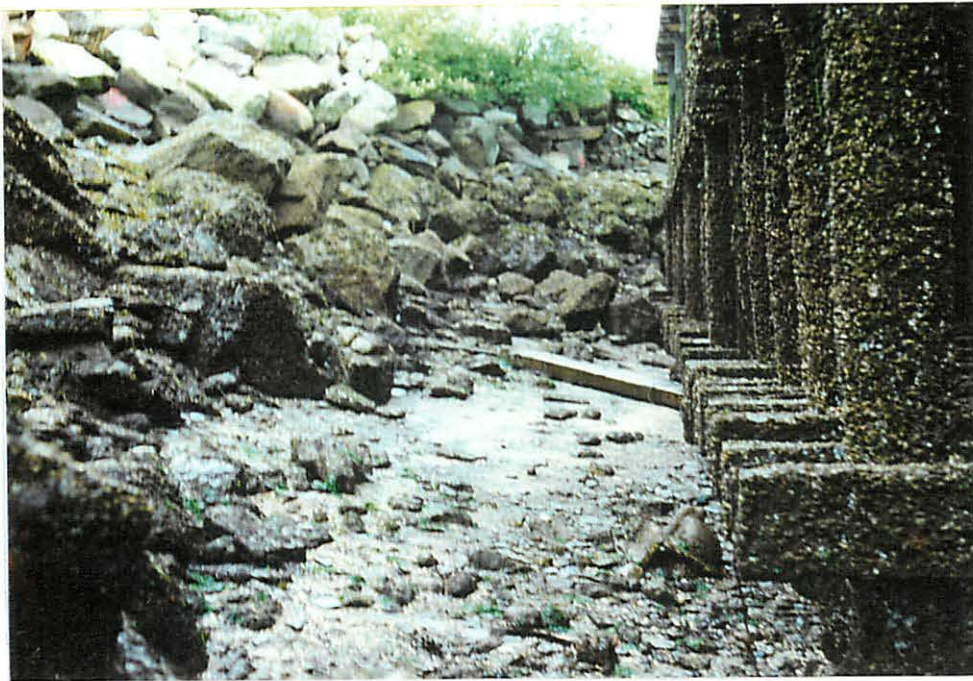
Photograph # 50:

This photograph shows the sandy area with scattered rocks between the existing rock embankment and the first pile of the mooring wall in the region of transects # 2 to # 5. Small clams were found in this area.

3.5 to 7:	This is a continuation of the large rock boulders (rip rap) in the upper intertidal zone. The 3.5 meter point marks the beginning of the Fucus/barnacle zone. (see photograph # 26).
7 to 8:	This is a continuation of the large rock boulders (rip rap) in the upper intertidal zone. The 7 meter point marks the beginning of the barnacle/mussel/Fucus zone (see photograph # 26).
8 to 9:	This is a small area near the toe of the rock embankment where there is mixed seaweed as well as barnacles and mussels where the dominant life is filamentous brown algae. (see photograph # 26).
9 to 12.5:	This is a region of fine sand and broken shells with occasional rocks on the surface in the lower intertidal area from the toe of the rock down to the first pile for the mooring wall. Digs in the sand were carried out randomly and clams and marine worms were found in all digs. Substrate in digs is a silty mud. (photograph # 50)

3.5 to 4:	This is a continuation of the large rock boulders (rip rap) in the upper intertidal zone. The 3.5 meter point marks the beginning of the barnacle zone. (see photograph # 28).
4 to 8:	This is a continuation of the large rock boulders (rip rap) in the upper intertidal zone. The 4 meter point marks the beginning of the Fucus/barnacle zone. (see photograph # 28).
8 to 9:	This is a continuation of the large rock boulders (rip rap) in the upper intertidal zone. This is a mixed area of barnacles, mussels, Fucus, and filamentous brown algae.
9 to 12.4:	This is a region of fine sand and broken shells with occasional rocks on the surface in the lower intertidal area from the toe of the rock down to the first pile for the mooring wall. Digs in the sand were carried out randomly and clams and marine worms were found in all digs. Substrate in digs is a silty mud. (photograph # 50) See results of Benthic Digs.

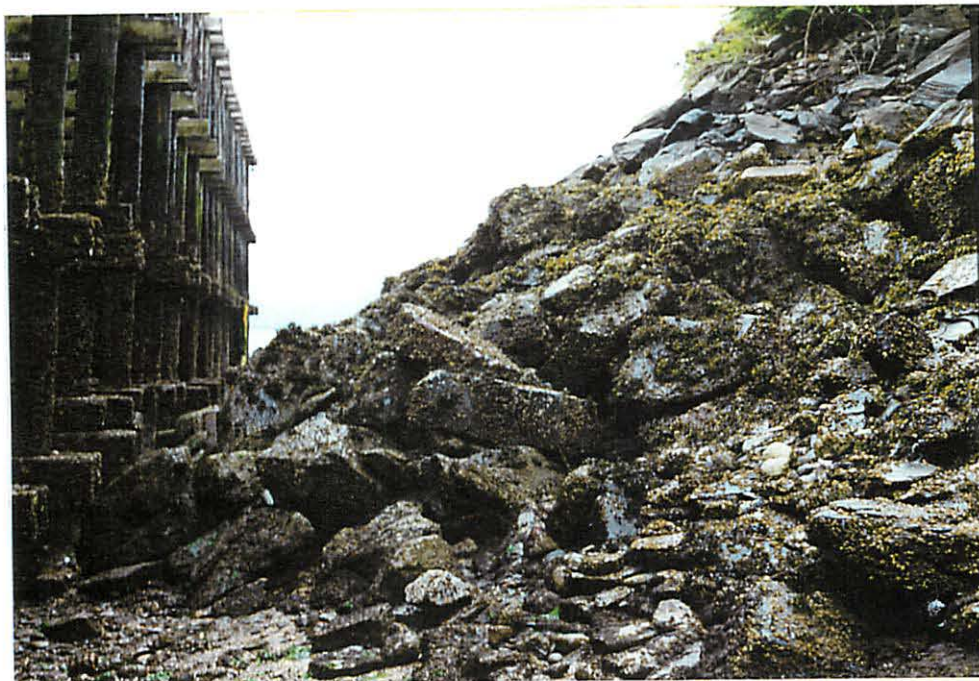
Photograph # 51:

This view shows the existing rock embankment in the region of transect # 6, where the toe of the rock reaches down to the first row of piles for the mooring wall.

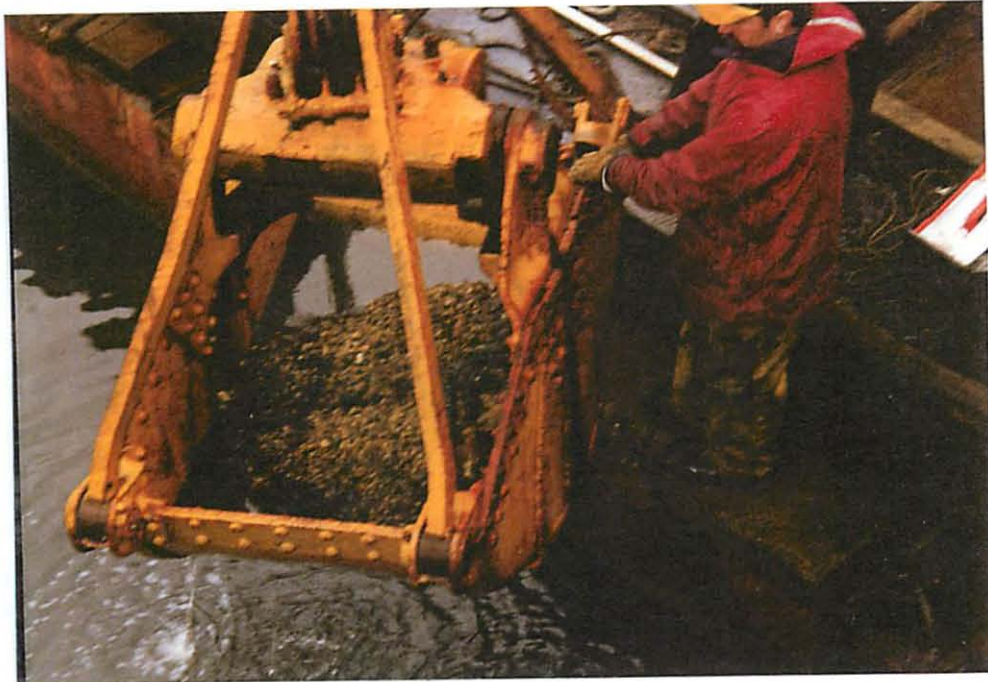
Photograph # 52:

This photograph shows the equipment for and relative sample size of the subtidal Benthic grabs.

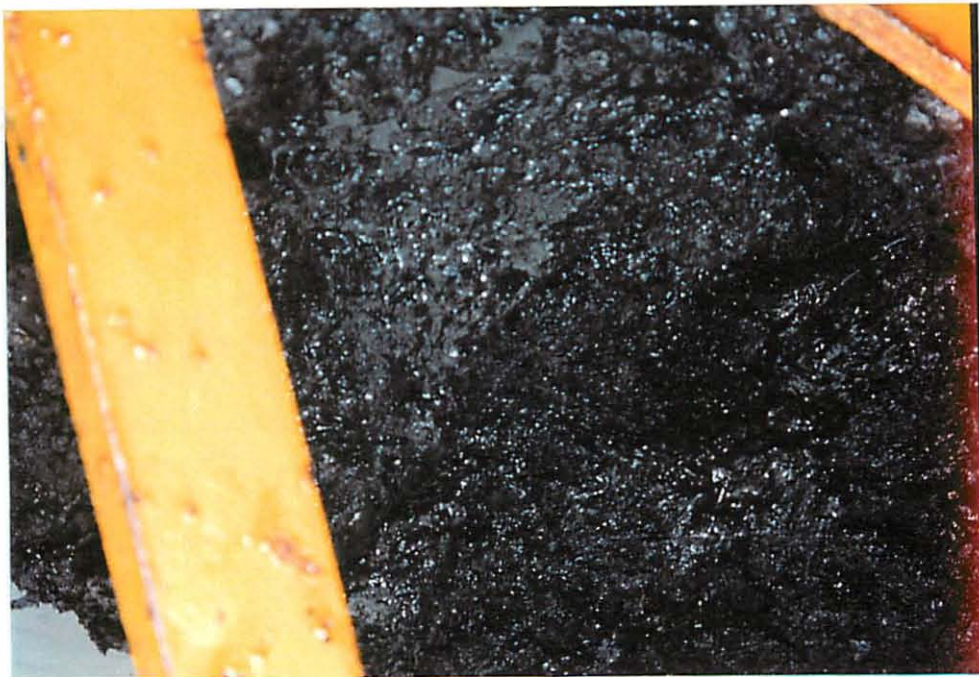
Photograph # 53:

This photograph is an example of the sediment found in grabs taken very close to the existing mooring wall.

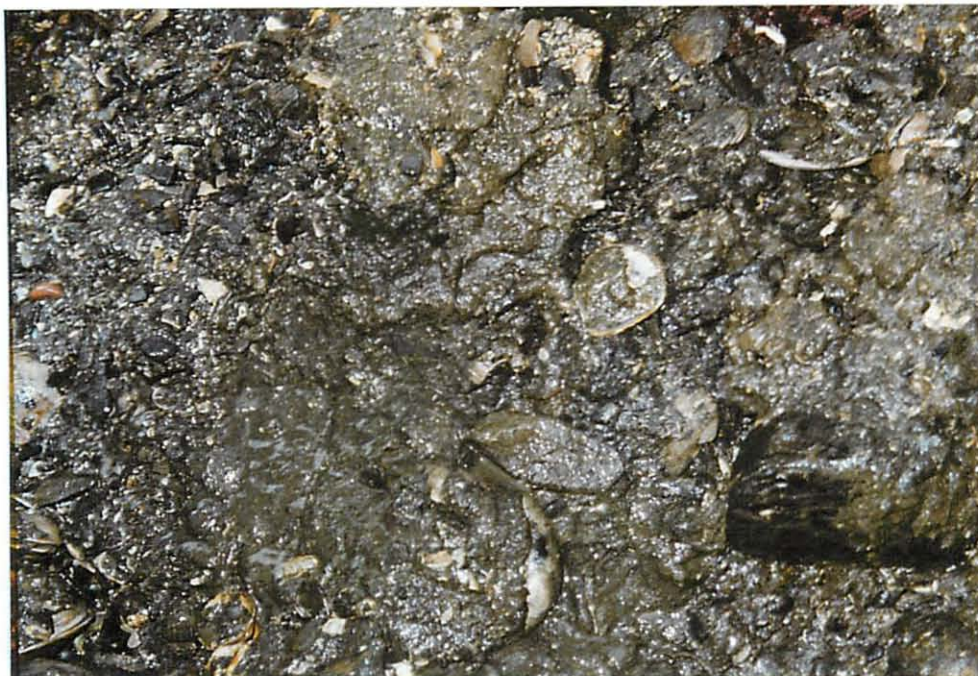
Photograph # 54:

This photograph is an example of the sediment found in grabs taken about 16 meters out from the existing mooring wall along a line parallel to the loading ramp.

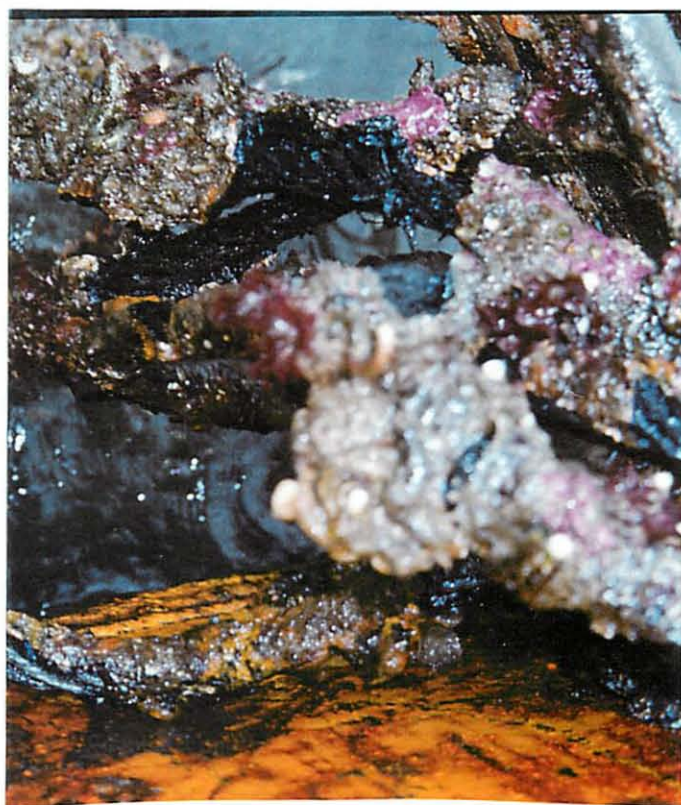
Photograph # 55 & 56:

These two photographs are illustrative examples of the types of epiphytic growth revealed in the various grabs.

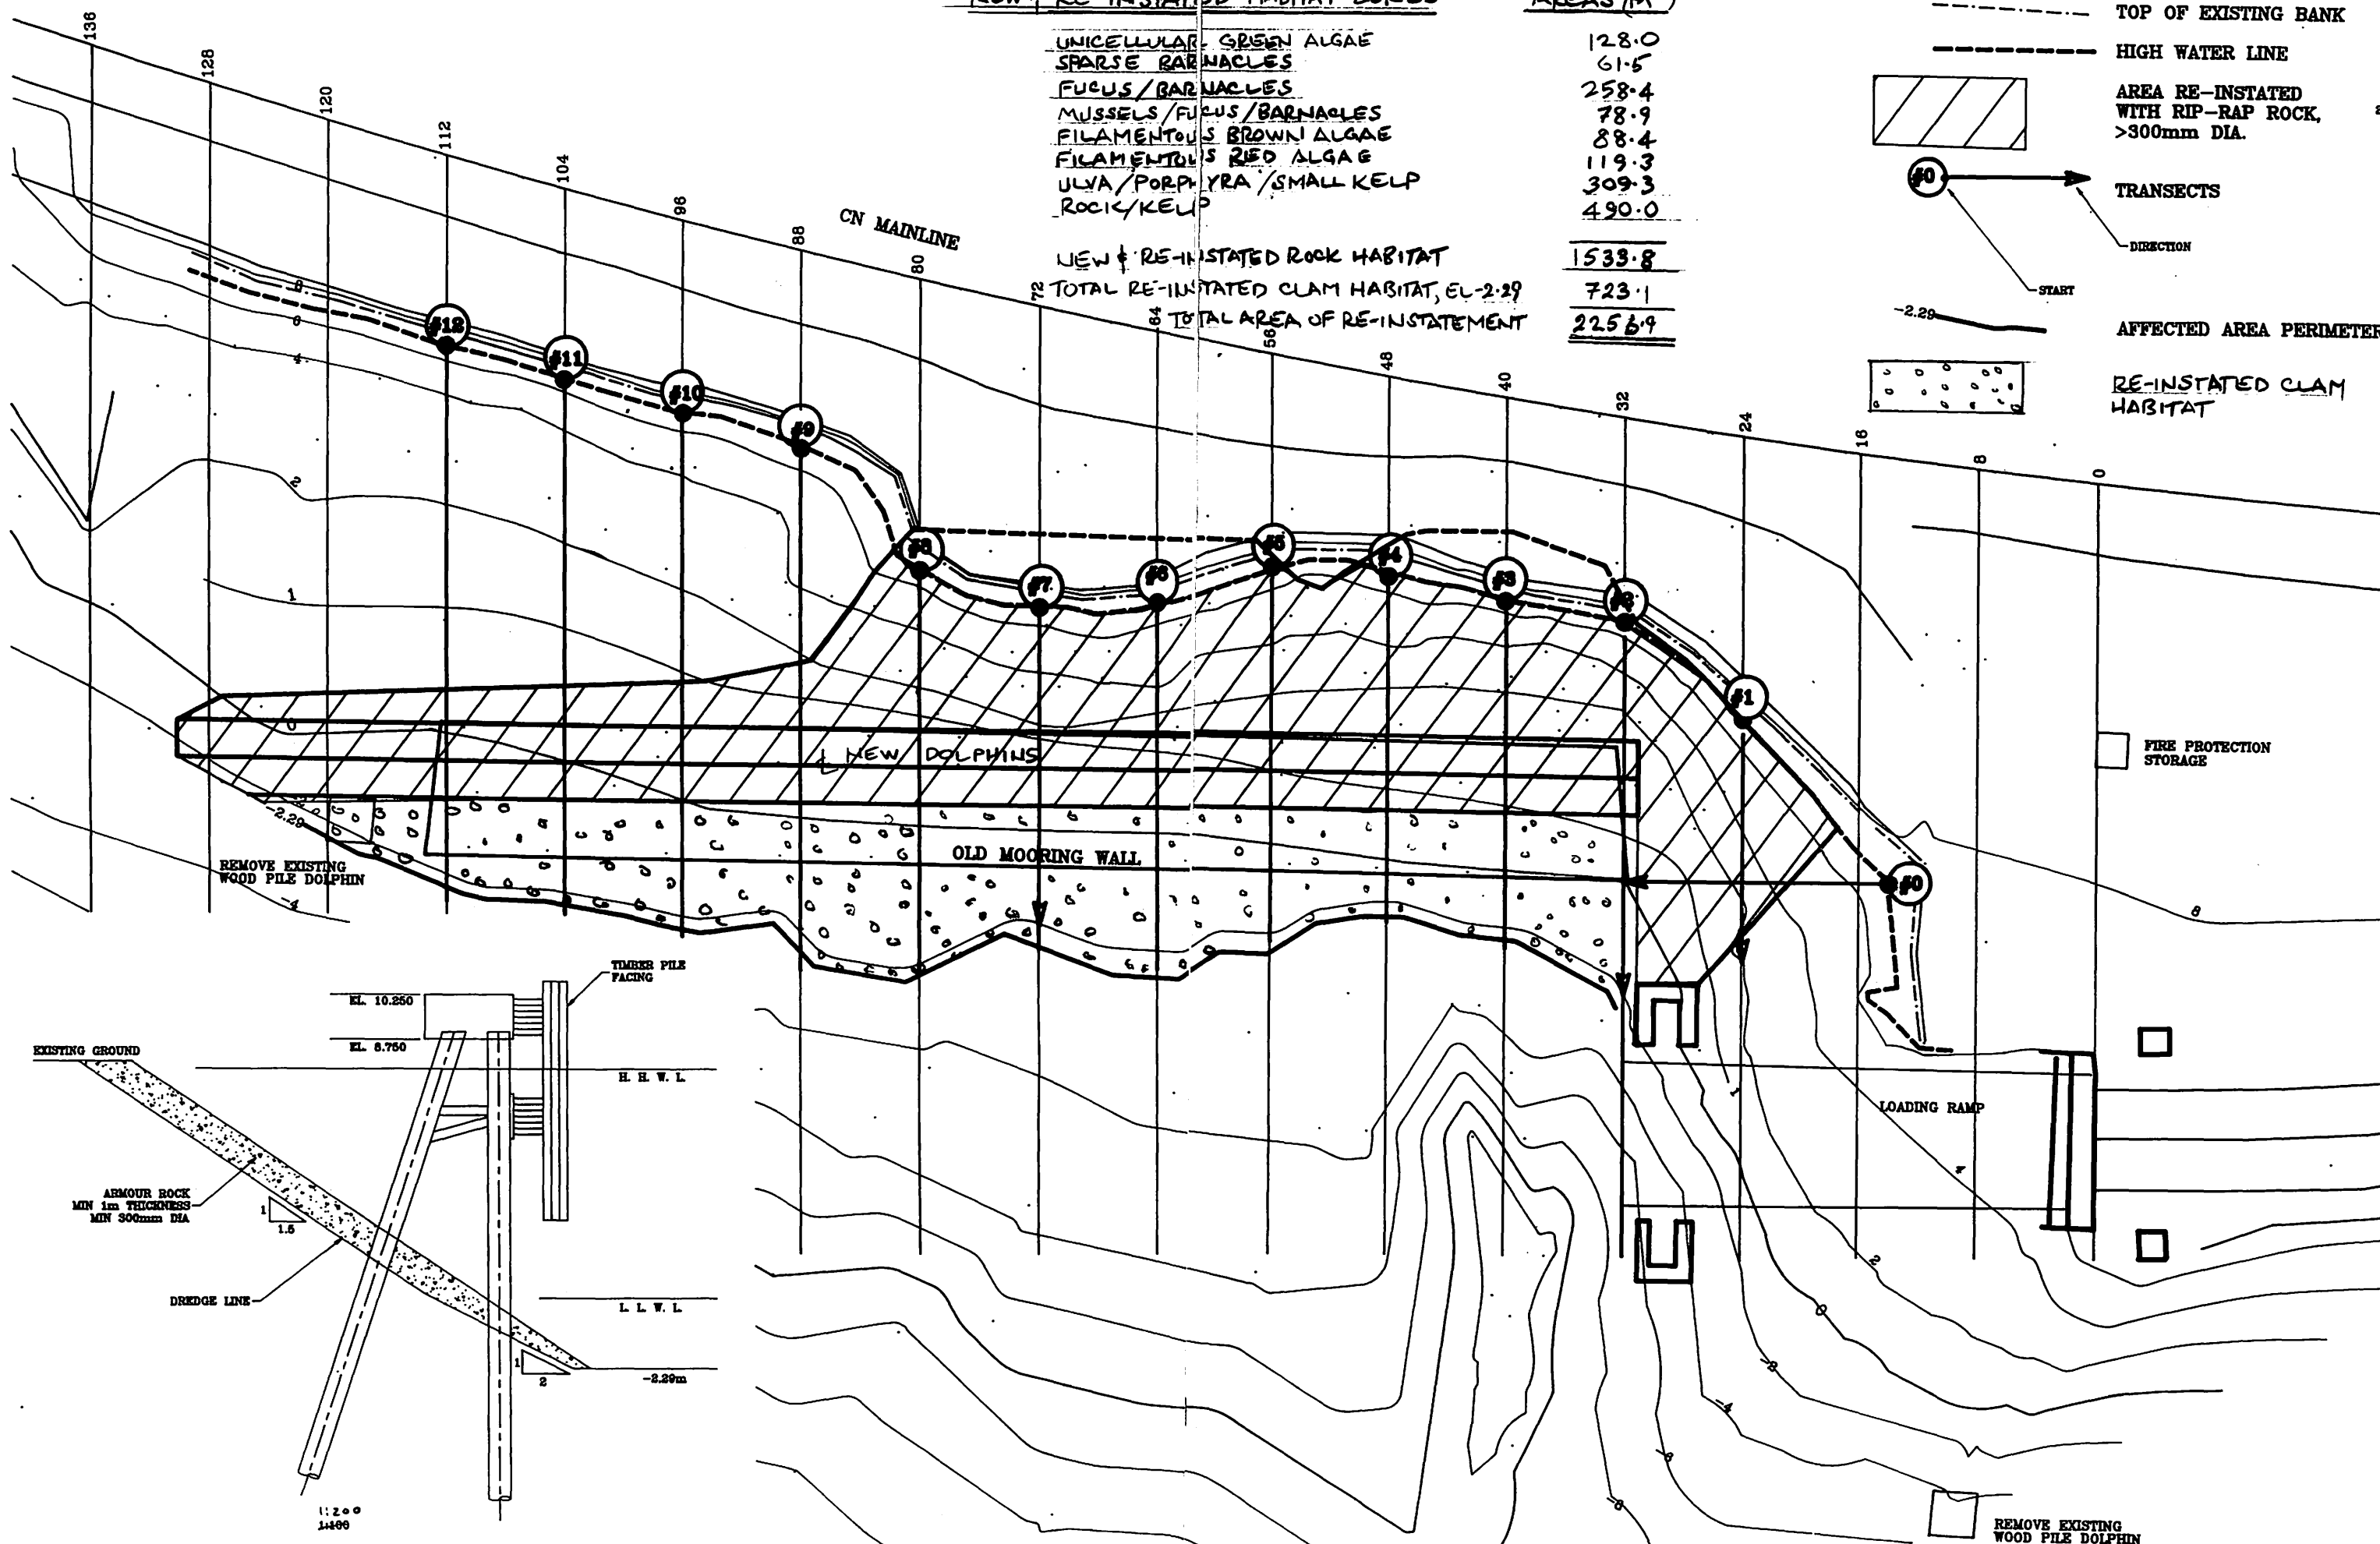
NEW & RE-INSTATED HABITAT ZONES

± TOTAL RE-INSTATED CLAM HABITAT, EL-2.29 **723.1**

± TOTAL AREA OF RE-INSTATEMENT **2256.9**
