THE FLOODED TAILINGS IMPOUNDMENT AT THE EQUITY SILVER MINE

W.A. Price¹ and M. Aziz²

ABSTRACT

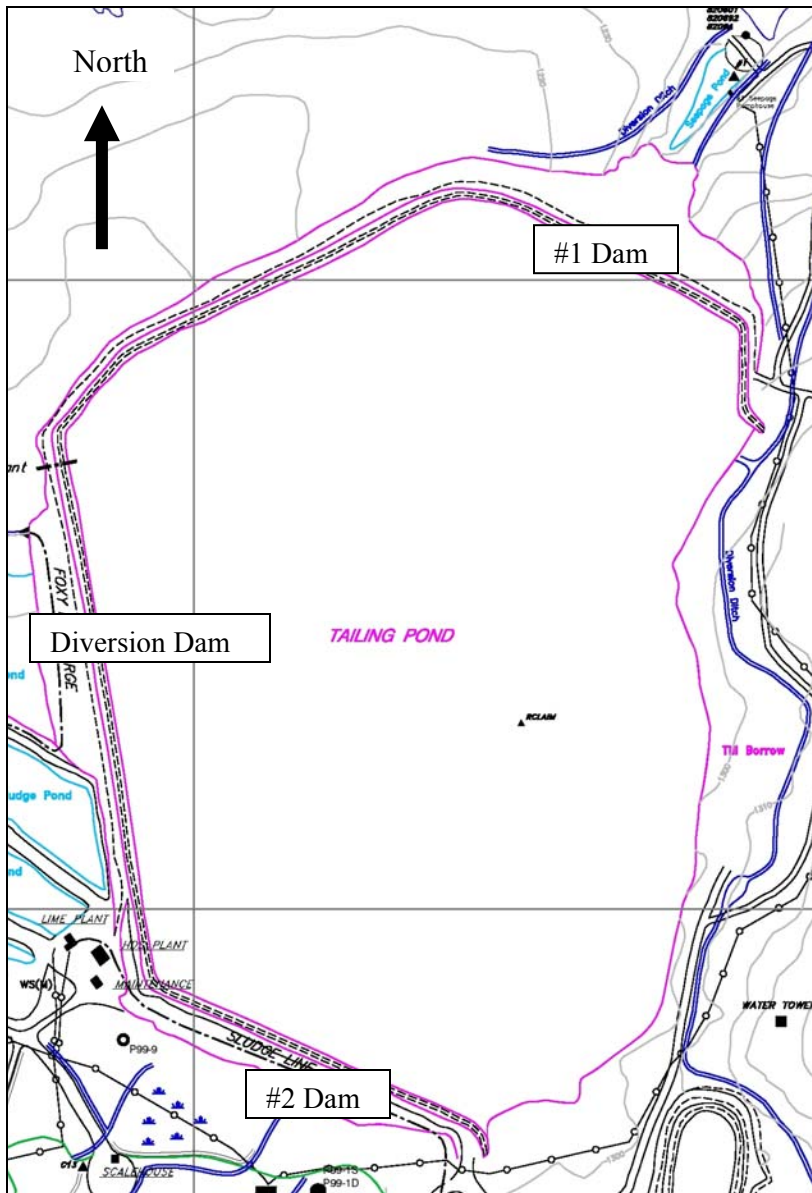
Figure 1. Map of Tailings Impoundment

The tailings impoundment has dams on the north, west and south sides (#1, Diversion, and #2 dams respectively), and is constrained by a natural slope on the eastern side (Figure 1). The impoundment has a surface area of 120 ha with very little additional catchment if the diversion ditches are operational. An emergency spillway capable of passing the probable maximum flood (PMF) is located on natural rock at northeast corner at 1292.5m elevation. The spillway reports to the Berzelius Diversion, which limits drainage input into the impoundment from the higher natural ground on east side above the impoundment. The Berzelius Diversion flows into Foxy Creek at the north end of the property.

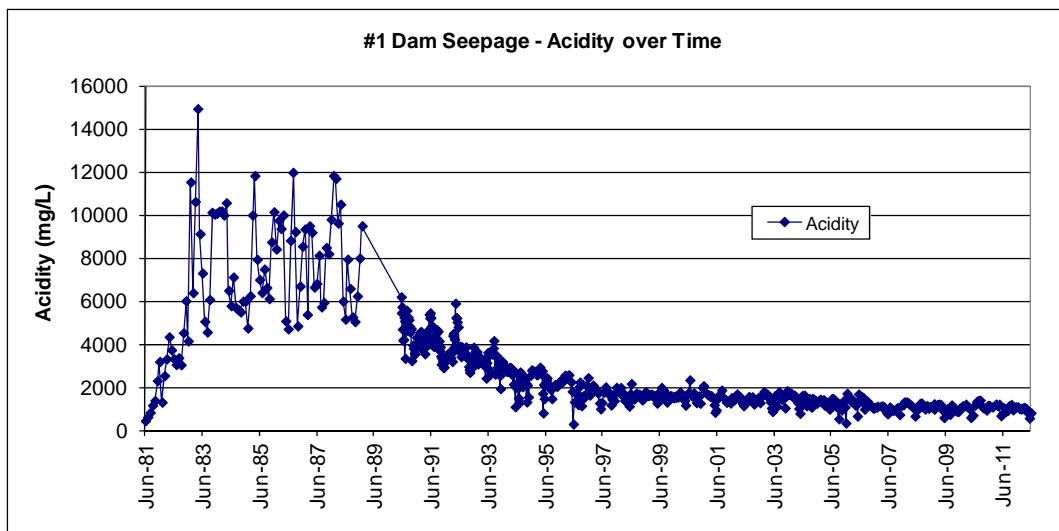
Figure 2. Concentration of acidity in drainage from #1 Dam

Seepage through the #1 Dam contacts acidic waste rock in the toe of the dam, becomes acidic, and is collected in a seepage pond named #1 Dam Seepage (Figure 2). During mining, ARD from #1 Dam Seepage was pumped into the tailings impoundment to increase cyanide degradation and lower the pH of the water sufficiently for re-use in the mill. Since mine closure, drainage from #1 Dam Seepage has been pumped to a holding pond and treated using lime along with drainage from the waste rock dumps and plantsite. Other smaller seepages from the tailings impoundment occur through the Diversion Dam into the Diversion Pond and through #2 Dam into the ARD collection system. These smaller seepages are much lower in volume and are not acidic since the rockfill for those dams was NPAG.

Acidity from the #1 Dam Seepage Pond increased rapidly from 1981 to 1982 and exceeded 10,000 mg CaCO₃eq /L from 1983 to 1989. Since 1989, acidity has steadily decreased and is now less than 1500 mg CaCO₃eq /L. It is theorized that the decrease in acidity is due to the depletion of finer, more reactive sulphides and a higher ratio of drainage to exposed rock than large waste rock dumps. The average volume of seepage from the #1 Dam is 68,076 m³/yr, approximately 20% of the volume, but only 4% of the acidity load that the site needs to treat. Improvements to the collection of acid water below the #1 Dam have included diversion ditches to reduce the volume of uncontaminated drainage that is collected and purchase of a diesel generator to provide power for the pumps in the event of a power failure.
