RECONNAISSANCE INVENTORY OF

DAMSUMLO LAKE

WATERSHED CODE 480-0278-657-01

SURVEY DATES : AUGUST 23 - 25, 1996

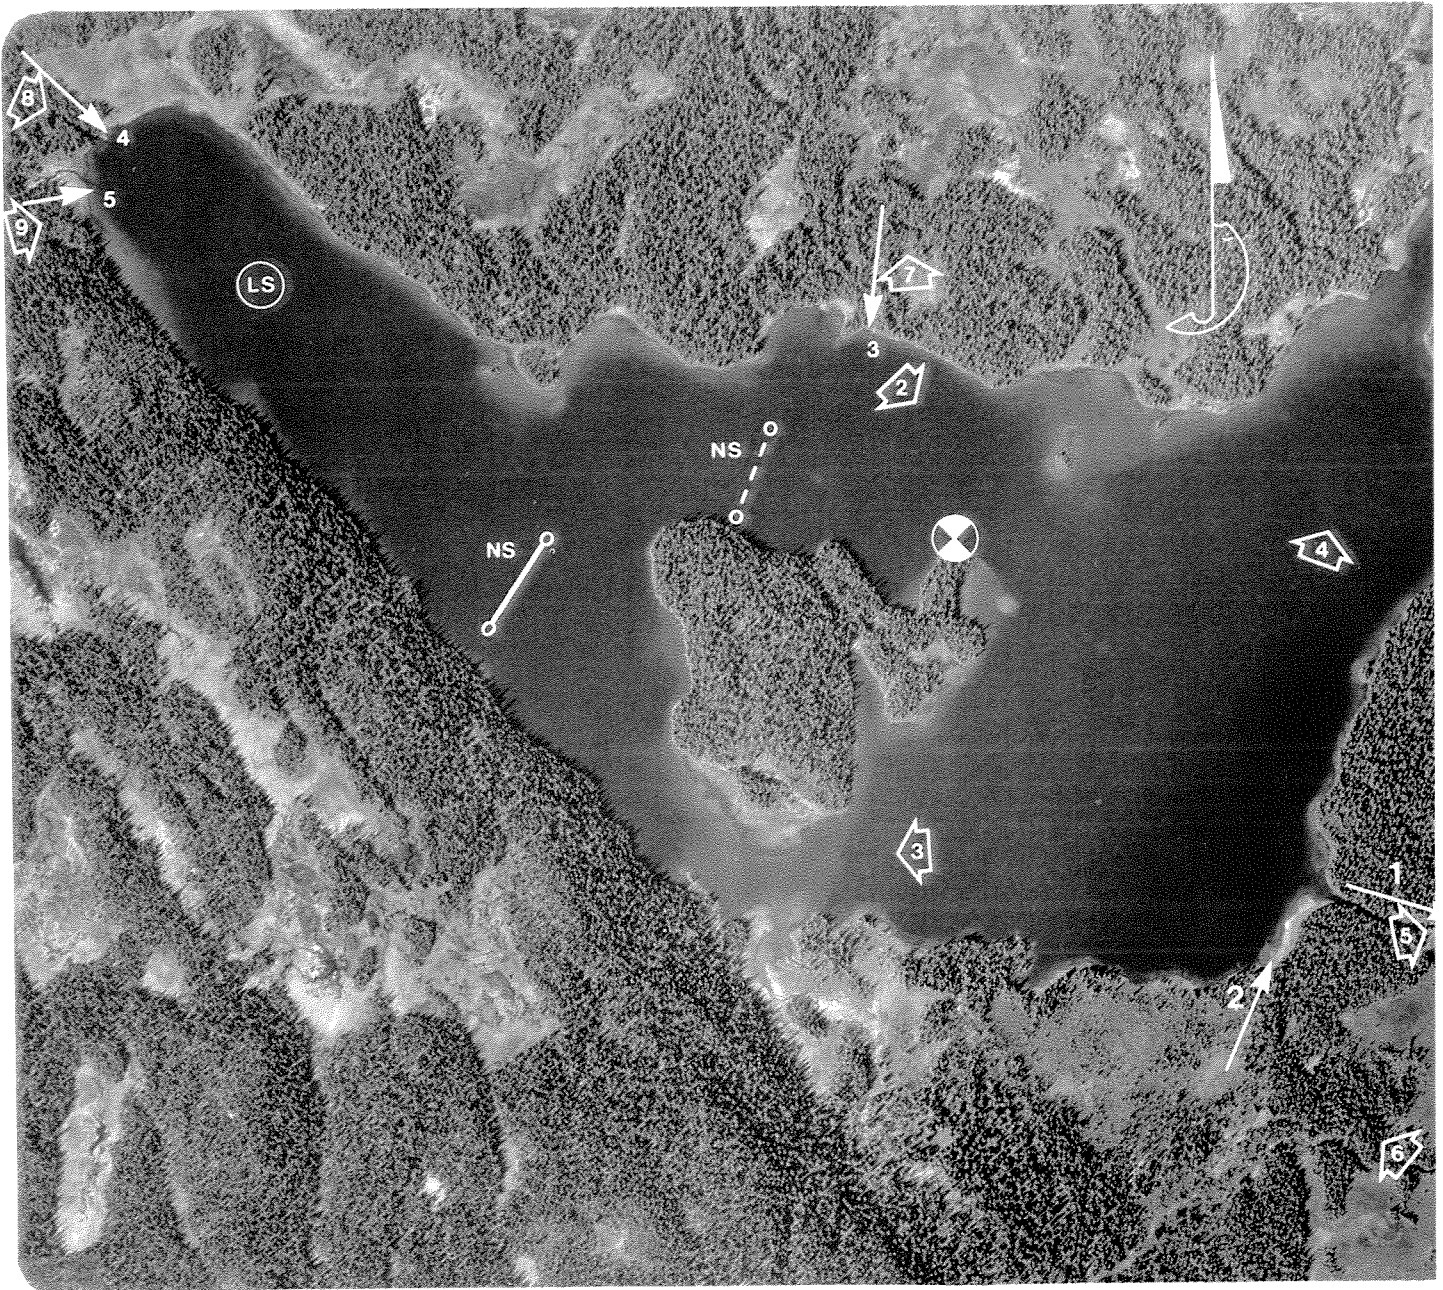
Figure 2. Damsumlo Lake except northeast arm. Enlargement from air photo.

AIR PHOTO #: 30BCB92073 #112

The benchmark was established in a 50 cm dbh subalpine fir 10 m from shore on the northeast point of the large island. An iron spike was placed in an orange circle painted on the tree trunk, 2.15 m above the current lake level. The location of the benchmark is shown in Figure 2. The high water mark was located 0.15 m above the current lake level.

Quantitative characteristics of the stream surveys and fish collection can be found on the stream survey forms in Appendix B and Table 1. Numbering of the streams (C1, C2, etc.) in this section corresponds to labels on Figures 2 and 3, and other figures and tables in this report. Six channels were examined.

Limnological sampling was conducted at midday on August 25, 1996 at the Damsumlo Lake limnology station labelled on Figure 2. The survey was performed under clear skies with a light southeasterly wind creating calm surface conditions. Raw data and associated information were recorded on the RIC standard "Lake Biophysical Data Form" which is reproduced in Appendix D. Water samples were collected at 0.0 m, 10.0 m and 16.0 m depths, apportioned into aliquots for general chemistry and metals analysis, and shipped to Zenon Laboratories on ice for processing. Zenon's records show that the Damsumlo Lake samples were received on August 27, 1996 within the 72 hr RIC standard time frame for water sample transport.

Table 2. Water chemistry parameters estimated by Zenon Laboratories. Samples were collected at the limnology station labelled in Figure 2. Each sample was collected by a single cast of a 3.2 L non-metallic Van Dorn bottle on August 25, 1996. MDC = minimum detectable concentration for the analytic method.

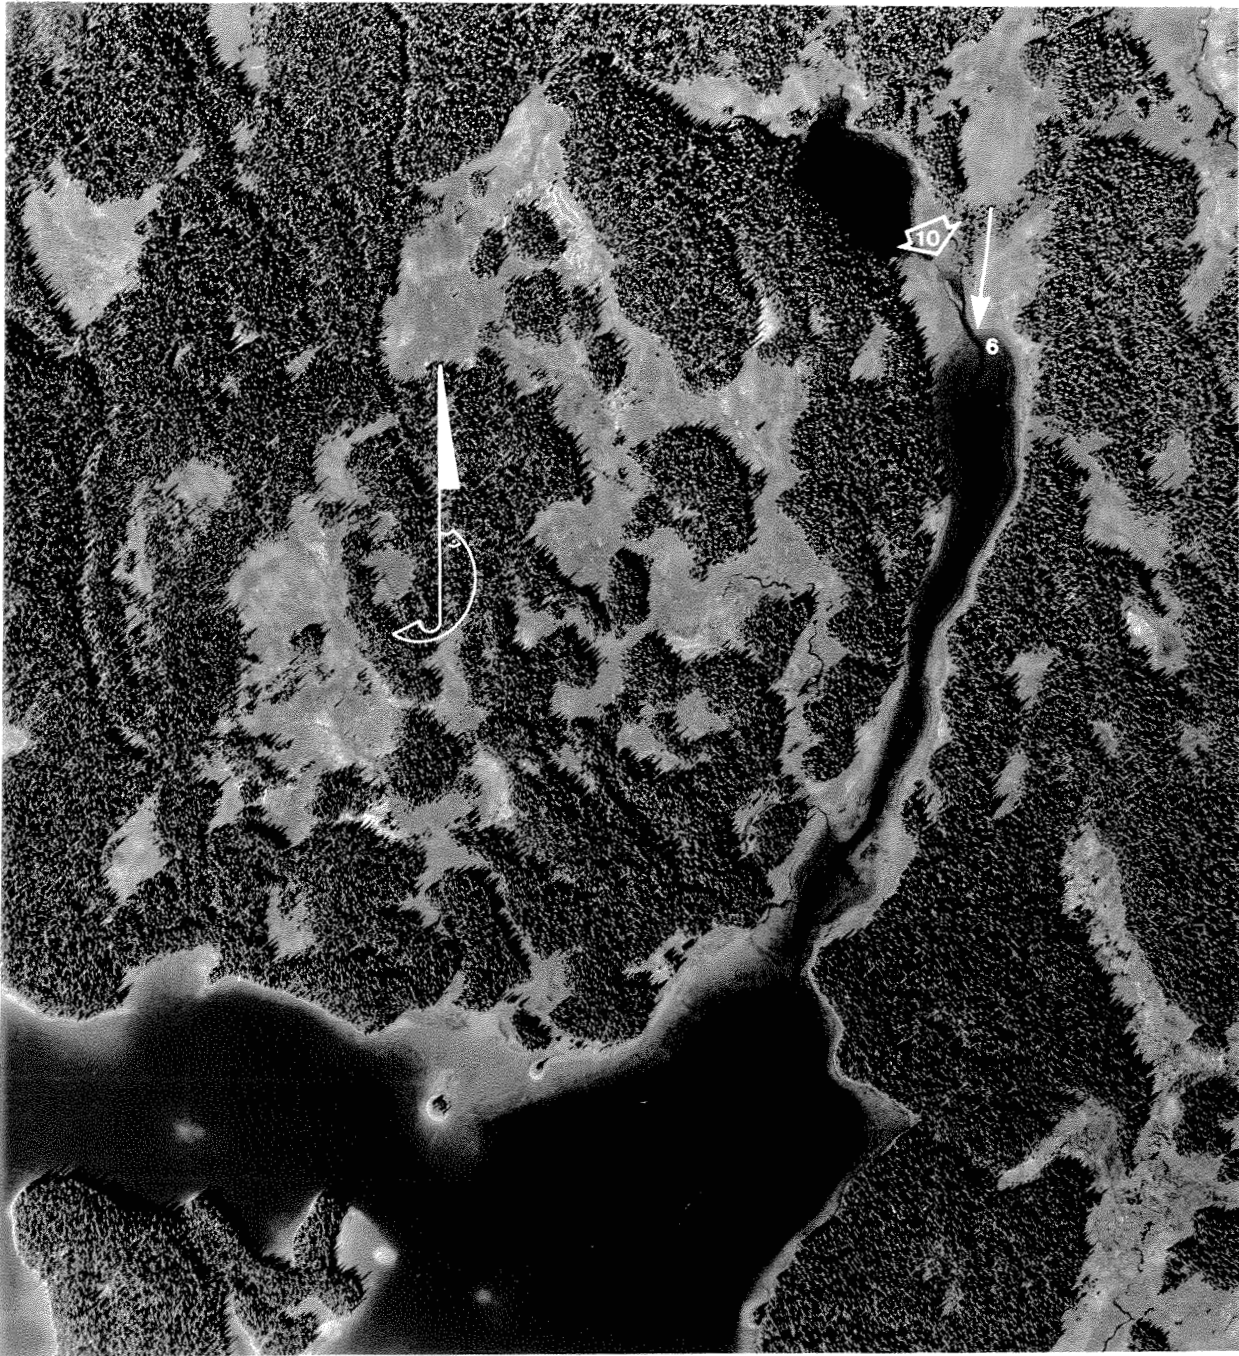
Figure 3. Northeast arm of Lake. Enlargement from air photo. LEGEND

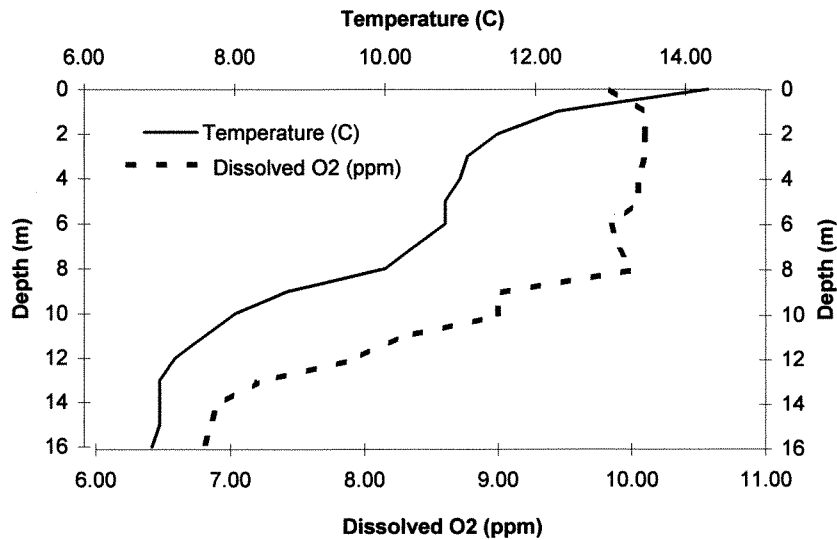
Figure 5. Temperature and dissolved O₂ profiles for Damsumlo Lake on August 25, 1996. The sampling device was a YSI 57 temperature/oxygen meter. Sample interval was 1 m.

The oxygen - temperature profile of Damsumlo Lake on August 25, 1996 is shown in Figure 5. The lake was stratified at time of survey. The thermocline was located between 8 m and 12 m. Substantial near-surface warming was also evident. Dissolved oxygen was depleted below 8 m though the hypolimnion was not anoxic.

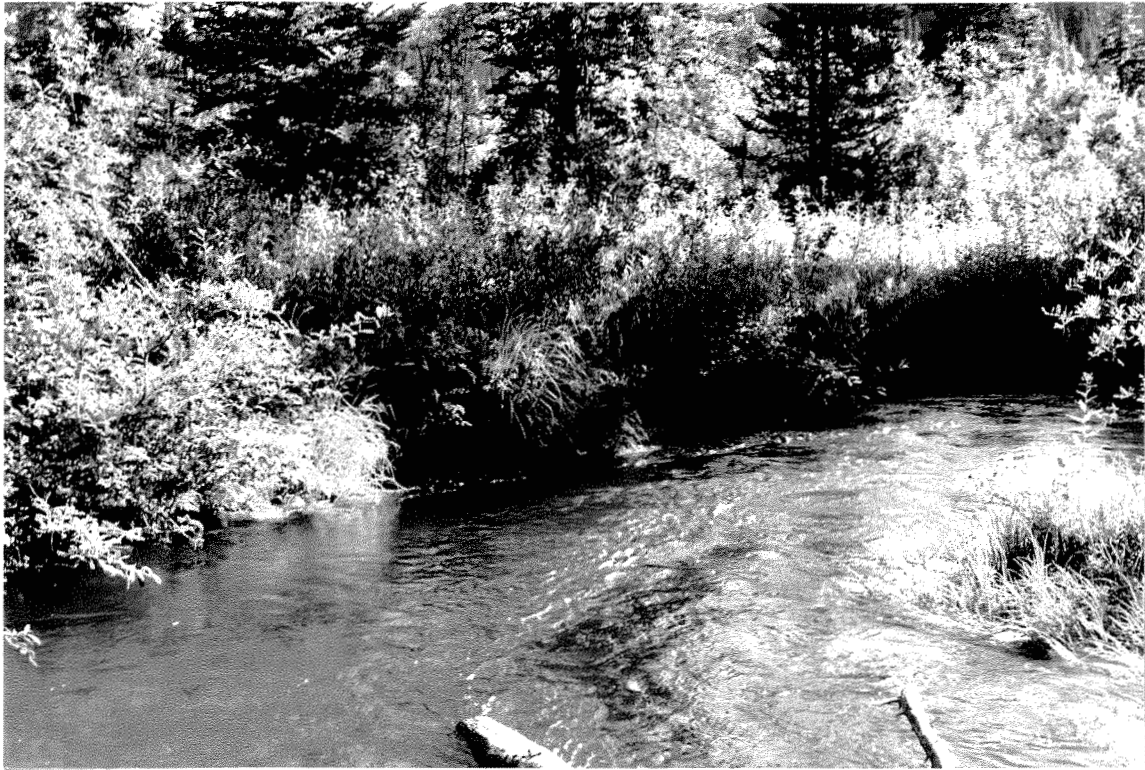
Photograph 5. Downstream view of Damsumlo Creek, C1, WC 480-0278-657, outlet of Damsumlo Lake.

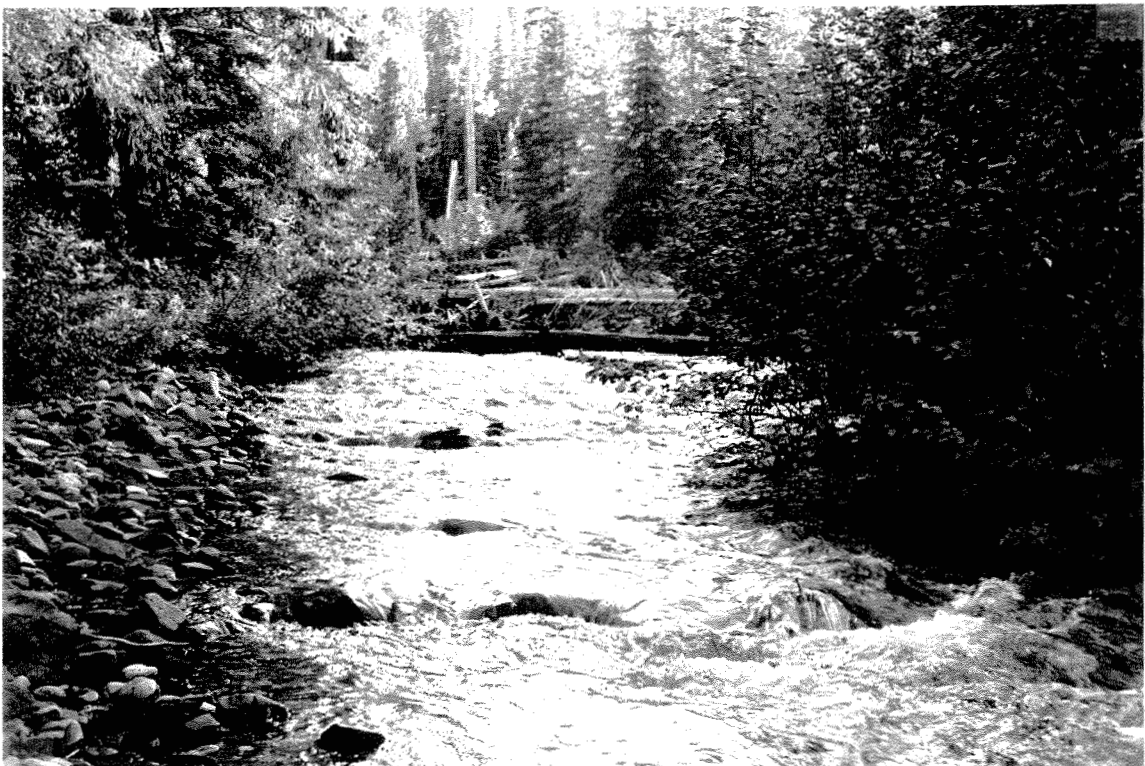
Photograph 6. Upstream view of C2, WC 480-0278-657-453, inlet to the south shore of Damsumlo Lake.

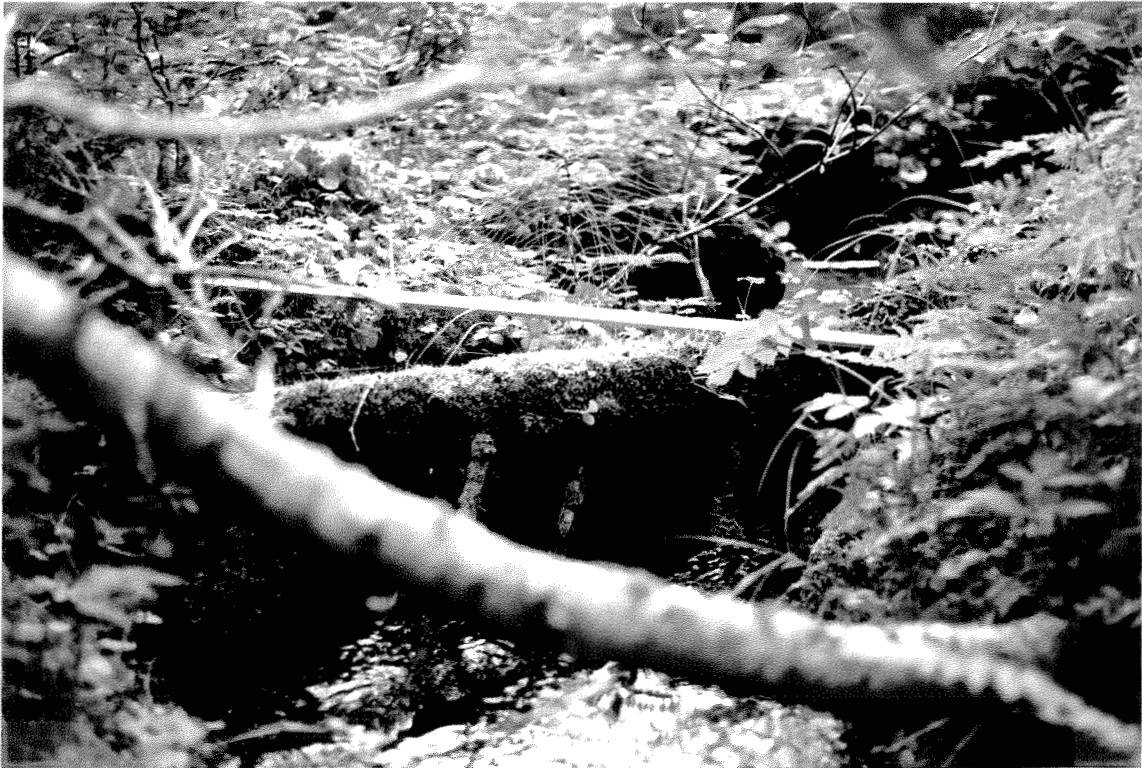
Photograph 7. Upstream view of C3, WC 480-0278-657-493, inlet to the north shore of Damsumlo Lake.

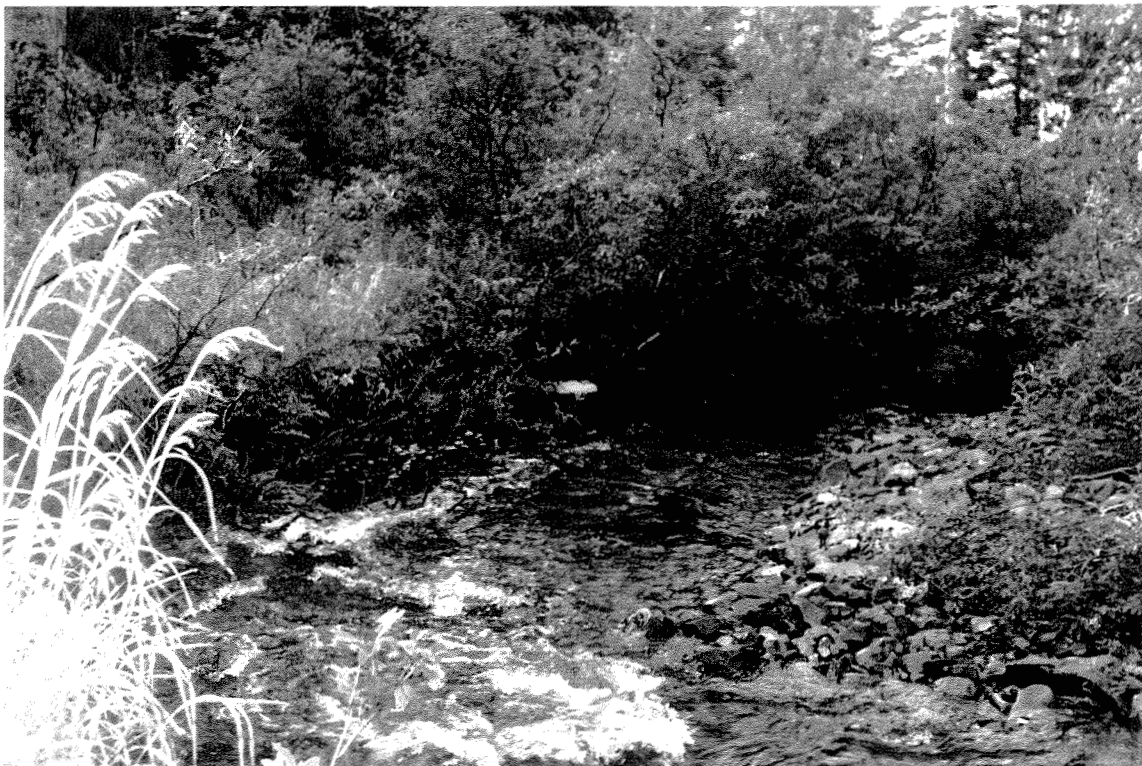
Photograph 8. Downstream view of C4 (WC pending), inlet to the northwest bay of Damsumlo Lake.

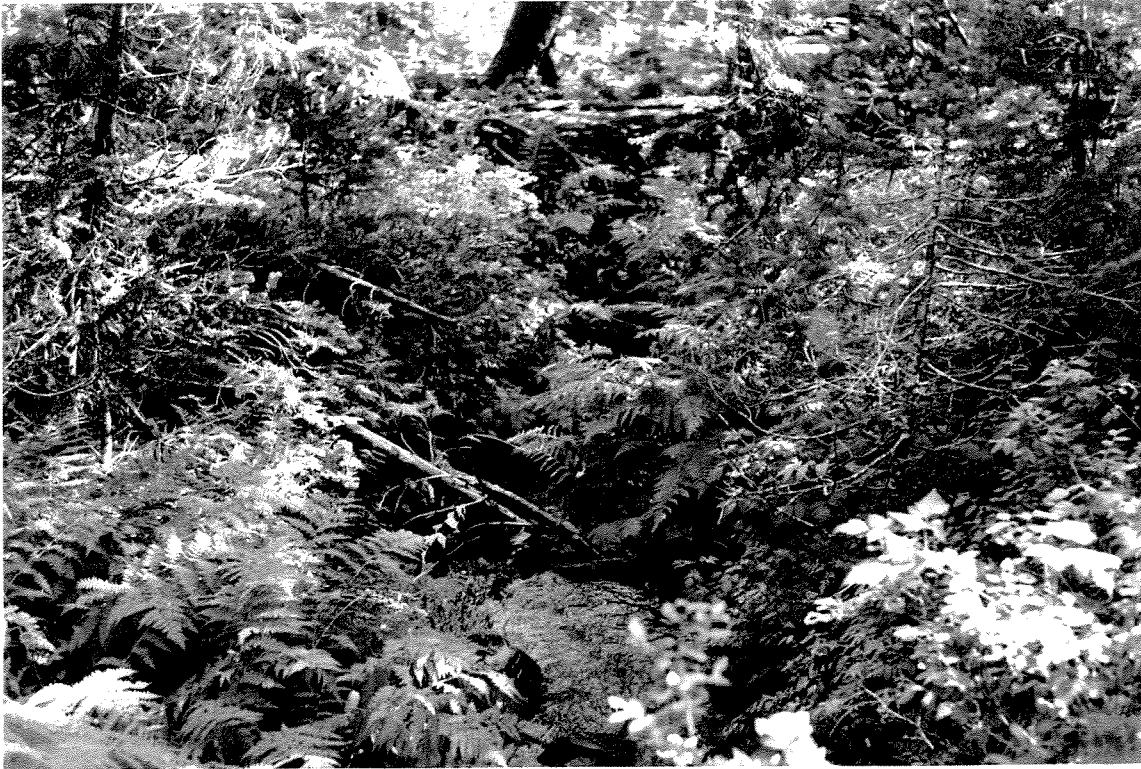
Photograph 9. Downstream view of C5, WC 480-0278-657, inlet to the northwest bay of Damsumlo Lake.

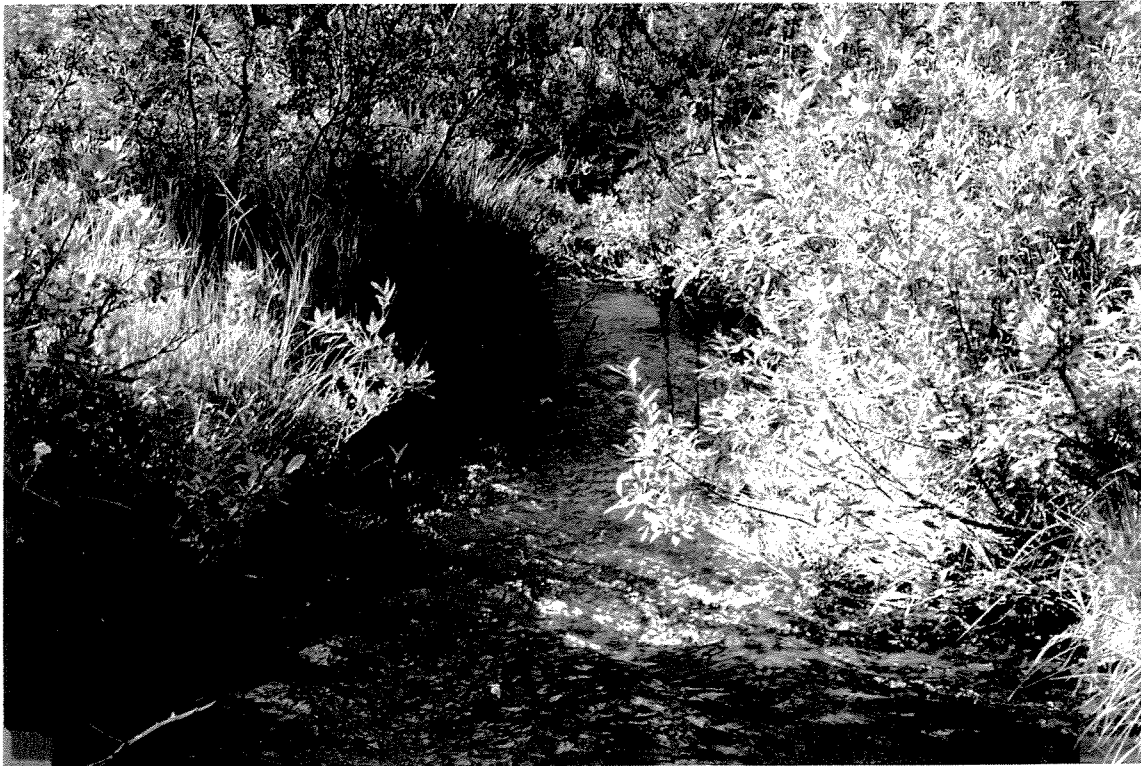
Photograph 10. Downstream view of C6, WC 480-0278-657-434, inlet to the northeast arm of Damsumlo Lake.

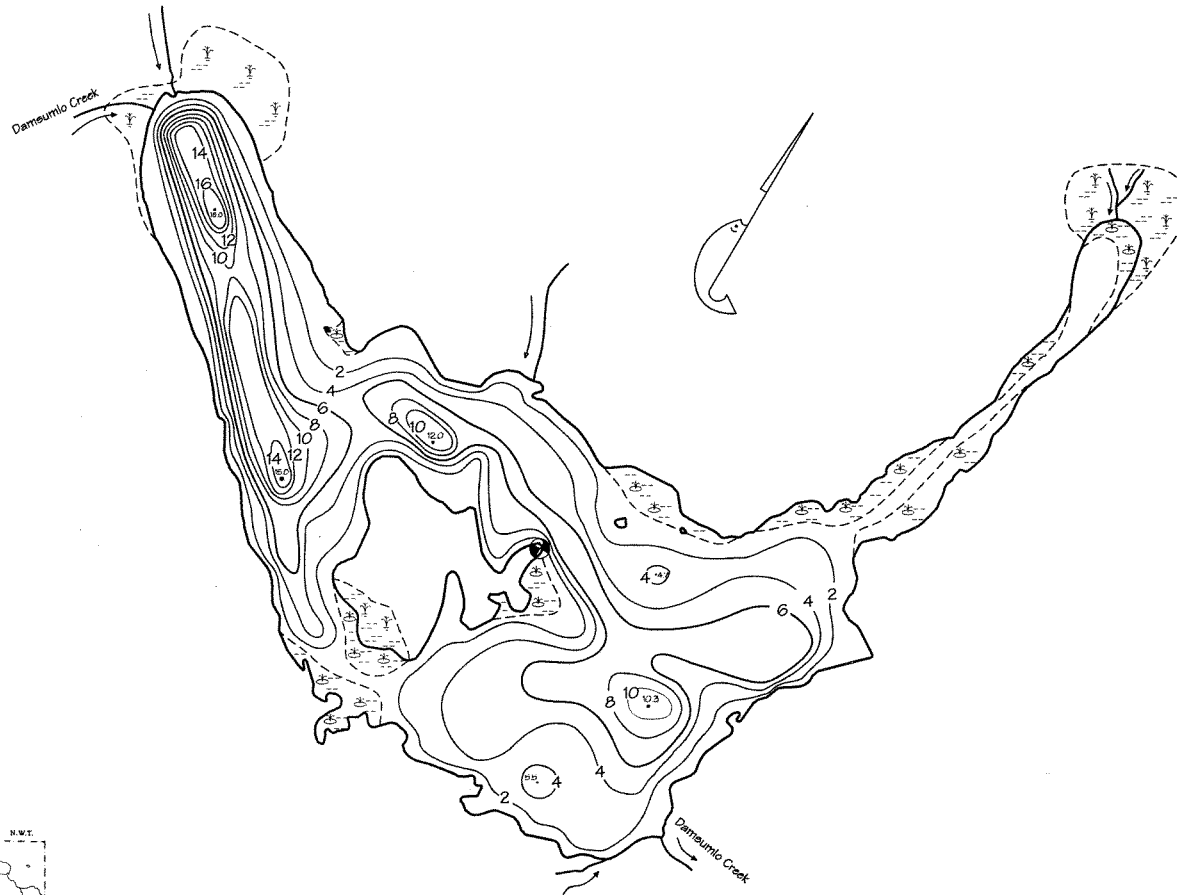
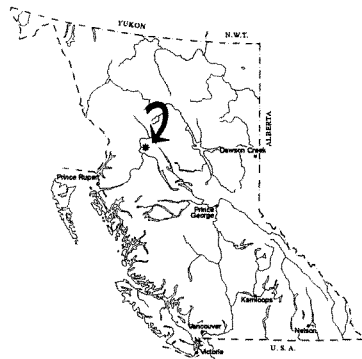
APPENDIX F. BATHYMETRIC MAP

Reduced to
33%
of Original Size

NOTES: 1 - Depths are in Metres; 2 - Denotes Bench Mark; 3 - Not intended for navigational use. Uncharted rocks and shoals may exist.
