**Baboon Lake  
(480-697200-12300-01)  
01607BABL**

**SECONDARY LAKE INVENTORY  
1997 STUDIES**

**Ministry of Environment, Lands and Parks  
Project No. IVBVS622 (FRBC)**

**HATFIELD CONSULTANTS LTD.**  
Suite 201 - 1571 Bellevue Avenue  
West Vancouver, BC  
V7V 1A6  
Tel: (604) 926.3261 Fax: (604) 926.5389  
Email: hcl@hatfieldgroup.com

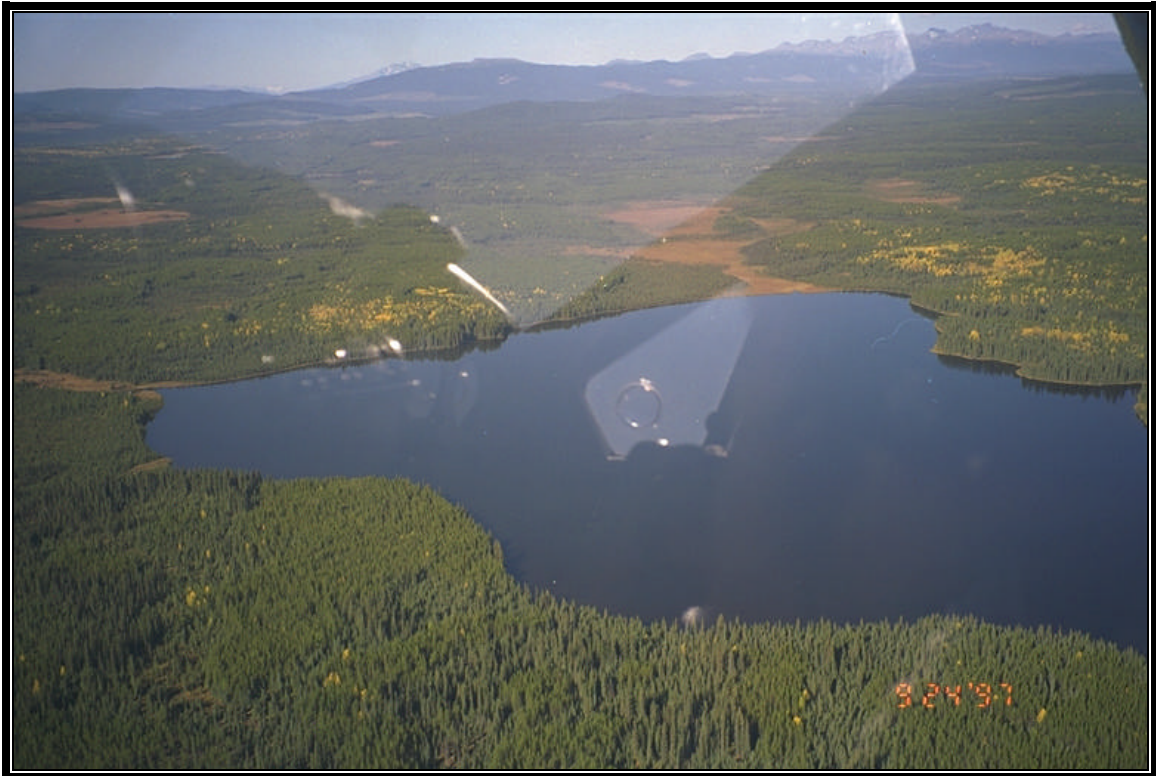
**Plate 1** Aerial view of lake looking west.

The lake is shown in Plates 1 and 2.

**Plate 1 Aerial view of lake looking west.**

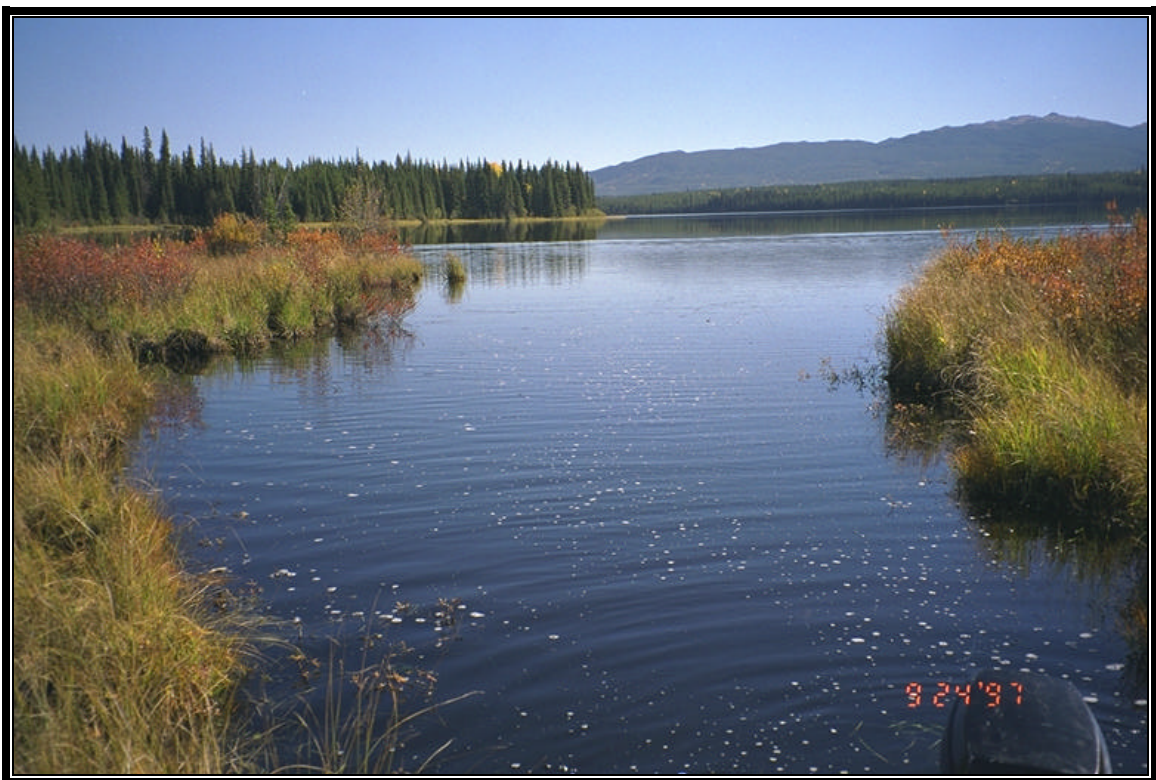
**Plate 2** View looking east from mouth of inlet ILP 97.
