Coho Spawner Surveys, Broodstock Capture and Beaver Dam Management in the Upper Bulkley River and Buck Creek in 2023

Prepared by Marjorie Lieuwen, Conservation Science Coordinator Buck Creek Canfor Hatchery and Nature Centre, A Rocha Canada

April 2024

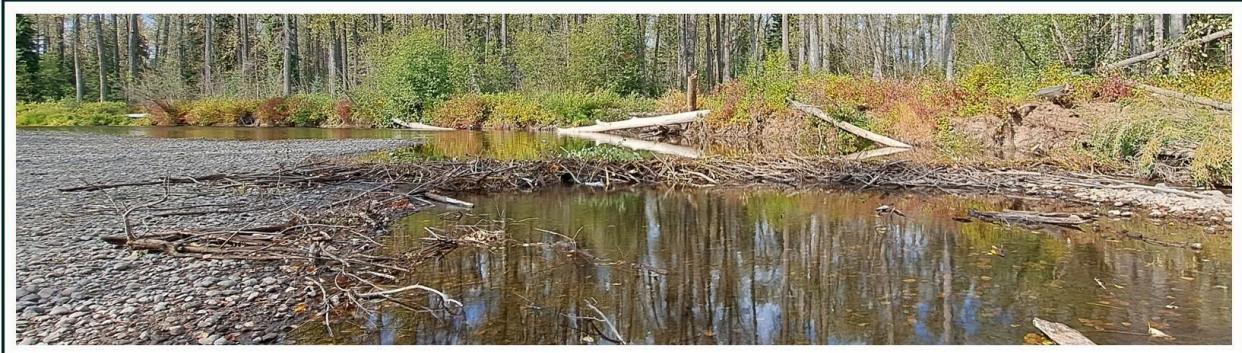
Impassable beaver dam 1

The first impassable beaver dam IBD1 was located about 1 km upstream of the Morice/UBR confluence and was notched. Approximately 30 coho were holding in a pool downstream of the dam. In this location 1 dead coho female was found (fork length 64 cm and POH length 53.5 cm) and upon dissection the female was determined to be a pre-spawn mortality, with 100% of eggs still tightly inside the skeins.

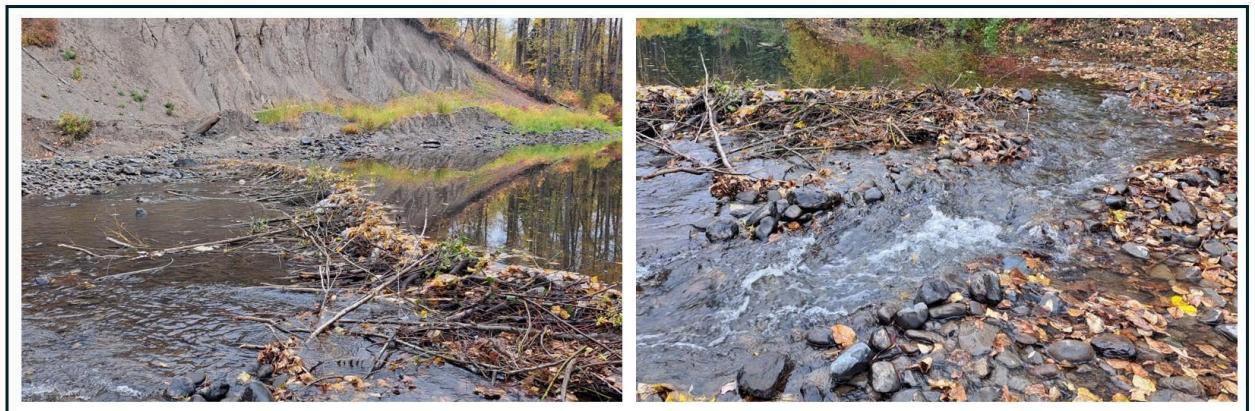
Impassable beaver dam 2, with the photo on the right showing side channel we created.

No coho were observed but several beavers dams were found. We opened up the dam IBD2 on the side. PBDs 2-4 were partial dams and passable, although we removed a small amount of sticks to make passage easier. IBD3 was located and breached, though no coho were observed below it.

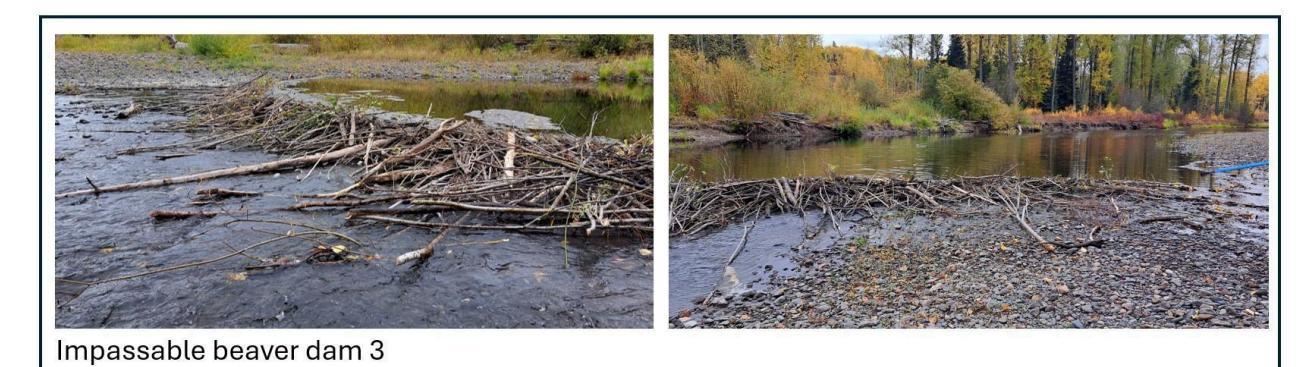
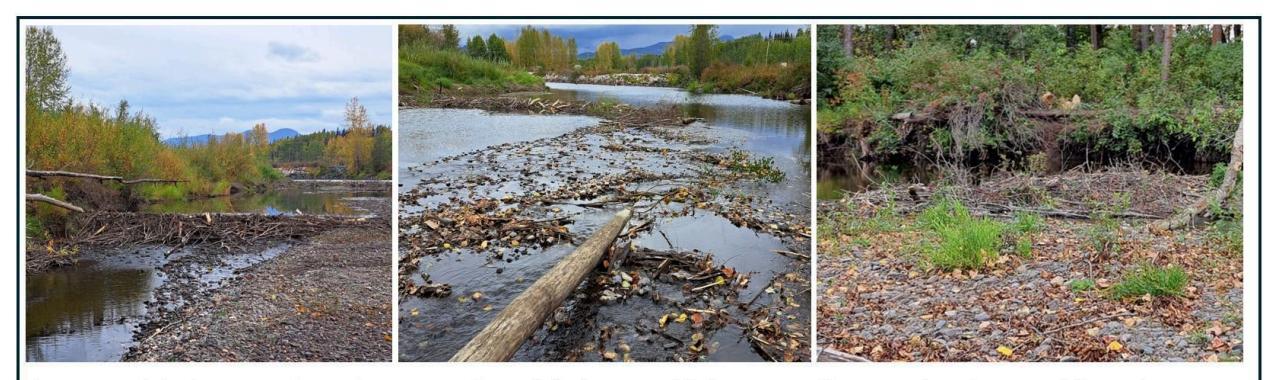
Impassable beaver dam 4, a complex of 3 dams which generally remained passable as long as we kept the middle section free of debris as shown in the middle photo.

IBD4 was already present in the summer. It is made up of two dams on river left and right. It was somewhat passable in the middle but we removed some debris that had accumulated.

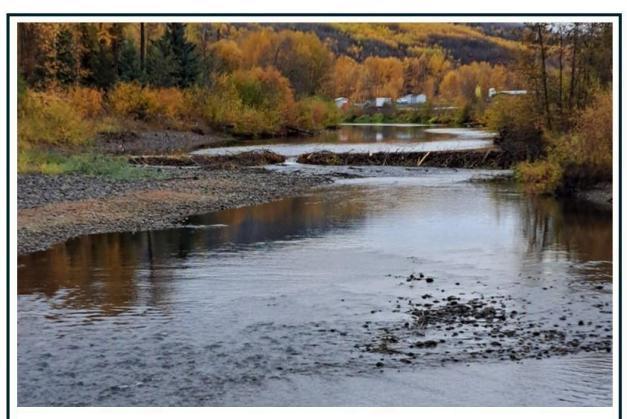
Impassable beaver dam 5, one of the largest dams, notched in the photo.

IBD5, a very large beaver dam, was located near Westland Helicopters.

We notched IBD5 and observed one sockeye in the beaver pond upstream. Helicopter pilot Dylan de la Mere informed us he had seen a large number of coho swim through IBD5 after we left.

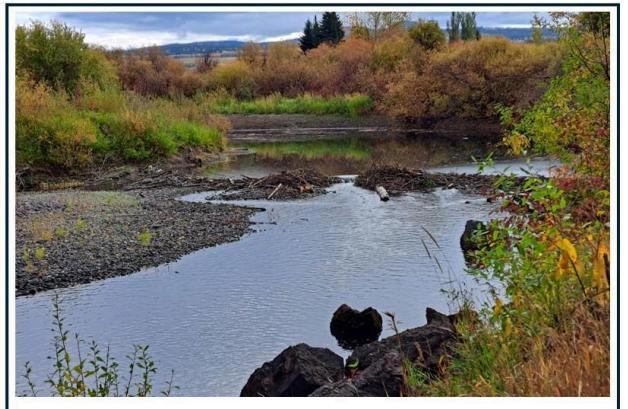
Impassable beaver dam 6, notched. Repeated notching evidenced by the mounds on either side.

IBD6 below the East Highway 16 bridge leaving Houston has been in place for several years. We observed coho holding below the dam and after notching we watched about 20 coho swim through.

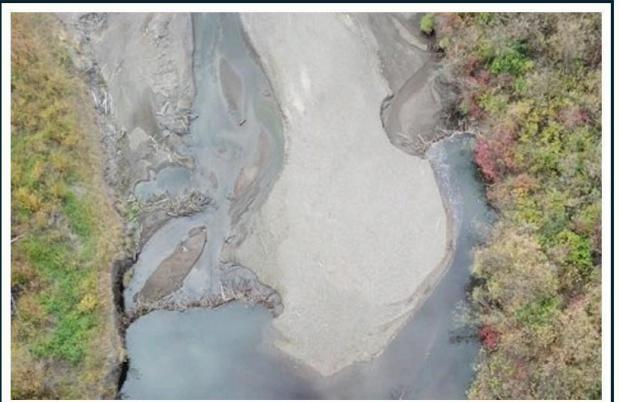
Impassable beaver dam 7. Drone photo showing the dams on each channel.

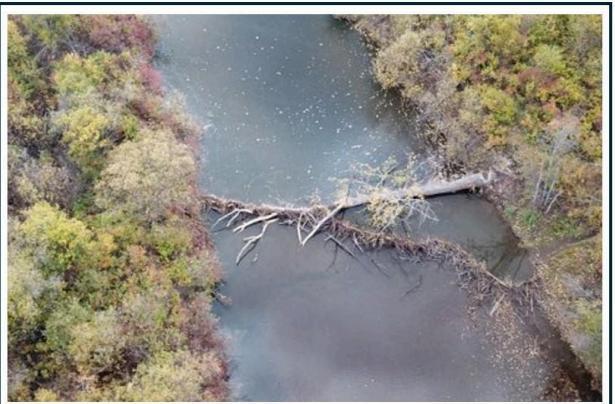
Impassable beaver dam 8, interestingly constructed around a felled tree.

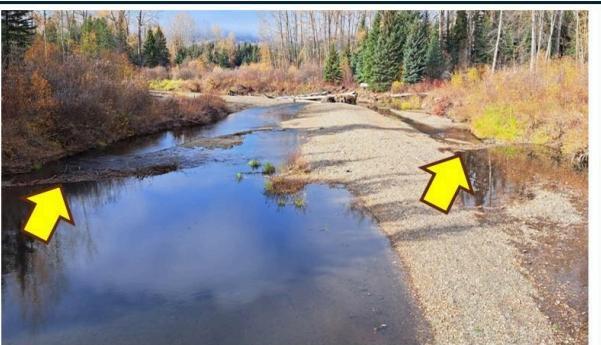
Impassable beaver dam 16 view from <u>Knockholt</u> Bridge, open in middle, arrows point to dams.

Rainfall on October 17th and 18th (4.6 and 3 mm) resulted in IBDs 15, 16 and 17 being blown out on the side. At IBD15 a few coho swam past the dam in the side channel when we were there.

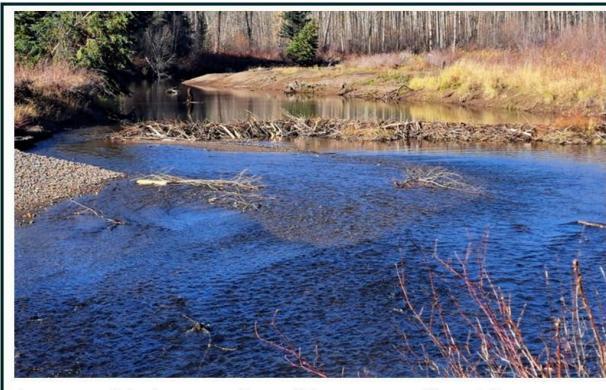
Impassable beaver dam 17, open on the side.

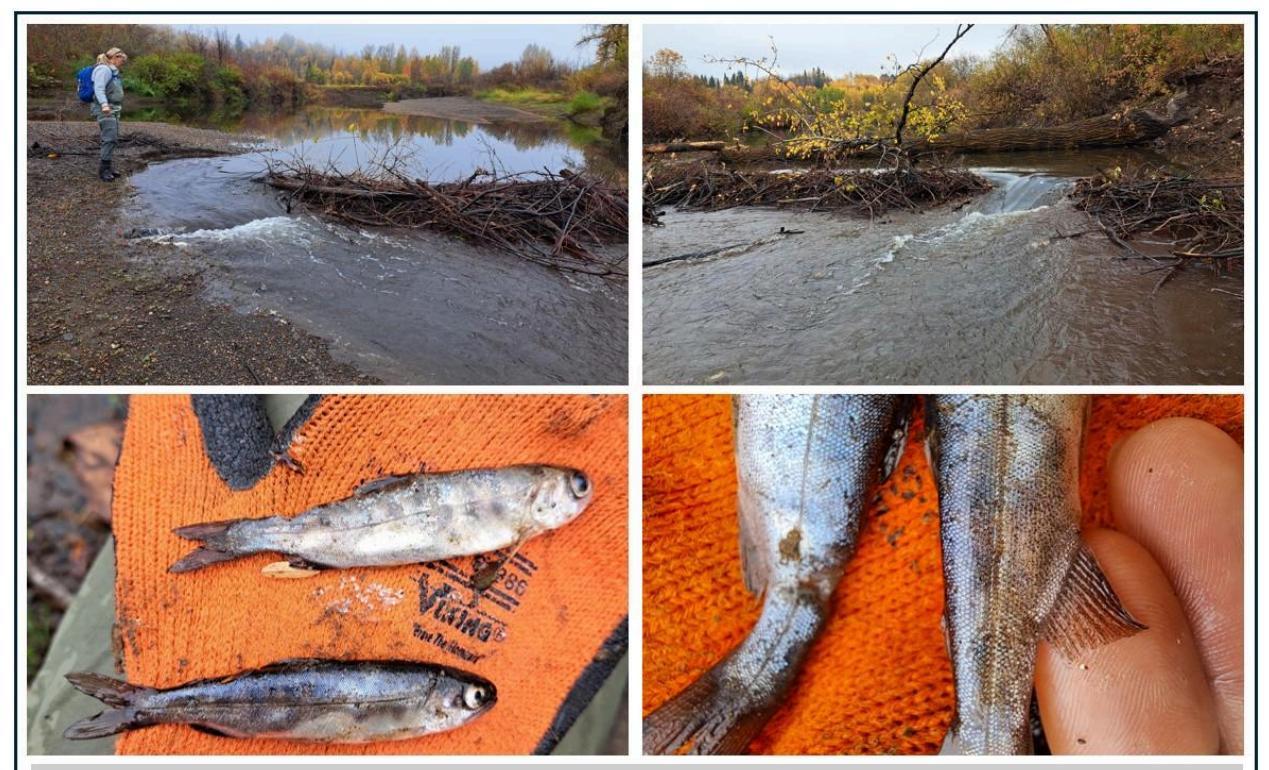
Oct 2: IBD7 opened on the side (top left). IBD8 notched (top right) which eventually broke away a bit more than pictured. Two dead chinook hatchery smolts were found below IBD8 before notching (bottom photos).

When we arrived at IBD8 there were two dead chinook hatchery smolts just below the dam. These would have been released by Toboggan Creek Hatchery in Spring 2023. We then notched IBD8, but the notch was too large with too much of the base removed, and the resulting water flow was higher than ideal. We walked upstream to IBD9 and along the way observed some small sucker fish stranded from the water level decrease. We were able to move most of them back into the river. This was the only occurrence of a "notch failure" that we experienced, but highlights the importance of caution in this process.

We then notched both IBD9 and IBD10. On the return walk we observed about 10 coho upstream of IBD8.

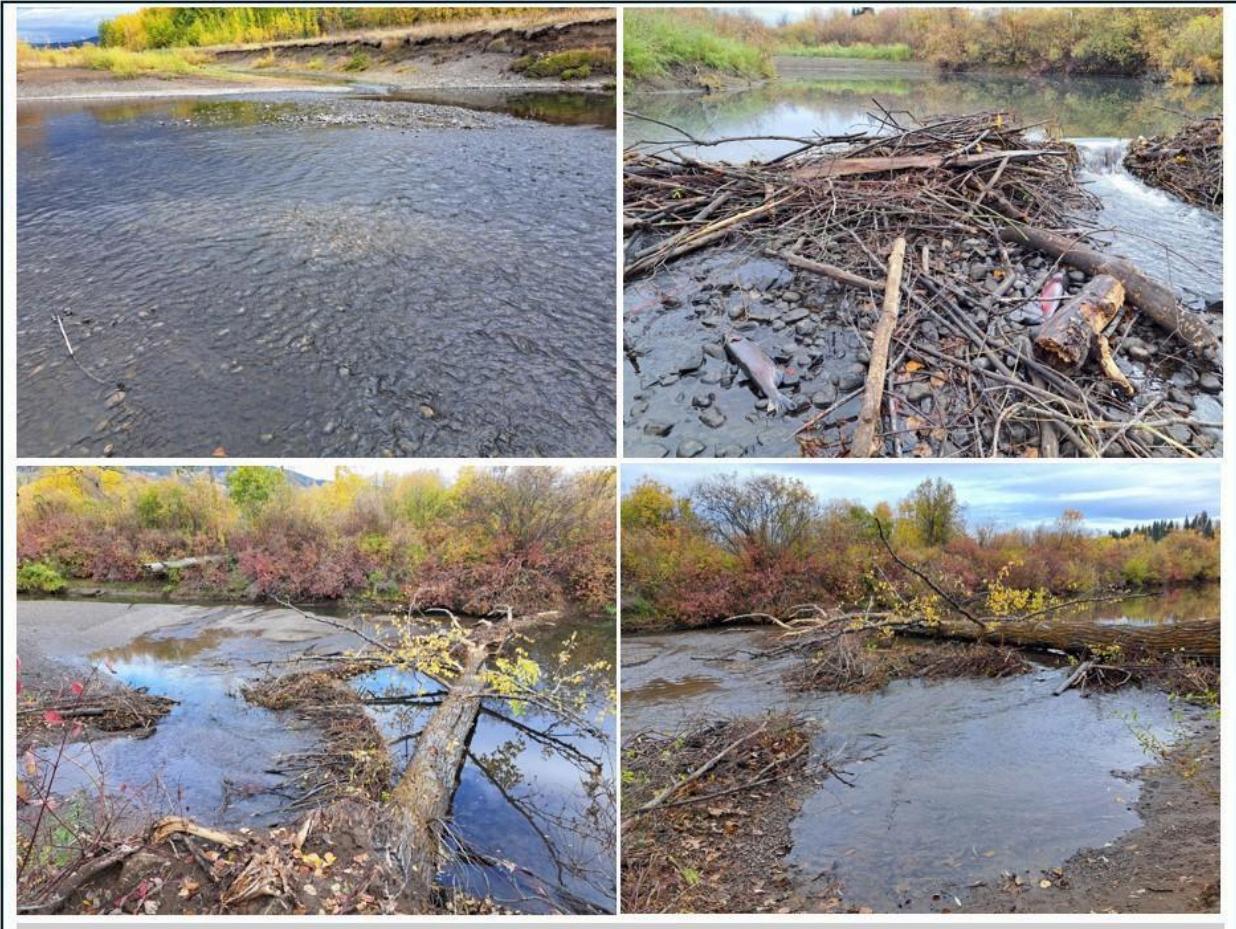
Oct 3: Coho redd downstream of IBD5 (top left). Dead coho female and male below IBD6 (top right), dam renotched after finding the dead spawners. IBD8 had been <u>closed up</u> with a new section of dam and we created a new notch (bottom images).

IBD6 was notched again. A dead prespawn female coho and dead male were found on the rocks just below the dam.

IBD7 was still flowing on the side. At IBD8 the beavers had created a new arm of the dam due to the damage caused on October 2. We opened a notch in this new section and the notch remained stable.

We revisited IBD5 and made a notch on the far side of the dam on river right since there were 8 coho spawning above the riffle downstream. There were about 30 holding just downstream of the dam. Another 50 were holding farther downstream along with 1 sockeye, and 6 coho spawning.

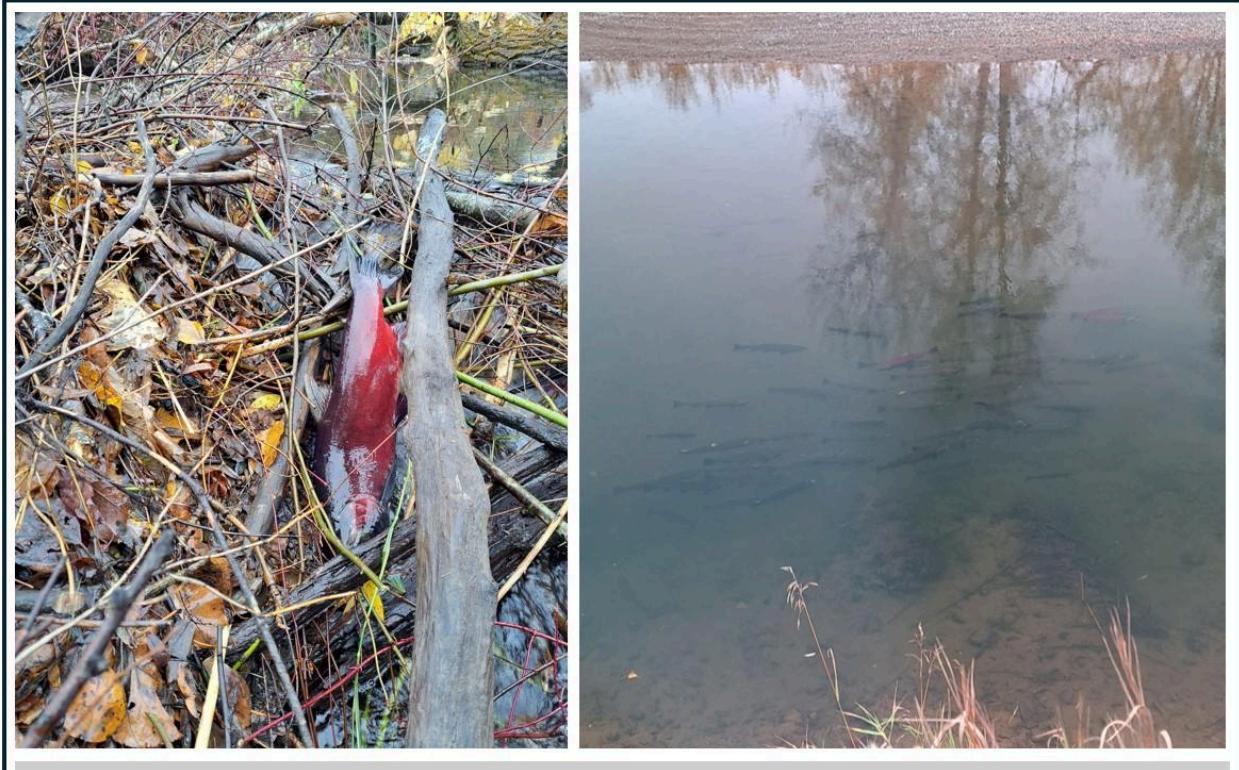
Oct 5: Dead male coho on IBD8, and approximately 100 coho holding below IBD9

There were about 100 coho in the pool downstream of IBD9, which had been closed by beavers. We notched the dam, then walked upstream to IBD10 and notched it again. While returning to IBD9 we did not observe any coho but upon reaching IBD9 there were coho migrating through that notch. We counted 283 in the course of an hour, and 11 more were swimming up to it when we left.

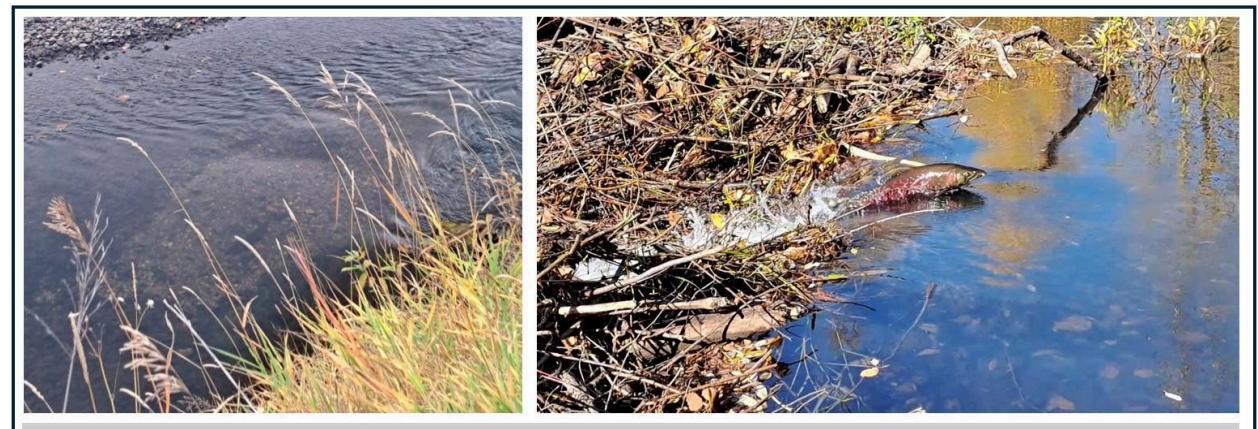
Oct 6: Coho spawner on redd downstream of IBD12 (left) and coho spawner jumping through our notch in IBD14 (right).

At IBD14 there were a large number of coho holding below the dam, which had been closed by the beavers. As we approached a coho jumped from the plunge pool we had created and made it overtop of the dam. Another tried but fell back down. While we reopened the notch there were coho swimming into our legs in the plunge pool. We counted 200 coho swimming through the notch in the course of an hour. There were still about 50 coming upstream as we left.

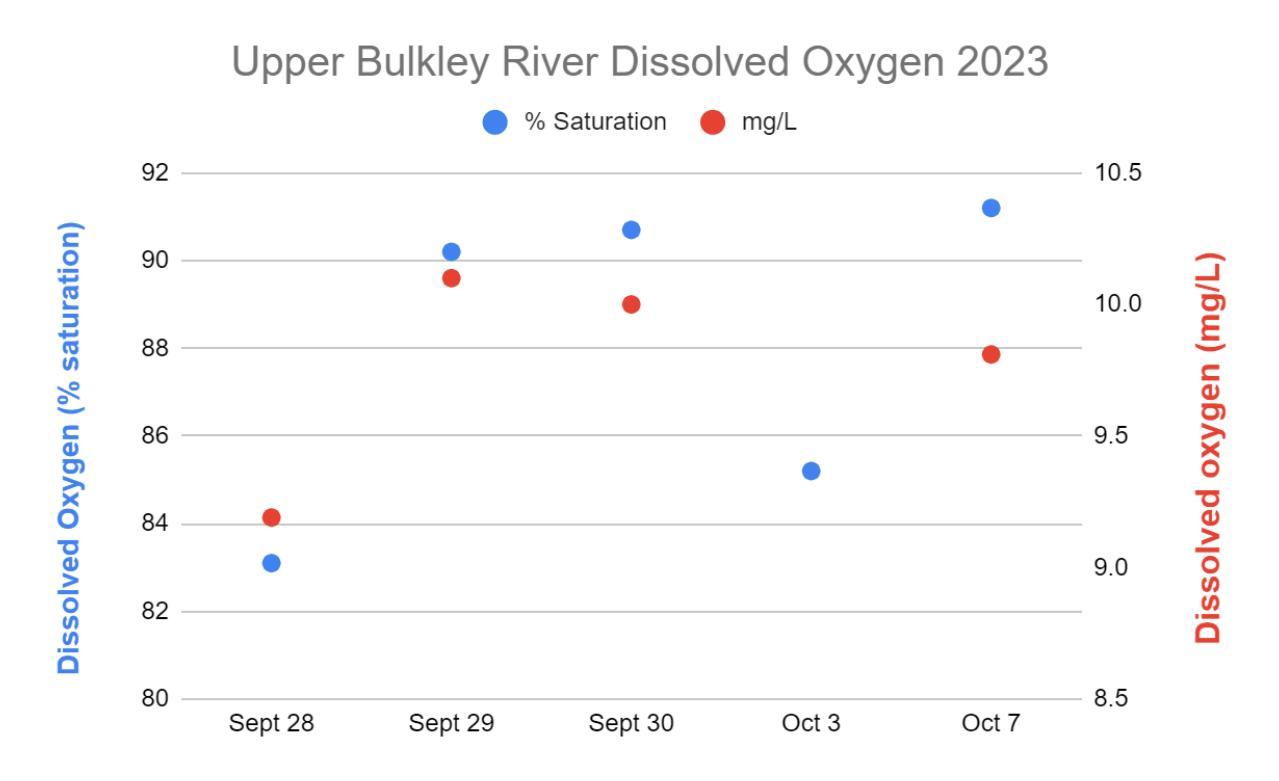
Dissolved oxygen measurements taken in the Upper Bulkley River at the holding tank location for coho broodstock in 2023.

Dissolved oxygen measurements were taken in the Upper Bulkley River at the broodstock holding tank location, in a slow-moving pool. Battery-powered aerators were required to maintain satisfactory oxygen levels inside the broodstock holding tanks. The chart below shows the measurements taken in the river outside the tanks.
