Alvin Creek - 197379 - Appendix

Site Location

PSCIS crossing 197379 is located on Alvin Creek 28km south-west of Houston, BC at approximately km 29.8 on the Morice-Owen Forest Service Road (FSR), approximately 0.2km upstream from the confluence with the Owen River. The stream is known locally as Alvin Creek, draining Alvin Lake however the naming convention is not documented for either the stream or the lake within the freshwater atlas of BC. This memo was previously titled "Tributary to Owen Creek - 197379".

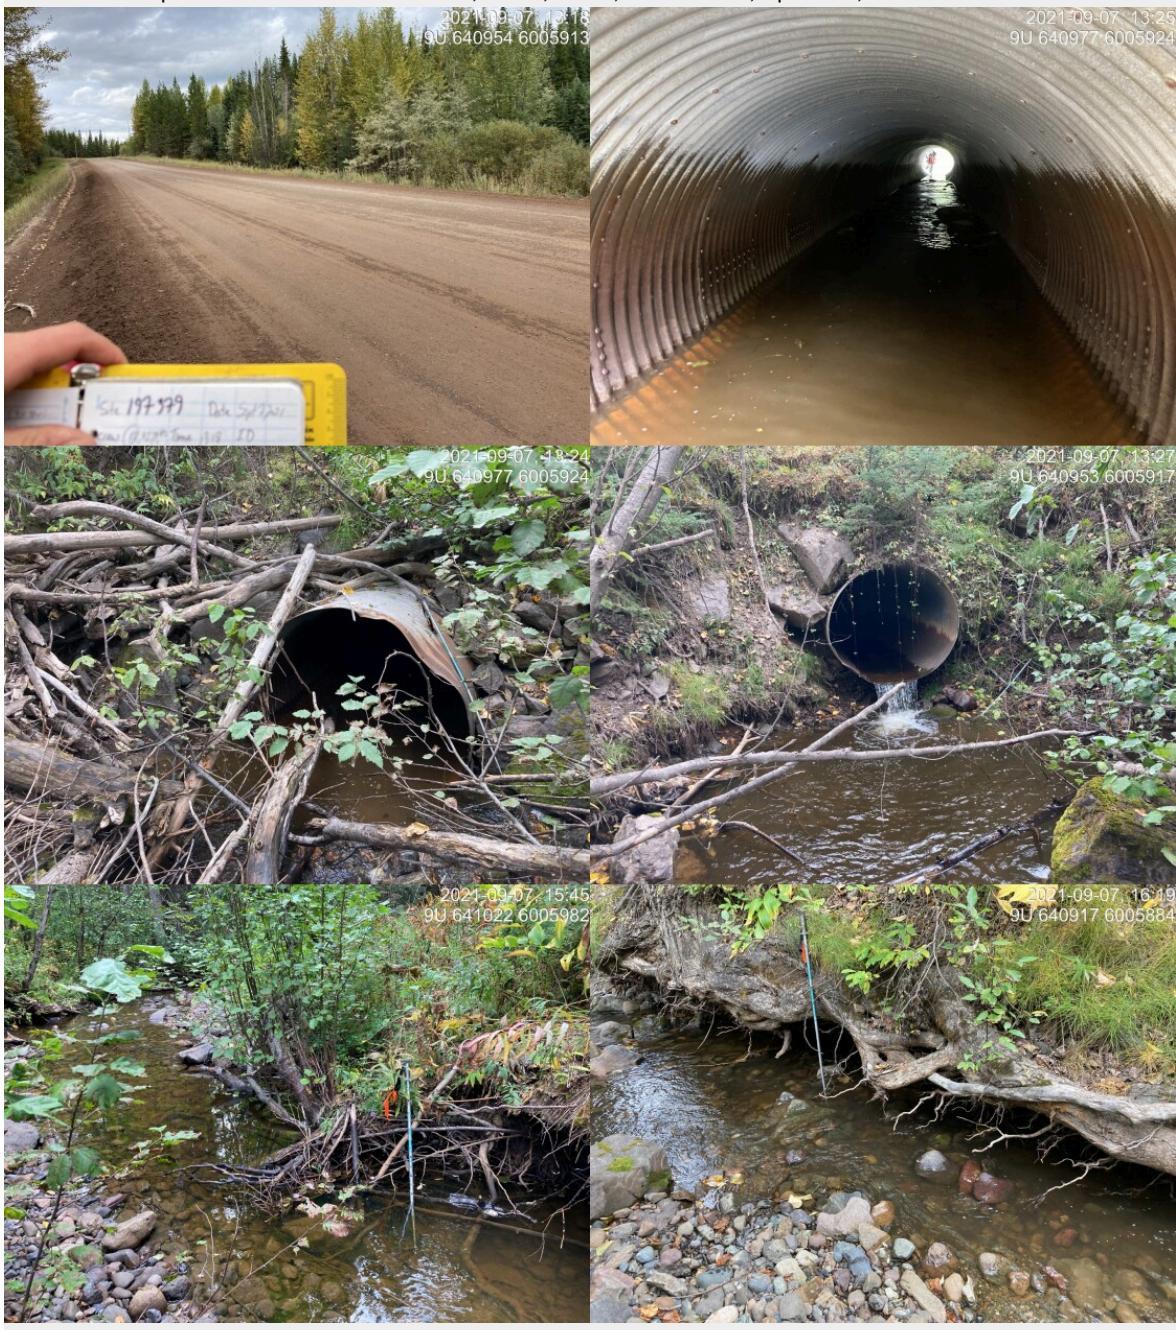
Comments: Two thirds of culvert on upstream side has baffles. Fish sampling and PIT tagging conducted. Design underway by MoF. 13:18

Photos: From top left clockwise: Road/Site Card, Barrel, Outlet, Downstream, Upstream, Inlet.

Should restoration/maintenance activities proceed, replacement of PSCIS crossing 197379 with a bridge (19m span) is recommended. The cost of the work was estimated by Mark Dewit (Ministry of Forest Area Engineer) at \$800,000 for a cost benefit of 1 linear m/\$1000 and 3.4 m²/\$1000 with the relatively high costs of the work predicted primarily related to the large amount of road fill present at the site, the large width of the two lane FSR and the subsequent significant excavation required to install the large replacement structure.

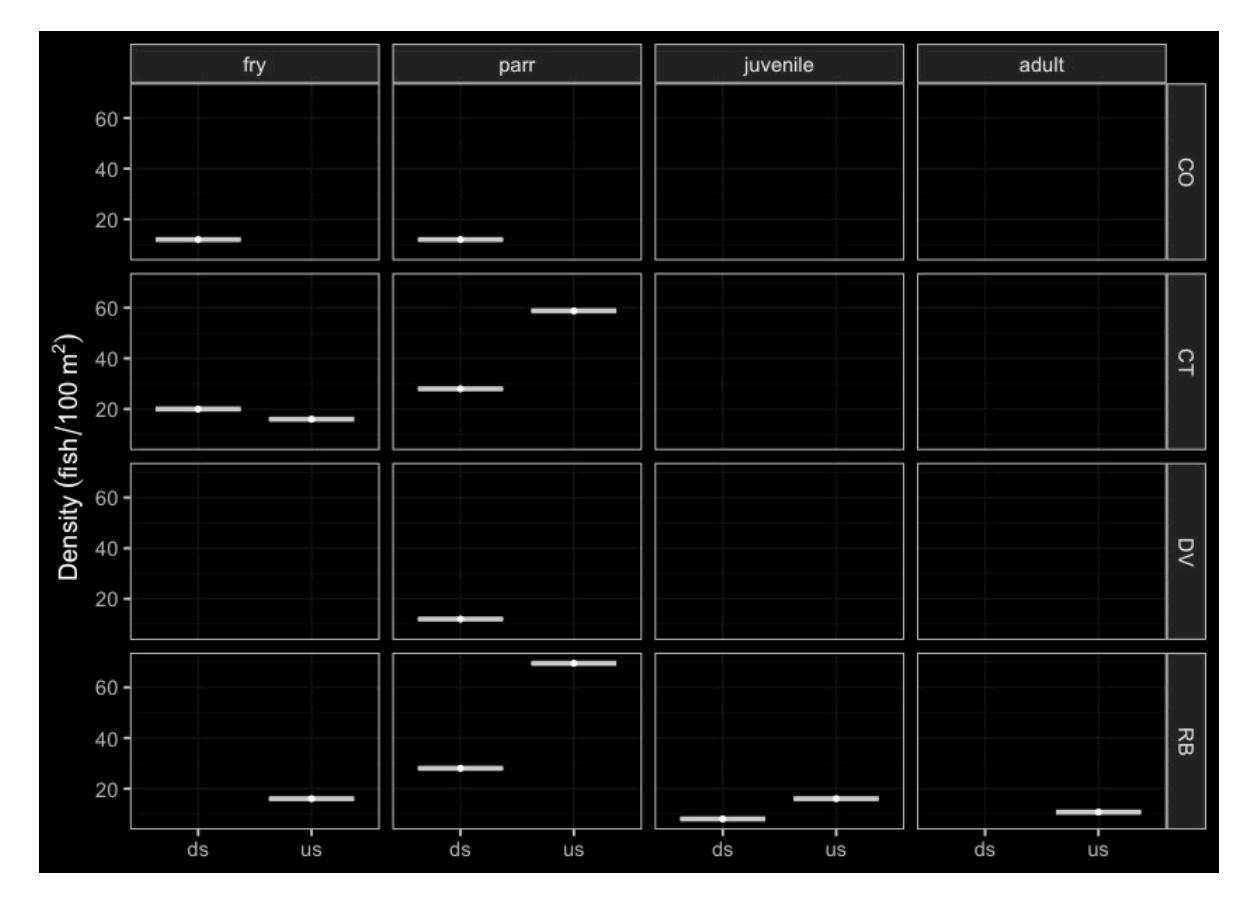
Figure 5.1: Densites of fish (fish/100m2) captured upstream of PSCIS crossing 197379.

Electrofishing results from sampling conducted in 2022 is summarised in Tables <u>5.5</u> - <u>5.6</u> and Figure <u>5.1</u>. A total of 35 fish were captured upstream and 30 fish were captured downstream (Figure <u>5.5</u>). Although coho, dolly varden, rainbow trout and cutthrout trout (rainbow and cutthrout were potentially hybrd rainbow/cutthrout) parr (likely 1 year old fish) were captured downstream of the crossing, only rainbow trout and cutthrout trout were captured upstream. As noted, the stream was mostly dry at the time of electrofishing, with fish concentrated in pools. All fish over 60mm that were captured were tagged with Passive Integrated Transponders (PIT tags) with data stored <u>here</u>.

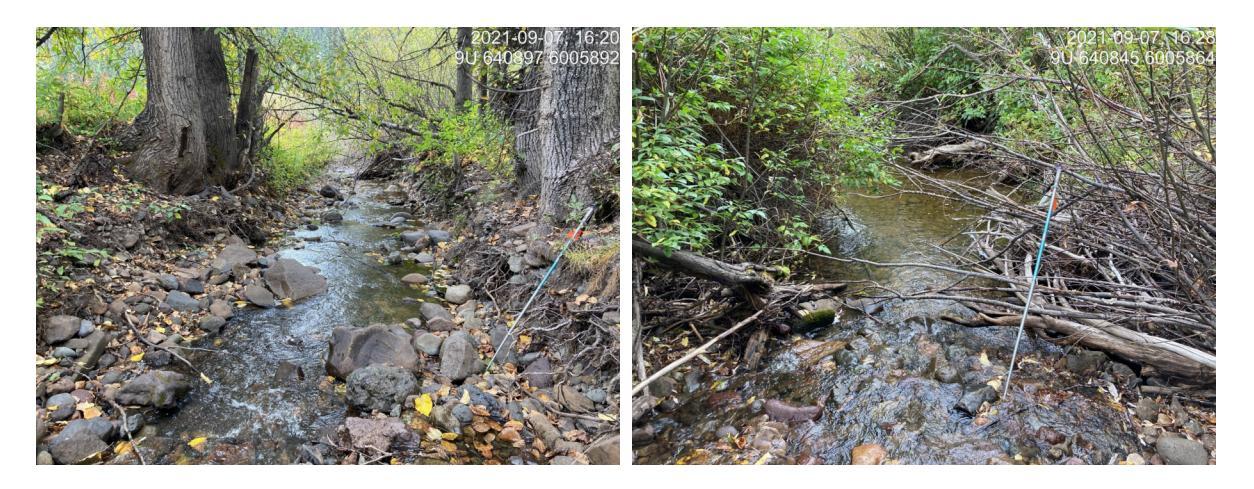
The stream was surveyed downstream from crossing 197379 for 190m (Figure <u>5.2</u>). The dominant substrate was cobbles with gravels sub-dominant. The average channel width was 4.3m, the average wetted width was 2.6m, and the average gradient was 3.3%. Total cover amount was rated as moderate with overhanging vegetation dominant. Cover was also present as small woody debris and undercut banks. The stream had signs of high flow due to eroded banks. Habitat below the culvert was rated as medium value with likely important rearing areas for coho and steelhead rearing during high flow events in the Owen Creek mainstem.

Figure 5.2: Left: Typical habitat downstream of PSCIS crossing 197379. Right: Typical habitat downstream of PSCIS crossing 197379.

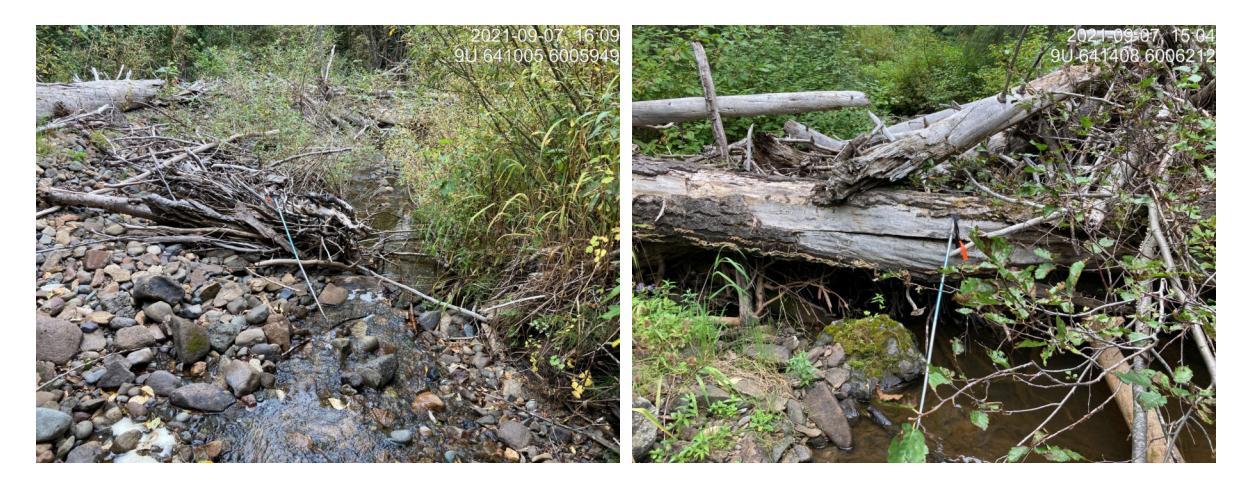
The stream was surveyed for 800m in a downstream direction to the culvert from the location of an approximately 8m high waterfall (Figure <u>5.3</u>). The average channel width was 6.4m, the average wetted width was 3.1m, and the average gradient was 4.8%. The dominant substrate was cobbles with gravels sub-dominant. Total cover amount was rated as moderate with undercut banks dominant. Cover was also present as small woody debris, large woody debris, deep pools, and overhanging vegetation. Near the falls, bedrock dominated the stream substrate and the gradient was noted as 7%. The mixed decidous and coniferous forest riparian was noted as healthy. Pockets of gravel suitable for coho, steelhead and resident rainbow trout/cutthrout trout were observed. Overall, the habitat upstream of the FSR was rated as high value, containing habitat suitable for rearing and spawning of both anadromous as well as resident fish species. Of note, when the site was revisited in 2022 the stream was primarily dewatered with numerous fish concentrated within isolated pools.

Figure 5.3: Left: Typical habitat upstream of PSCIS crossing 197379. Right: Large woody debris jam upstream of PSCIS crossing 197379.

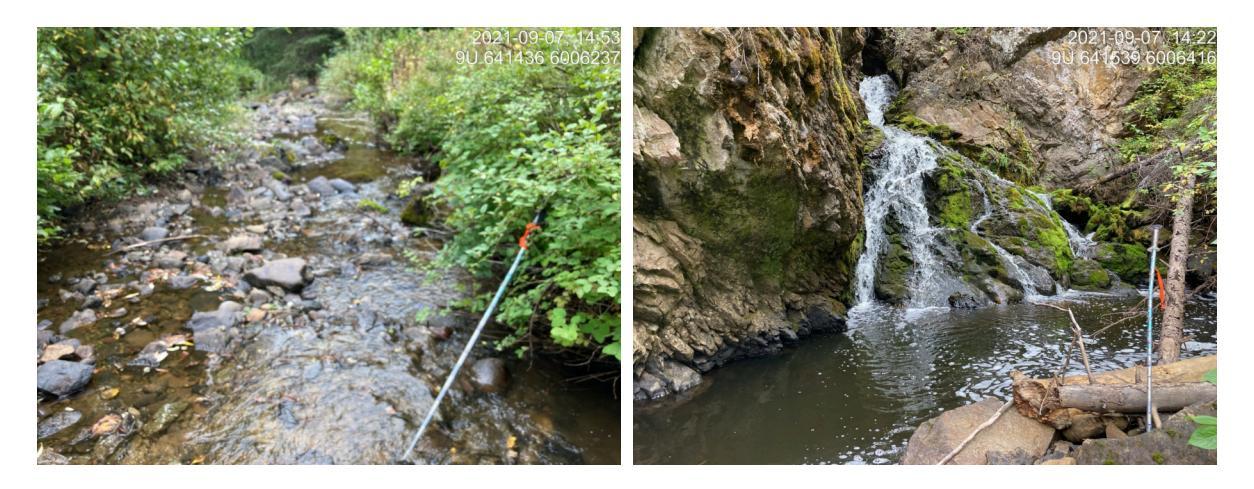
Figure 5.4: Left: Typical habitat upstream of PSCIS crossing 197379. Right: Waterfall upstream of PSCIS crossing 197379.

There was 0.8km of habitat upstream of the culvert between the Morice-Owen FSR and the 8m high waterfall with habitat rated in 2022 as high value for coho, steelhead and resident rainbow/cuthrout rearing and spawning. Crossing 197379 was ranked as a high priority for proceeding to design for

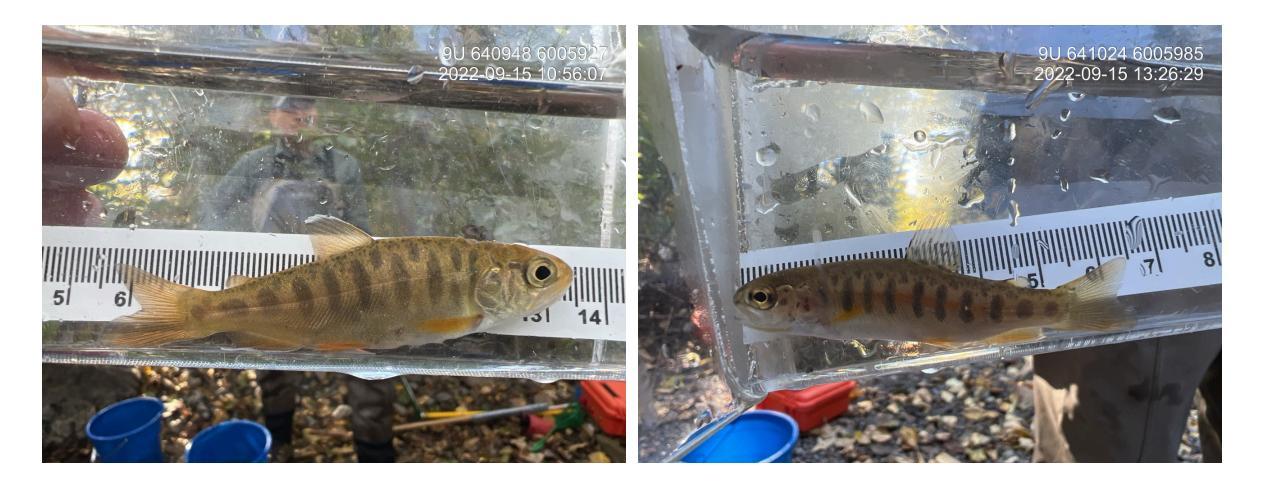
Figure 5.5: Left: Coho captured downstream of PSCIS crossing 197379. Right: Cutthroat trout captured upstream of PSCIS crossing 197379.
