# JUVENILE COHO POPULATION ESTIMATES IN THE TELKWA RIVER PONDS MAY 1994

DAVID BUSTARD AND ASSOCIATES

DEPARTMENT OF FISHERIES AND OCEANS RESOURCE RESTORATION SECTION SALMONID ENHANCEMENT PROGRAM

May 1994

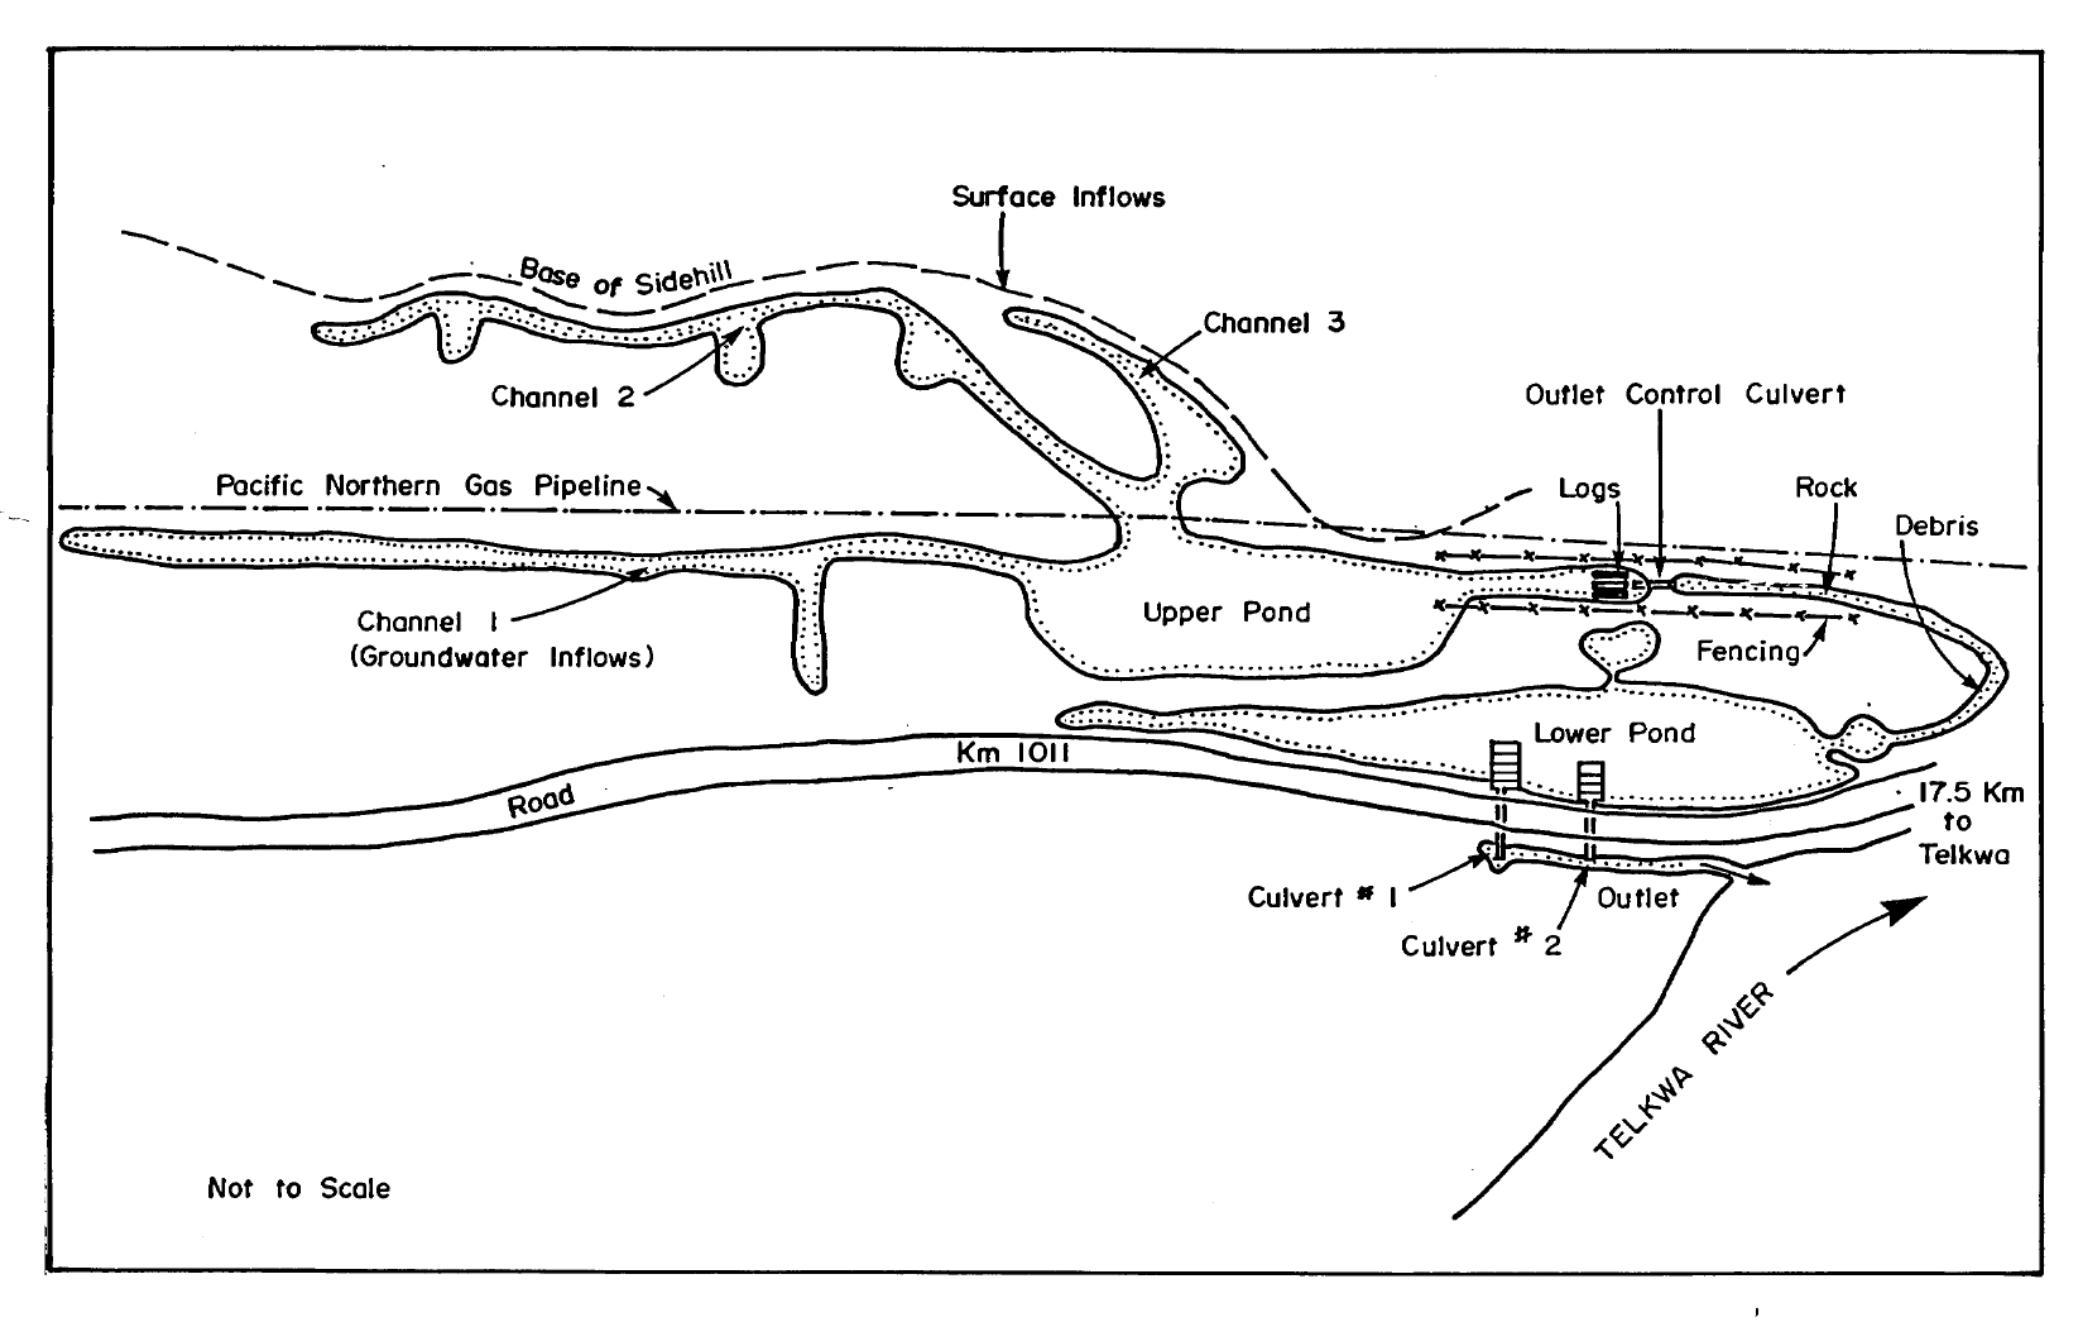
Figure 1. Approximate Configuration of Ponds at Km 11 on Telkwa River Forest Road, May 1994

Mark-and-recapture estimates were conducted in the Telkwa ponds during mid-May (May 17 to May 22, 1994) just prior to the main period of smolt outmigration. The ponds were separated into seven sections (Figure 1) and 64 minnow traps baited with roe were set overnight throughout the ponds during the initial marking period as delineated in Table 1. The same number of traps were used for the recapture three days later.

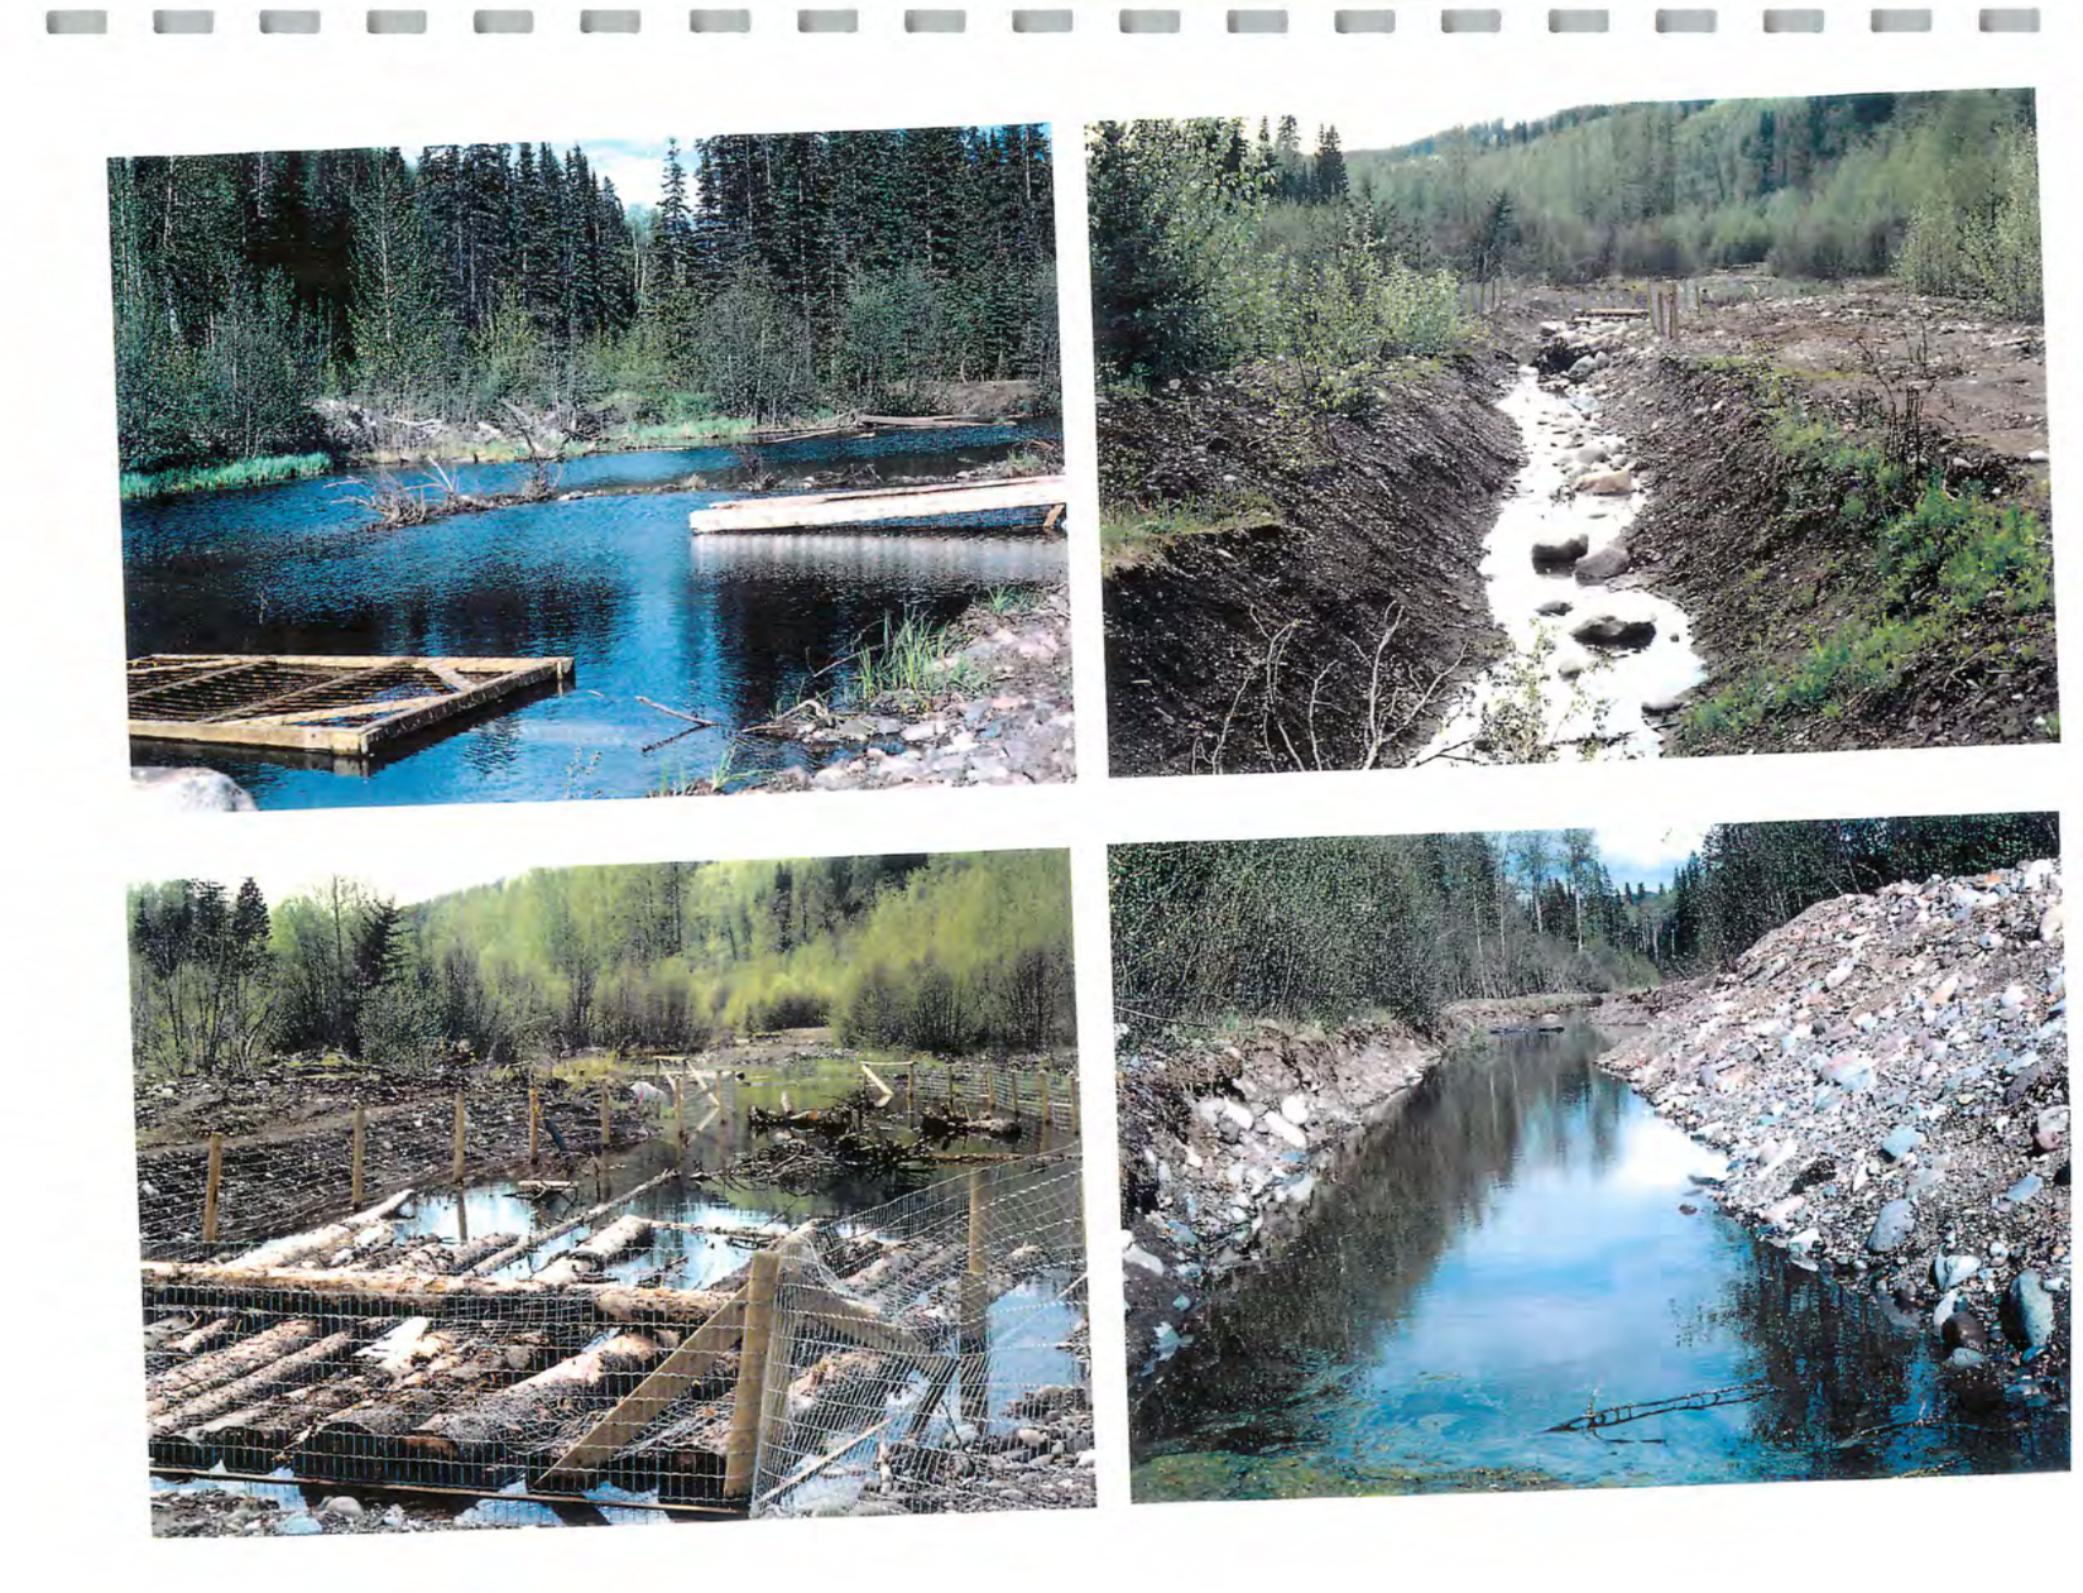
#### (PHOTOS ON FOLLOWING PAGE)

#### Photo 1 (top left)

Lower pond showing caged culvert inlet structures.

### Photo 2 (top right)

Connecting channel between upper and lower pond - rock cover.

### Photo 3 (lower left)

Logs and fencing at outlet to upper pond.

### Photo 4 (lower right)

Channel 1 collects groundwater and feeds into pond complex.

The "caged box inlet" in conjunction with a wire cage on the outlet of a submerged culvert appeared to provide an effective means of providing juvenile fish access into the Telkwa ponds. Similarly, no dams were constructed at the outlet of the upper pond where fencing and a log debris placement were located at the outlet control culvert. Beavers continue to use the ponds and were observed during the surveys.

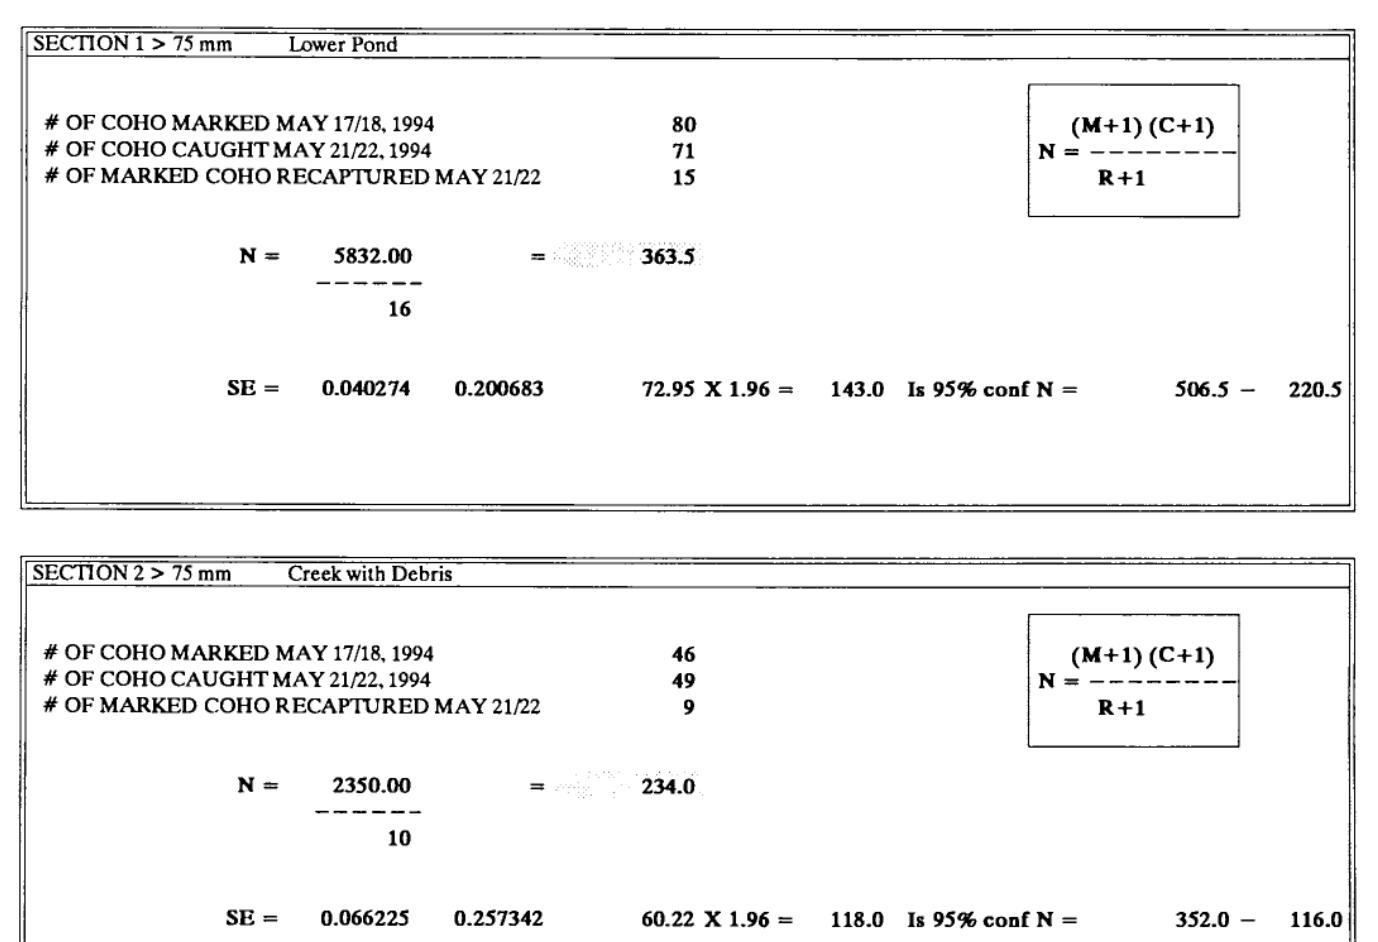
## **TELKWA PONDS POPULATION ESTIMATES - SECTIONS 1 AND 2**

Population estimates were conducted using the Chapman modification of the Petersen formula (Chapman 1951) and the 95% confidence intervals were calculated using the standard error of the estimate (Robson and Regier 1971). The estimates were separated by pond section and by coho less than or larger than 75 mm fork length. Visual observations suggested that many of the coho larger than this size were probably going to smolt in the near future.

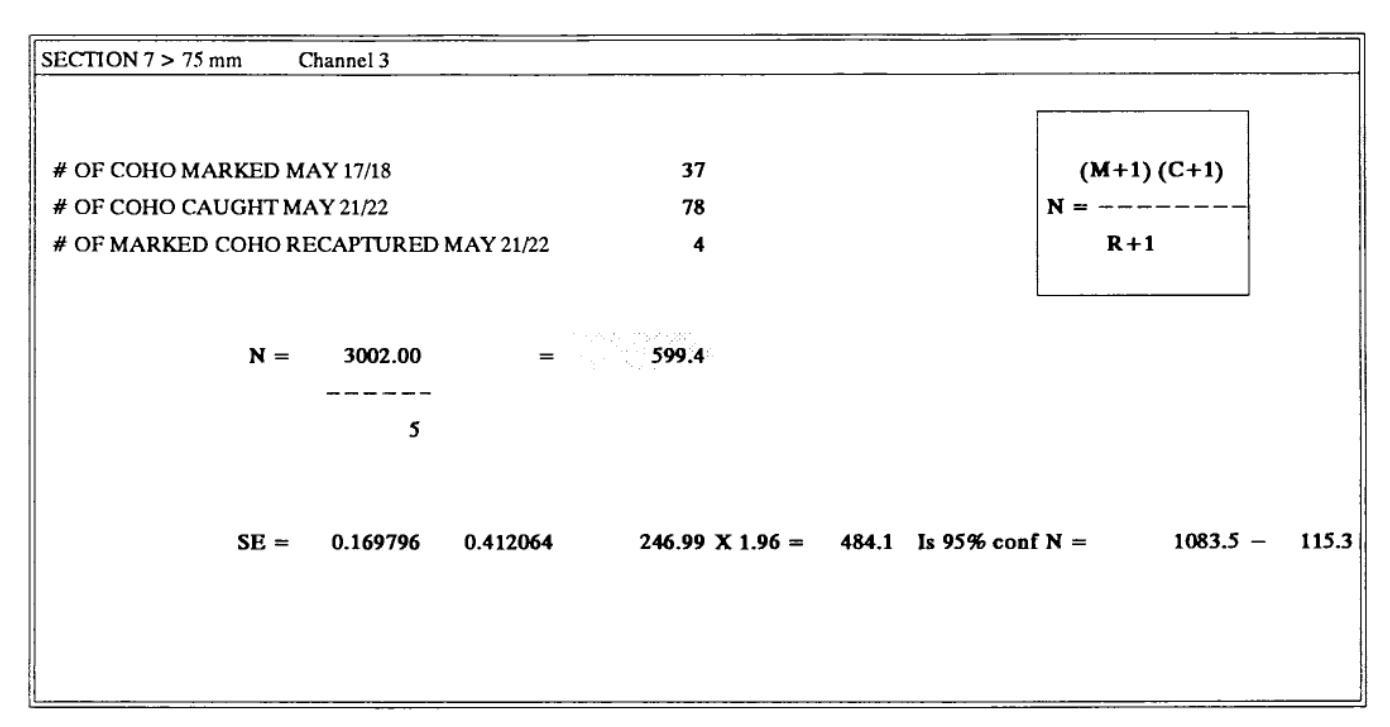
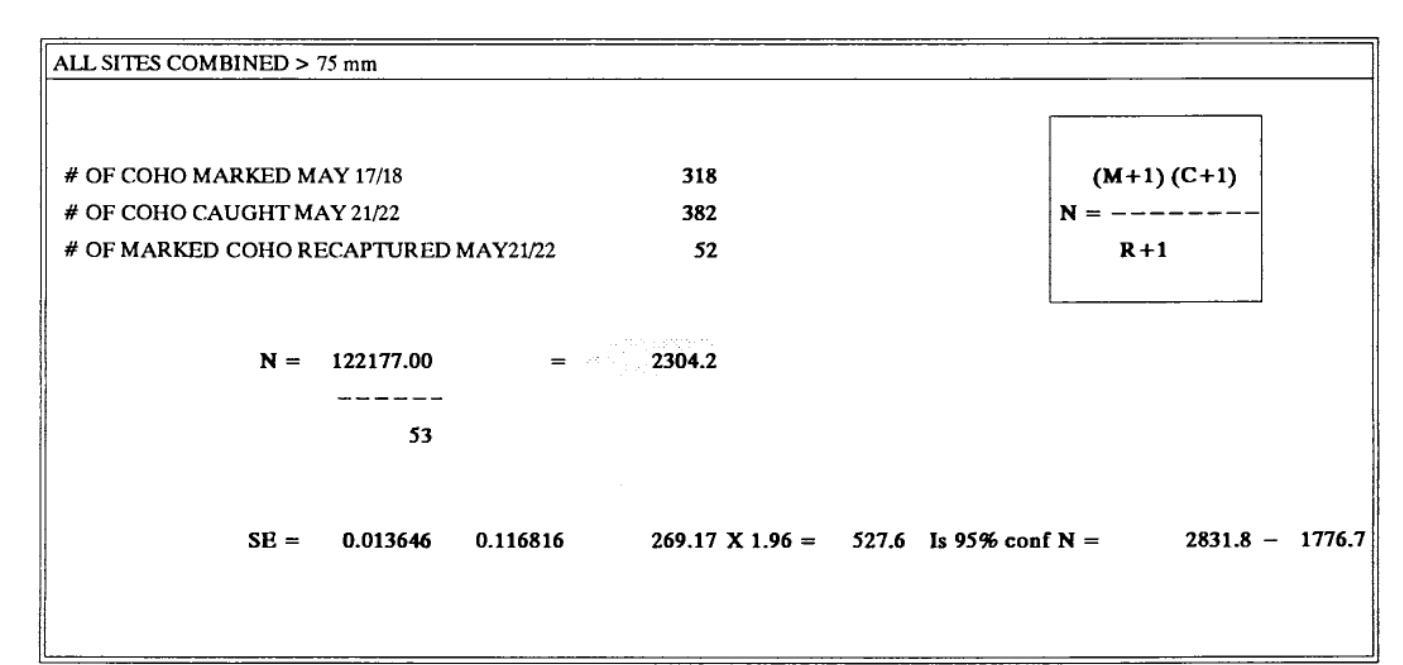
## TELKWA PONDS POPULATION ESTIMATES - SECTION 7 AND COMBINED

TELKWA POND P	OPULAT	ON EST	IMATES - ALL	SITES COMB	NED < 75 m	m
ALL SITES COMBINED < 7	/5 mm					
						7
# OF COHO MARKED MA	<b>AY</b> 11/12		22		(M+1) (C+1)	
# OF COHO CAUGHT MA	Y 15/16		43		N =	-
# OF MARKED COHO RE	CAPTURED	MAY 15/16	2		R+1	
-						
N =	1012.00	=	336.3			
	3					:
SE =	0.290659	0.539128	181.33 X 1.96 =	355.4 Is 95% con	f N = 691.7	v —

Table 4 summarizes the results of the population estimates by section and size. The total population estimate for all coho in all sections was 2640 fish (95% confidence intervals of 2042-3238). Of this, 2304 (87.3%) were 75 mm or larger coho and it is assumed many of these fish will be leaving the ponds as smolts within the next month. This compares with a total estimated coho population in the ponds in 1993 of 1186 fish including 222 smolts (Bustard 1993).
