# Watershed Assessment of the Kitseguekla Community Watershed.

# (Kispiox Forest District)

Skeena Cellulose Inc, Carnaby Division.

January 2001

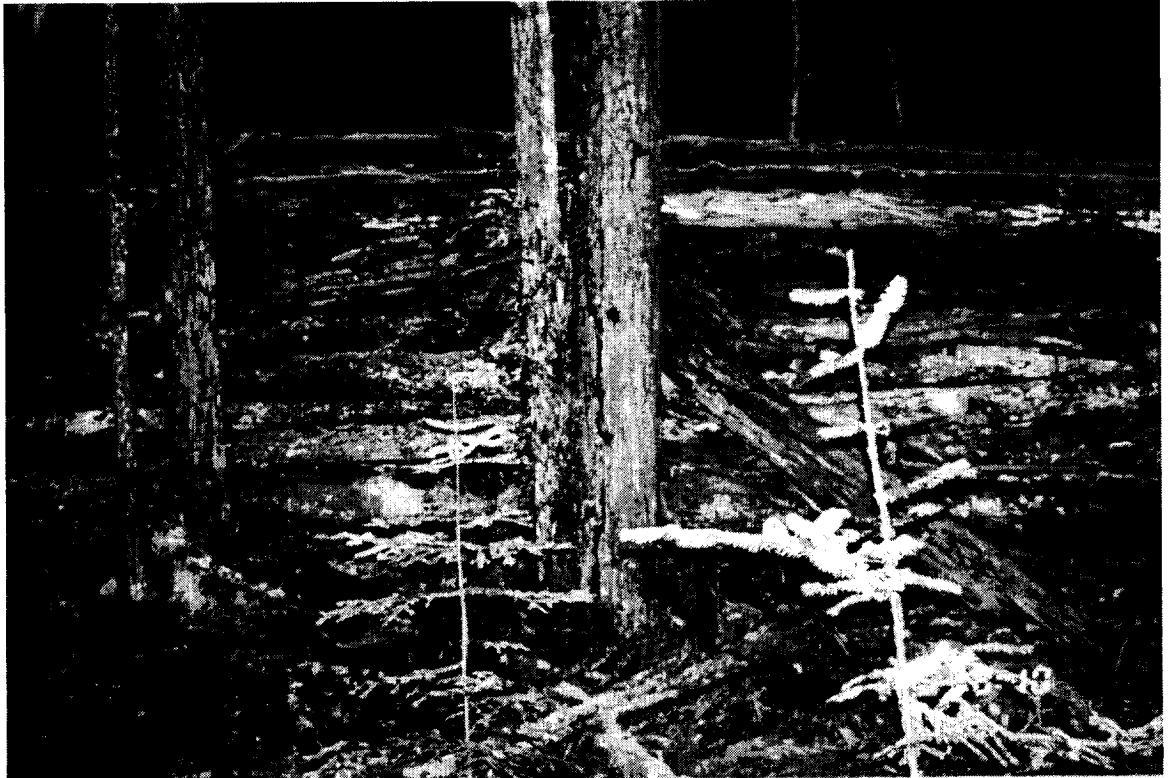
The main road in this unit is the Andimaul extension. This grade was built in the 1970s to access timber in the area but was not used at that time. The road traverses approximately half of terrain unit 2 with a slight favorable grade. The grade is located on steep ground (20 to 70%) below a major slope break. The method of construction for the road was side-cast. The side-cast material is partially retained by right of way wood that was not taken to the mill (see photo 1, below). Stream, gully and NCD crossings have not been deactivated and do not have adequate drainage structures but minimal erosion has occurred to this point.

Photo 1: The Andimaul Extension. Major portions of the road are constructed with sidecast material behind the right of way wood. This is the section with the tallest right of way wood and side-cast that was field checked and represents the "worst case example".

northern portion of Terrain Unit 3 and a corridor along the lower reaches of Kits Creek. 7) Deactivate the existing roads.

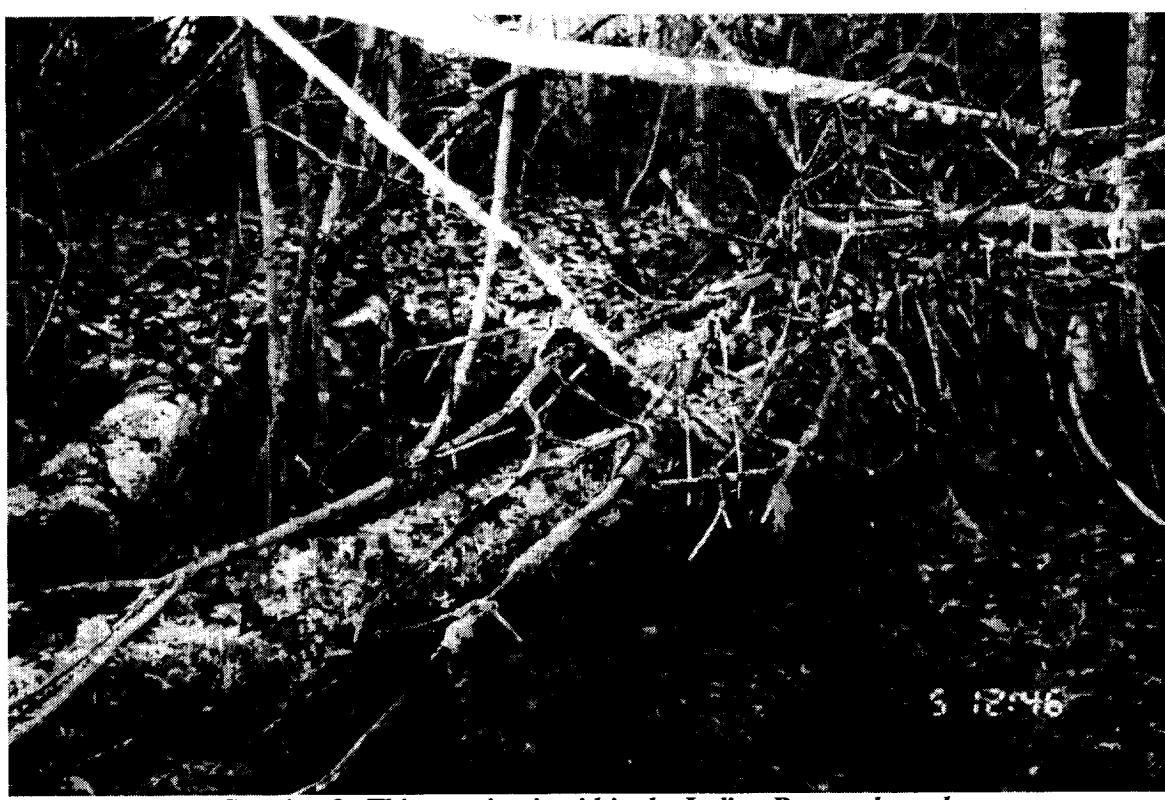
This unit has been extensively harvested and has a remnant road network that does not appear to have been deactivated to any extent. One section of road was field checked. This road begins near the beaver dam in the northeast of the unit and traverses in a southwest direction to a stream crossing (crossing 2, map1, photo 3, below) at Kits creek. This crossing is found within the Indian Reserve boundary and is a log stringer / earth fill type that has not been deactivated. This site is not currently eroding stringers and sill logs are decayed. A failure of this crossing has the potential to generate a significant volume of fine-grained sediment and could redirect the channel. The road grade east of this crossing is eroding, has not been deactivated and is intercepting streamflow from several small tributaries and diverting it to the beaver dam. The beaver dam is then diverting a portion of its discharge from the Kits creek watershed and into the adjacent (eastern) watershed.

Photo 3: Stream Crossing 2. This crossing is within the Indian Reserve boundary.

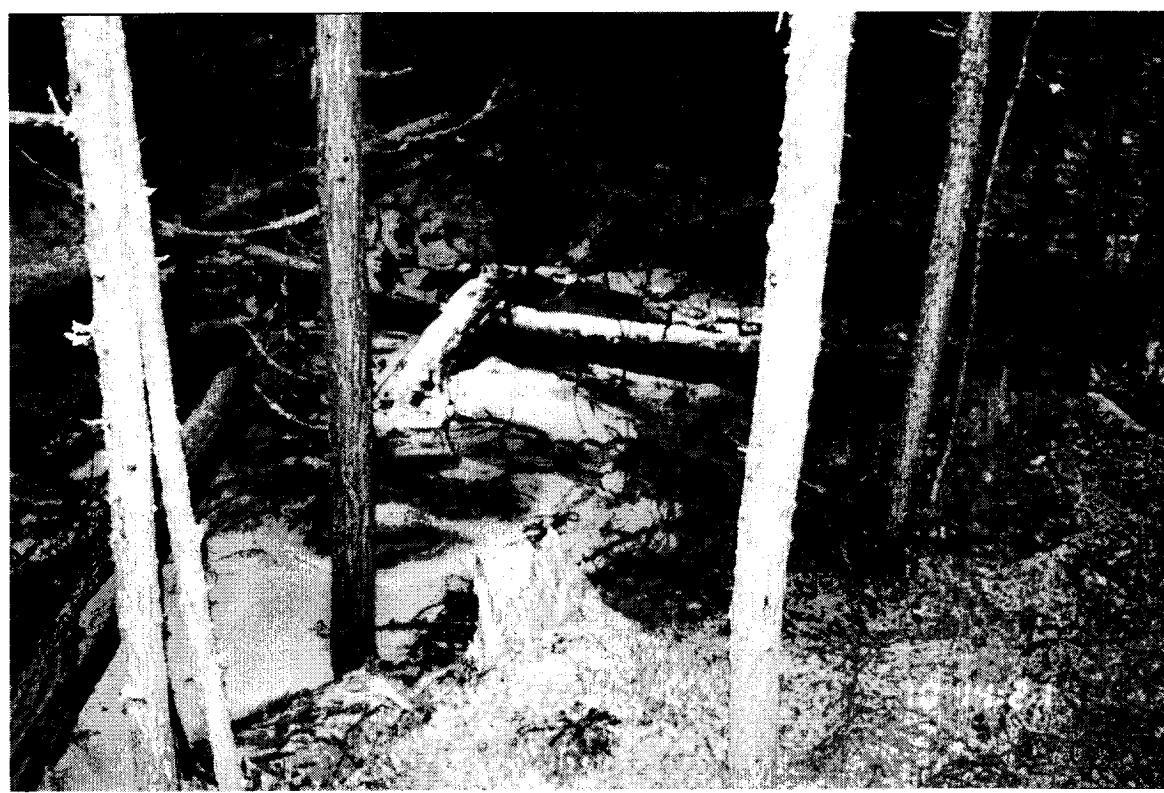
Terrain unit 1 is the headwater of the watershed. Stream network density in this unit is the highest of the three units. The general pattern of the network is dendritic but broken, hummocky surfaces and bedrock control have resulted in a somewhat disorganized array of tributaries and dis-tributaries. Channel morphologies found here are predominantly step-pool types for lower gradient reaches and cascade / step-pool for higher gradient reaches. The step - pool morphology of these lower gradient reaches is a result of the recruitment and incorporation of Large Woody Debris (LWD) from the riparian forest. The steps are formed when LWD backwaters the stream thus trapping sediment and organic material. Large volumes of fine-grained sediments are stored in these reaches (see photo 4, below). The north west corner of the unit has a levee (likely a debris flow levee that predates the current forest cover) that is directing stream flow to the east.

Photo 4: An example of the stream type found in terrain unit 1.

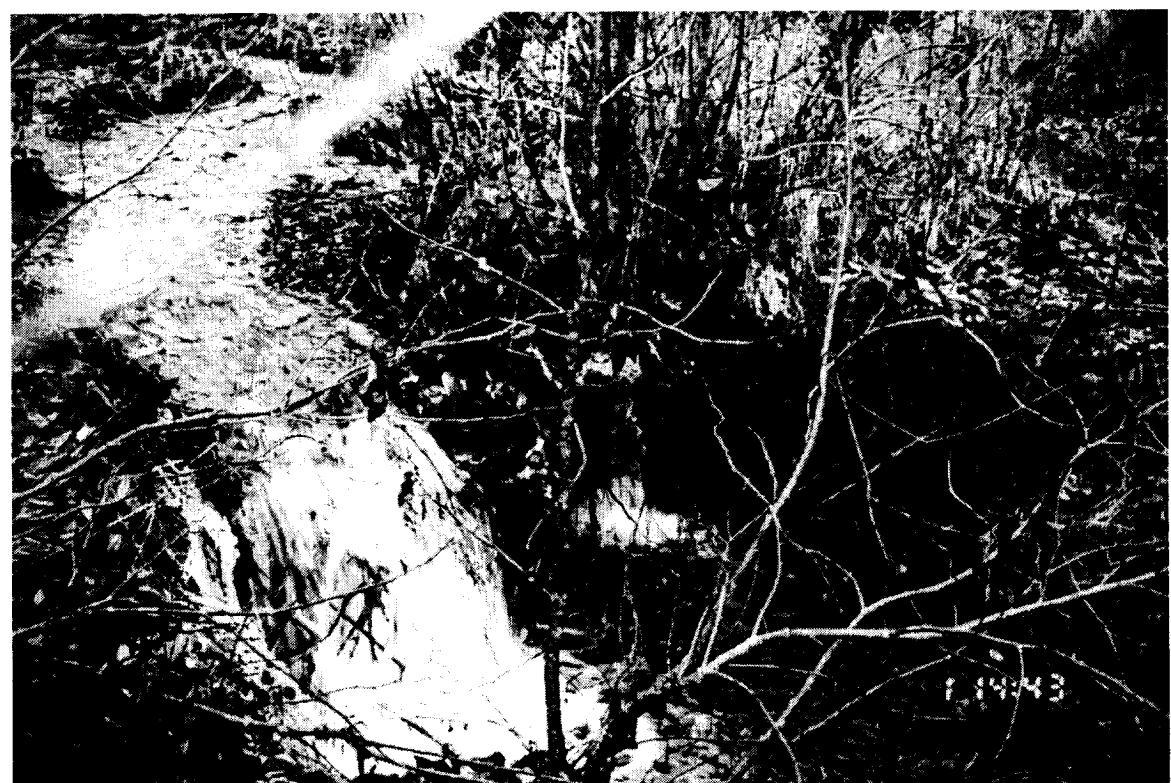
abandonment, channel straightening and minimal sediment storage capacity. Several actively eroding nick points (vertical steps on erodible substrate) occur in this unit (see photo 5). These nick points are a result of the lack of functional large woody debris and represent a serious vertical instability in the channel. Unless they are complexed and armored they will produce chronic and episodic inputs of fine sediment upstream of the water treatment plant intake.

Photo 5: Nick point on the lower reaches of Kits Creek within or adjacent to the Indian Reserve boundary.
