**Waterfall Creek Enhancement Project 2000
FsRBC Project #00-006-18**

Submitted to: the District of New Hazelton

Submitted by: Nortec Consulting

March 31, 2001

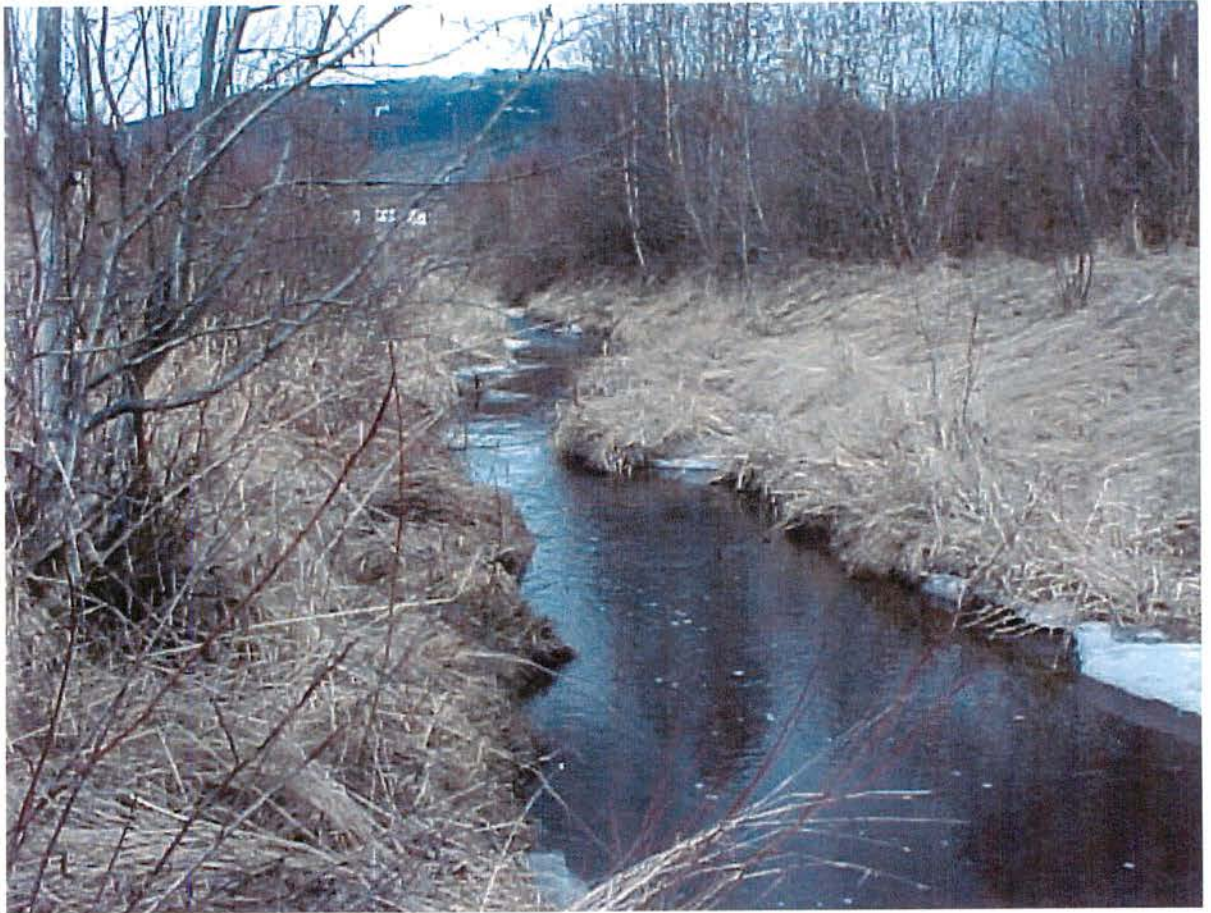
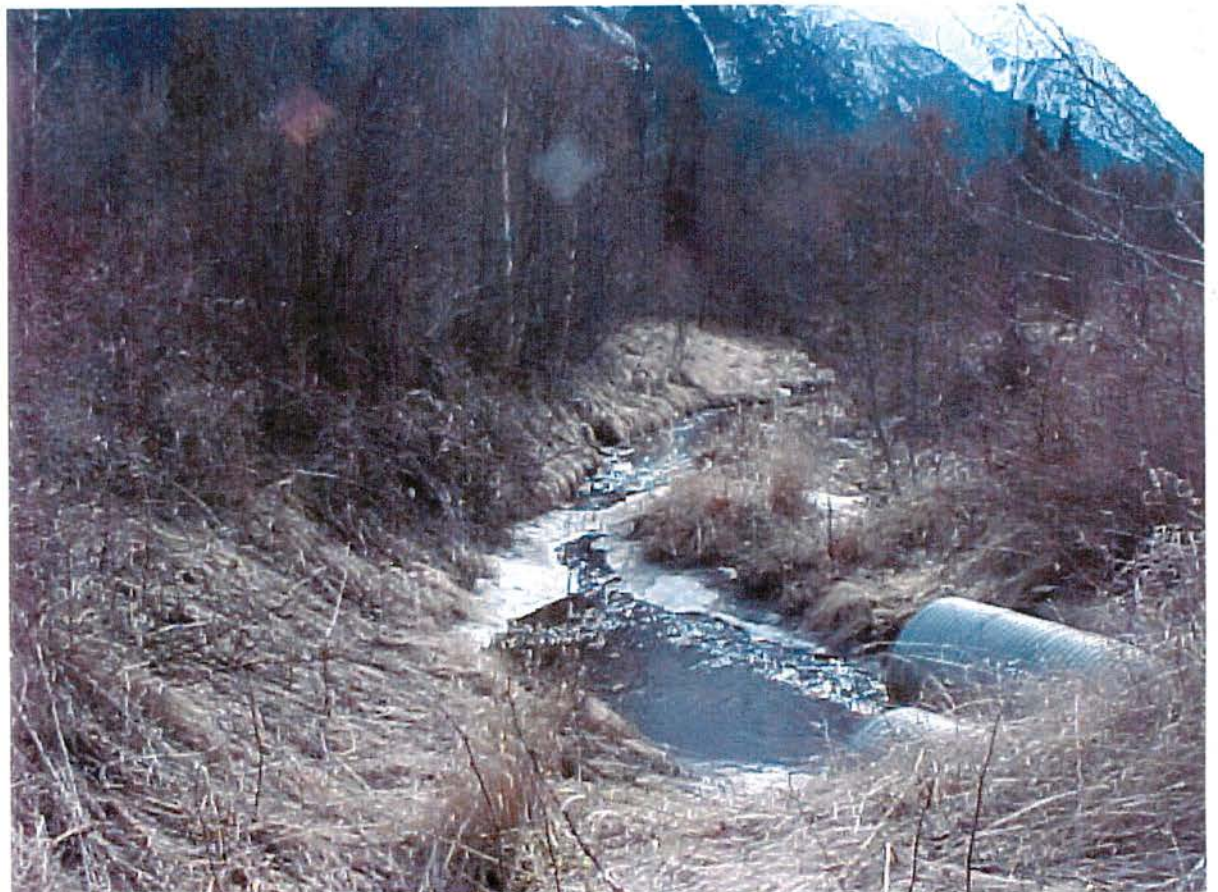
Photos
1 & 2

Site #1: Date of survey Dec. 4/00

- Length 262m, average channel width 3.5m, average wetted width 3m
- Ave. max. riffle depth 18cm, ave. max. pool depth 45cm
- Gradient <1%
- 40% pool, 5 % riffle, 55% flat, 0% side channel, 10% debris unstable
- Cover total 40%, composition - 30% pool, 20% instream veg, 20% overstream veg, 30% cutbank
- Crown closure 20%, South/West aspect
- Substrate: 75% fines, 8% small gravel, 9% large gravel, 5% small cobble, 5% large cobble, with moderate compaction.
- Bank height .3m, 90% unstable, channel is unconfined, texture fines & gravels, 0% bar presence
- Flow stage low, water temperature 0-1 degree celcius

- Fish observed, lack of habitat diversity, siltation and organics throughout

Above: Site 1 Viewed from downstream, near foot of Thirteenth Avenue, looking upstream.
Below: Site 1 Viewed from culverts under CN tracks at Twelfth Avenue, looking downstream.

- Site 1 will have boulder clusters and pool development downstream of twin culverts under the CNR tracks to provide resting area and over wintering pools. (*See Site Map 1 by Kingston & Assoc.*)
- Site 2 - Two culverts will be removed and replaced with new culverts with improved fish passage hydraulics and rock clusters, below the monitoring weir for water level control on culverts. (*See Site Map 2 by Kingston & Assoc.*)
- Site 3 (see Stream Details) two sets of twin culverts are proposed for removal to eliminate potential passage problems. (*See Site Map 3 by Kingston & Assoc.*)
- Site 4 - Rock clusters are proposed to be placed to ensure low flow water level control through CN culverts. (*See Site Map 4 by Kingston & Assoc.*)

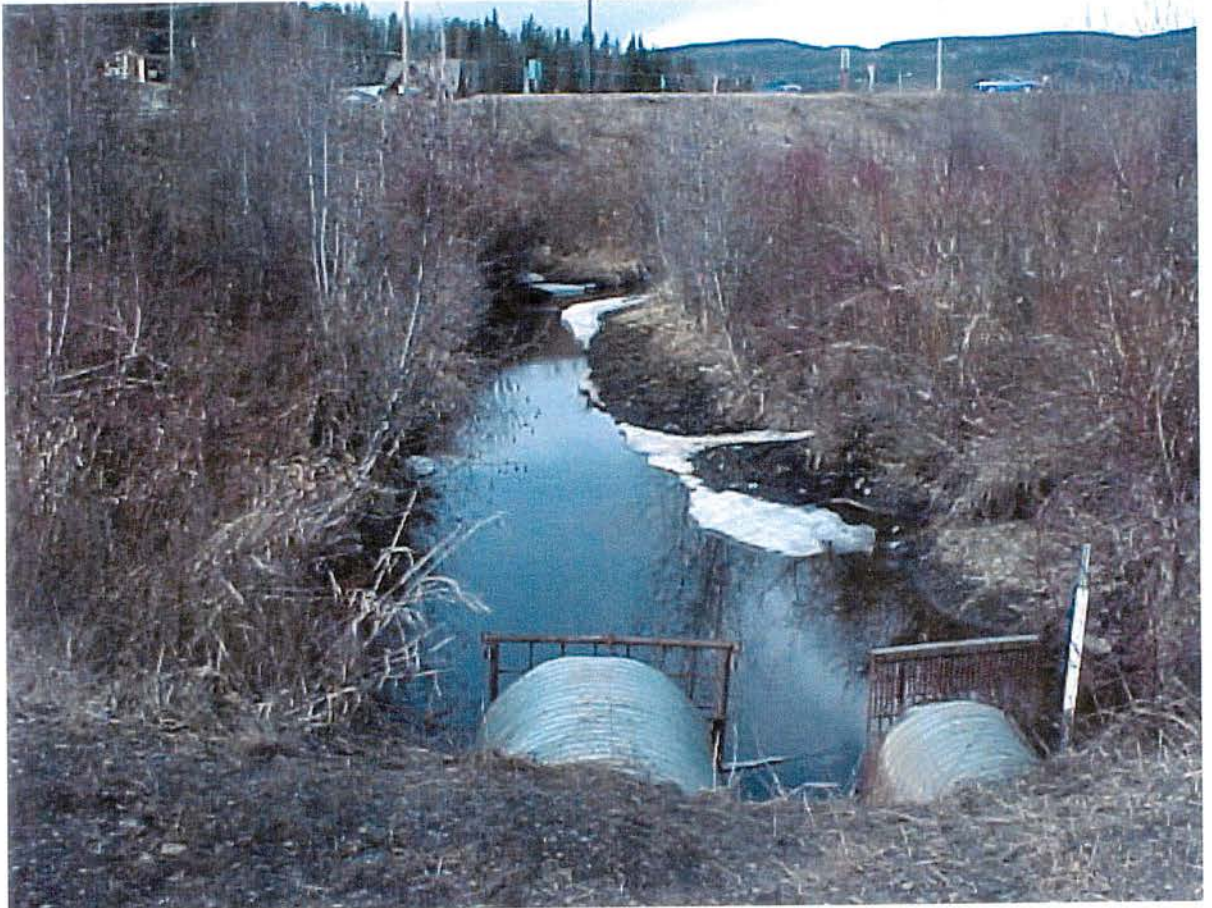
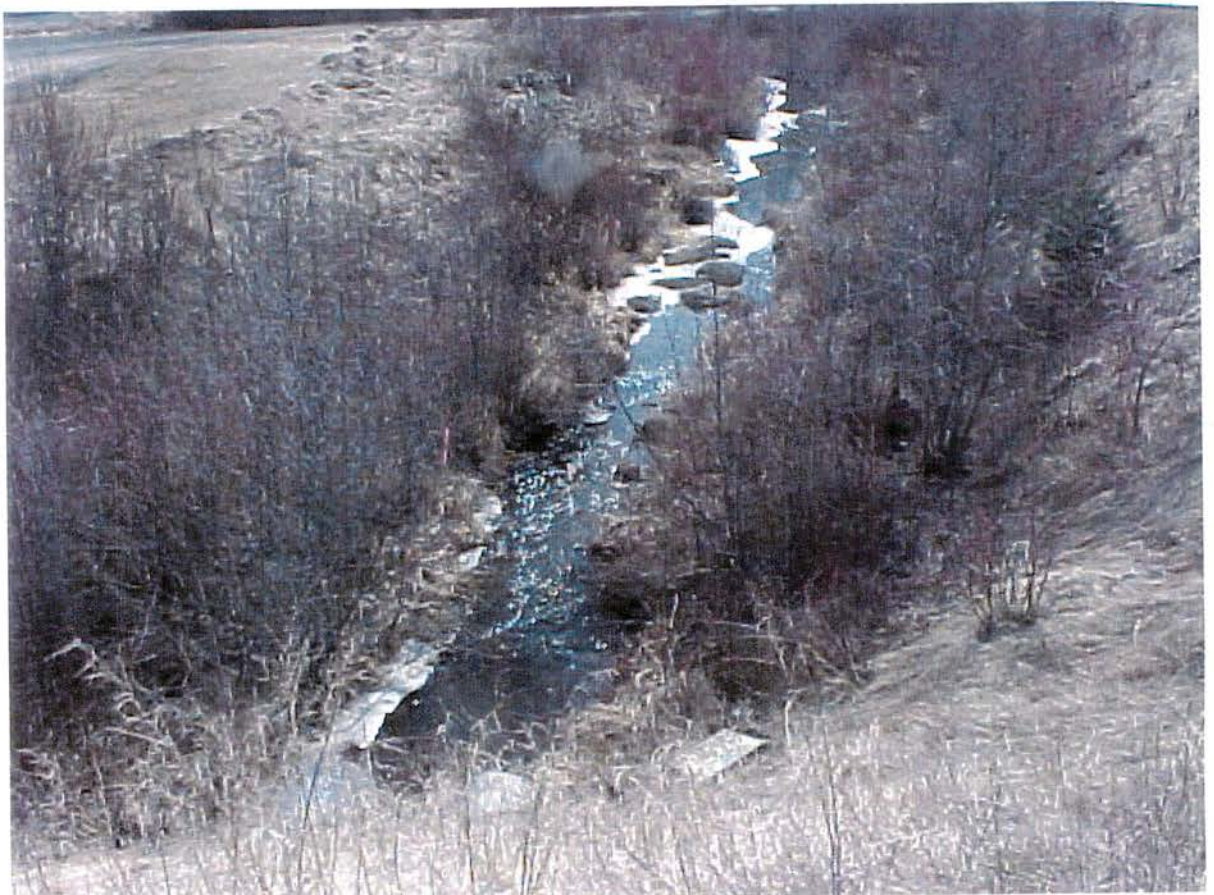
Photos
3 & 4

Site #2: Date of survey Dec. 12/00

- Length 92m, ave. channel width 4m, ave. wetted width 2.5m
- Ave. max. riffle depth 20cm, ave. max. pool depth 40cm
- Gradient 1%
- 20% pool, 30% riffle, 20% run, 30% flat, 20% side channel presence, 20% debris unstable
- Total cover 40%: composition – 20% pool, 20% instream veg. 30% overstream veg., 30% cutbank
- Crown closure 20%, aspect South
- Substrate: 20% fines, 15% small gravel, 10% large, 20% small cobble, 20% large, 15% boulder, compaction moderate
- Bank height .3m, 50% unstable, texture fines & gravels, valley channel ratio 2 – 5 and frequently confined, 0% bar presence
- Flow stage low, water temperature <1 degree Celsius, flood signs .3m
- Comments: water flowing under culverts at lower end of site

Above: Site 2 Viewed from culverts at Eleventh Avenue, looking upstream.
Below: Site 2 Viewed from Highway 16, looking downstream.

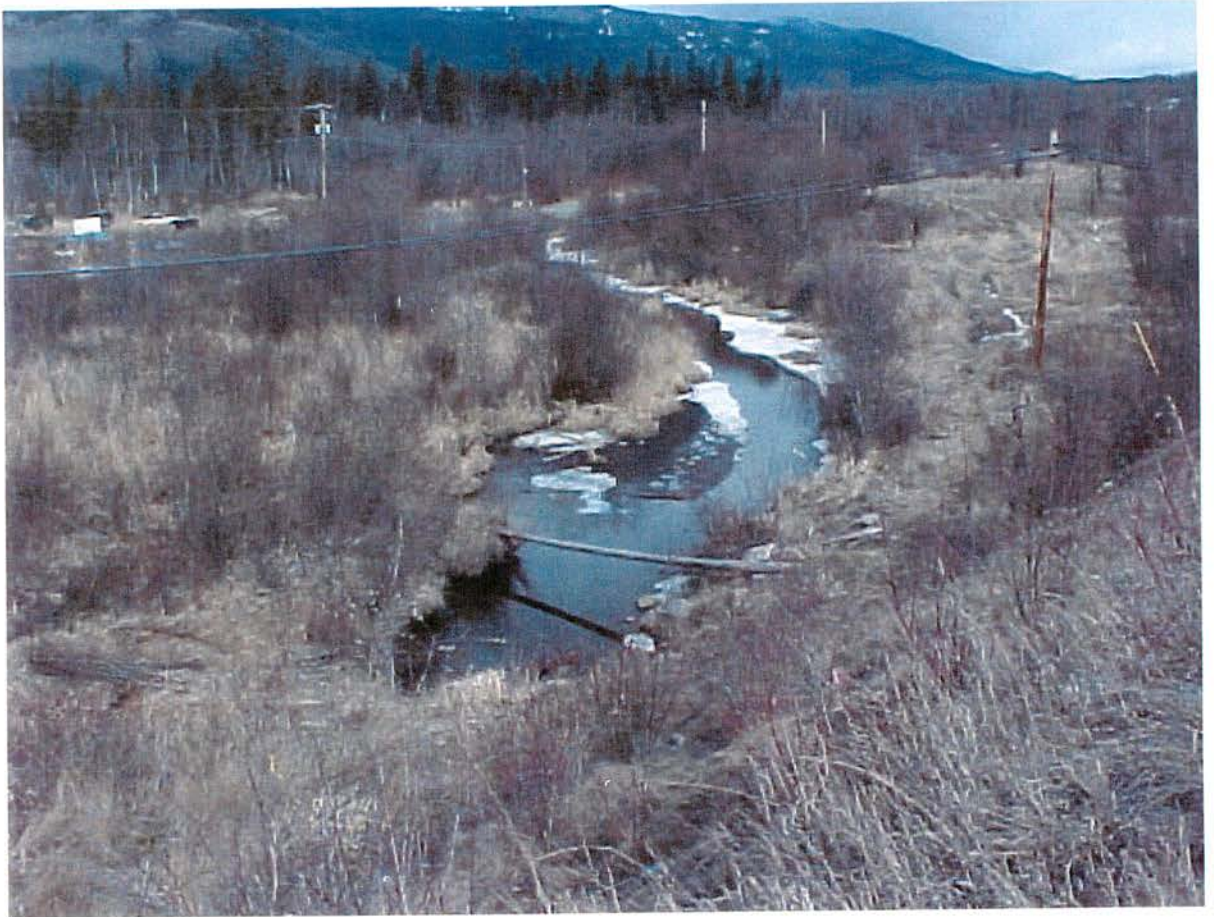
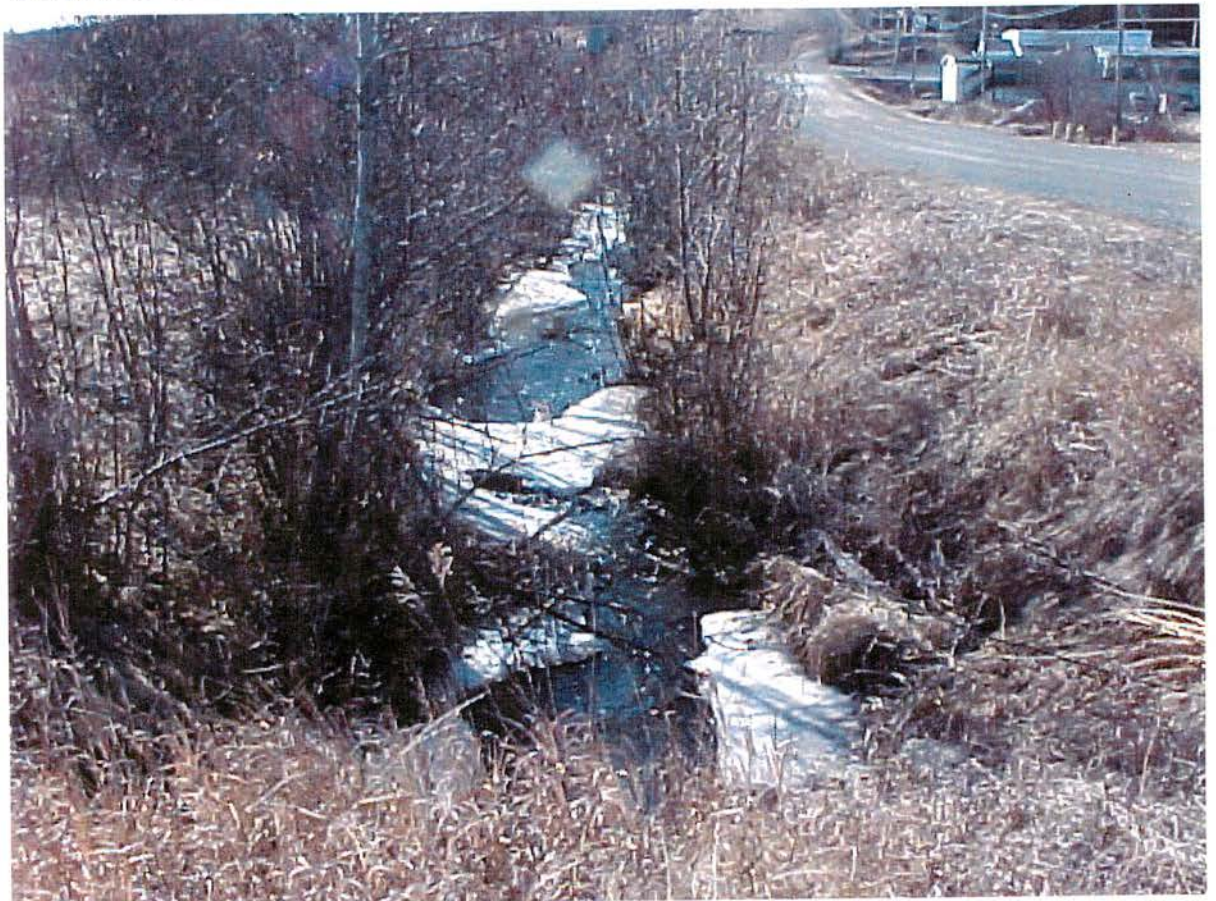
Photos
5 & 6

Site #3: Date of survey Dec. 14/00

- Length 239m, ave. channel width 3.5m, ave. wetted width 2.5m
- Ave. max. riffle depth 30cm, ave.max. pool depth 50cm
- Gradient 1%
- 20% pool, 30% riffle, 30% run, 20% flat, side channel 15%, 10% debris unstable
- Total cover 50%: composition – 30% pool, 20% overstream veg., 30% cutbank, 20% cobble boulder
- Crown closure 30%, aspect West/Southwest
- Substrate: 20% fines, 10% small gravel, 20% large, 15% small cobble, 20 large cobble, 15% boulder, compaction moderate
- Bank height .5m, 50% stable, texture gravels & fines, Occasionally confined
- Flow stage low
- Deep pool above hwy 16 culverts, 75cm depth

Above: Site 3 Viewed from Highway 16, looking upstream.

Below: Site 3 Viewed from culverts to be retained, looking downstream.

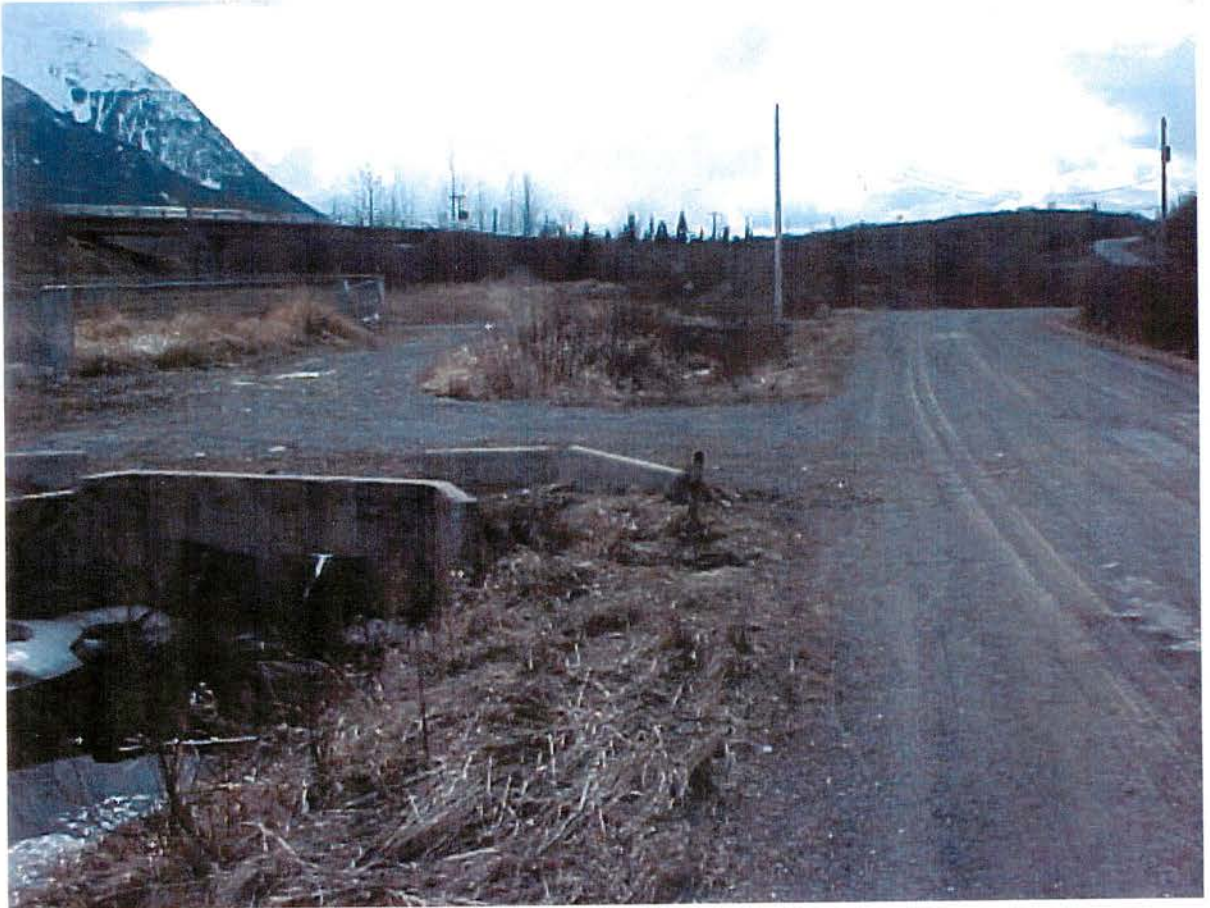
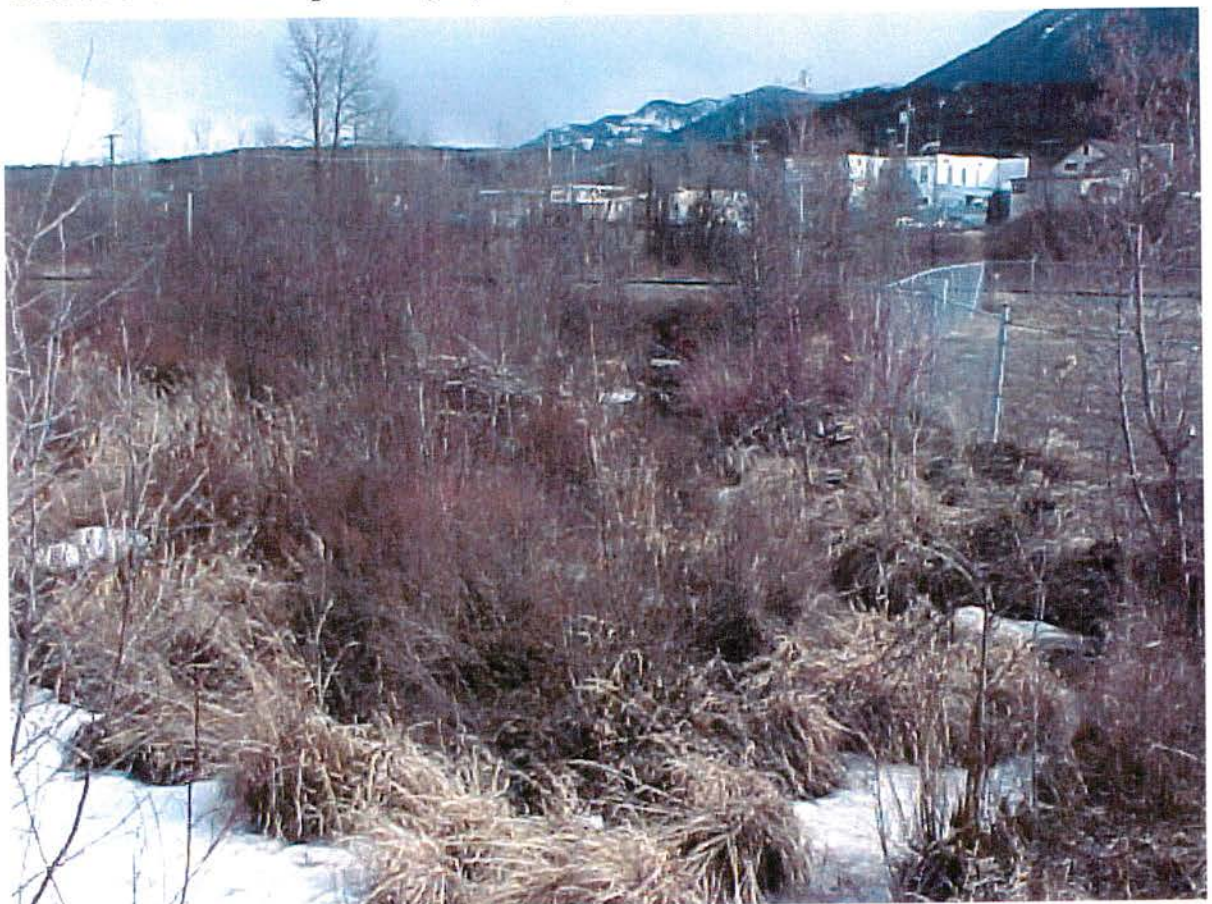
Photos
7 & 8

Above: Site 3 Showing culverts to be removed at bulk plant, looking downstream.
Below: Site 4 Showing site of proposed pool at former bulk plant, looking upstream.

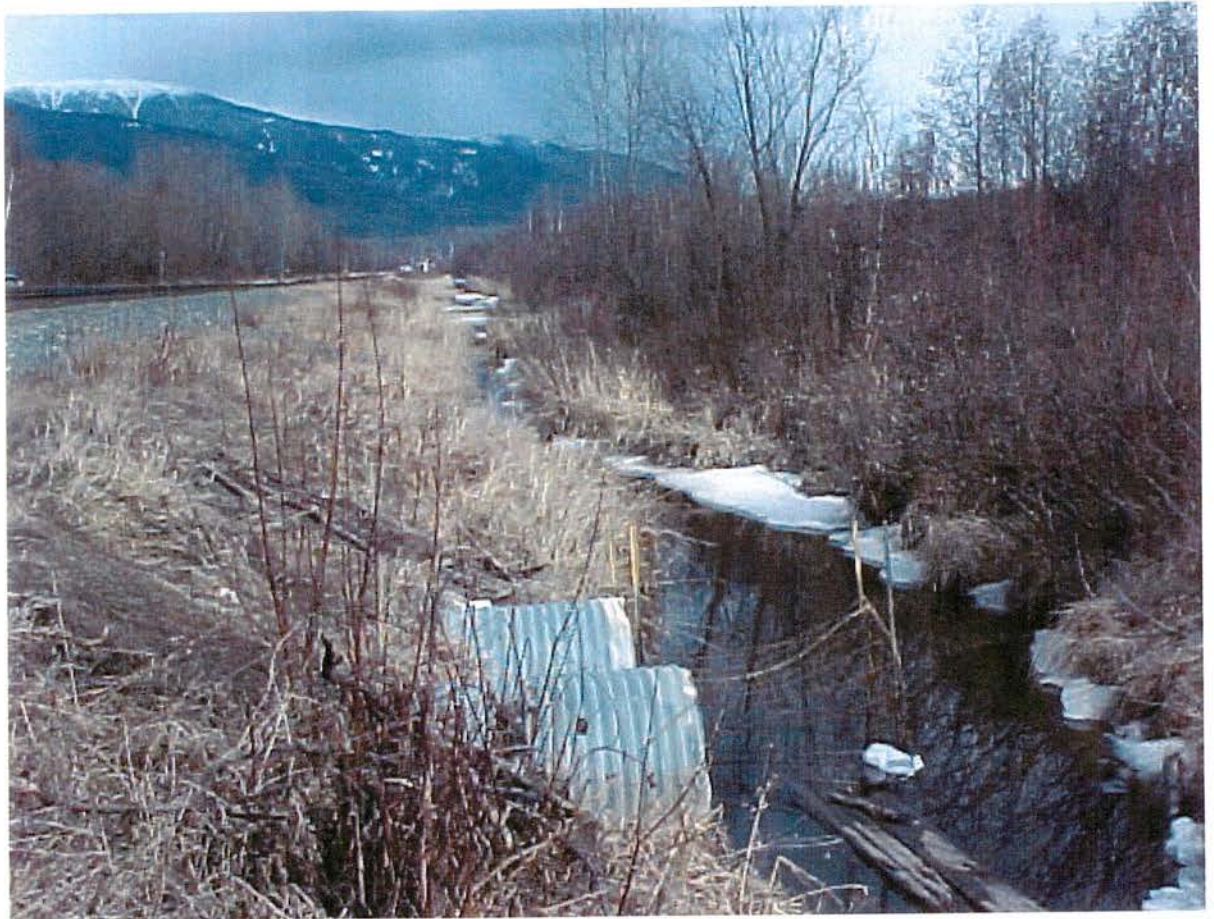
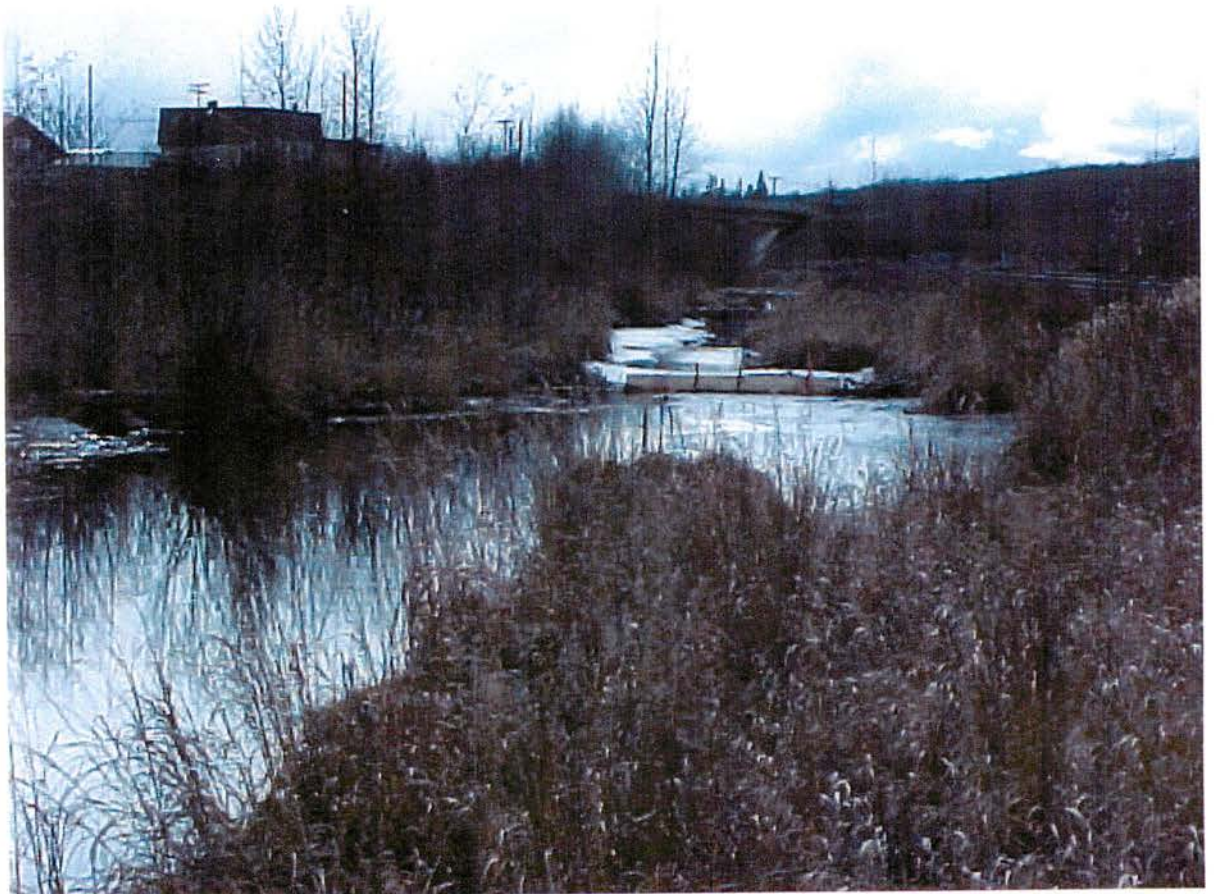
Photos
9 & 10

Site #4: FOC fish sampling site, with berm construction fall 2000 and site investigation. Refer to FOC for site info.

Above: Site 4 View from culverts under CN tracks, looking upstream.

Below: Site 4 Showing a temporary weir at midpoint, looking downstream.

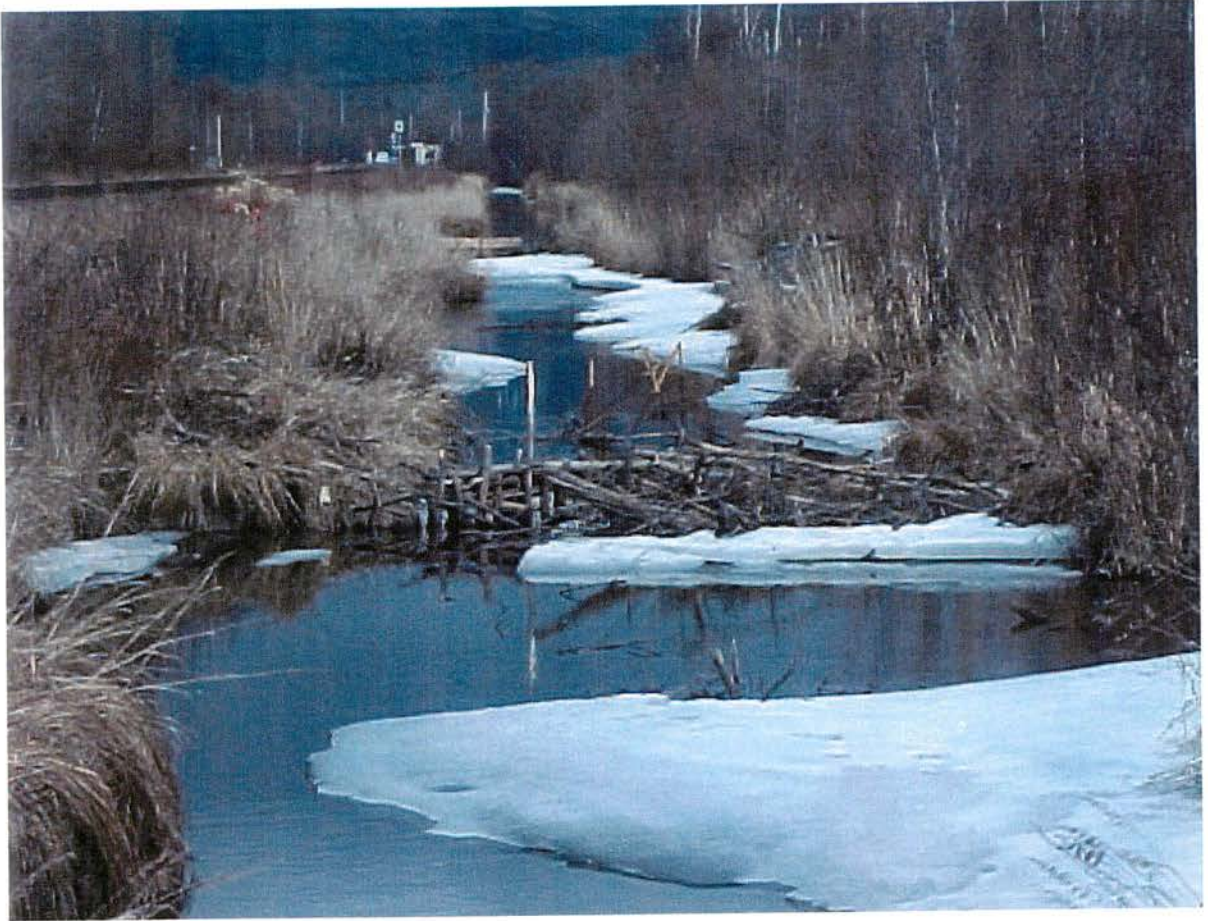
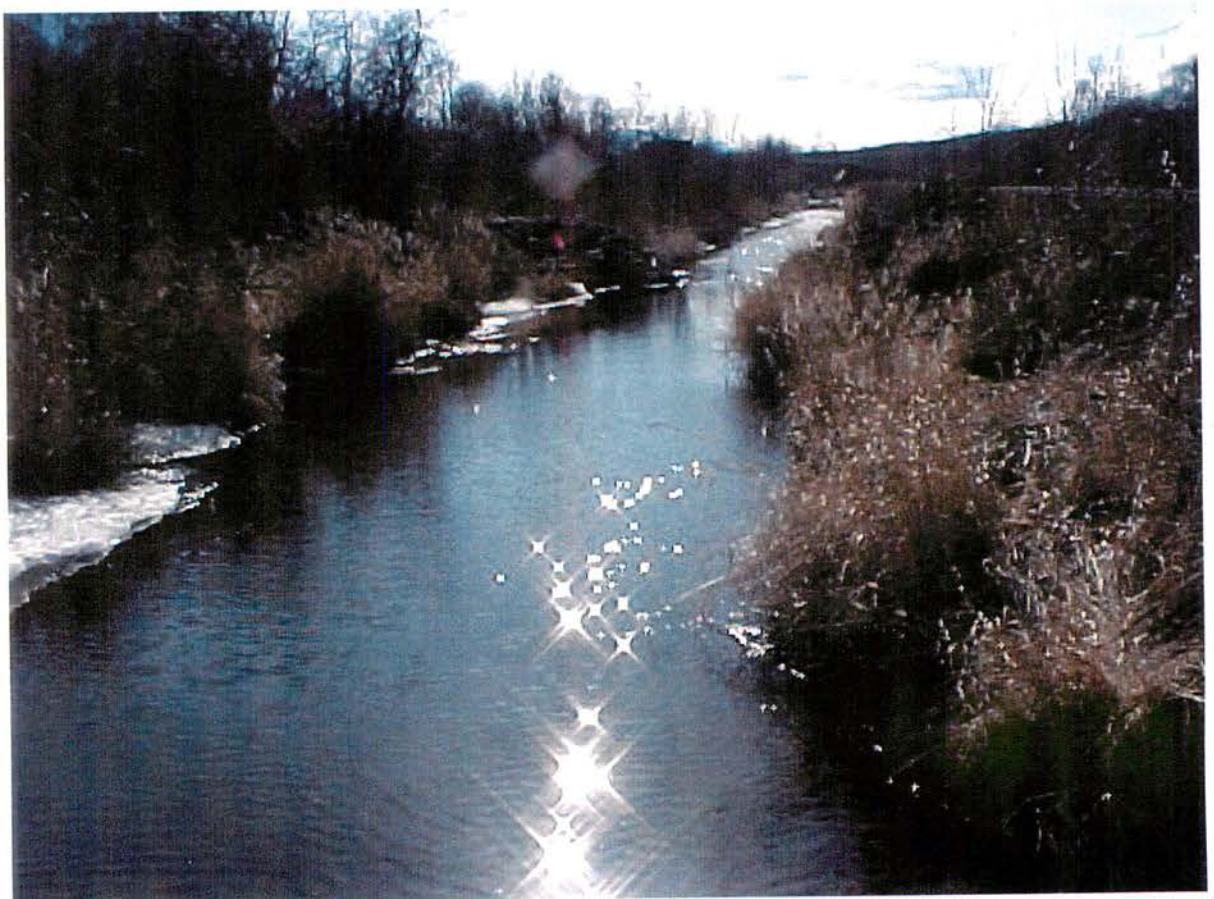
Photos
11 & 12

Above: Site 4 View from weirs at midpoint, looking upstream.
Below: Site 4 View from upper end, looking downstream.
