**HABITAT CONSERVATION FUND**

**FINAL REPORT**

**PROJECT NAME:**           Unnamed Kispiox Lake (Bartok Lake)  
Outlet spawning gravel placement

**FISCAL YEAR:**           1991-92

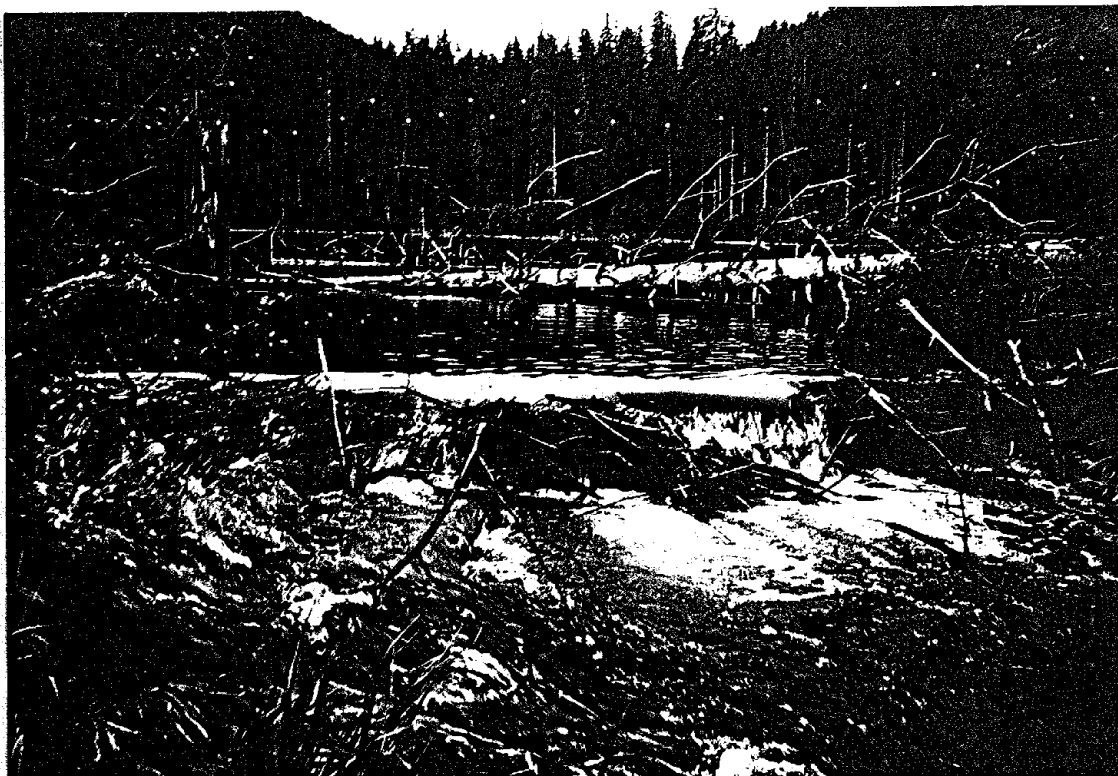
3. Small beaver dam at outlet of Bartok Lake.

The gravel and boulder placement was completed and rainbow trout were observed on the gravel the following spring. Beavers had constructed a dam at the lake outlet which was removed on May 29, 1991. The enhancement was assess again on June 15, 1991. About six pairs of rainbow trout were observed on the gravel. Spawning

From the initial assessment the project appears to be a success. Further assessment of utilization will be necessary to get an accurate estimate for the number of trout using the gravels. The outlet stream should be monitored during the spawning season to remove recurring beaver dams. The lake should be sampled within the next three years to assess the growth rates of the rainbow trout, to assess recruitment from the spawning pads and to determine if further stocking will be required.

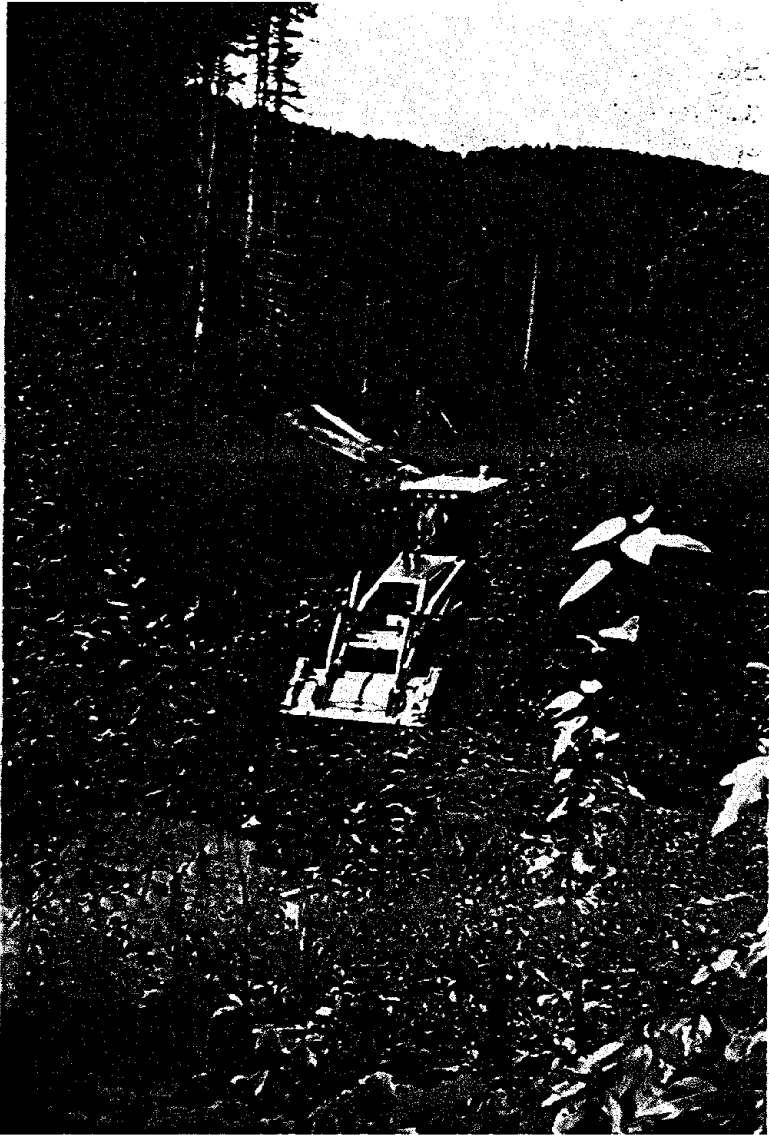
3. The backhoe excavating the old stream channel

The enhancement site was located about 80 km north of Hazelton adjacent to a mainline logging road (Mitten Main). ON September 25, 1990 a case 510 4 x 4 backhoe with a 20 foot extendahoe was used to excavate the mud and debris from the old stream bed, to a dept of 50 cm.

The backhoe started digging at the log culvert under the logging road and dug the channel out as it moved upstream to the lake outlet. The new channel was 26 metres long and varied between 2.5

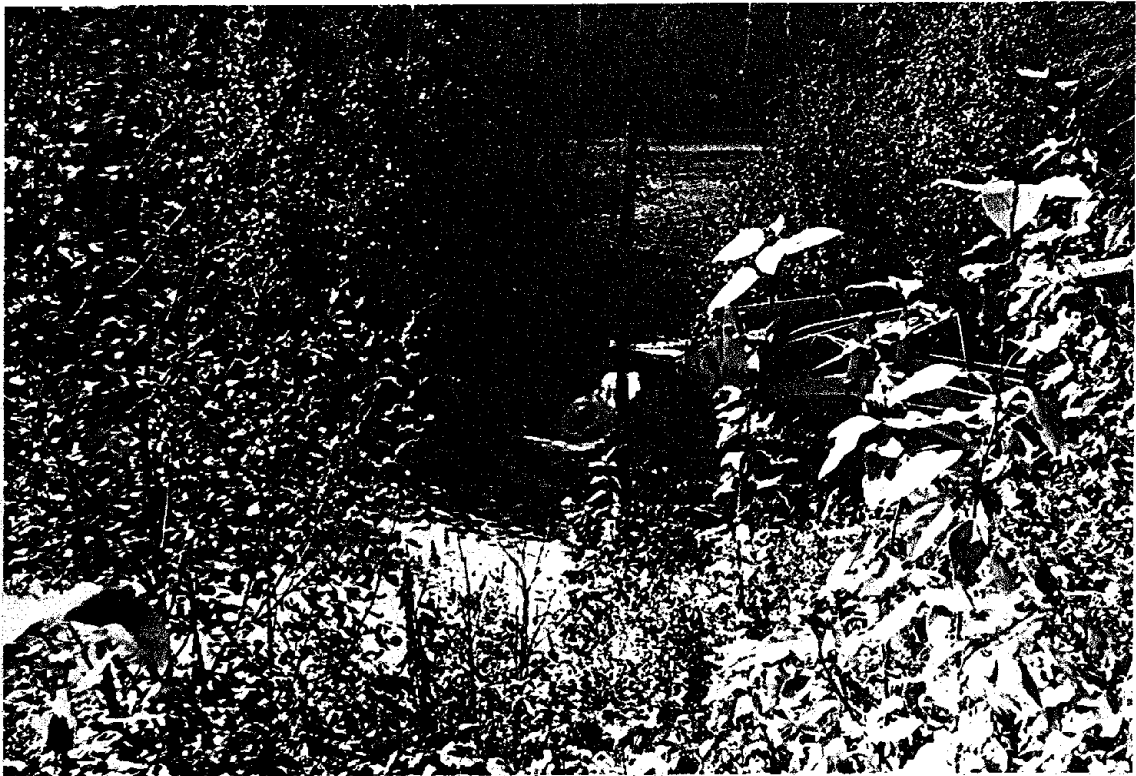
4. The backhoe placing gravels in the new channel

metres and 6 metres in width. A small beaver dam at the lake outlet was left in place to keep water out of the work area. After the excavation was completed the backhoe used its .5 yard bucket to transport the 18 yards of washed and screened gravel to the new channel. The gravel varied in size between .5 inches and one inch. After the gravel was placed in the channel the backhoe moved up to the lake outlet and placed the remainder of the gravel. The beaver dam was then removed to allow the creek to flow down the channel. The backhoe then proceeded to level and cleanup the worksite in preparation for seeding the area with grass seed.

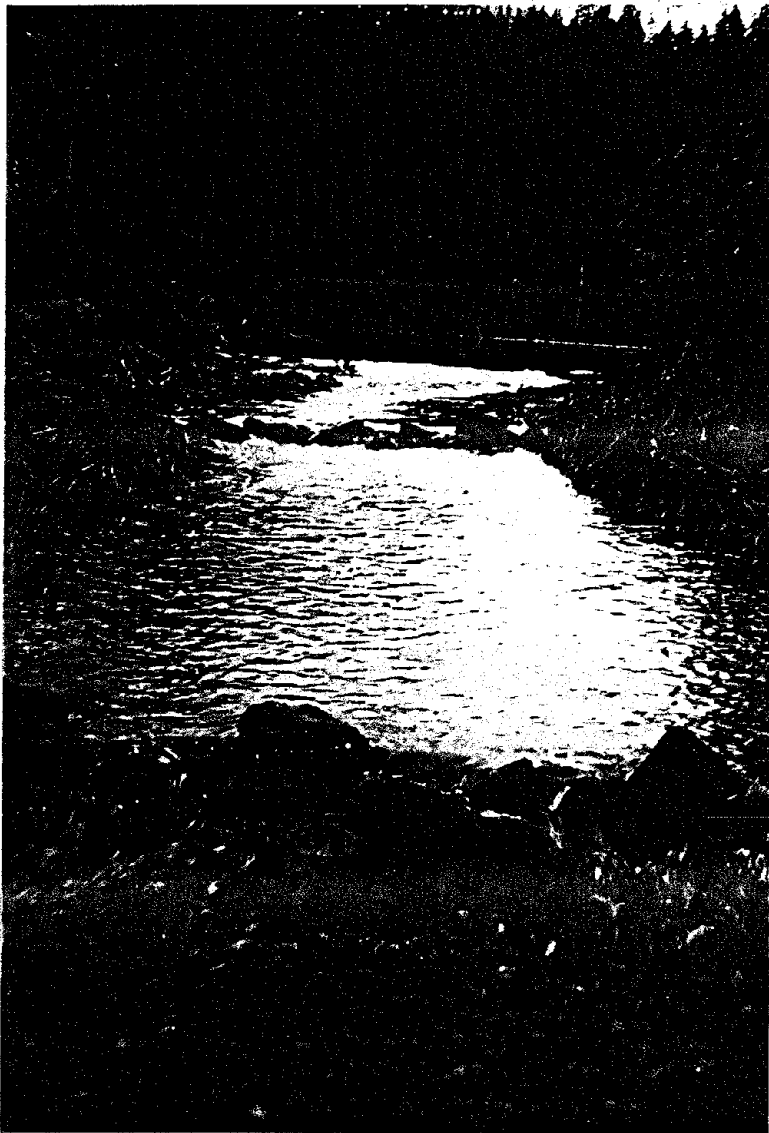
8. Lake outlet after enhancement
