# Zymoetz Watershed Restoration Program Aquatic Habitat Rehabilitation Works Summary Report

16-Km Side Channel (Site 54B)

### Zymoetz Watershed Restoration: 16 Km Side Channel (Site 54B)

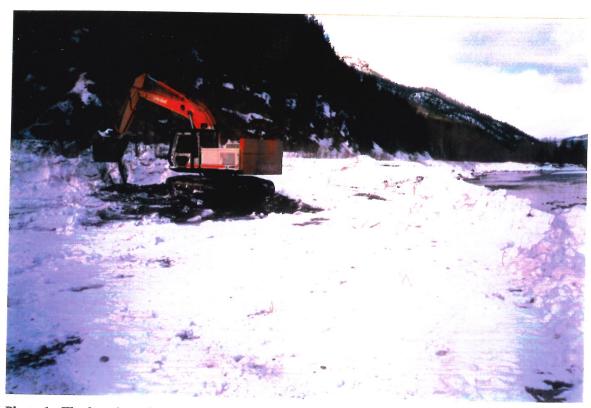
Photo 1. The location of 16-Km side channel before excavation began.

The following steps were taken beginning on March 13, 1999 when a John Deer 550 bulldozer cleared 1m of snow off of the dry channel as the first step to excavate a test channel (Photo 1):

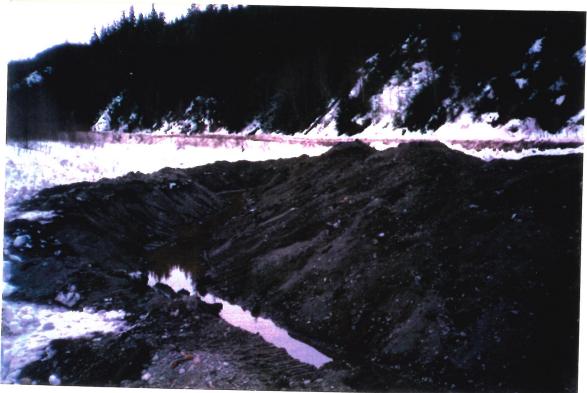
Photo 2. 16-Km side channel during the excavation.

- A Link-Belt 3400 excavator was used to dig the channel to a depth of 1.3 m at the top end to nearly 3 m where it meets the Zymoetz River (Photo 2);
- The channel was excavated 1m wide at its wetted width for a distance of 150m. The depth of the water was 10 to 20cm with flow of about 0.5cu.m/sec into the Zymoetz River. The goal was not to maximize the water flow, but to determine if a constant flow could be accessed at the lowest level of the water table. On March 27, the water flow in the channel was about triple the flow of March 17;

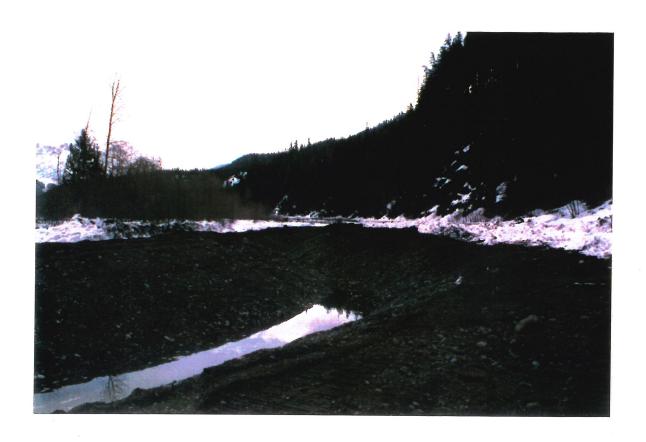
Photo 3. 16-Km side channel after bank sloping.

- The banks of the test channel were graded back to about 2:1 slope and leveled off along the top (Photo 3);
- The channel was meandered throughout its length instead of the original straight ditch design in order to simulate a more natural configuration.
